Final Reclamation Inspection

Operator: Noble Energy

Location ID: 327002

Weld County, CO

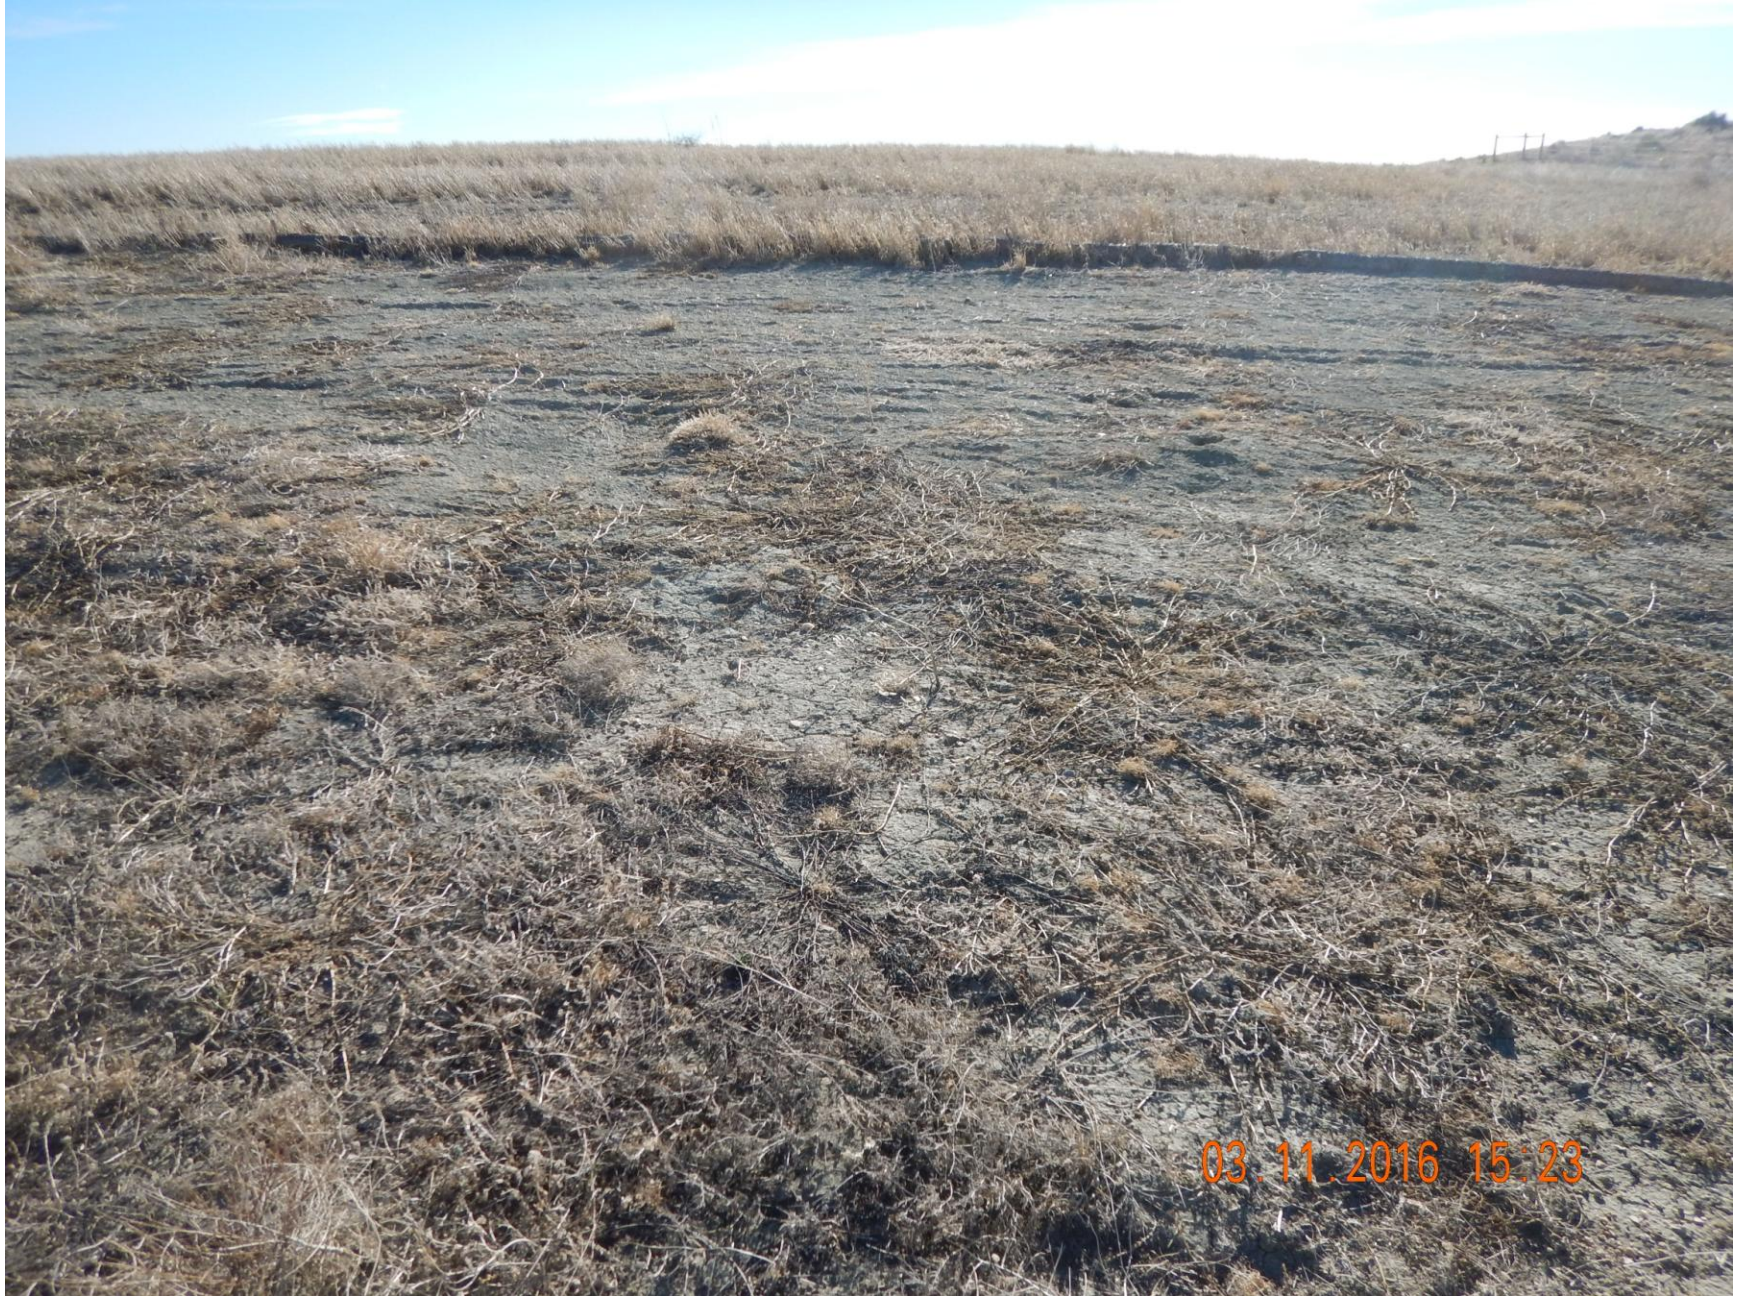
Figure 11: Photo taken from the north end of the location, facing south. Photo shows location has not achieved uniform vegetative distribution. Undesirable weedy plant species such as puncture vine shown in photo.

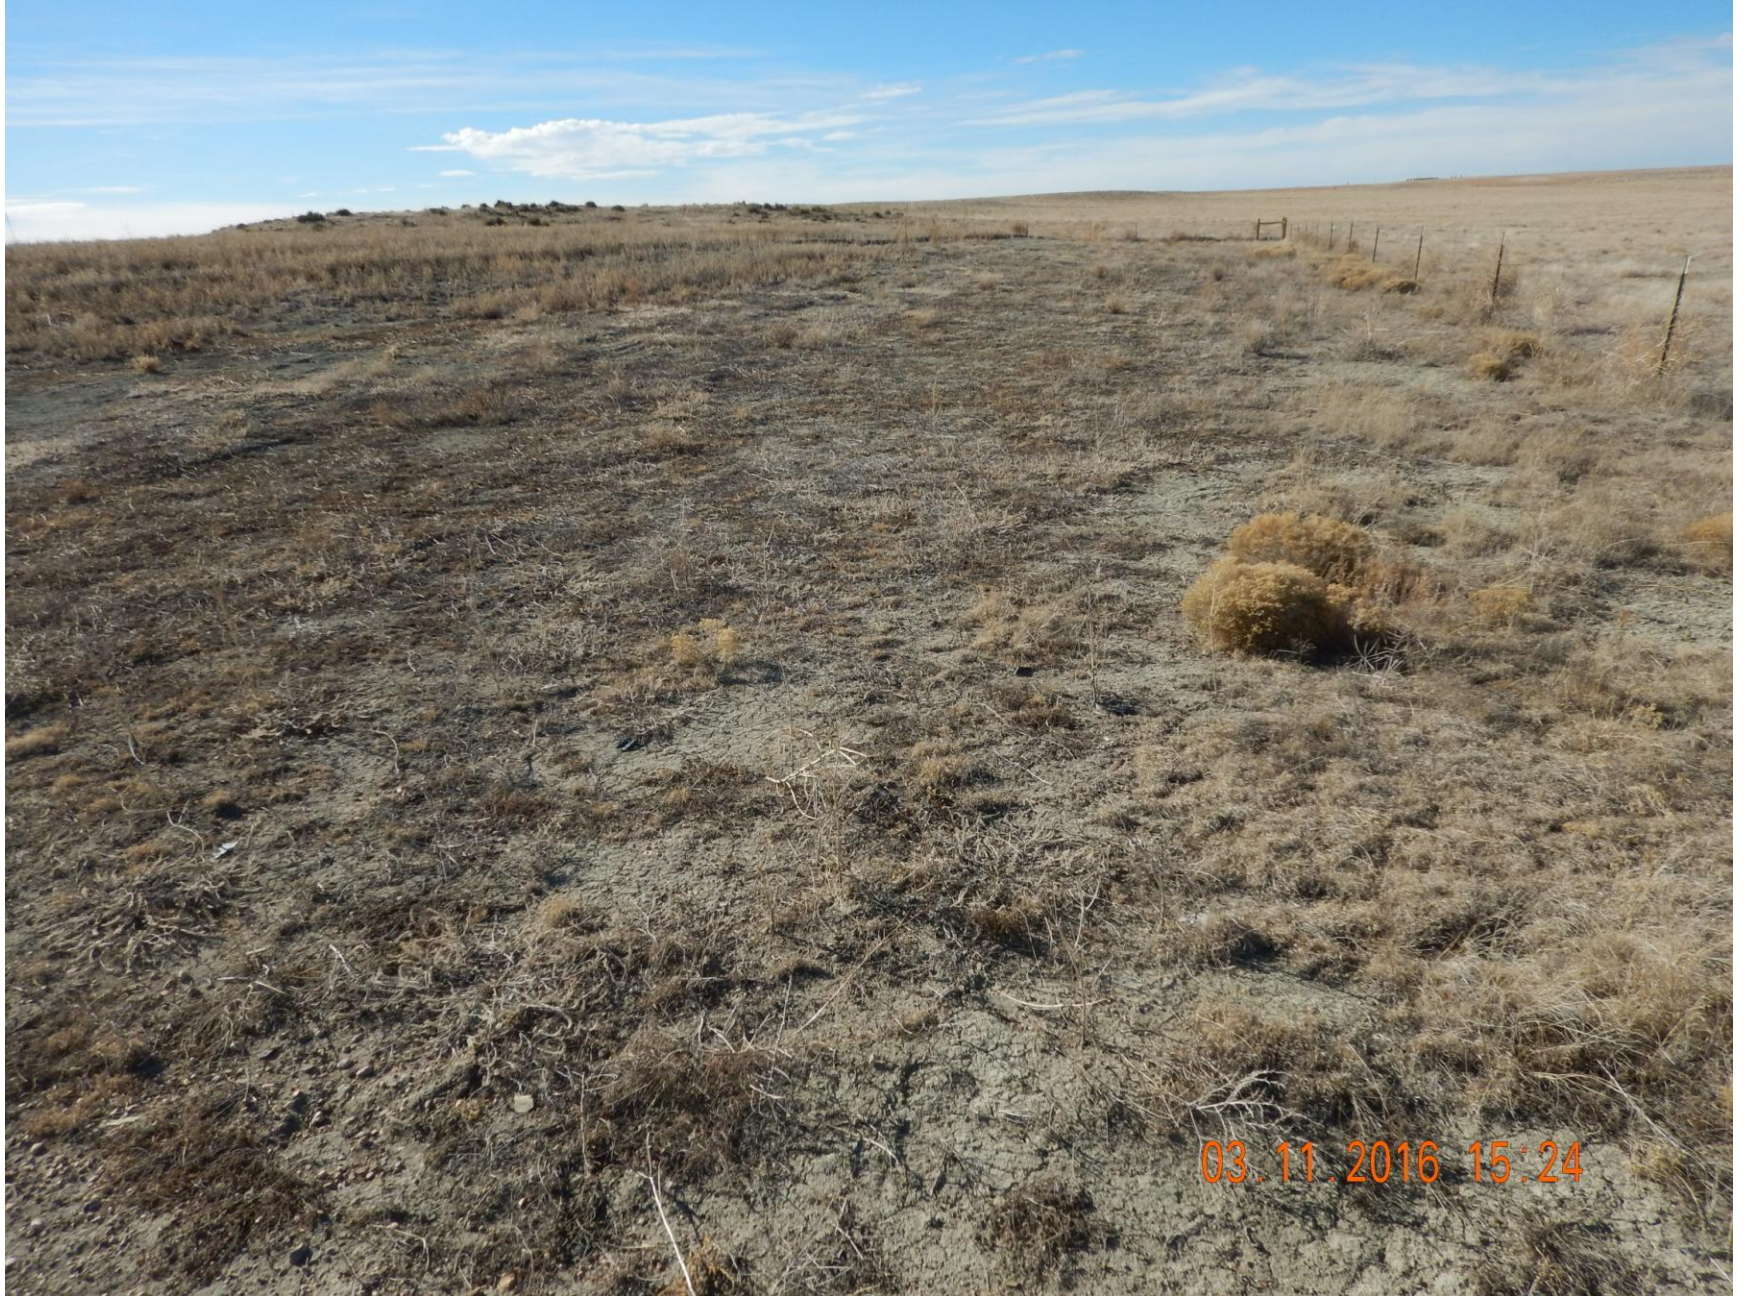
Figure 12: Photo taken from the northeast end of the location, facing west. Photo shows location has not achieved uniform vegetative distribution.

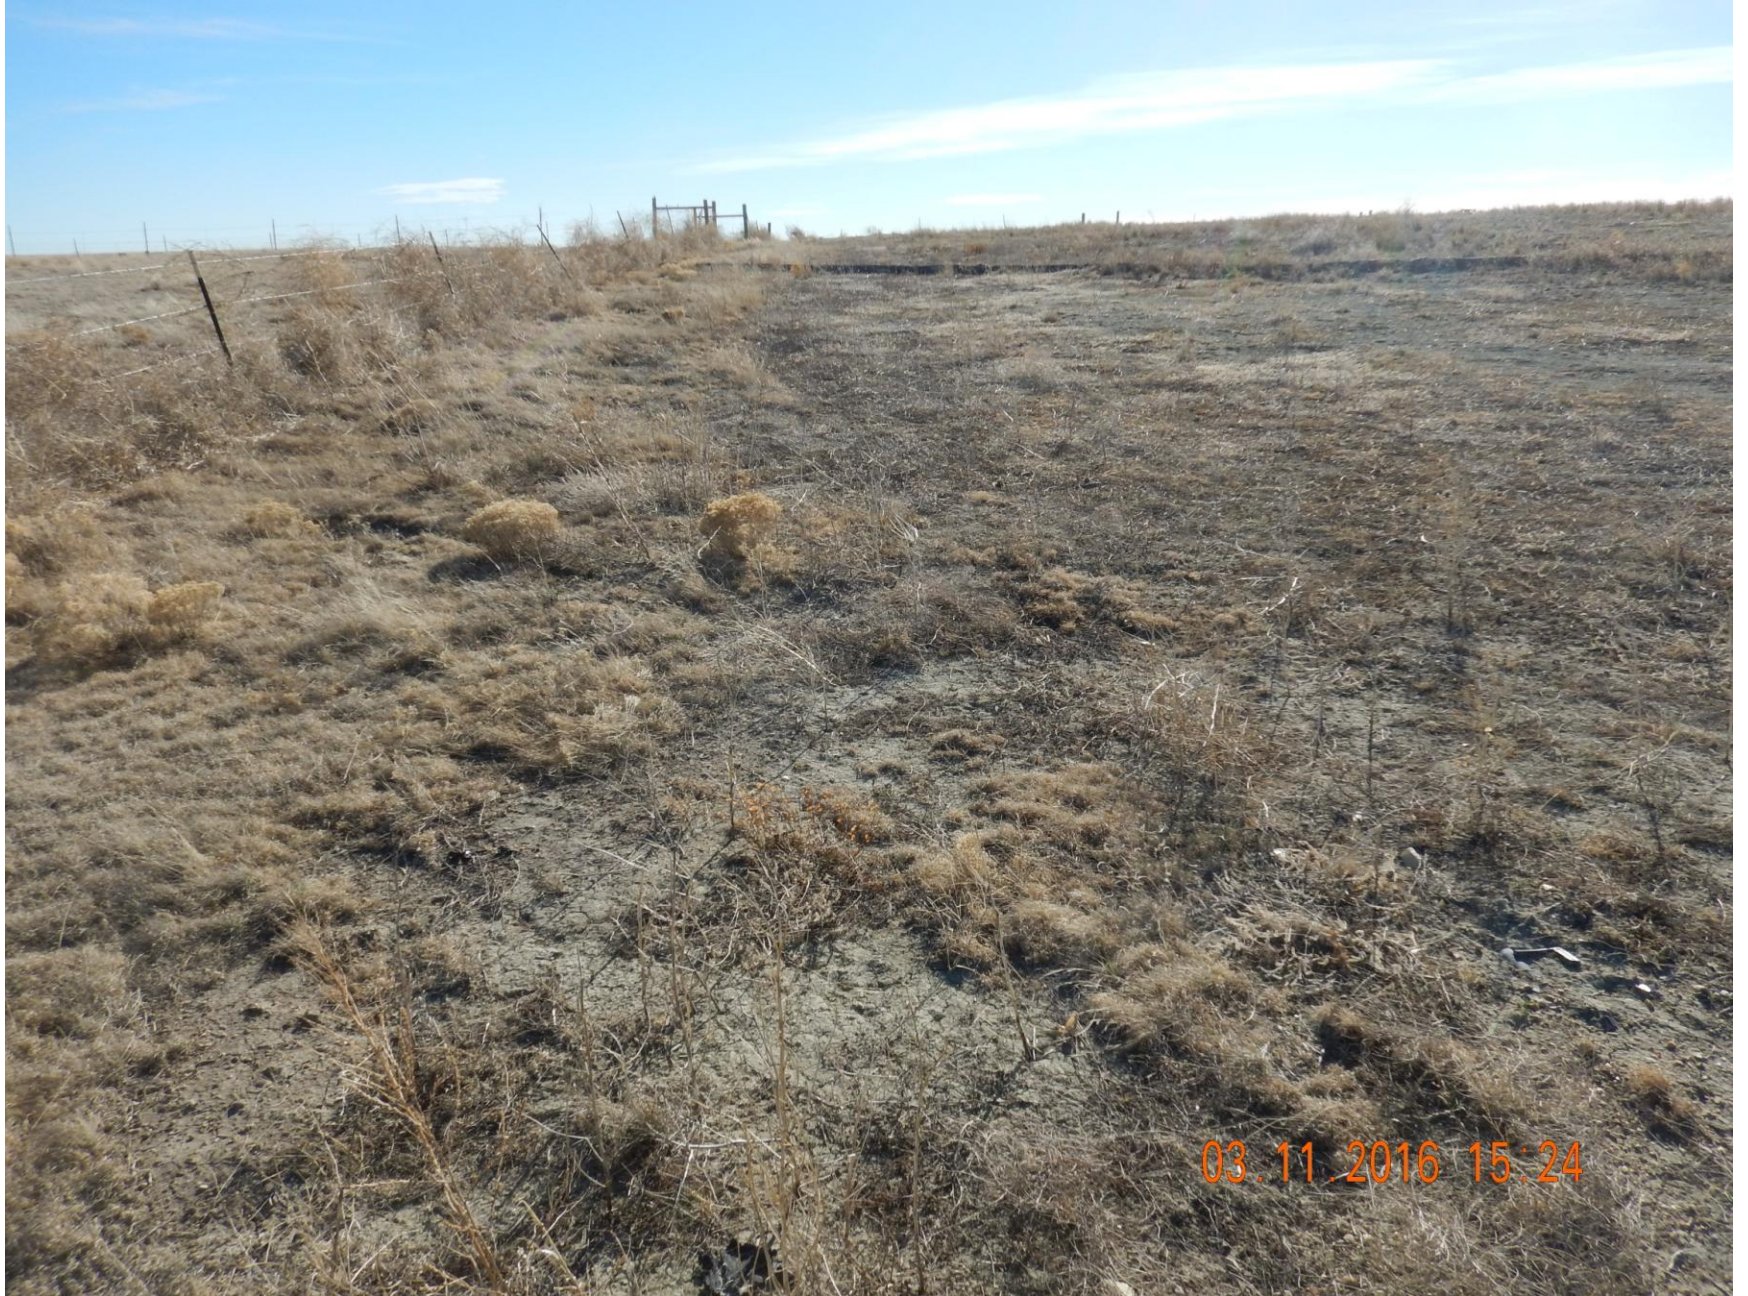
Figure 13: Photo taken from the northeast end of the location, facing south. Photo shows location has not achieved uniform vegetative distribution.

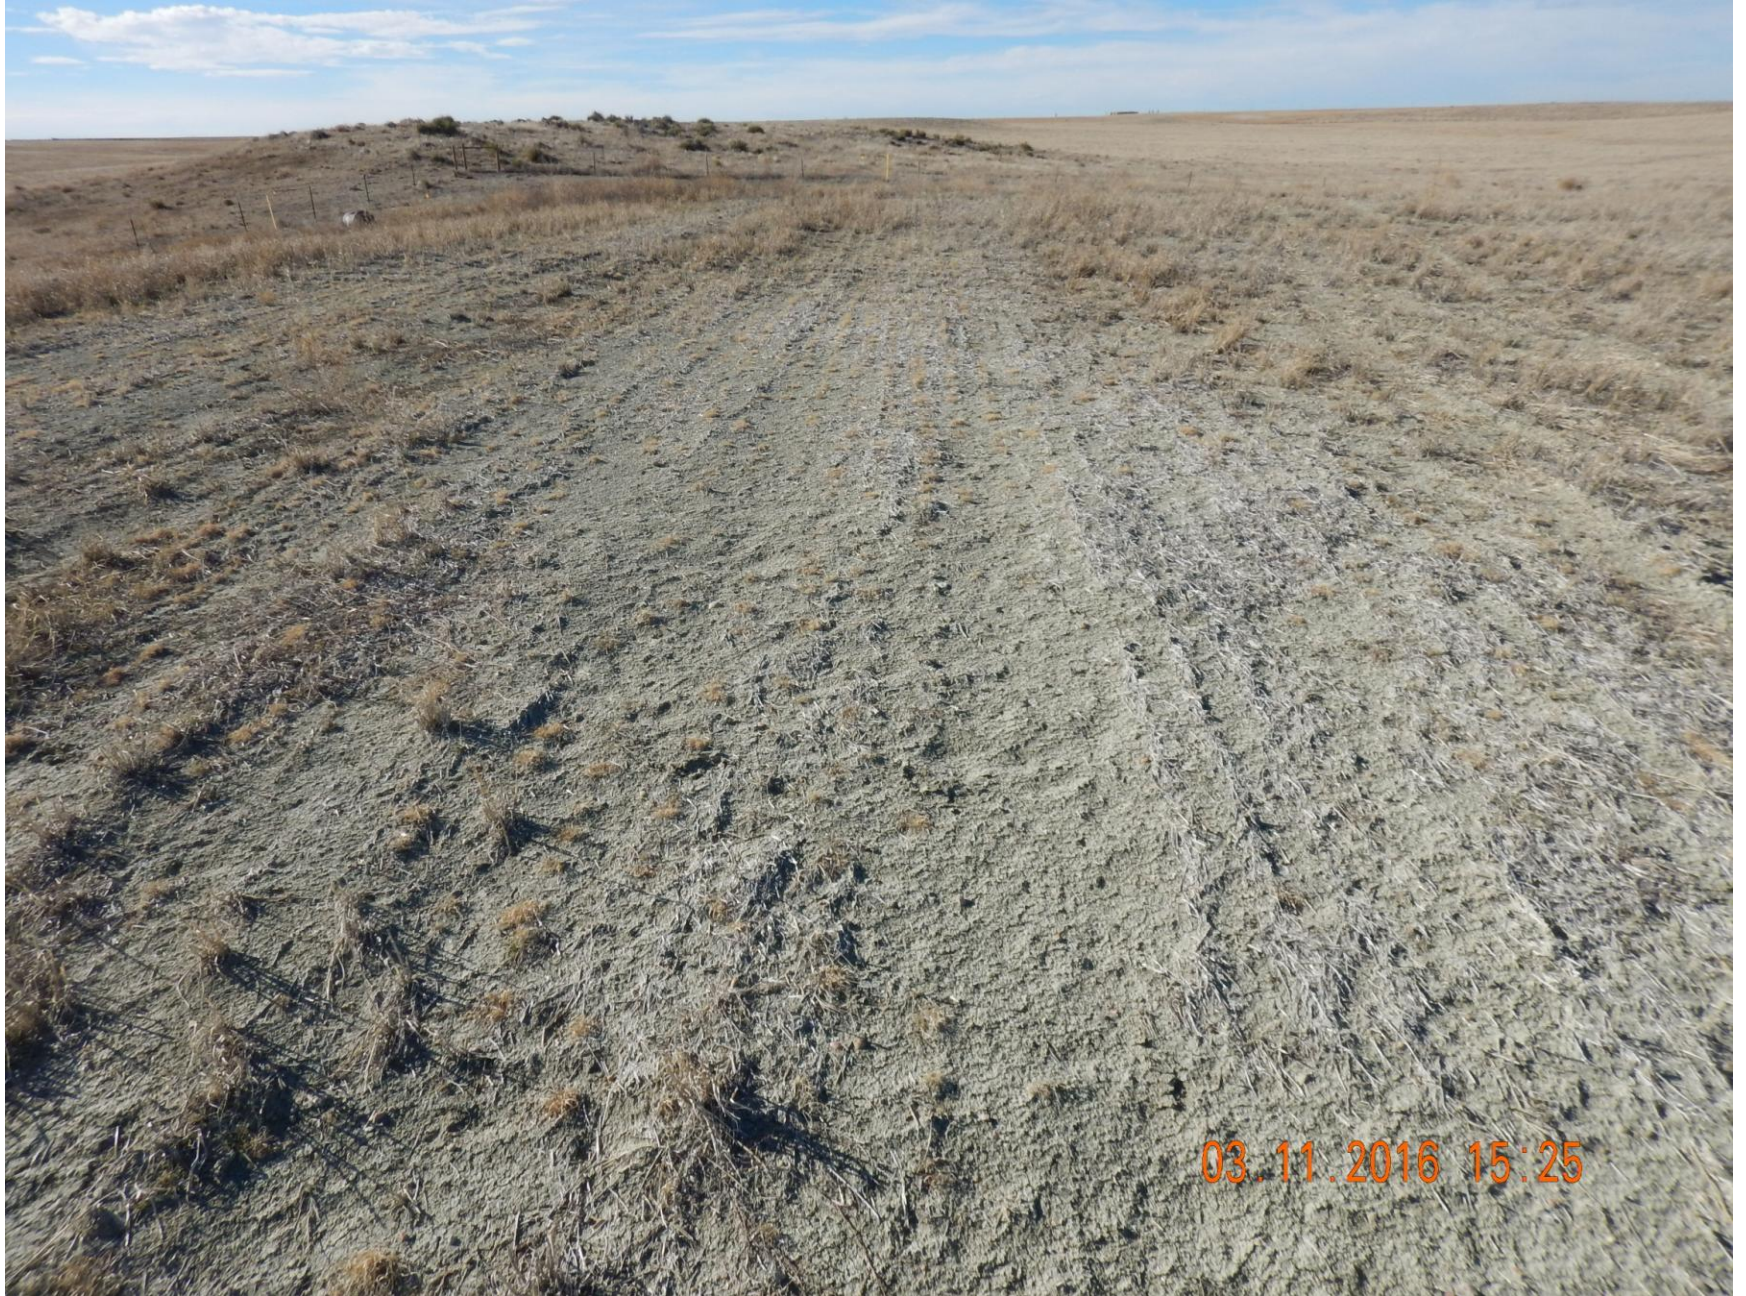
Figure 14: Photo taken from the east end of the location, facing west. Photo shows location has not achieved uniform vegetative distribution.

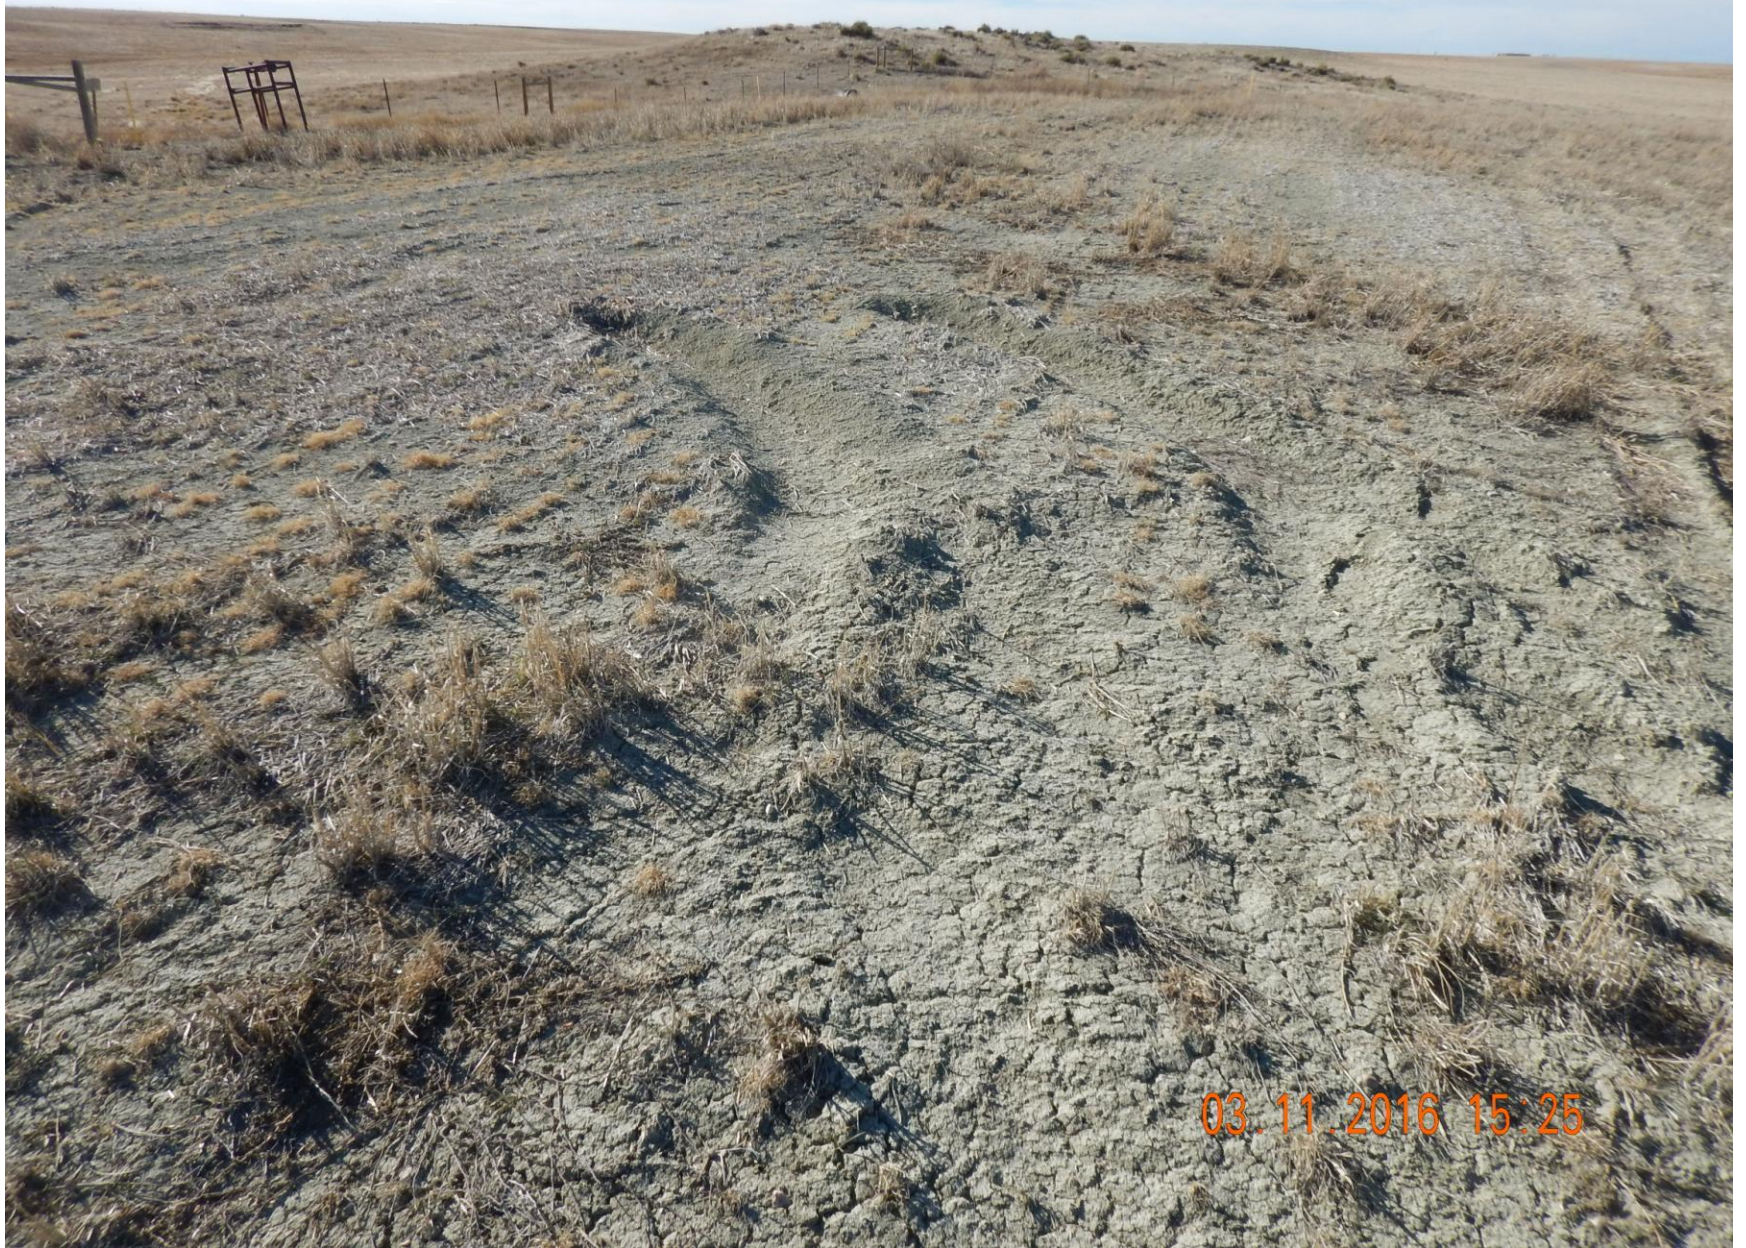
Figure 15: Photo taken from the northeast end of the location, facing west. Photo shows vehicle rutting; vehicles driving on reclamation area.
