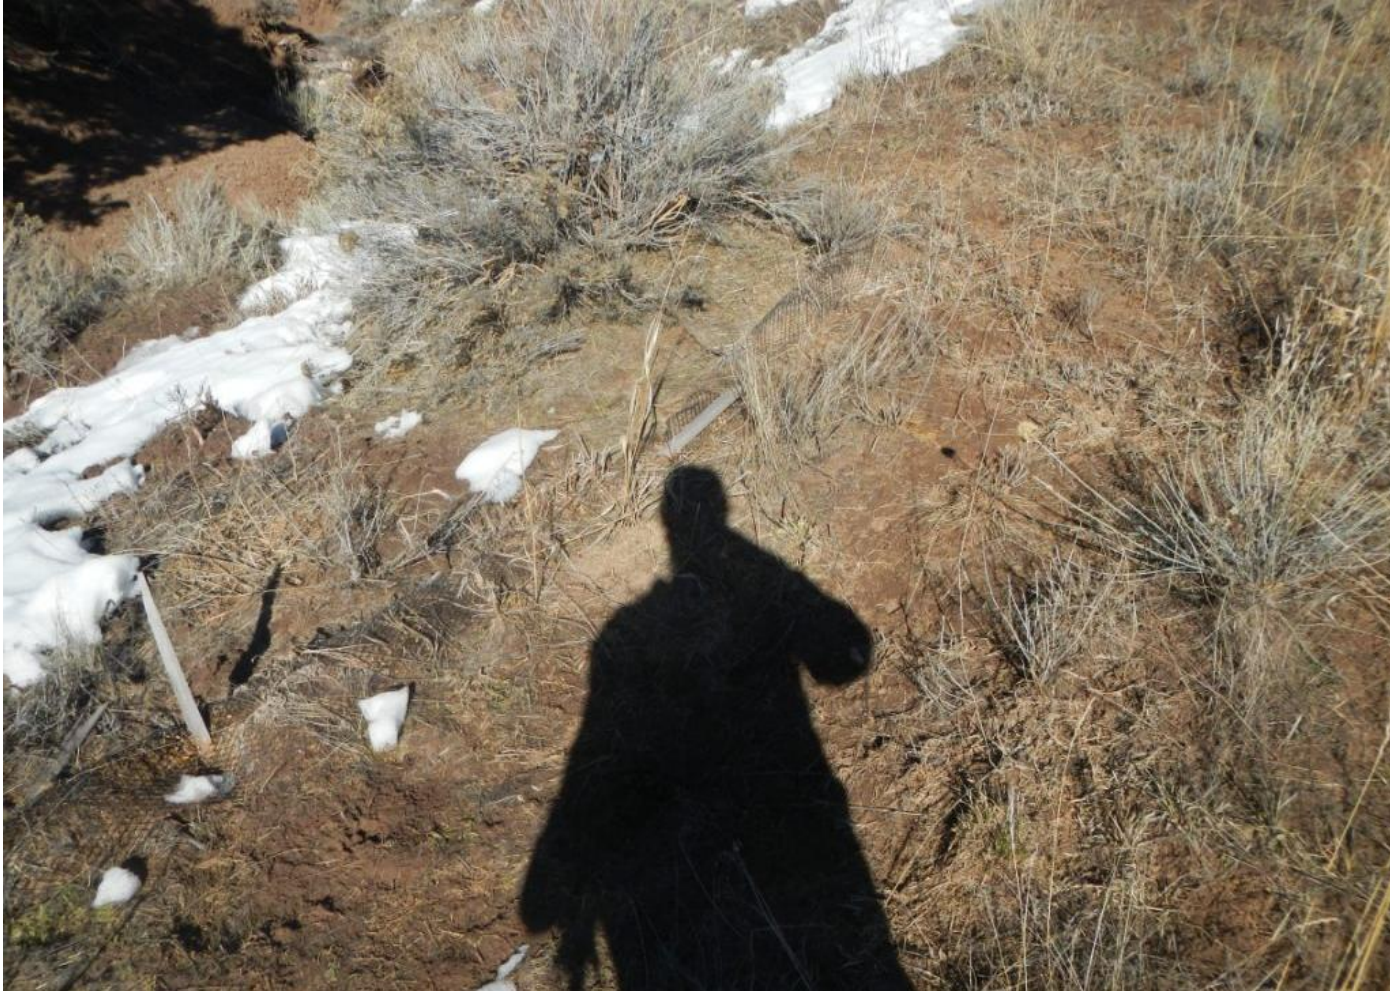
Photo 1. View of wattle along the northwestern edge of the project area and the edge of the gully that needs replacement. Contractors should be careful not to disturb vegetation while installing and maintaining BMPs on this location.

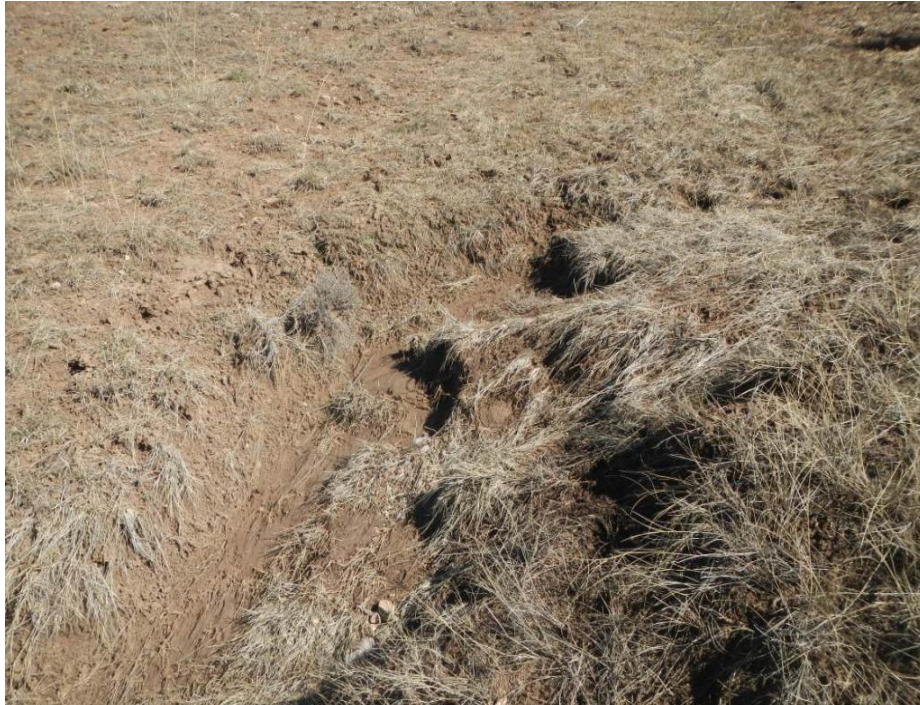
Photo 2 (on left). View of head-cut in northern portion of project area facing upstream.
Photo 3 (on right). Downstream view of head-cut shown in Photo 2 where an approximately 3 foot wide and 3 foot deep gully has formed.

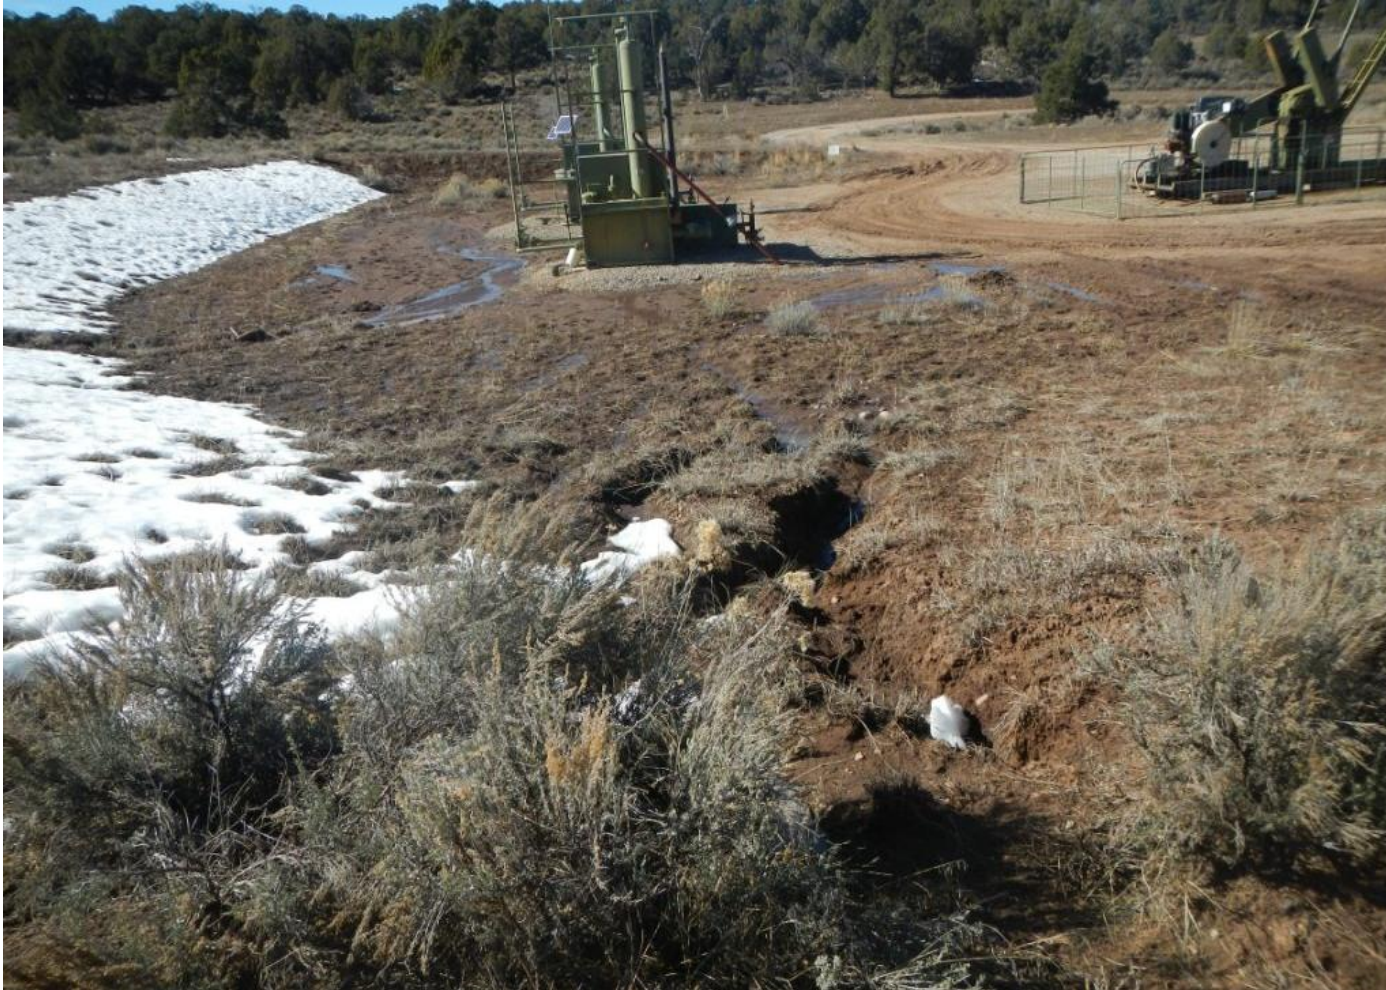
Photo 4. View of erosional channels and erosion occurring in several locations in the southeastern corner of the project area.

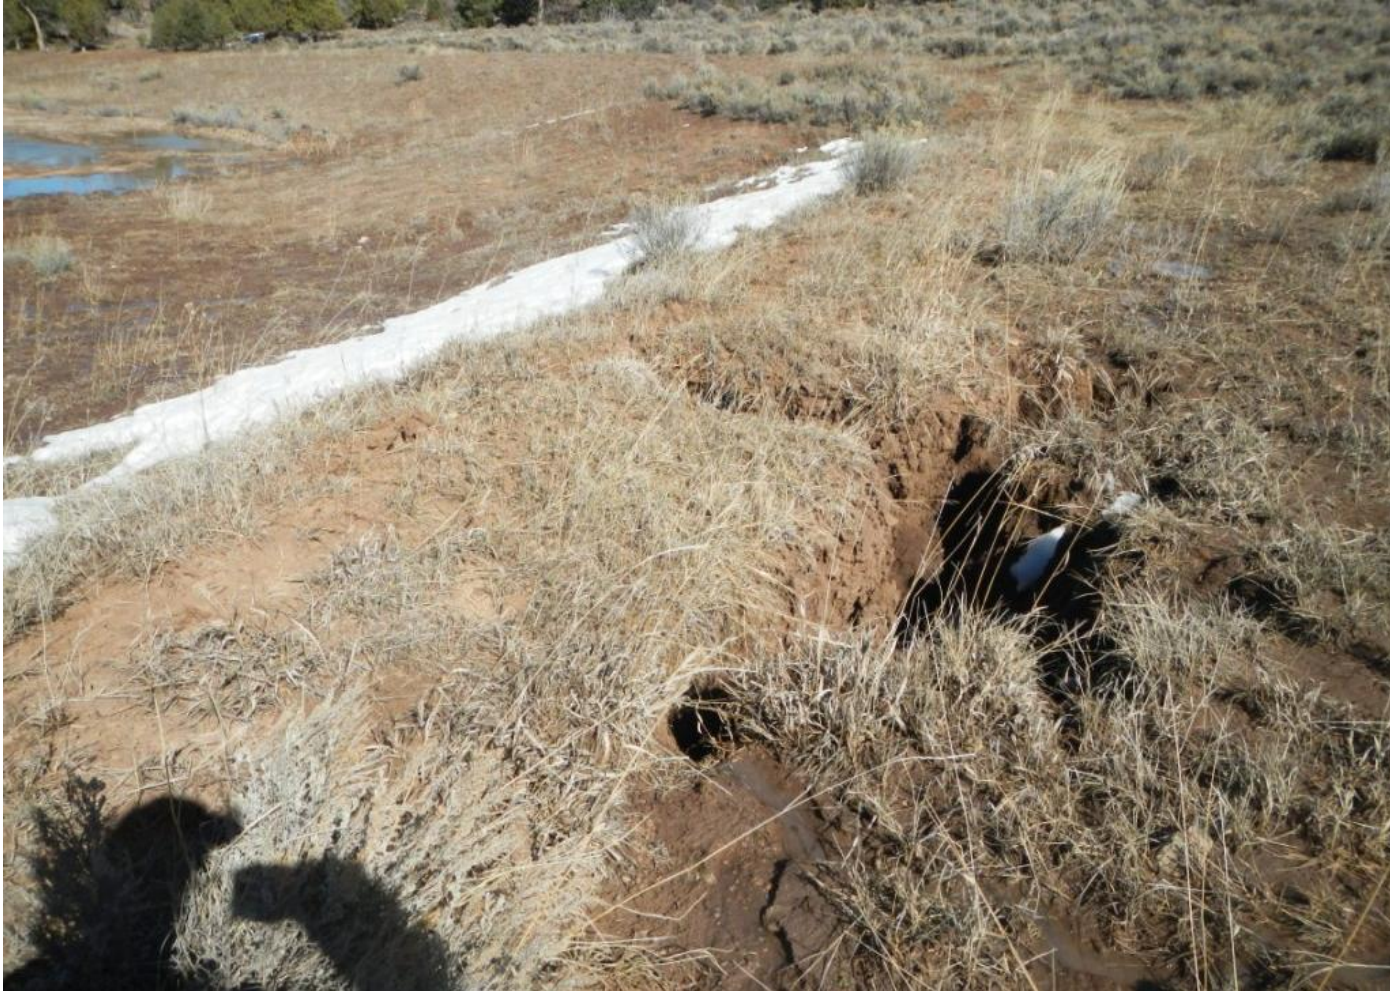
Photo 5. View of head-cut upstream from erosional channels shown in Photo 4. An approximately 6-foot-deep and 3-foot-wide-hole has eroded through the well pad here. This area needs stabilization and repair measures.

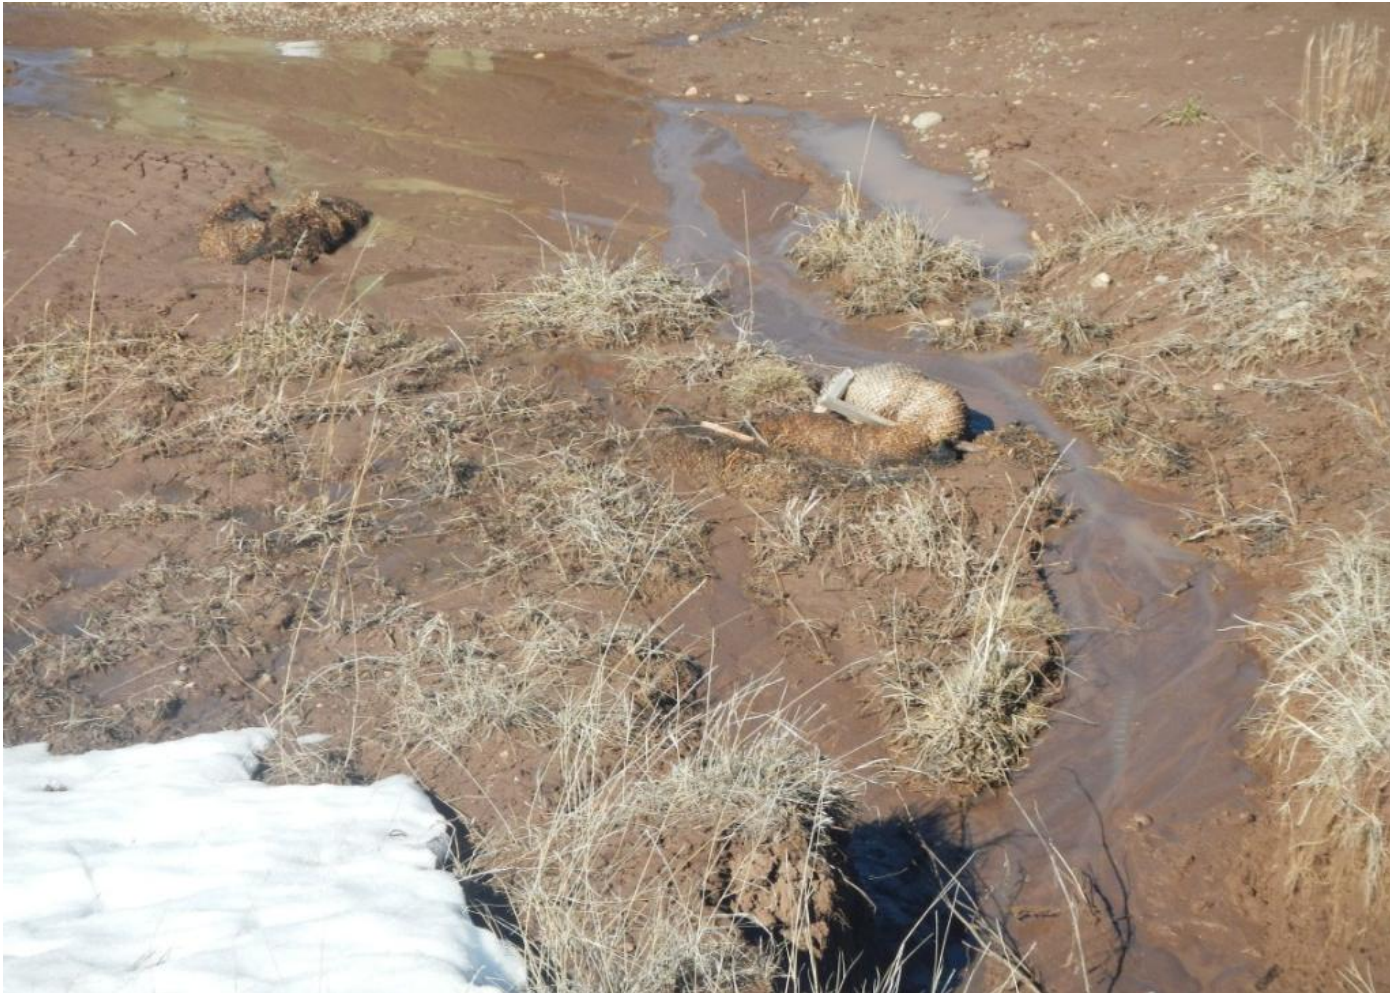
Photo 6. View of straw wattle in the southern portion of the project area that is no longer functioning.

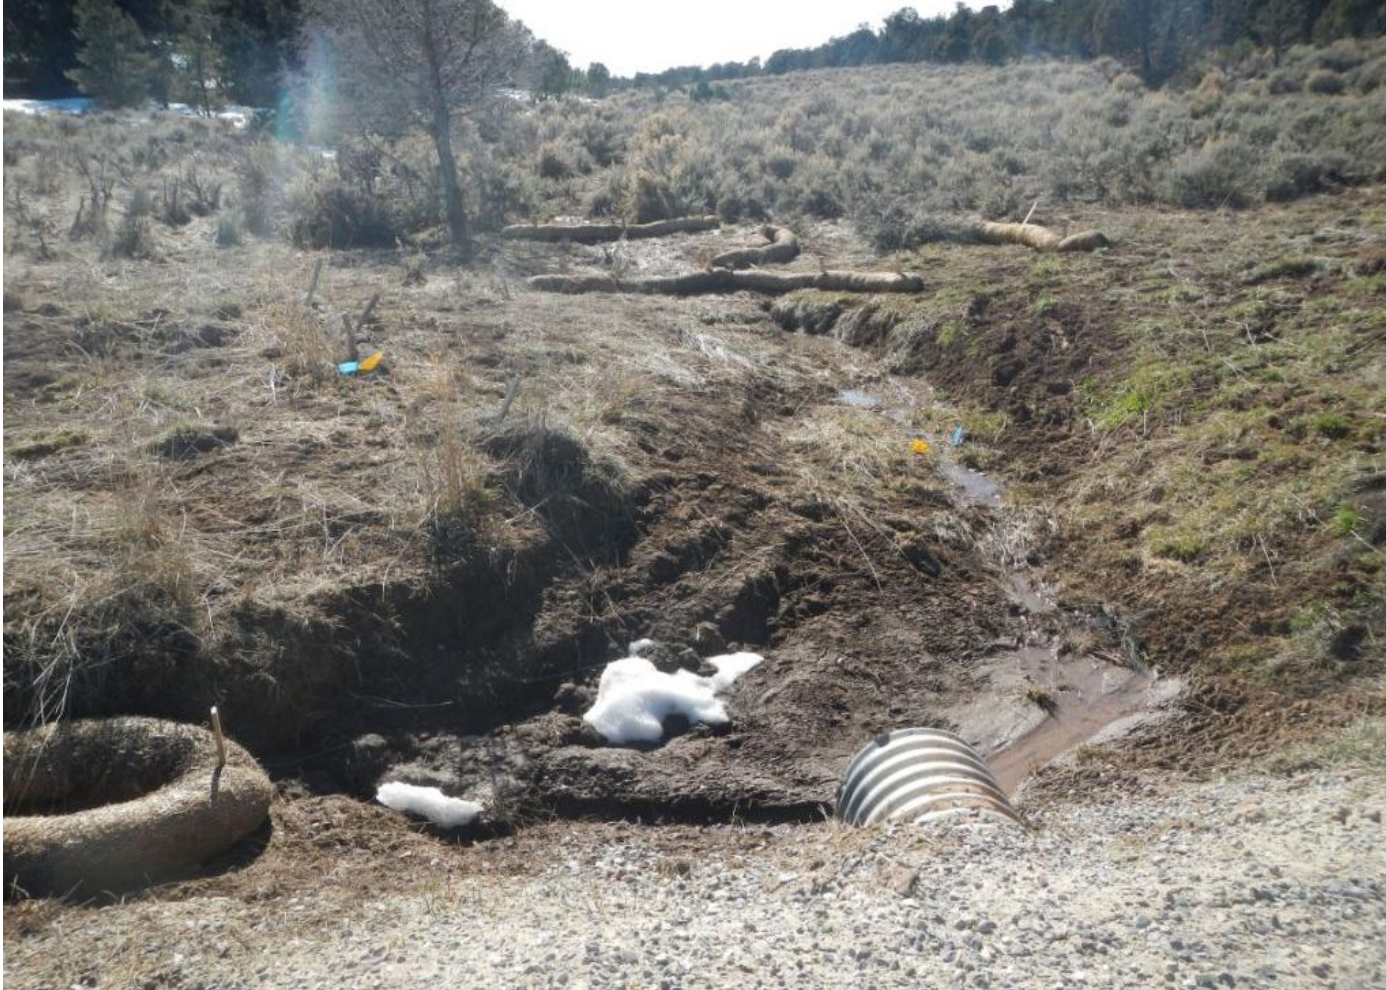
Photo 7. View of wattles at the entrance to the project area facing upstream. Many of these wattles appear to be functioning. Some need maintenance and/or replacement. Wattles may not be sufficiently de-energizing stormwater flows coming off of well pad (on left).

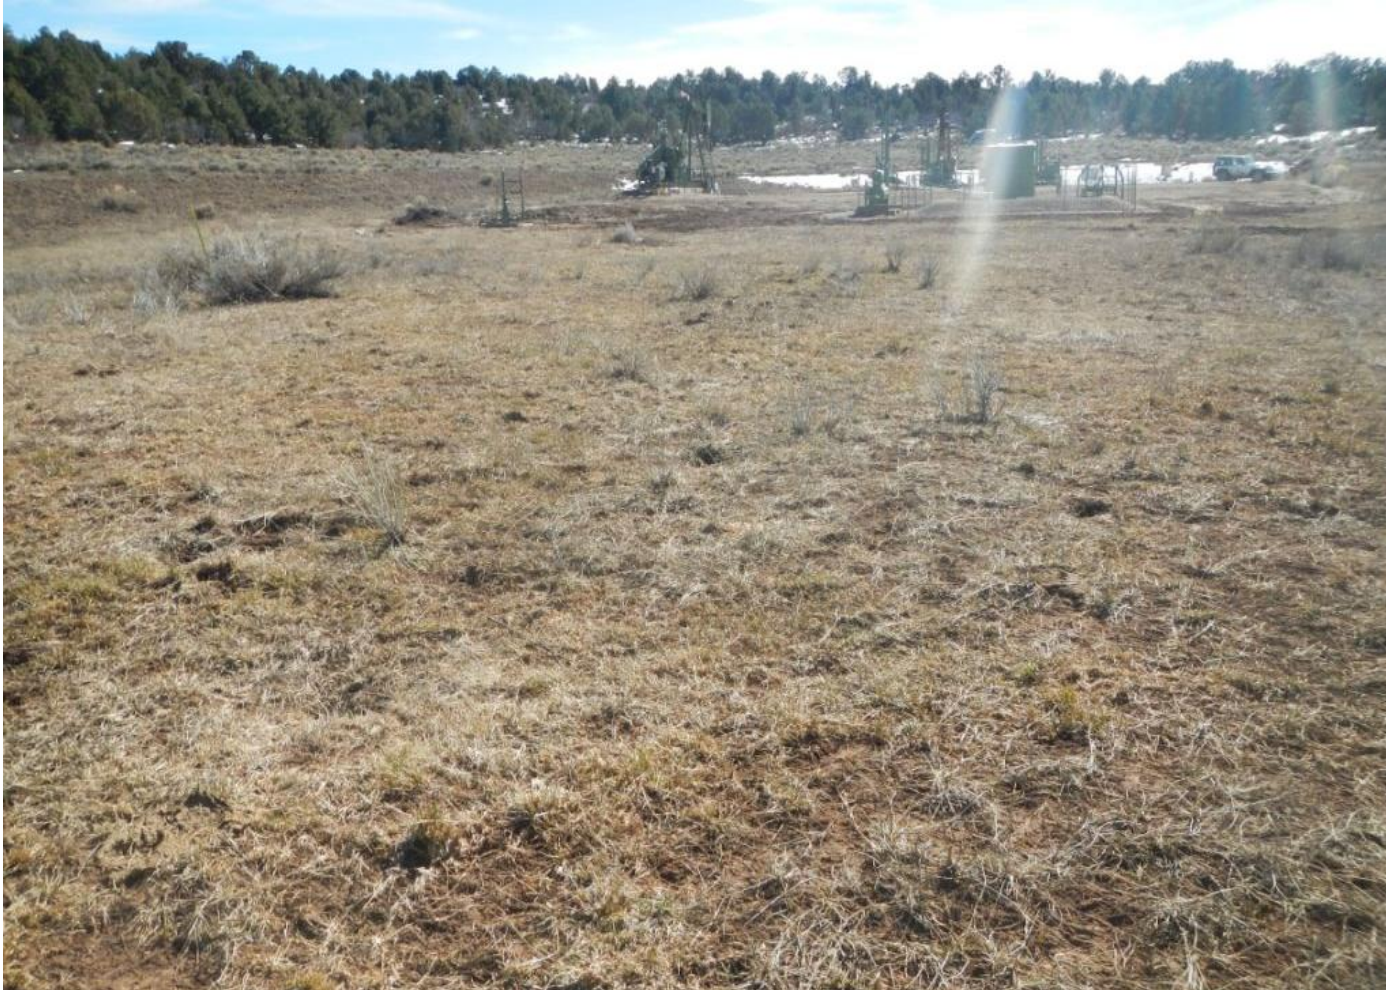
Photo 8. View of the project area from the northern corner facing center. Revegetation is largely comprised of western wheatgrass (*Pascopyrum smithii*), smooth brome (*Bromus inermis*), and rabbitbrush (*Chrysothamnus nauseosus*).
