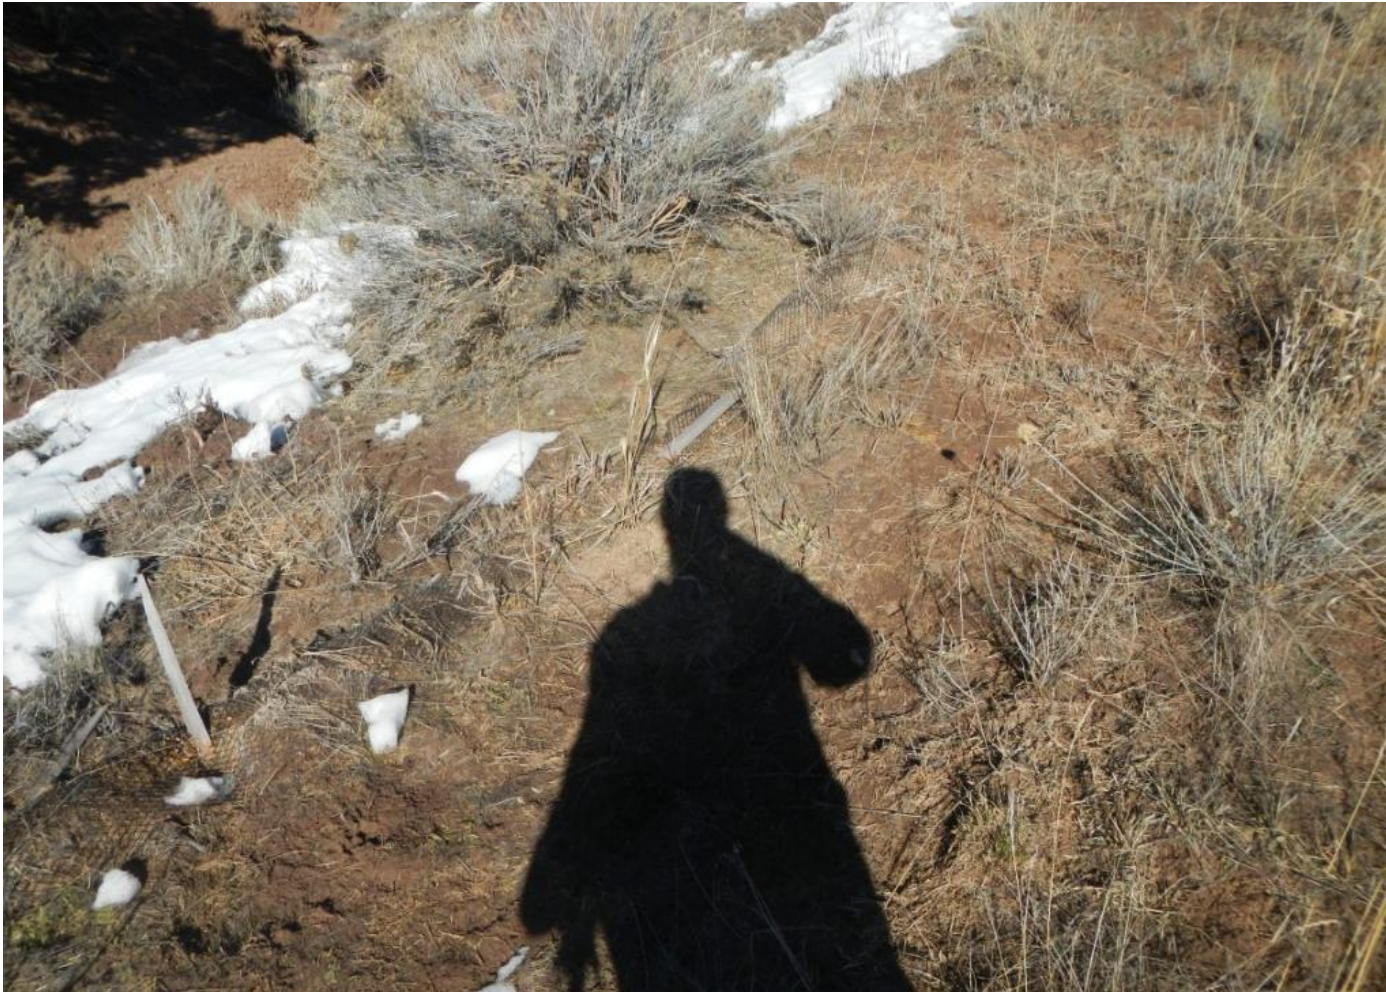
Photo 1. View of wattle along the northwestern edge of the project area and the edge of the gully that needs replacement. Contractors should be careful not to disturb vegetation while installing and maintaining BMPs on this location.

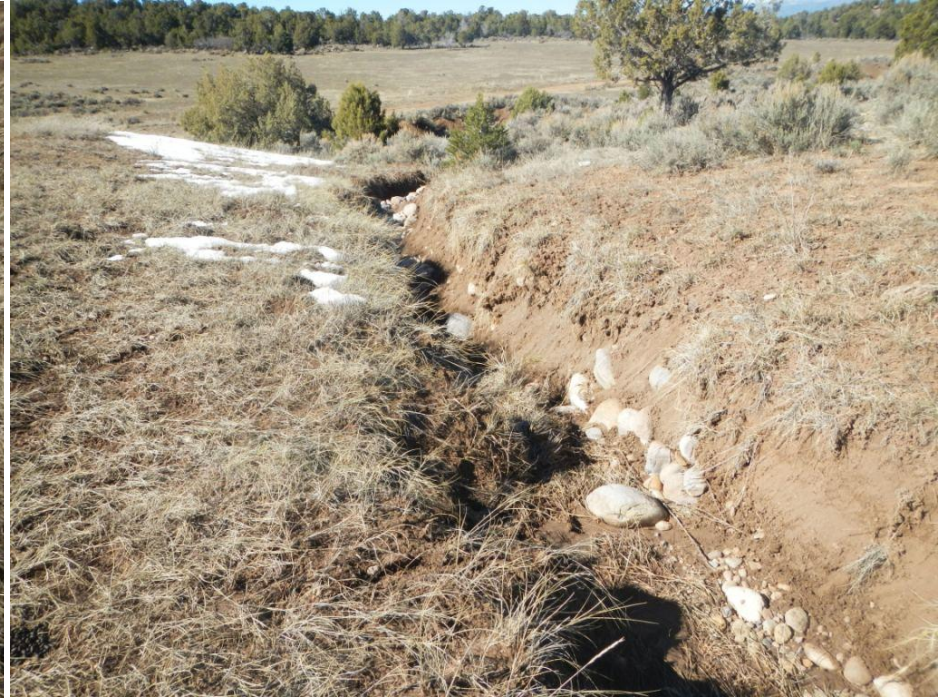
Photo 3 (on right). Downstream view of head-cut shown in Photo 2 where an approximately 3 foot wide and 3 foot deep gully has formed.

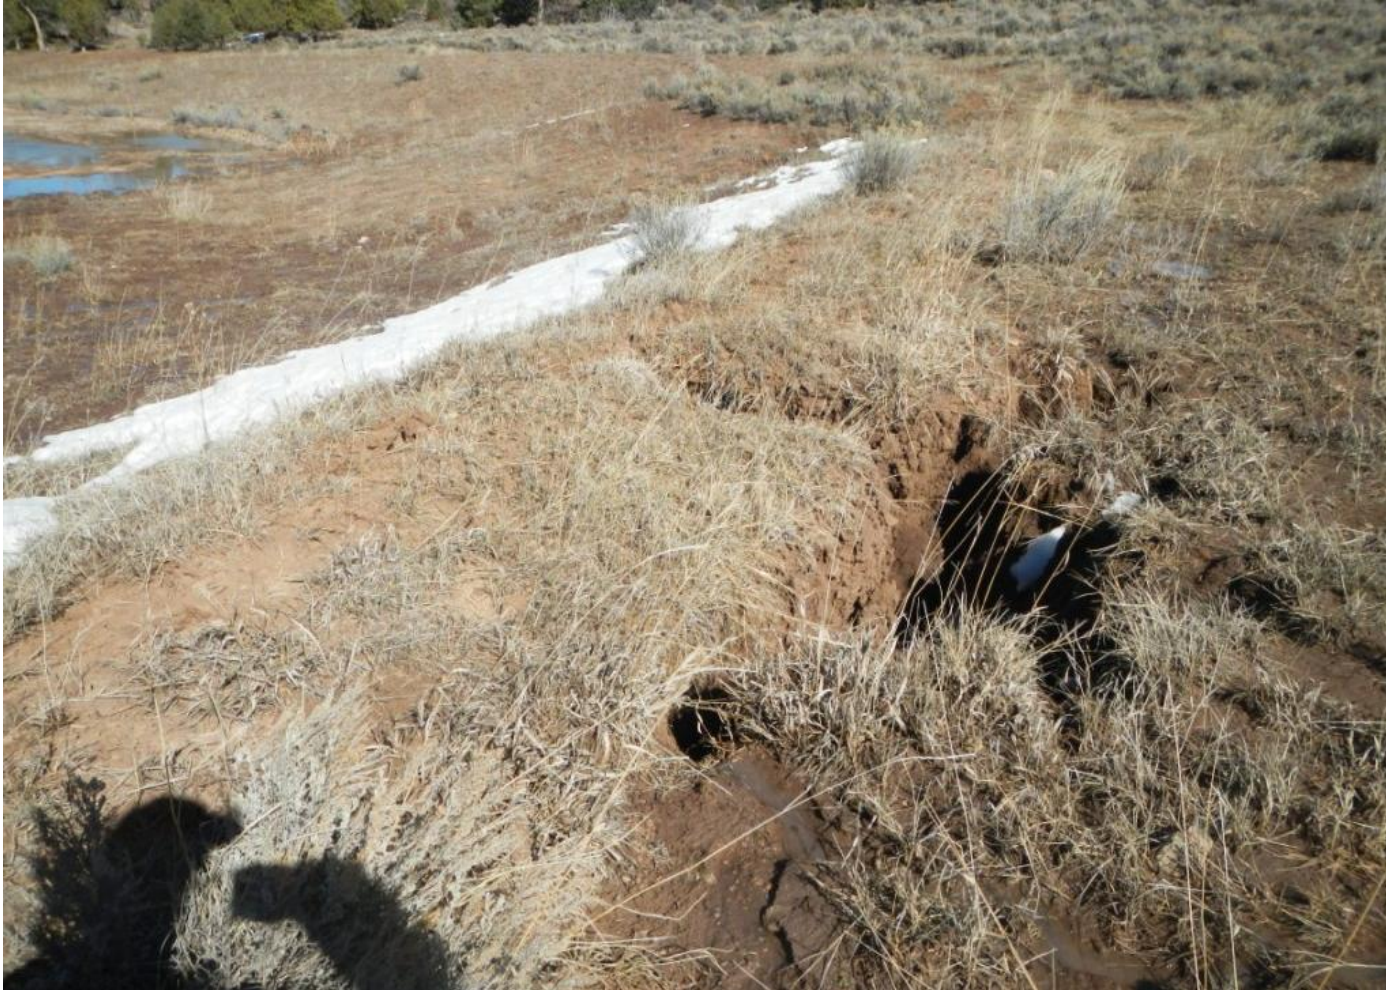
Photo 5. View of head-cut upstream from erosional channels shown in Photo 4. An approximately 6-foot-deep and 3-foot-wide-hole has eroded through the well pad here. This area needs stabilization and repair measures.

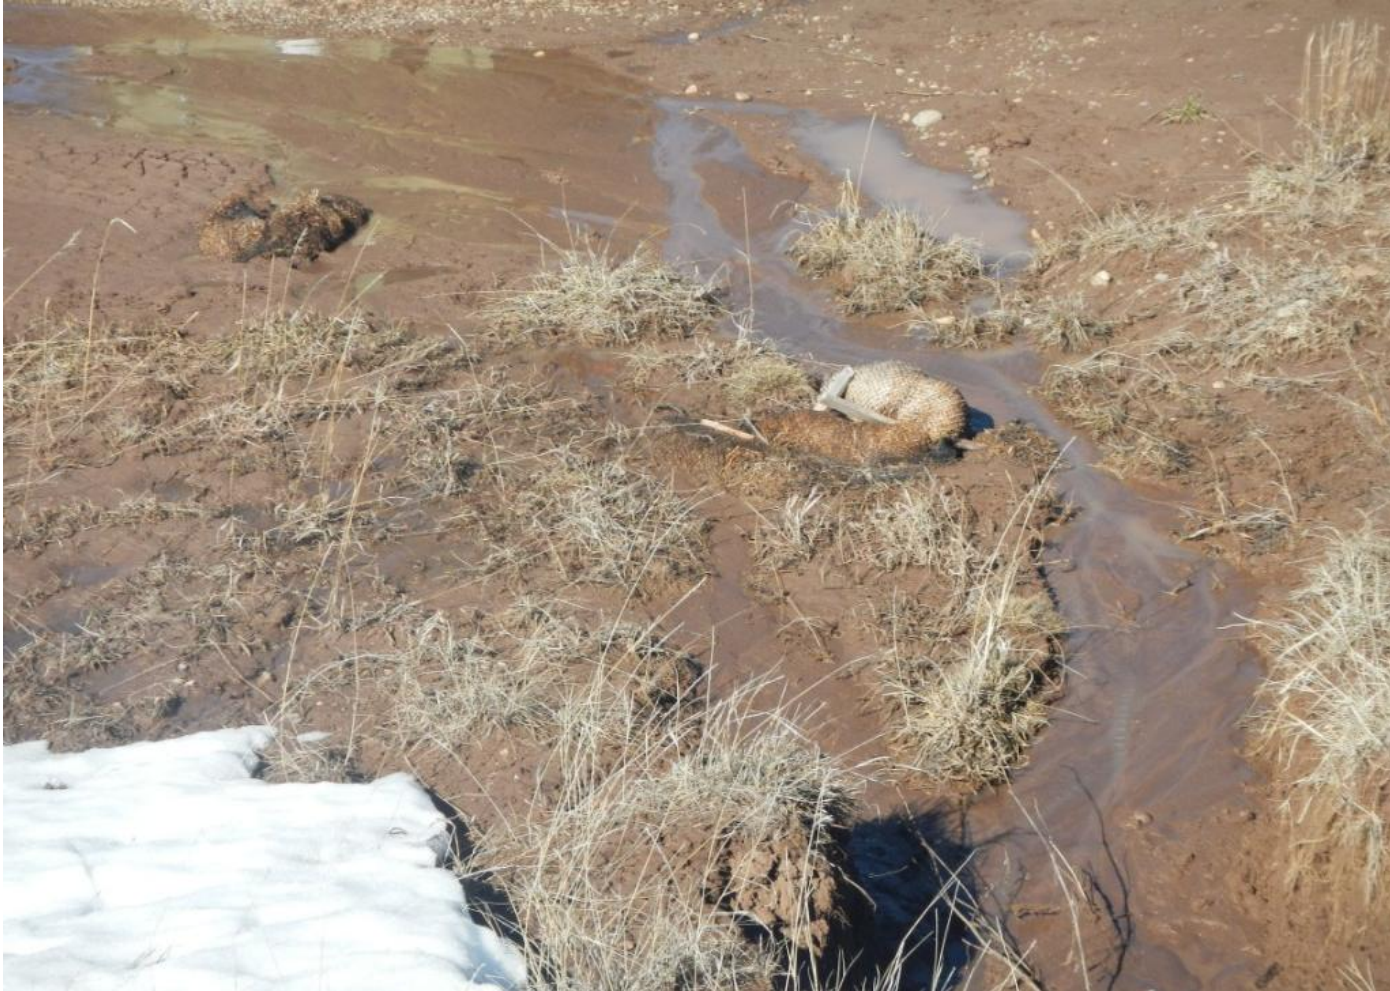
Photo 6. View of straw wattle in the southern portion of the project area that is no longer functioning.
