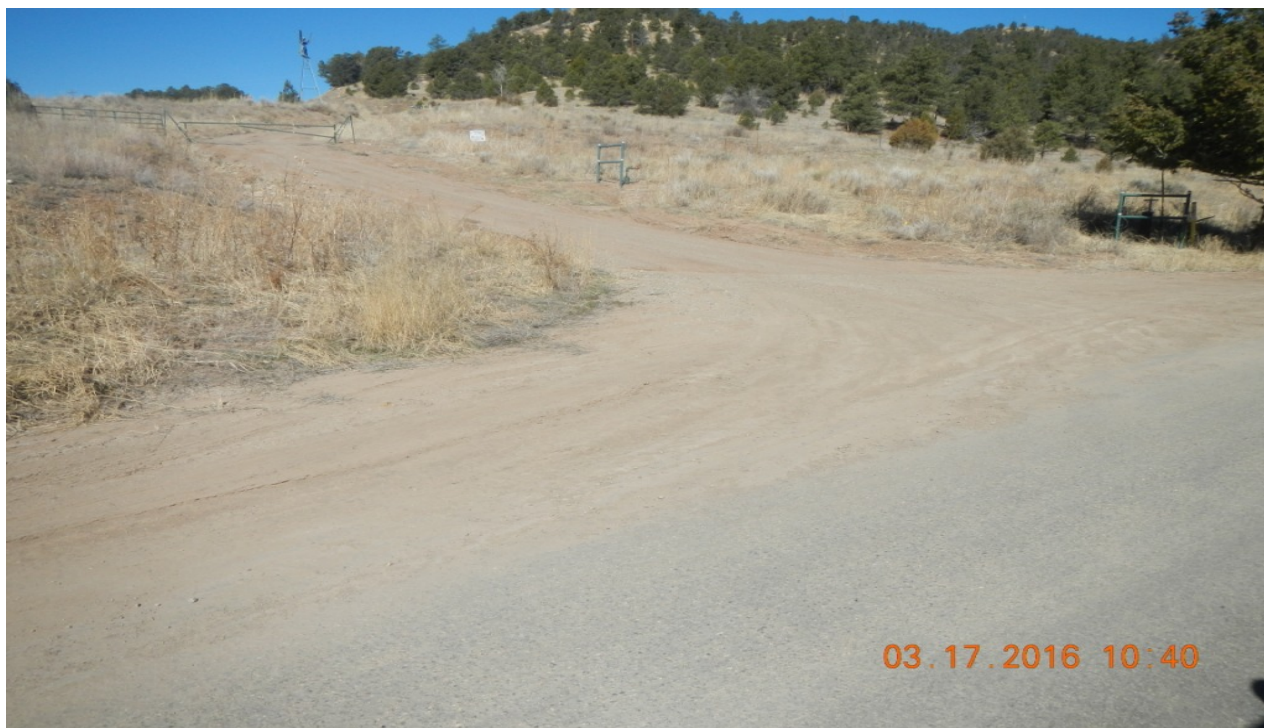
**photo 1:** Facing toward the access road from the county road.

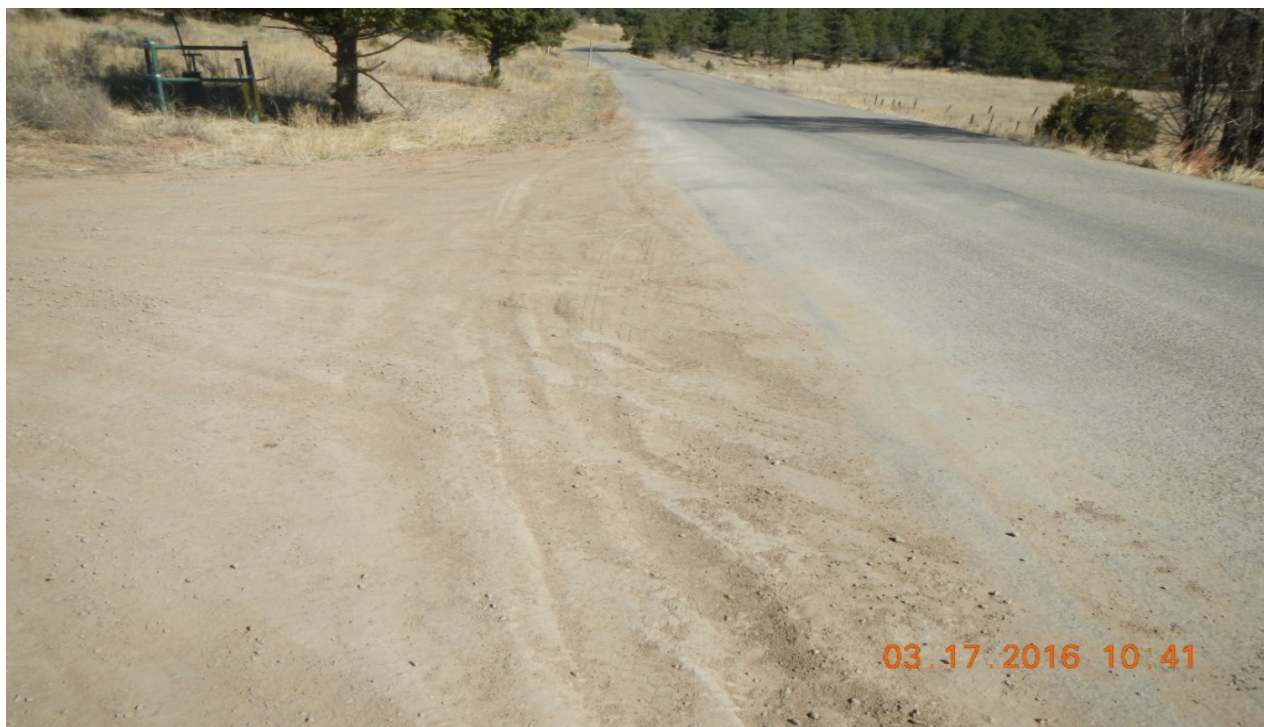
**photo 2:** Facing north toward county road at the beginning of the access road.

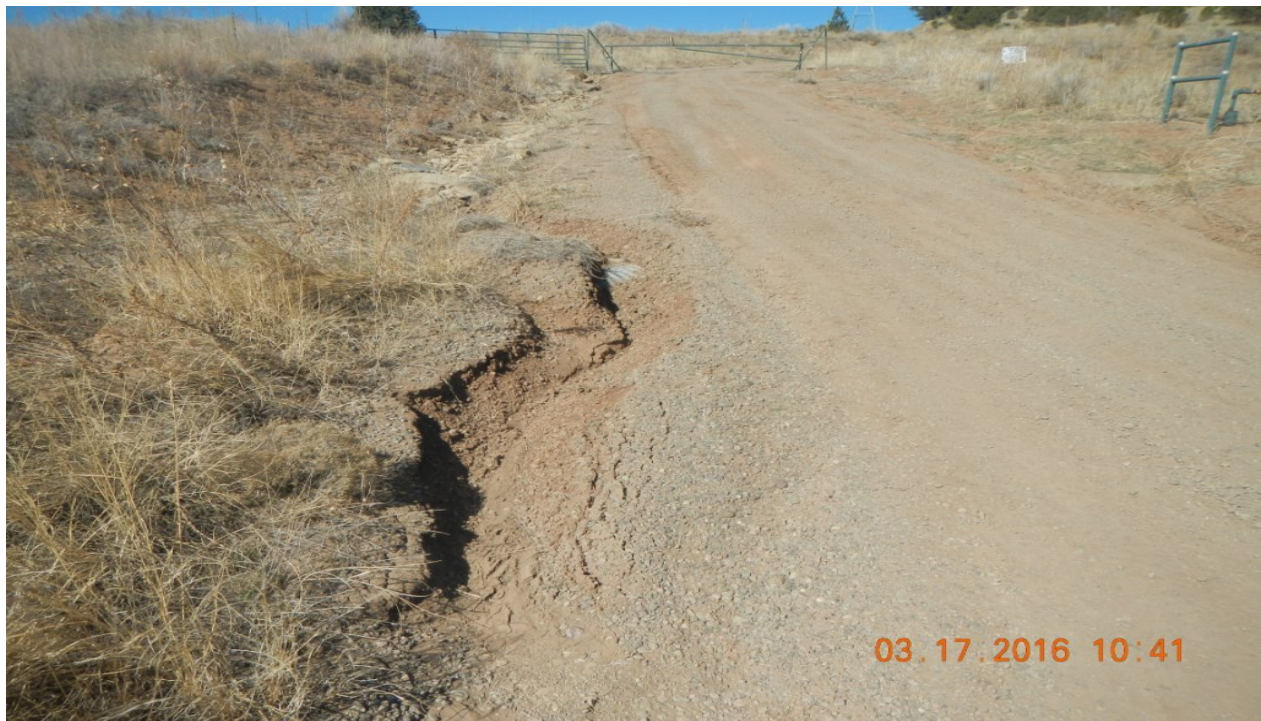
**photo 3:** Facing west toward the access road.

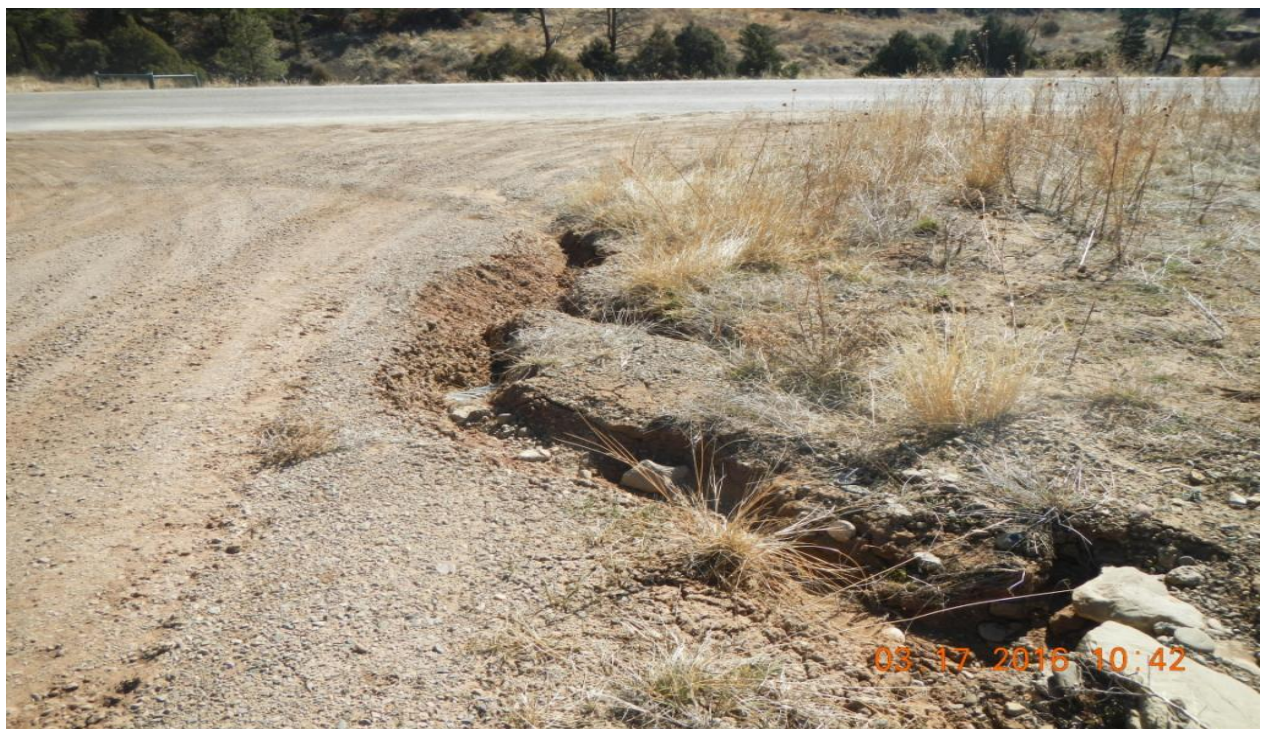
**photo 4:** An erosion channel has developed which is directing sediment towards the county road.

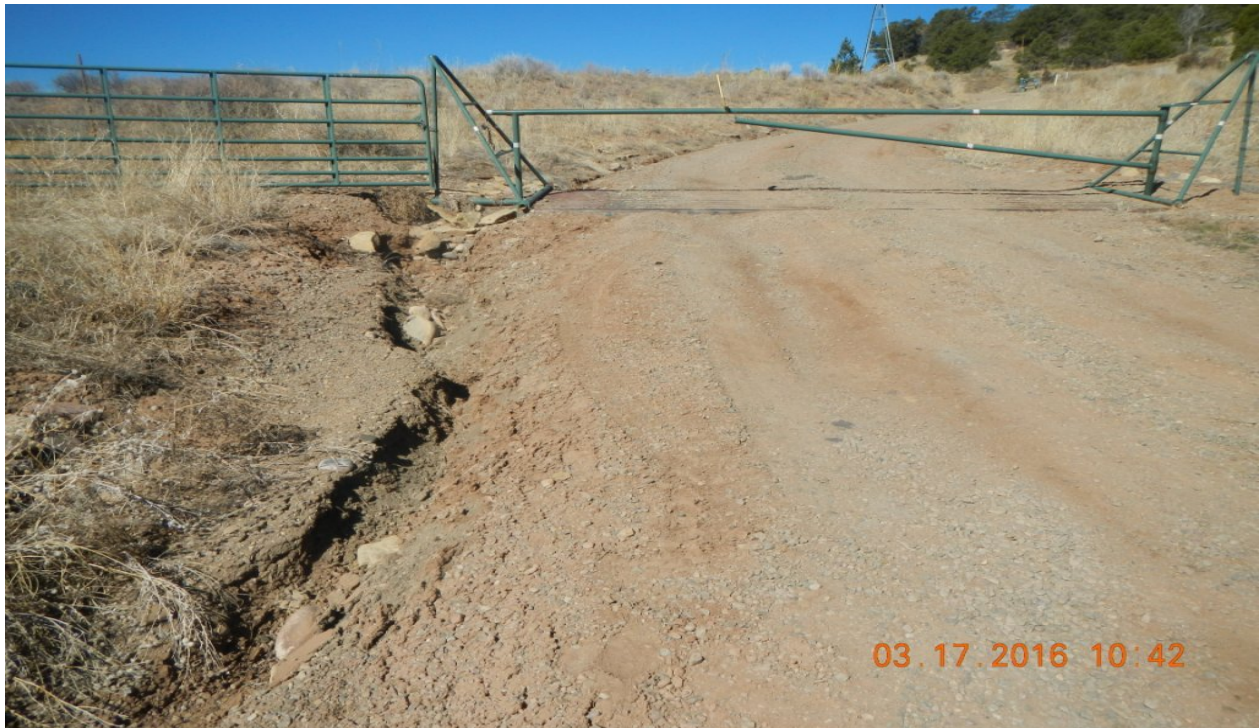
**photo 5:** Signs of erosion near the gate.

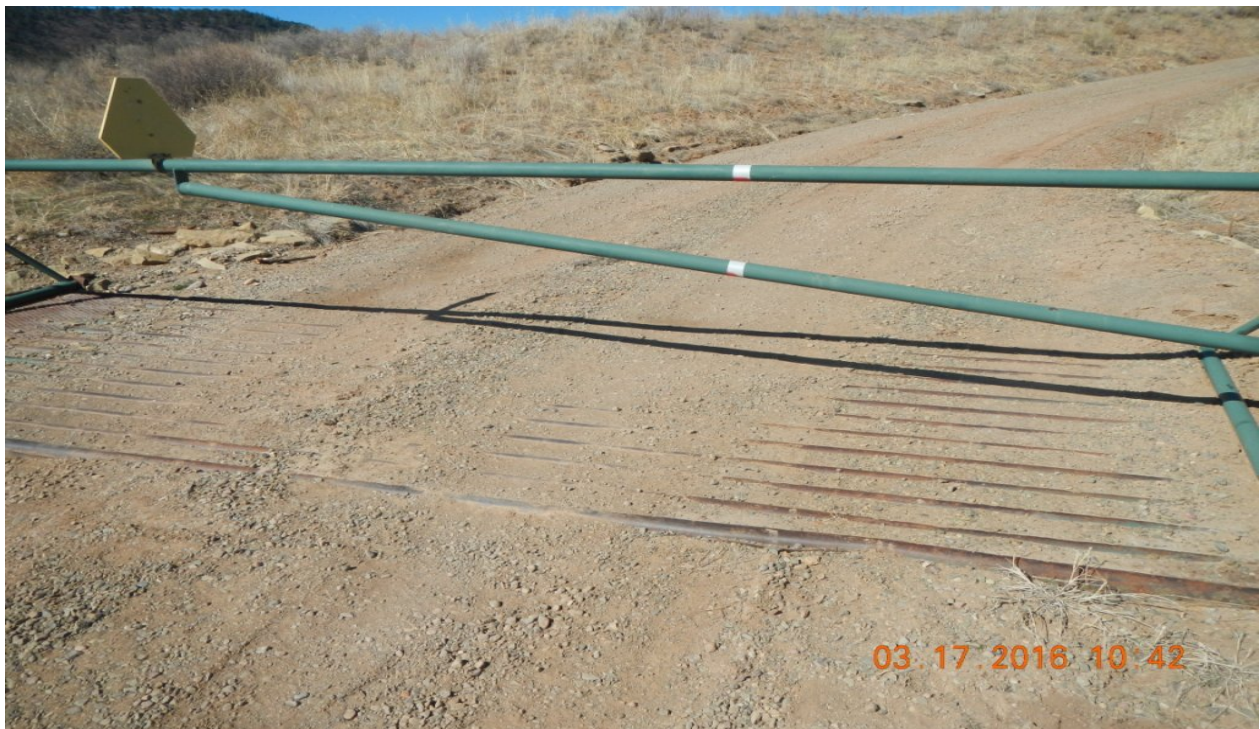
**photo 6:** Sediment has filled in the cattle guard.

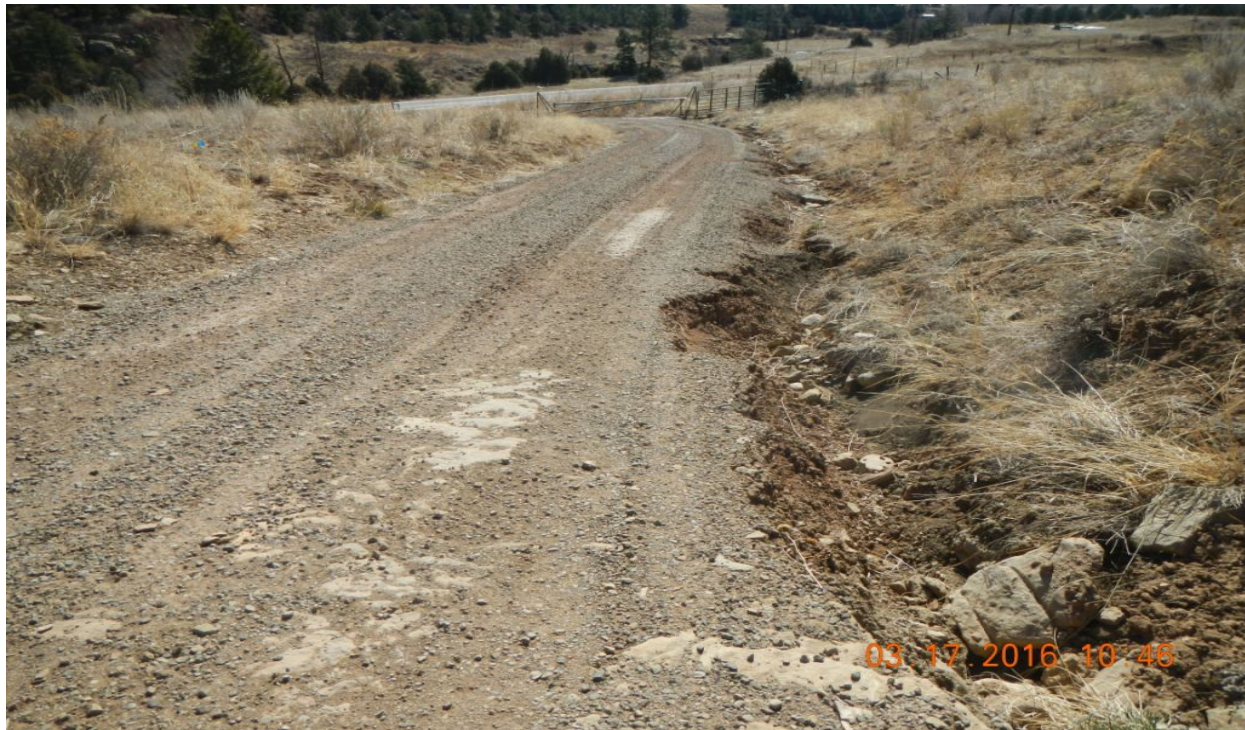
**photo 7:** Facing back toward the east, there are signs of erosion along the access road.

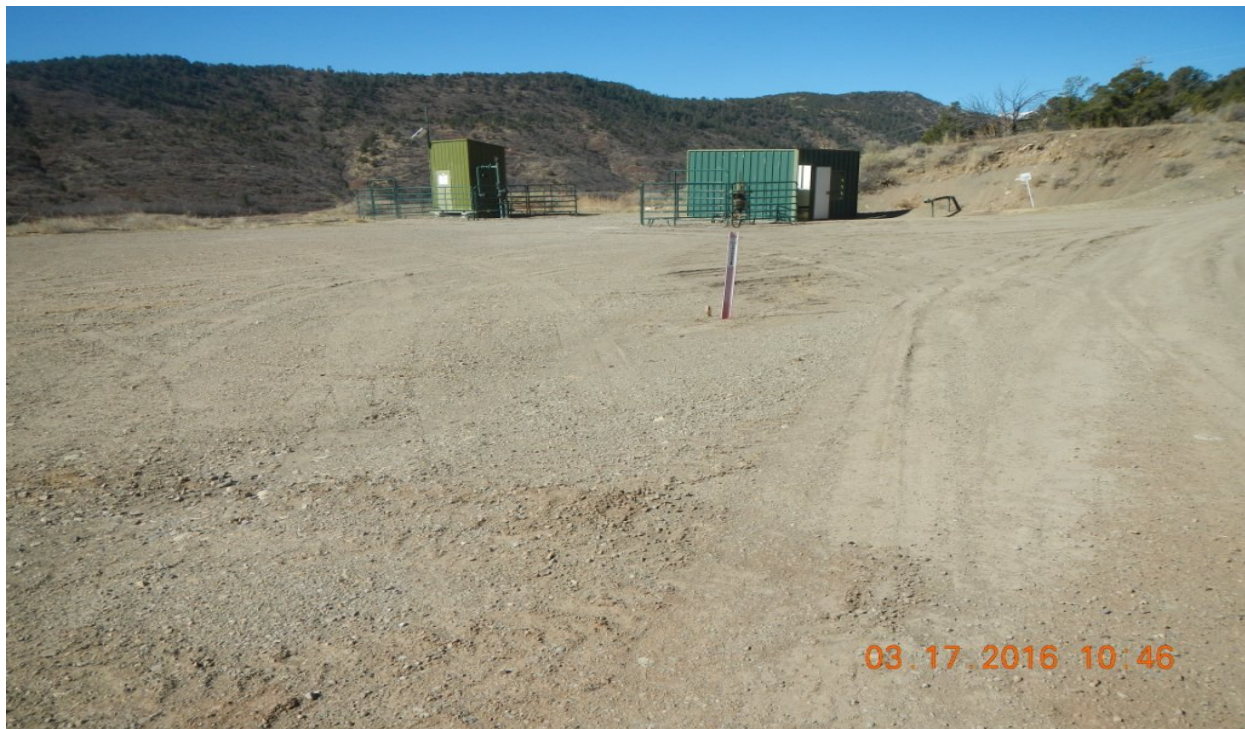
**photo 8:** Facing southwest toward the location.

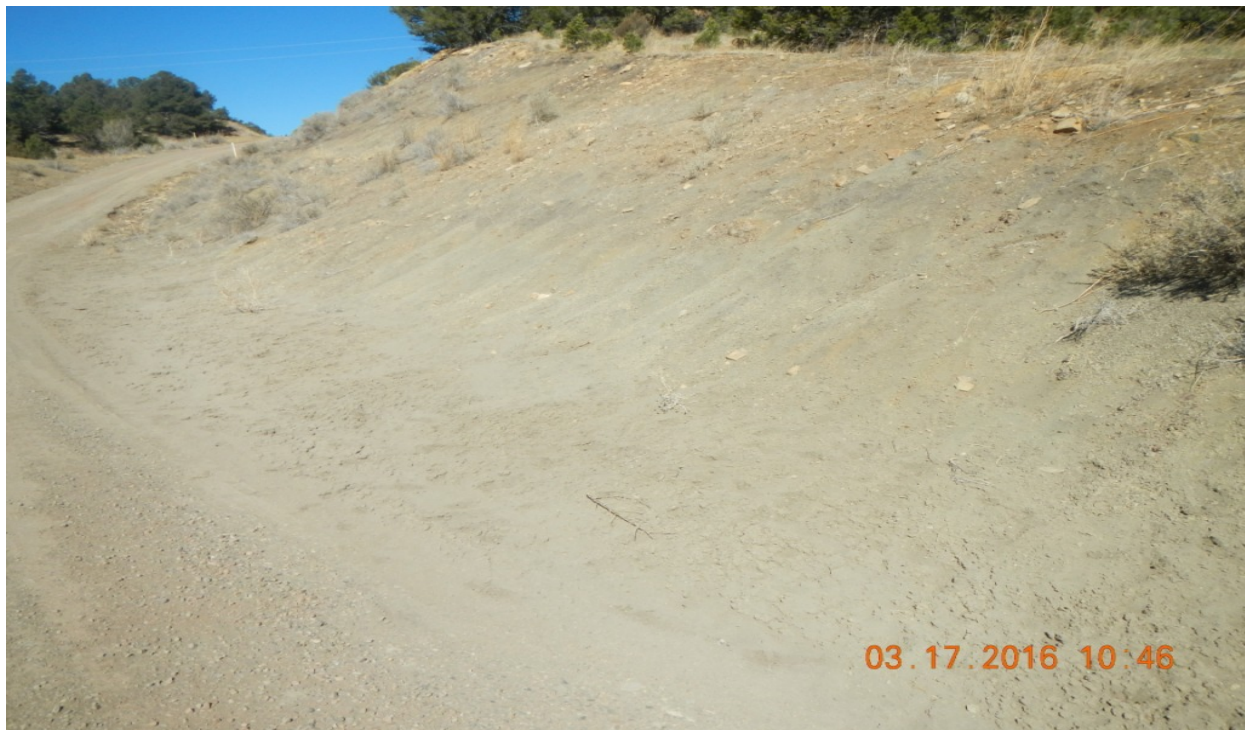
**photo 9:** Facing toward the northwest cut slope side of the pad, which is not adequately stabilized.

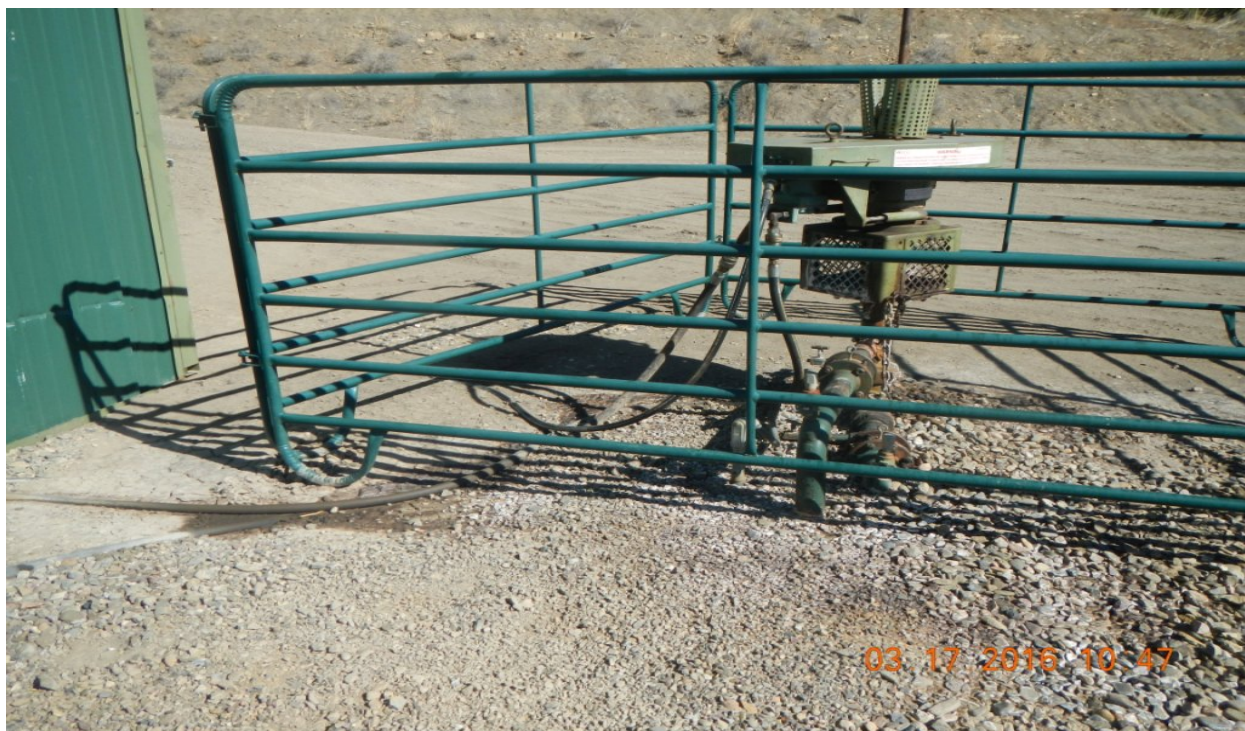
**photo 10:** Noticed oil stains around the well head.

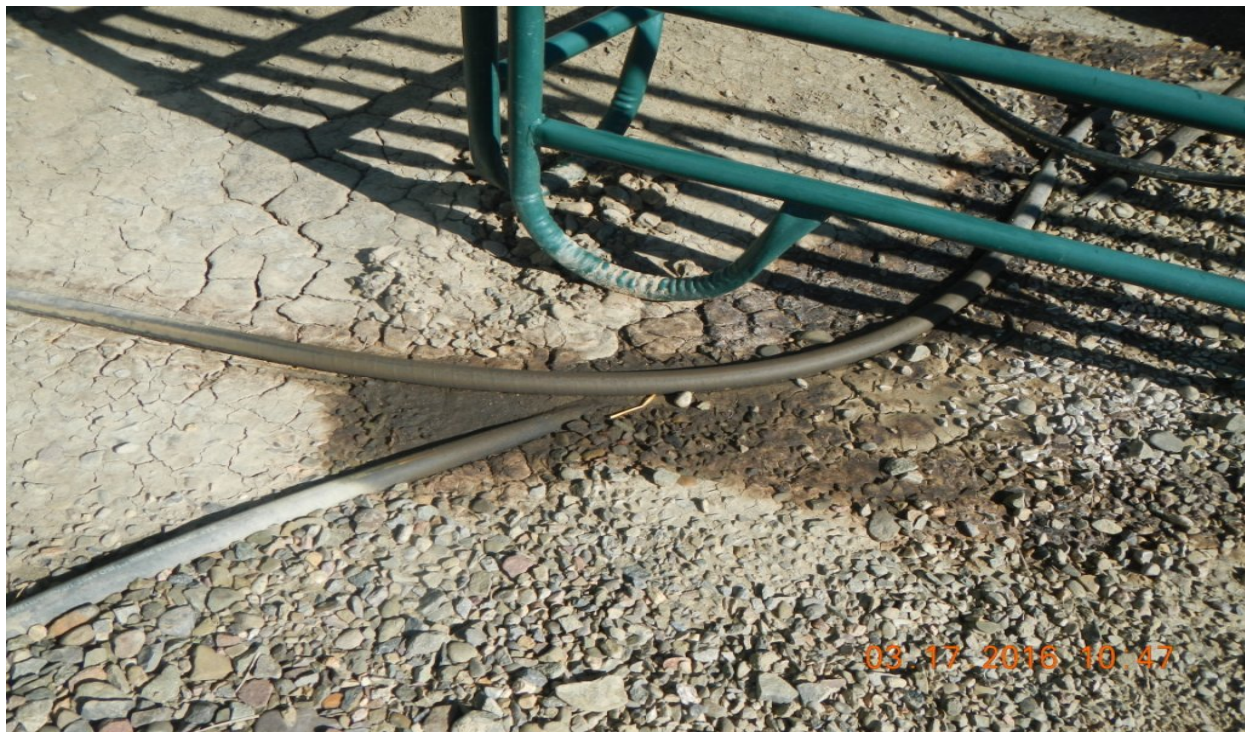
**photo 11:** Oil stained surface near the wellhead.

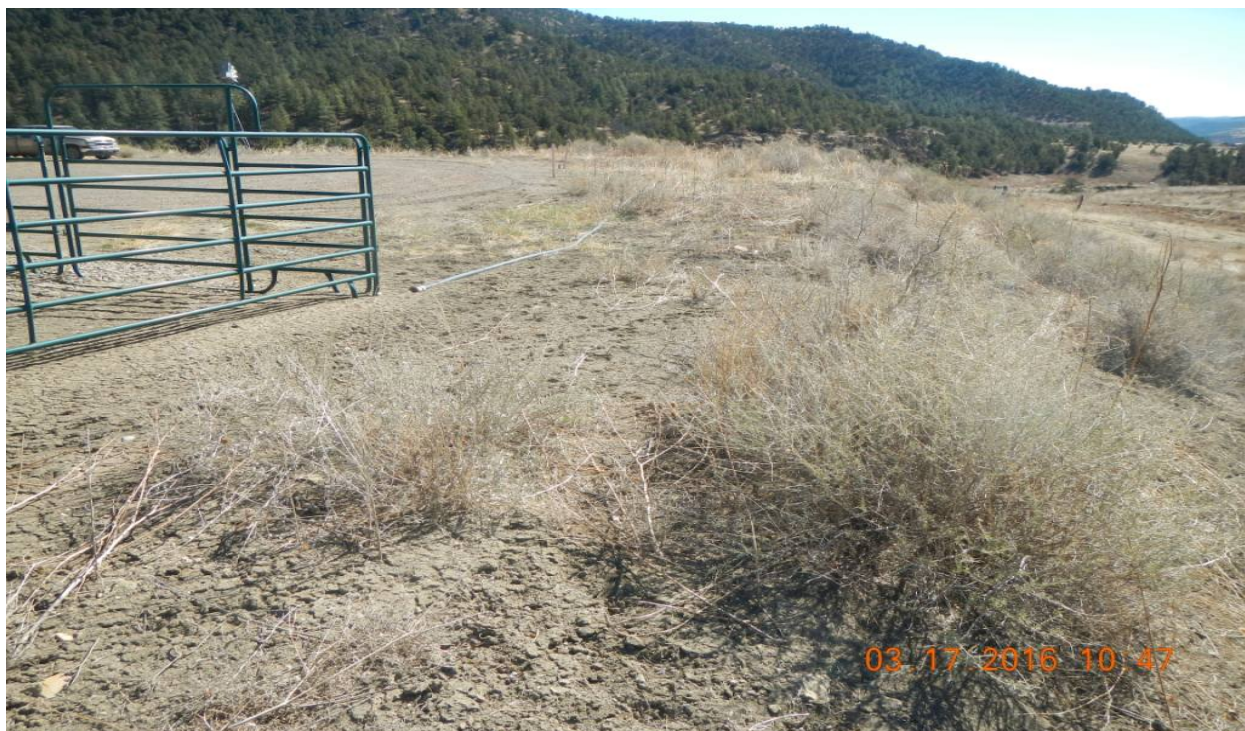
**photo 12:** South side of the location facing east.
