Interim Reclamation Inspection

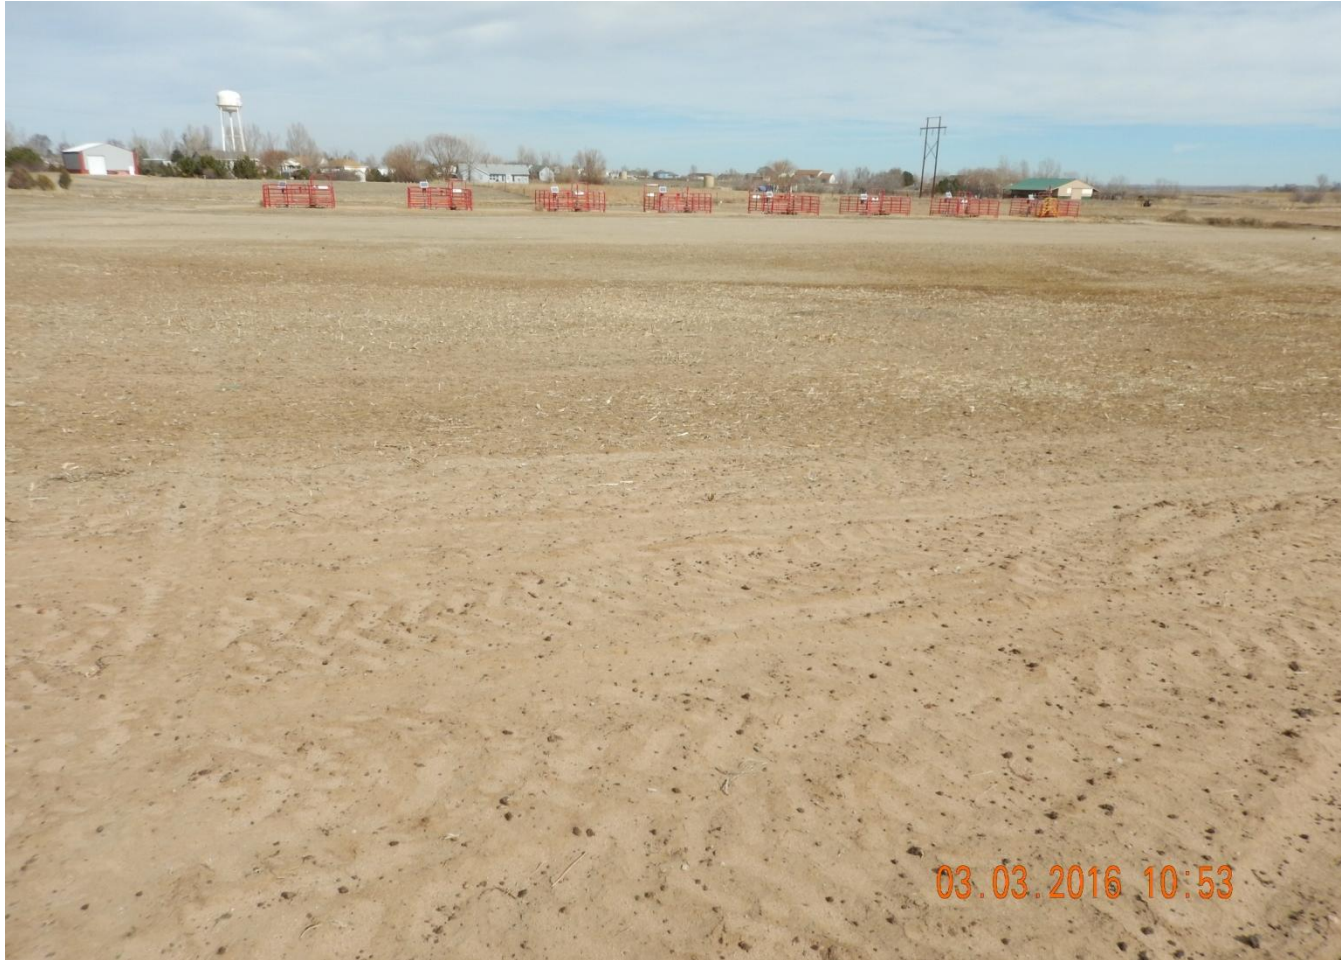
Photo 1. Photo taken from southern location, facing North towards the eight (8) PR wells. Interim reclamation in process- visible evidence of seeding.

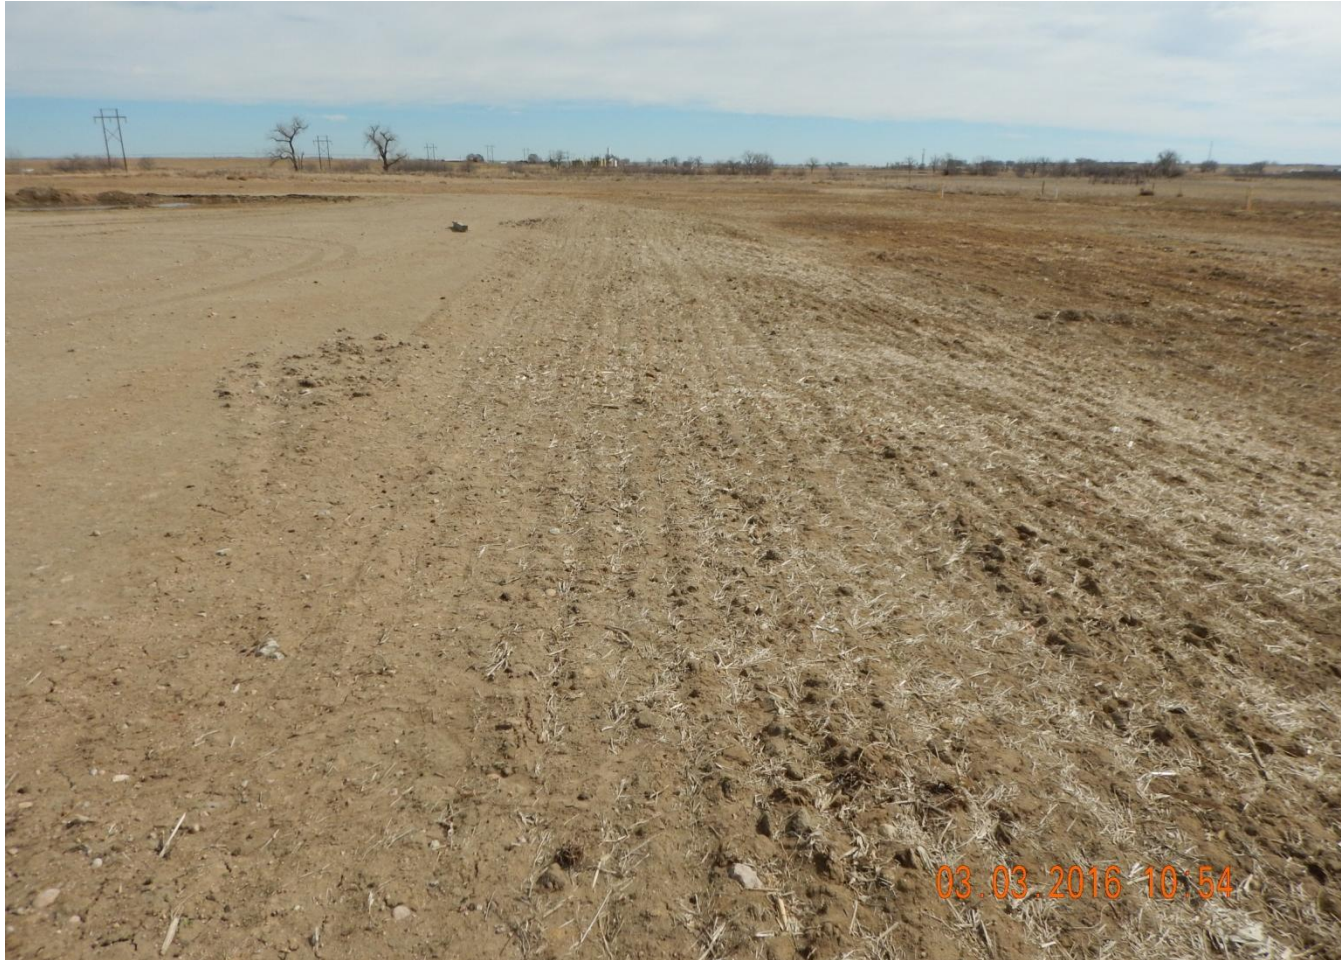
Photo 2. Photo taken from southern location, facing East. Interim reclamation in process- visible evidence of seeding.

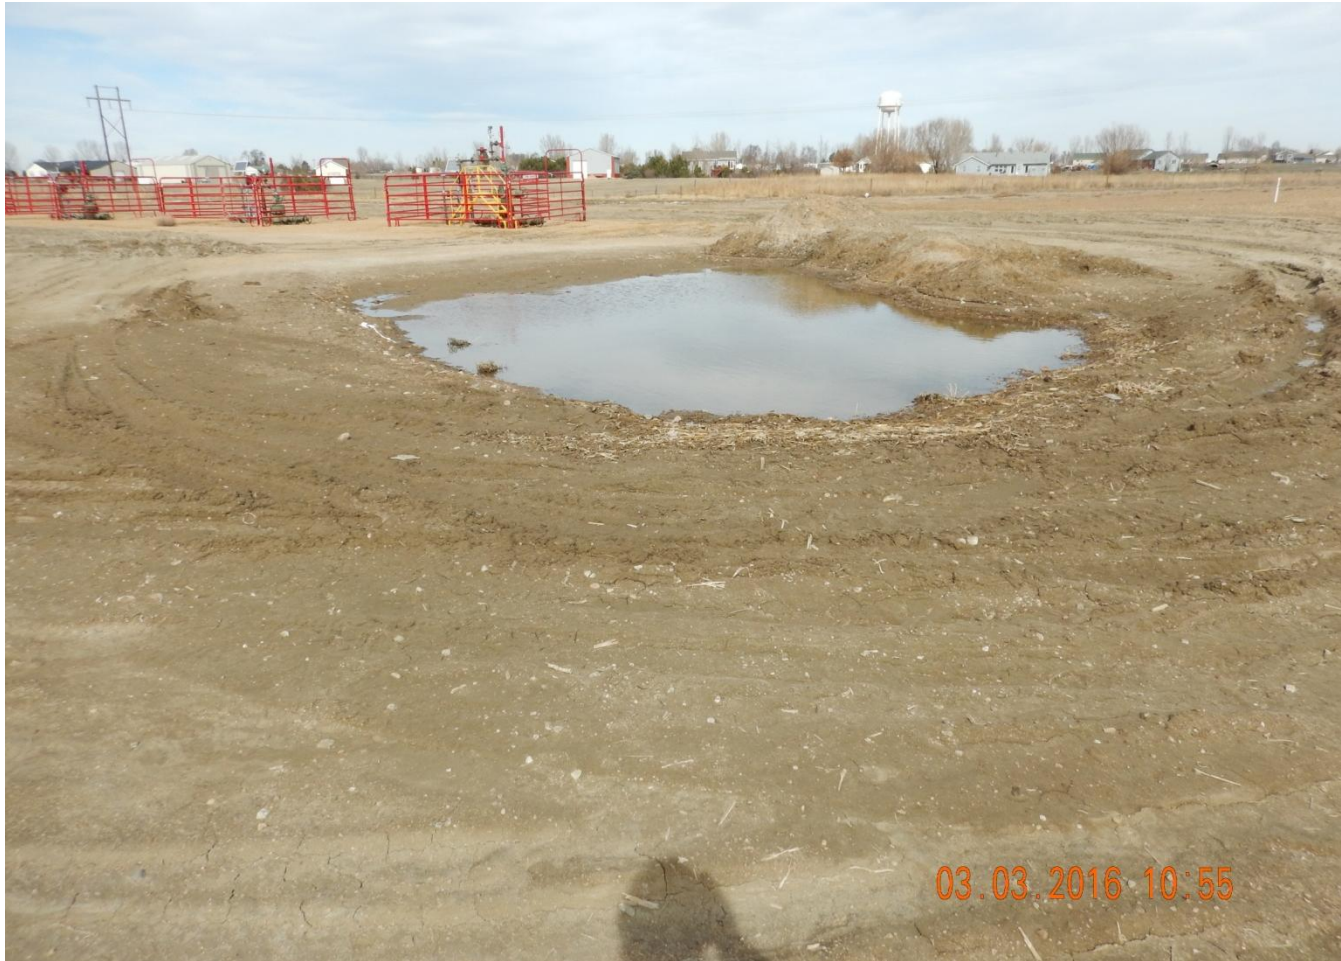
Photo 3. Photo taken from southeast location, facing North. Need to address ponding water. This is only causing additional runoff onto eastern interim reclamation area.

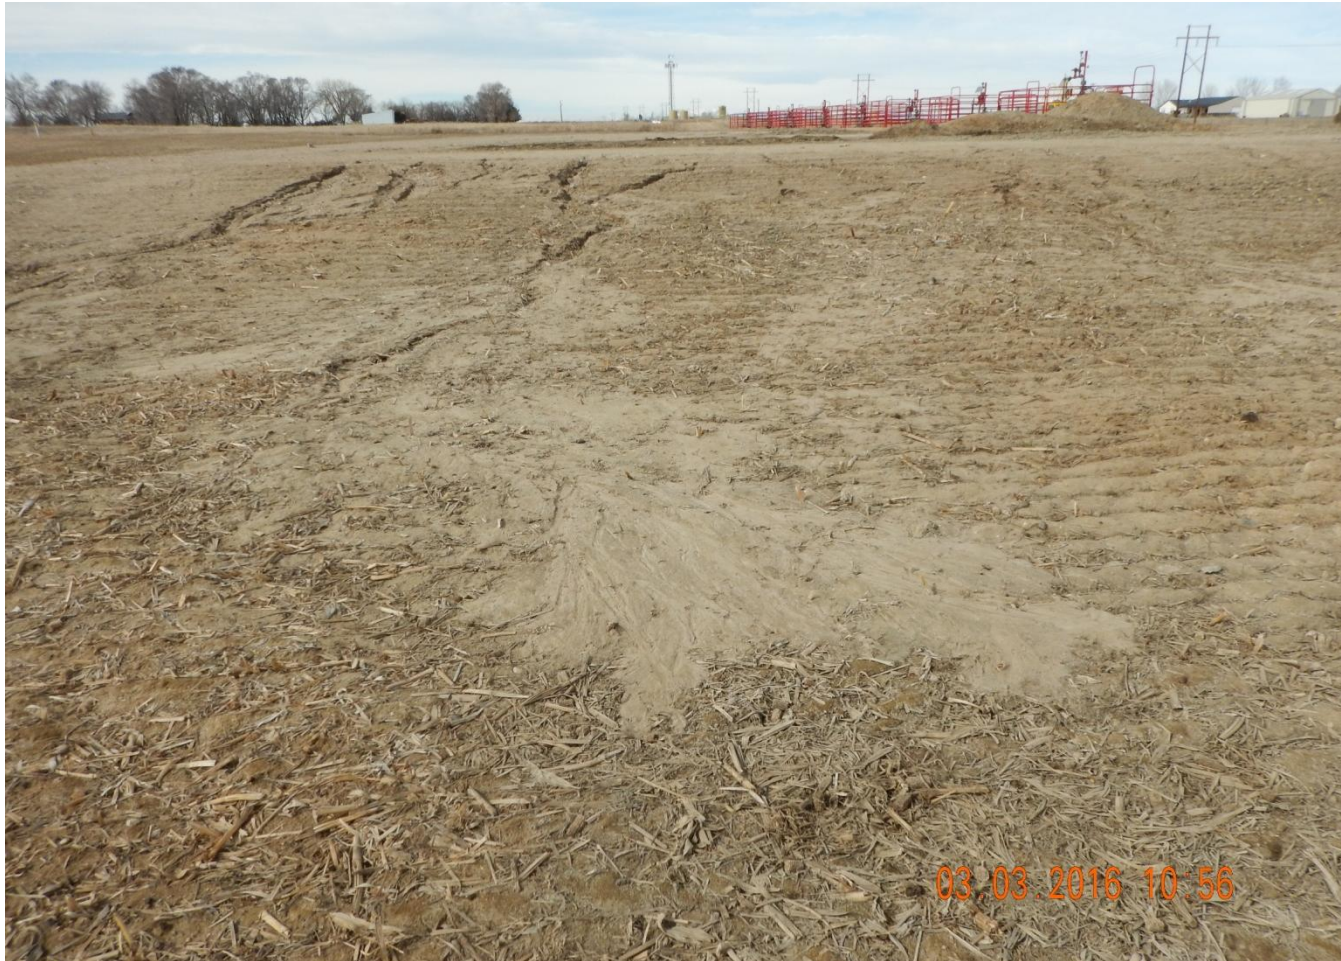
Photo 4. Photo taken from the eastern location, facing West. Interim reclamation area needs to be stabilized to minimize erosion while vegetative growth establishes. Erosion is occurring along portions of the eastern and northern interim reclamation area.

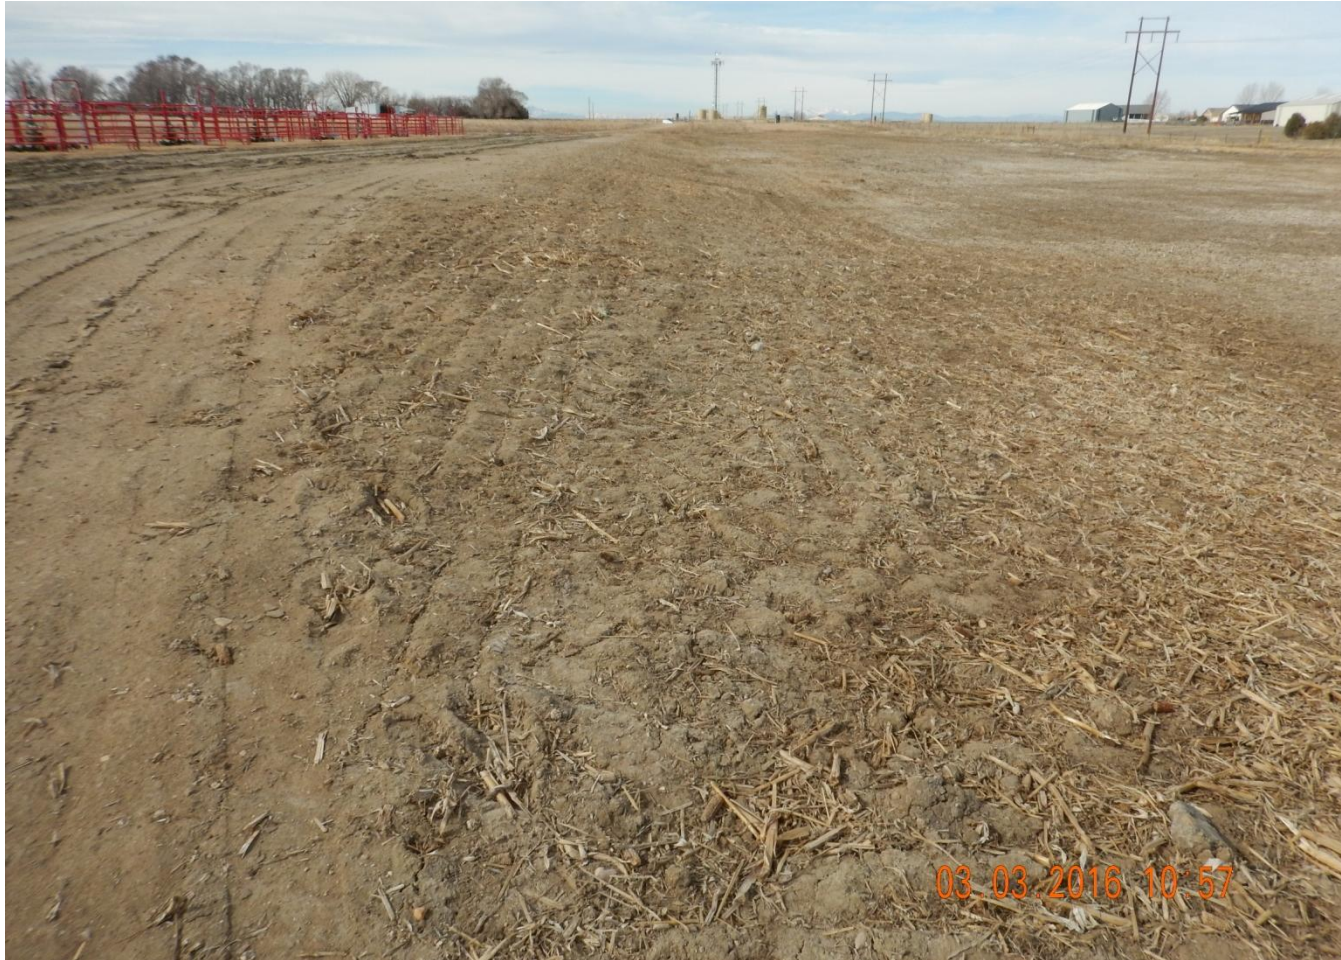
Photo 5. Photo taken from northeast location, facing West. Interim reclamation in process- visible evidence of seeding.

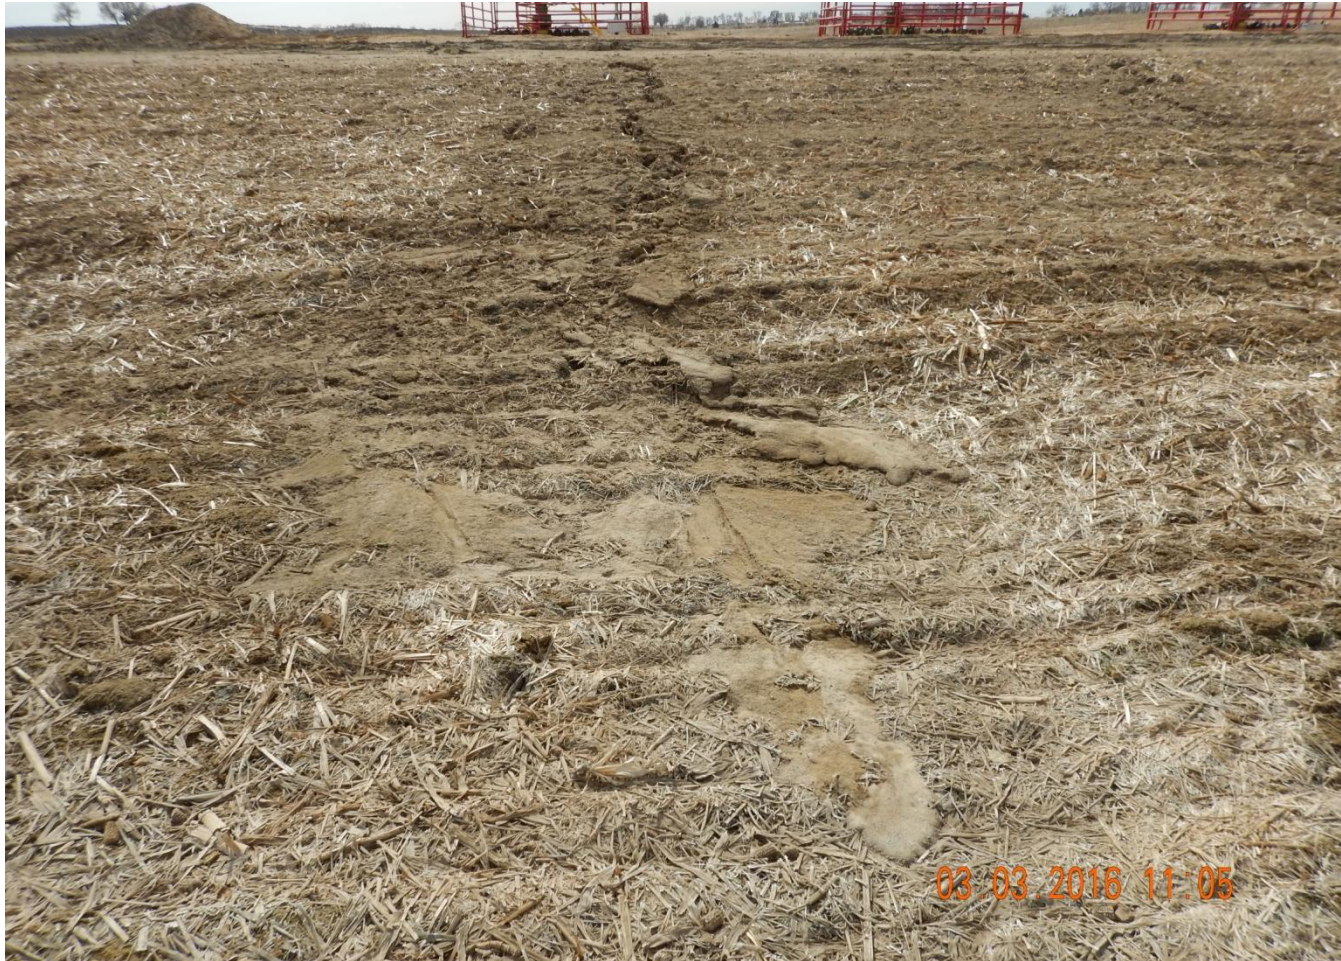
Photo 6. Photo taken from the northern location, facing South. Interim reclamation area needs to be stabilized to minimize erosion while vegetative growth establishes. Erosion is occurring along portions of the eastern and northern interim reclamation area.

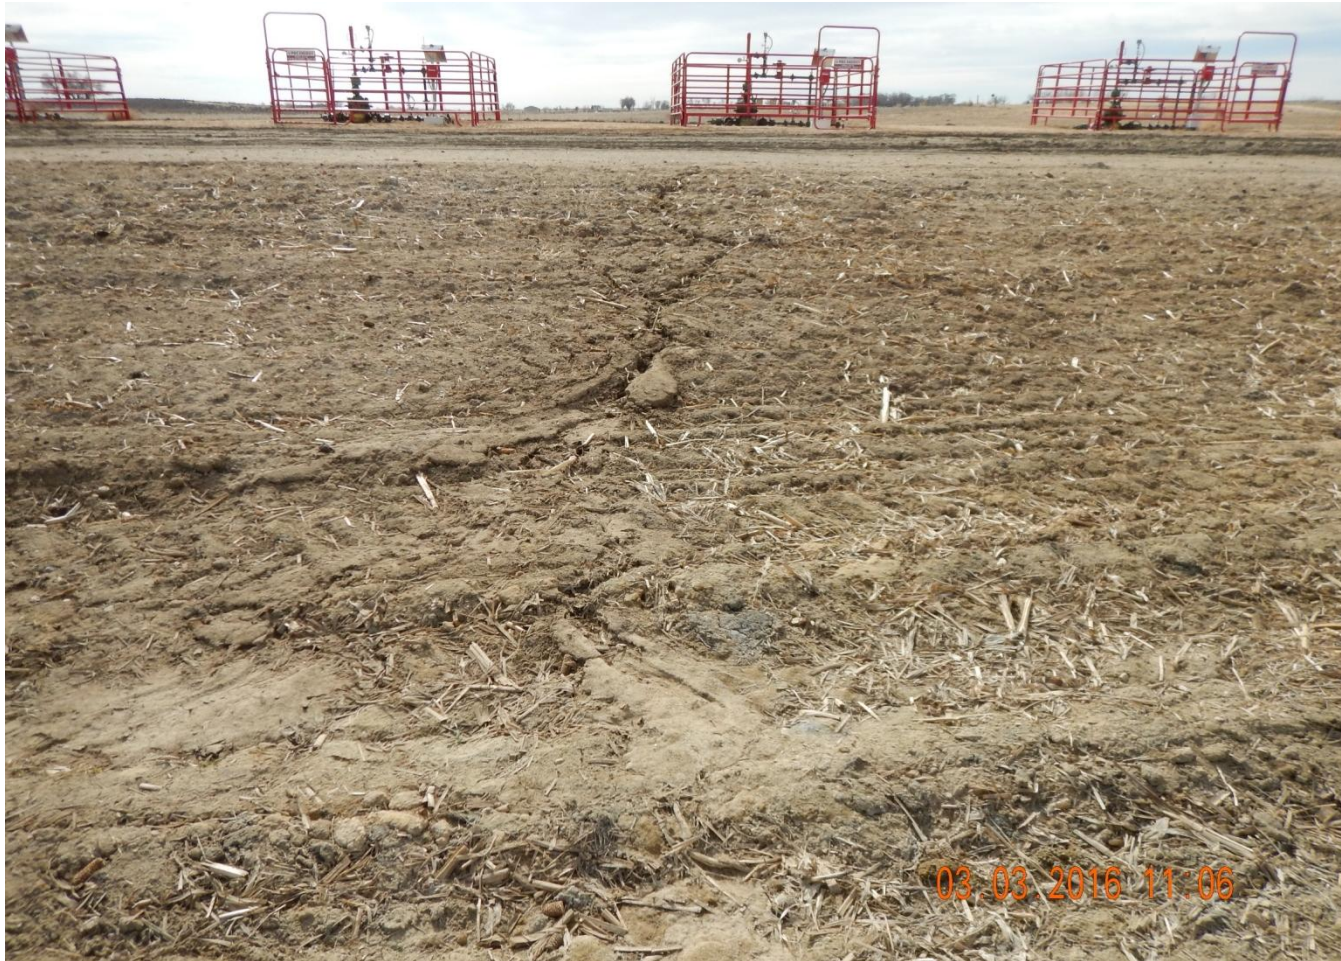
Photo 7. Photo taken from the northern location, facing South. Interim reclamation area needs to be stabilized to minimize erosion while vegetative growth establishes. Erosion is occurring along portions of the eastern and northern interim reclamation area.

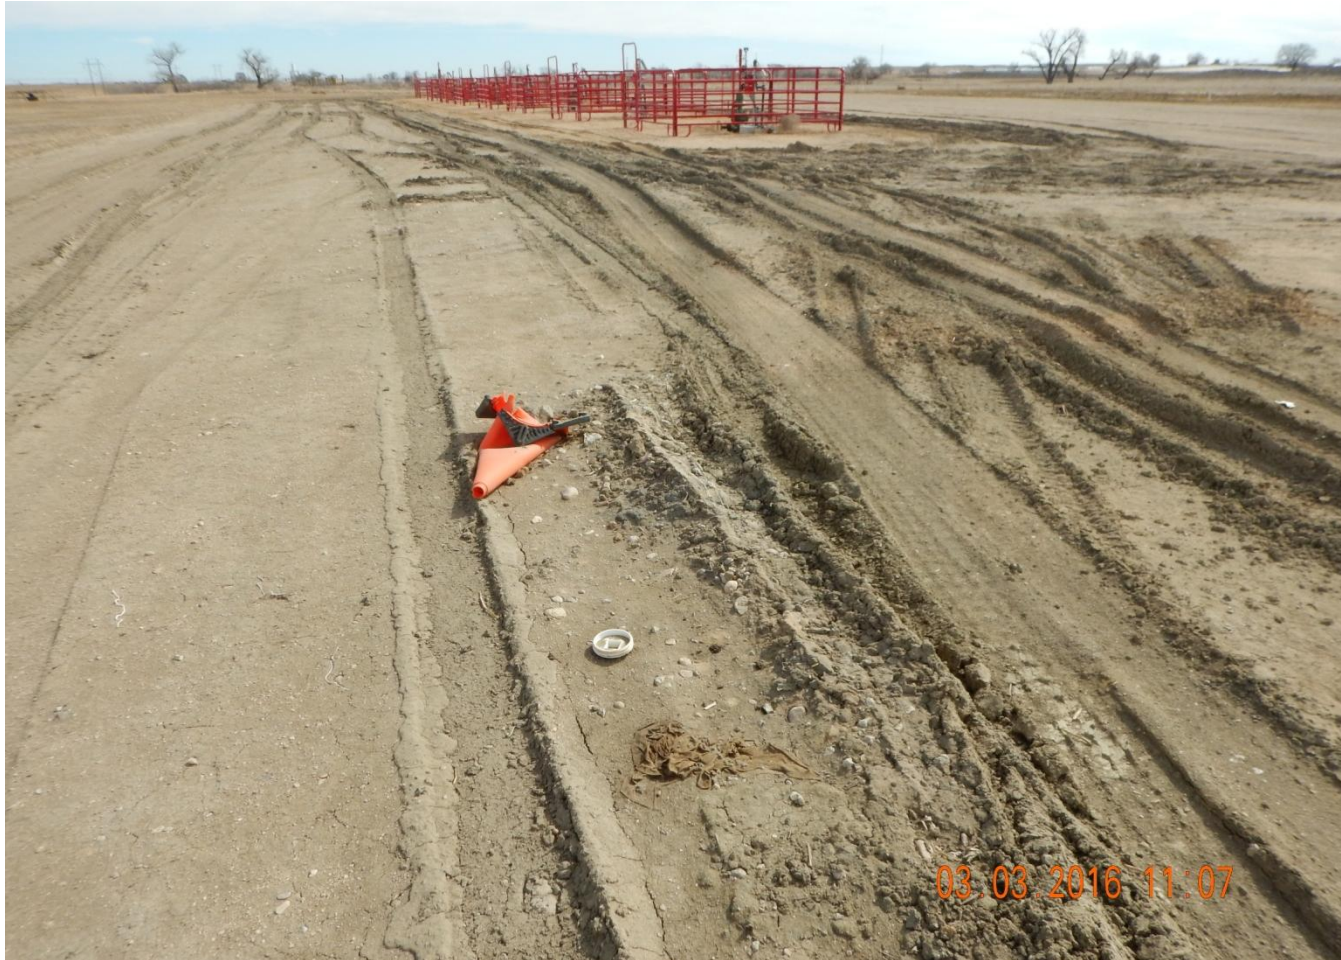
Photo 8. Photo taken from the western location, facing East. Need to remove waste material from location.

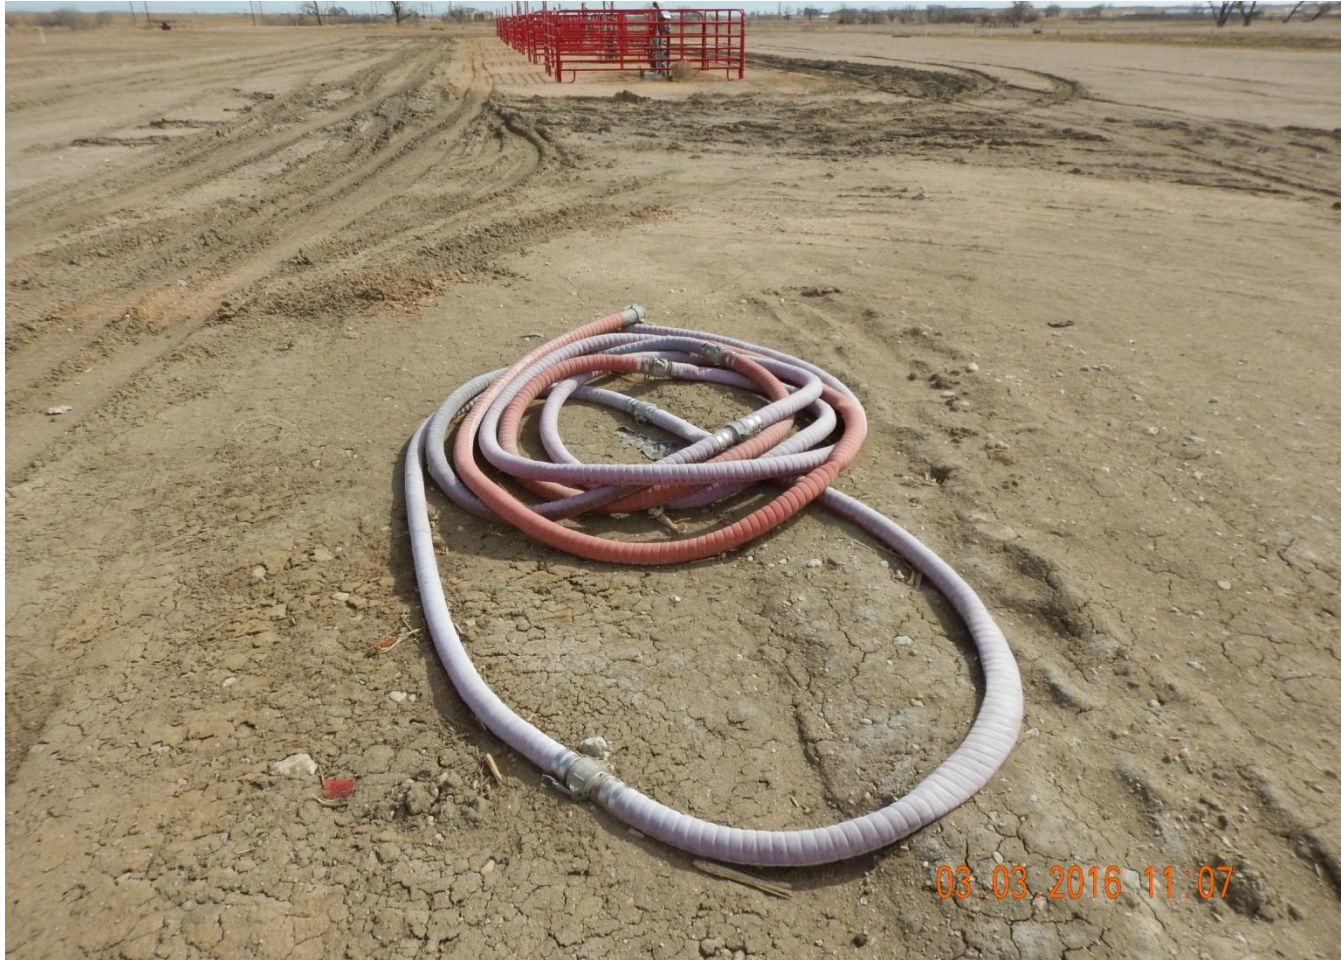
Photo 9. Photo taken from the western location, facing East. Need to remove waste material from location.

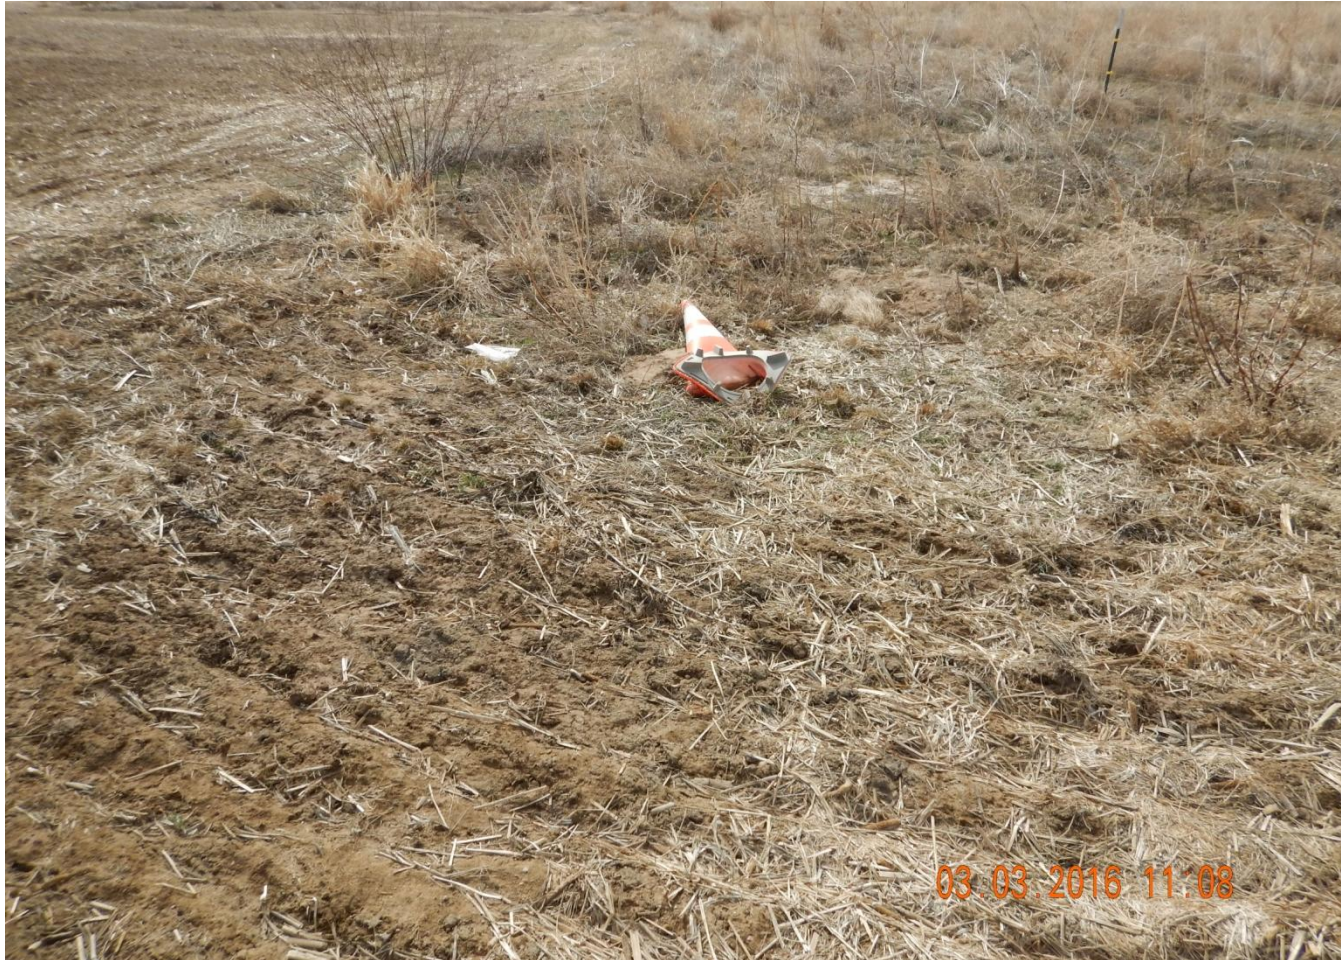
Photo 10. Photo taken from the western location, facing South. Need to remove waste material from location.

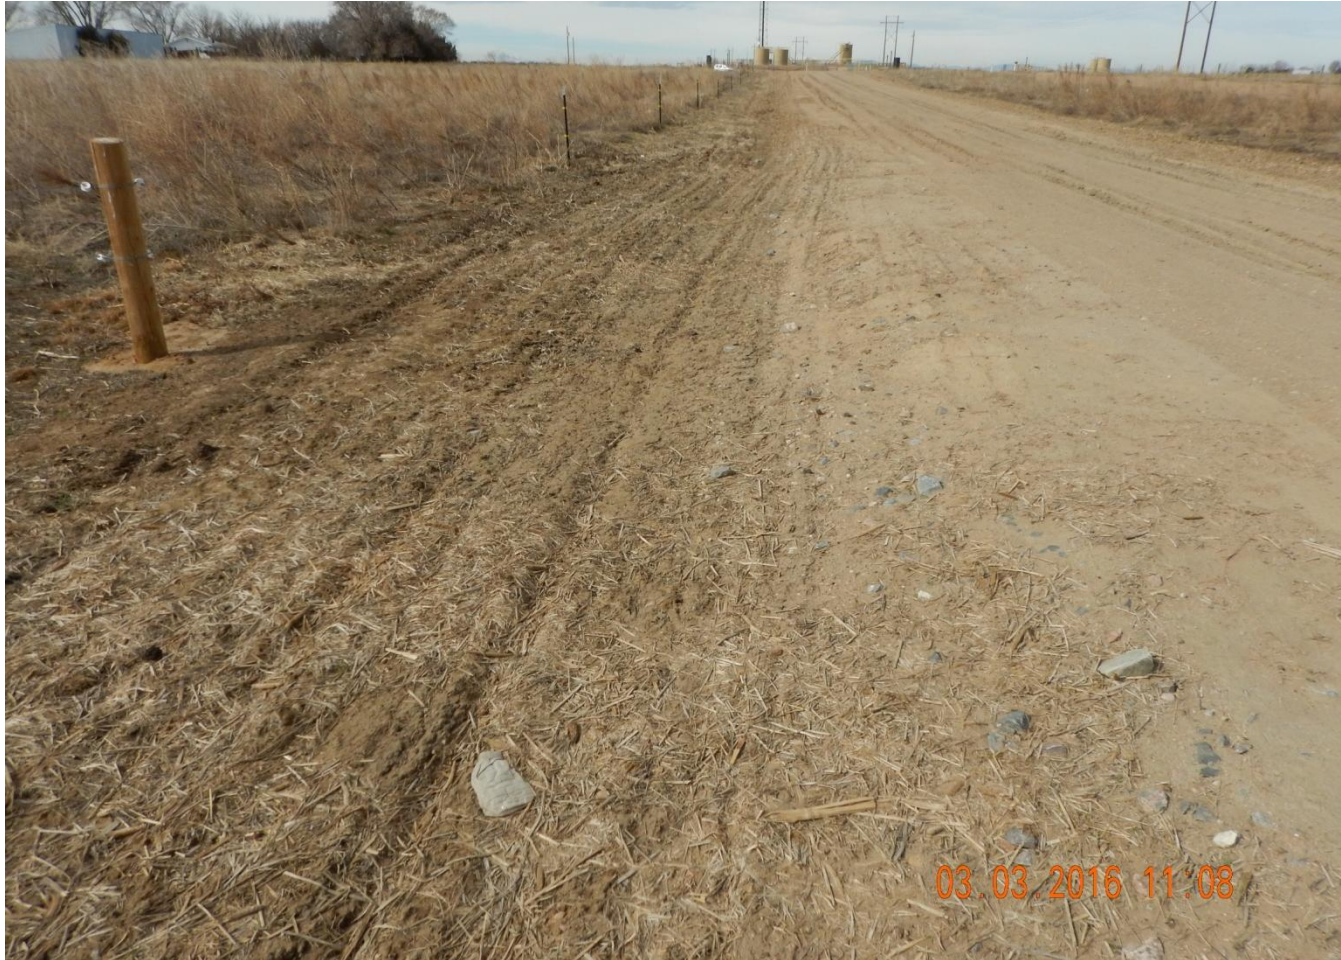
Photo 11. Photo taken from western location, facing West along south lease road. Interim reclamation in process- visible evidence of seeding.

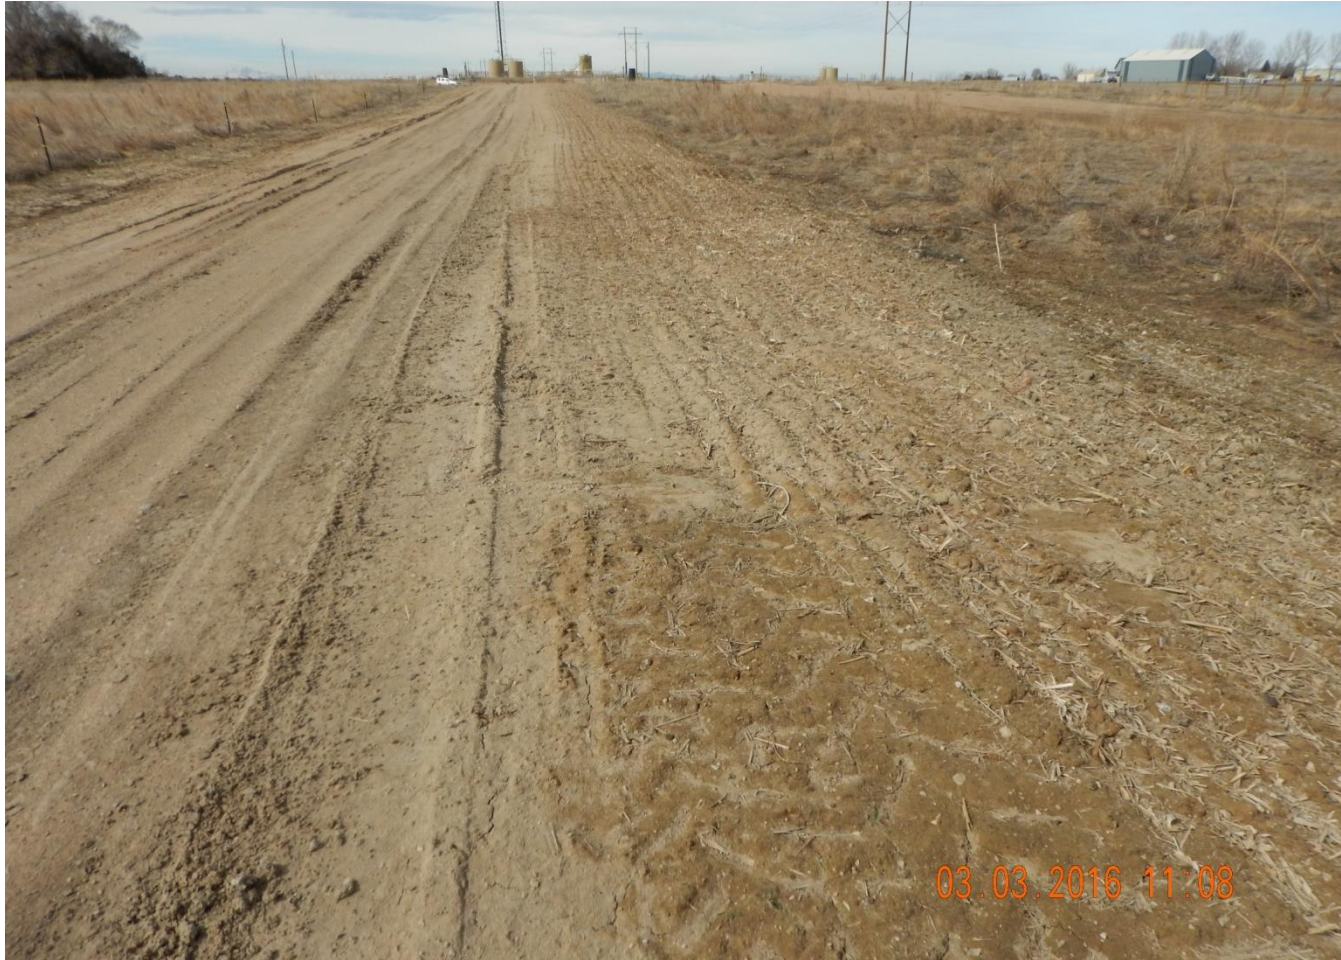
Photo 12. Photo taken from western location, facing West along north lease road. Interim reclamation in process- visible evidence of seeding.
