Interim Reclamation Inspection

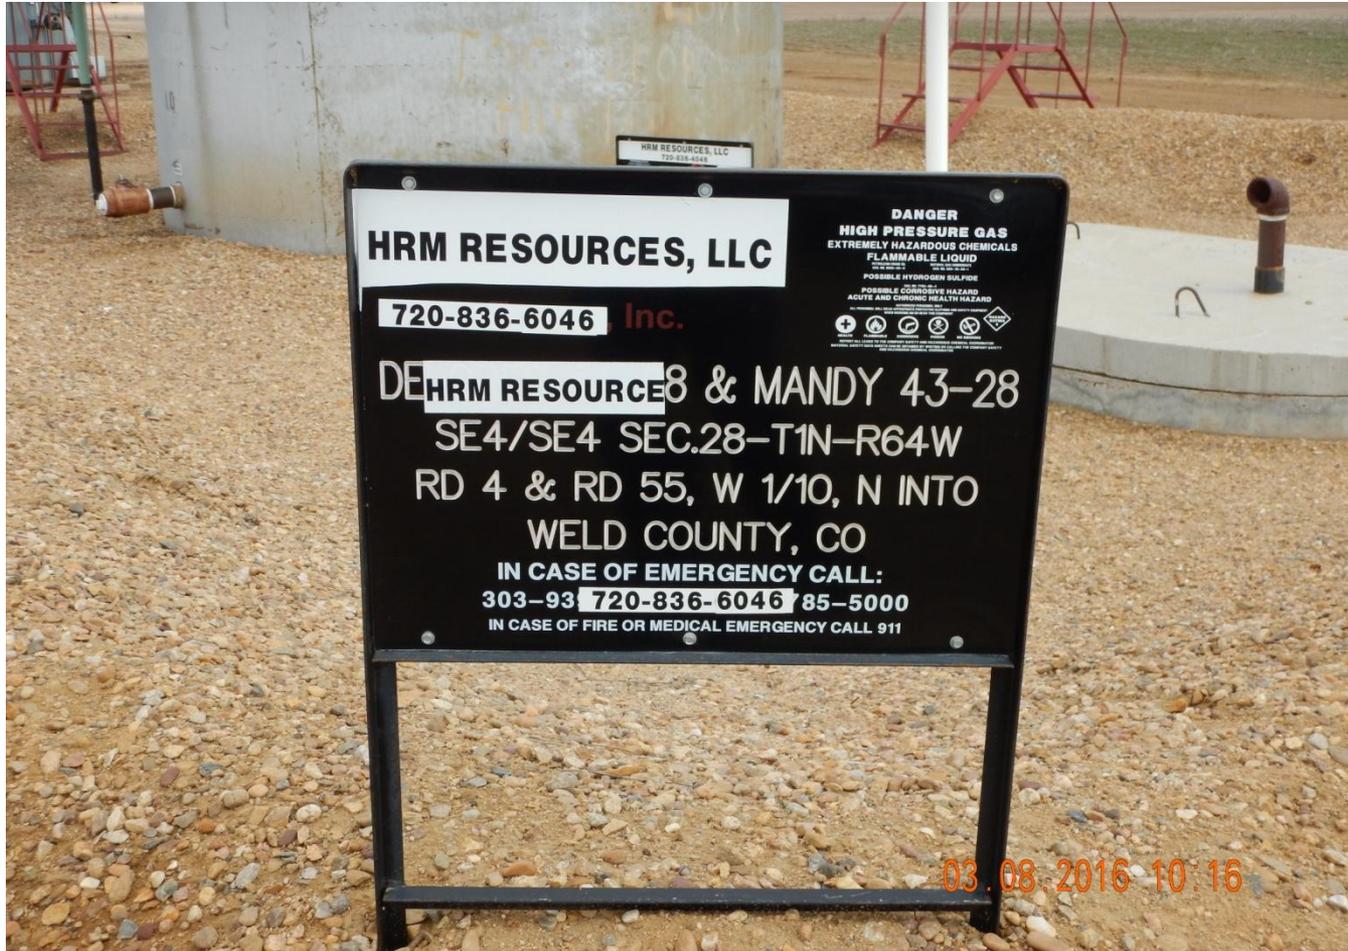
Photo 1. Photo taken of Tank Battery sign, servicing Mandy 43-28 (API# 123-10604).

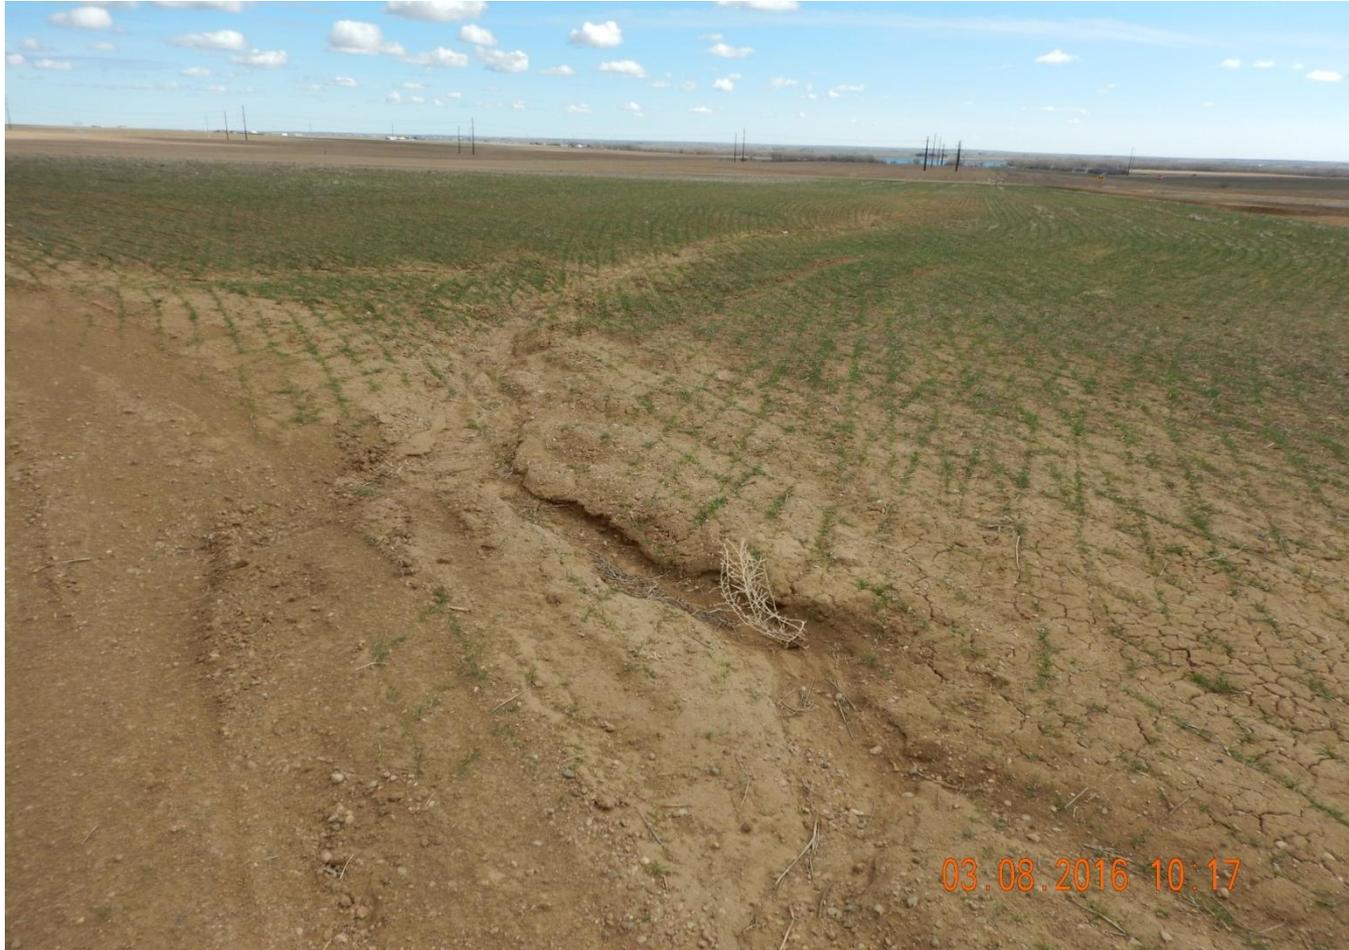
Photo 2. Photo taken from the southeast tank battery location, facing East. Need to control stormwater runoff that minimizes erosion and transport of sediment offsite per Rule 1002. Erosion and transport of sediment is occurring east, offsite, onto cropland. Refer to following photos illustrating erosion and transport of sediment on cropland.

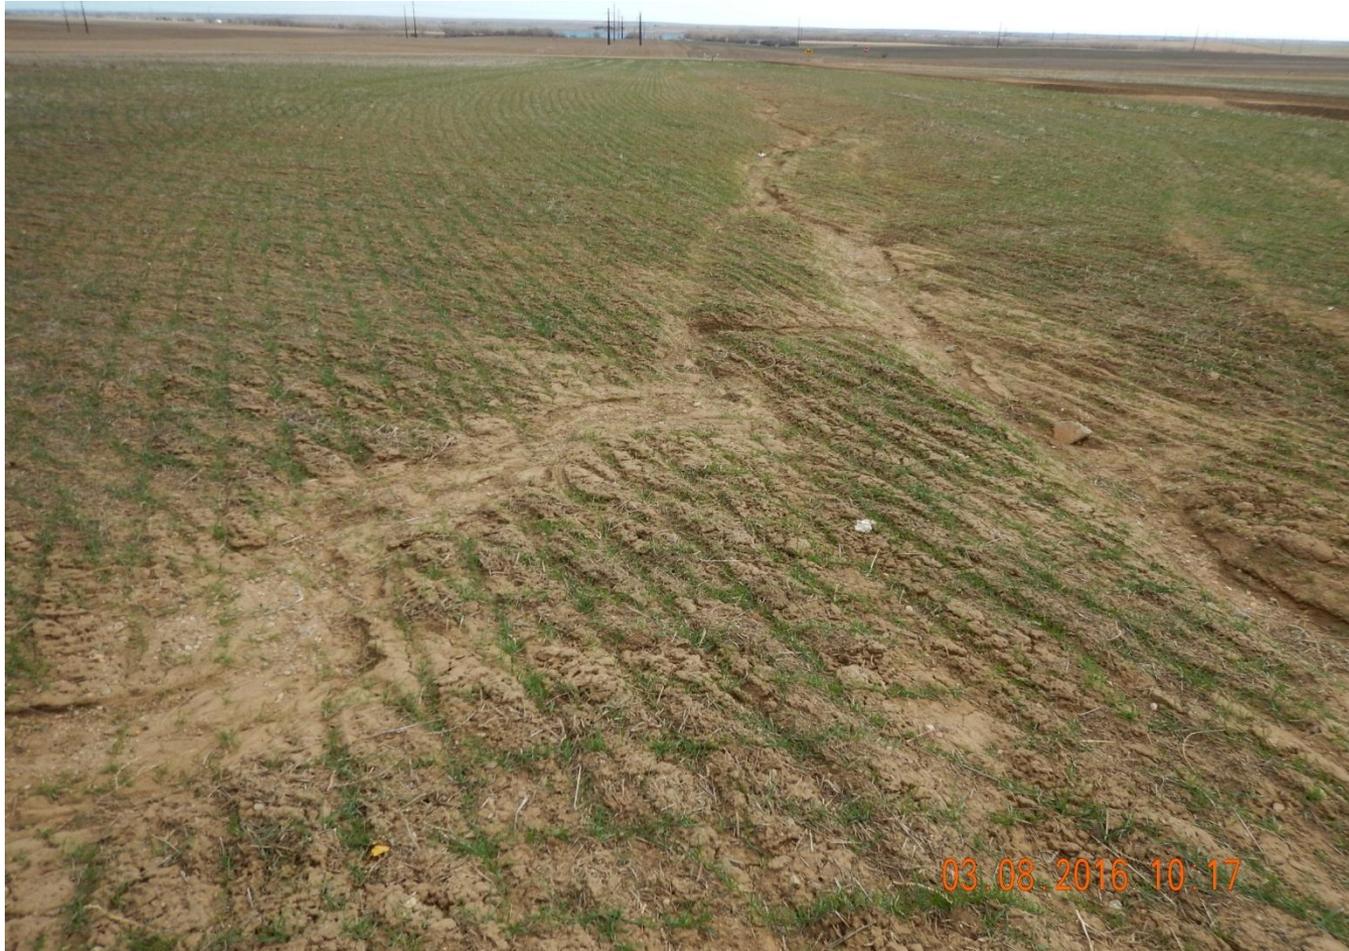
Photo 3. Photo taken east of tank battery location, facing Southeast. Photo illustrating erosion and transport of sediment on cropland.

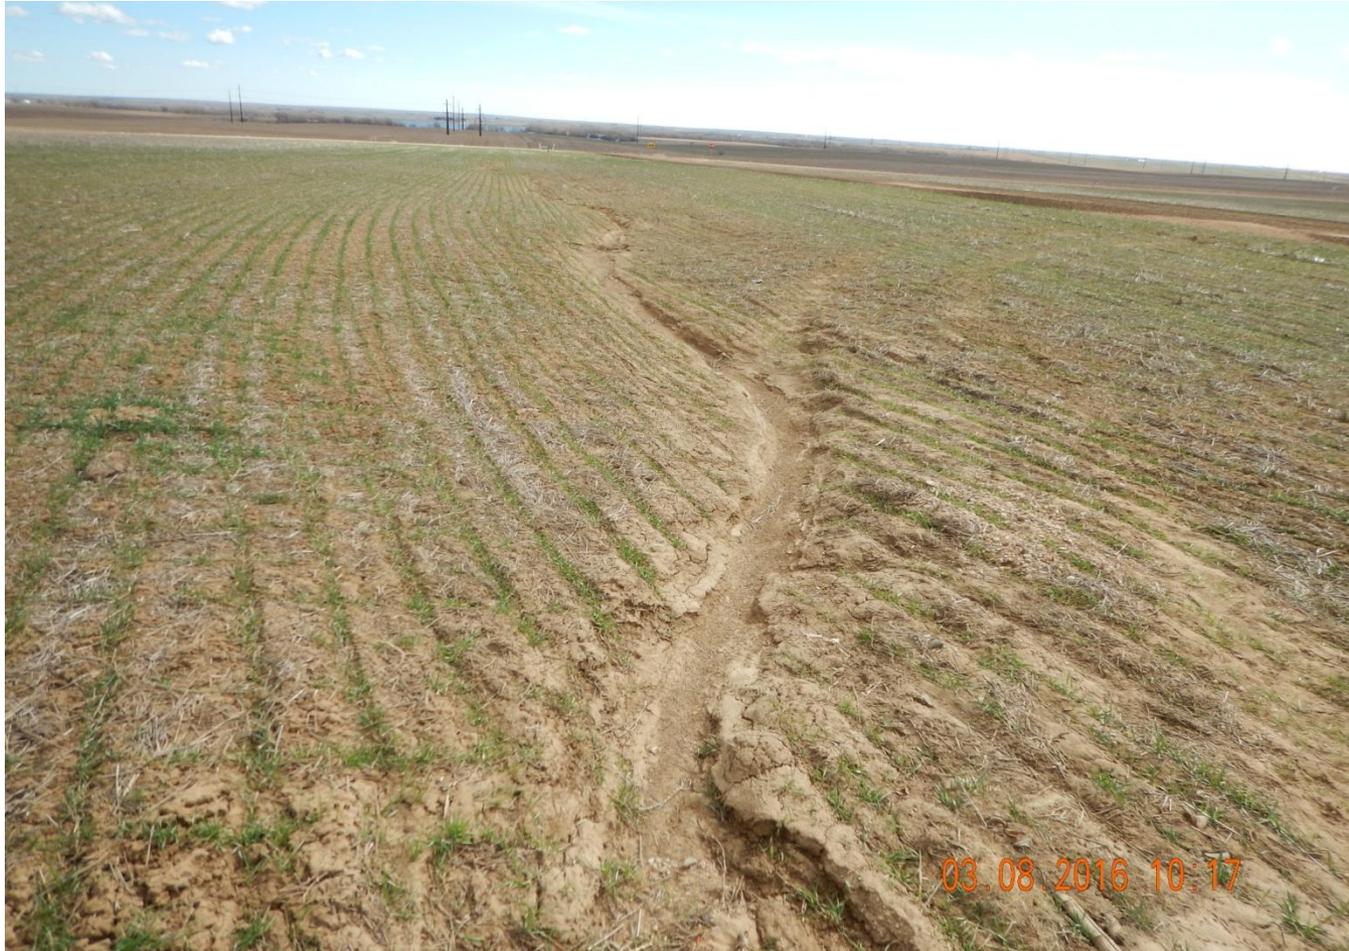
Photo 4. Photo taken east of tank battery location, facing Southeast. Photo illustrating erosion and transport of sediment on cropland.

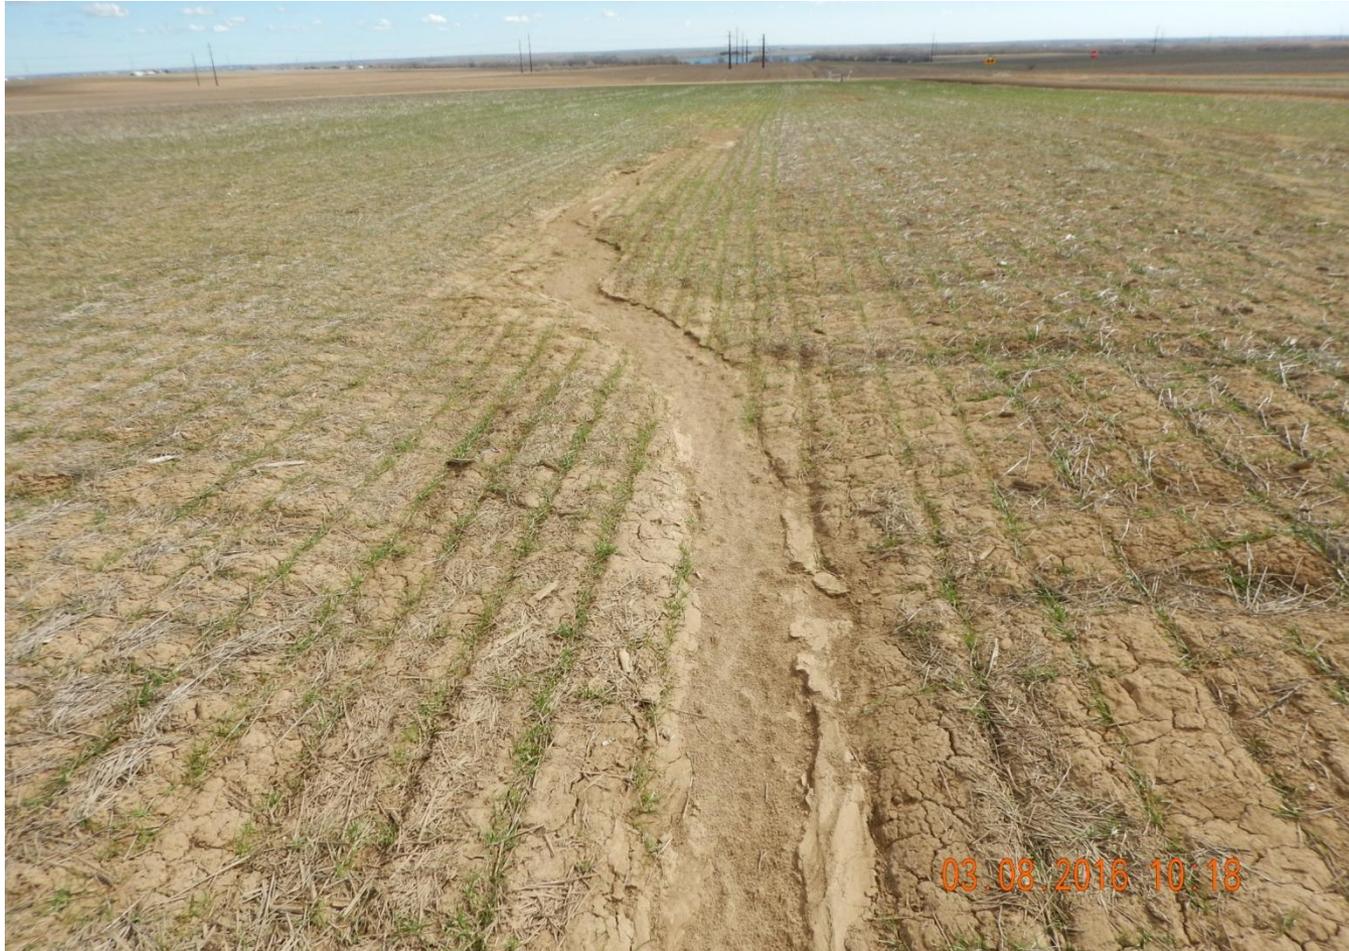
Photo 5. Photo taken east of tank battery location, facing Southeast. Photo illustrating erosion and transport of sediment on cropland.

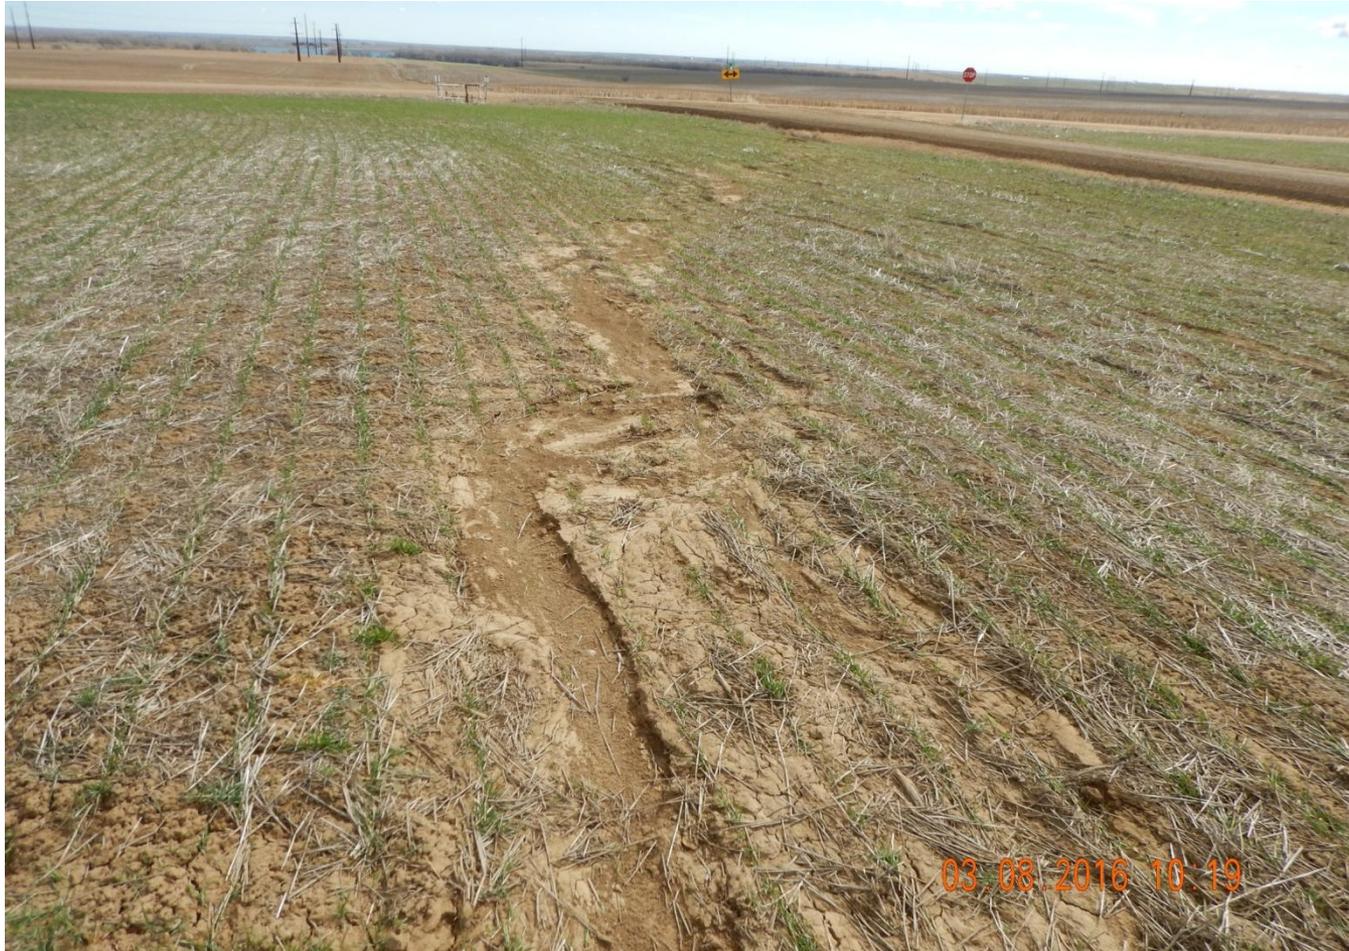
Photo 6. Photo taken east of tank battery location, facing Southeast. Photo illustrating erosion and transport of sediment on cropland.

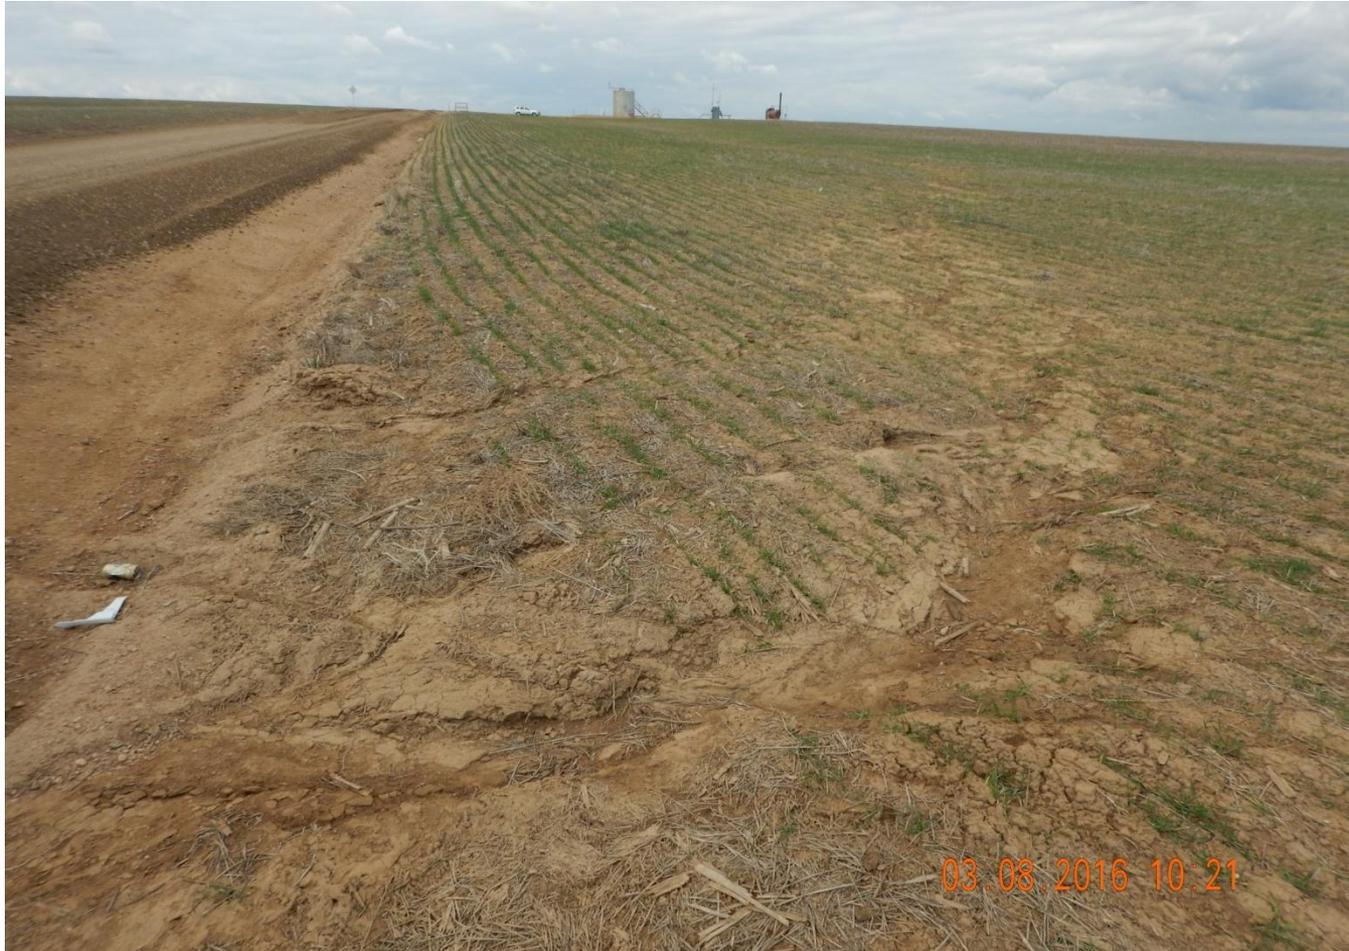
Photo 7. Photo taken east of tank battery location, facing West towards tank battery. Photo illustrating erosion and transport of sediment on cropland, then onto CR 4.

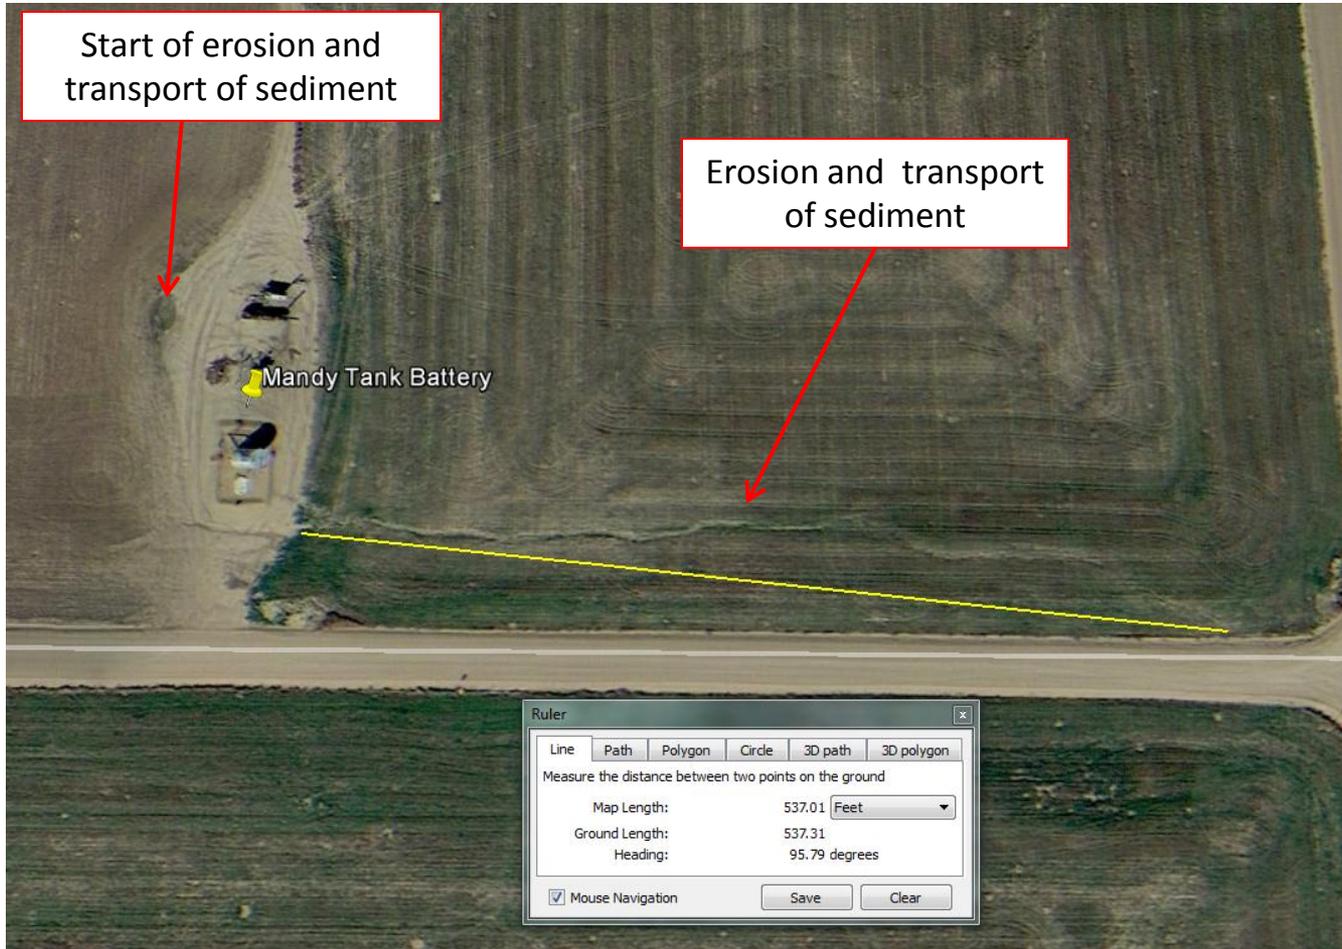
Photo 8. Google Earth aerial photo taken 10/9/2015. Erosion and transport of sediment initiates on the western area of the tank battery, then travels east through cropland, and then onto the north roadside ditch of CR 4, totaling approximately 535 feet.
