Interim Reclamation Inspection- Tank Battery Location

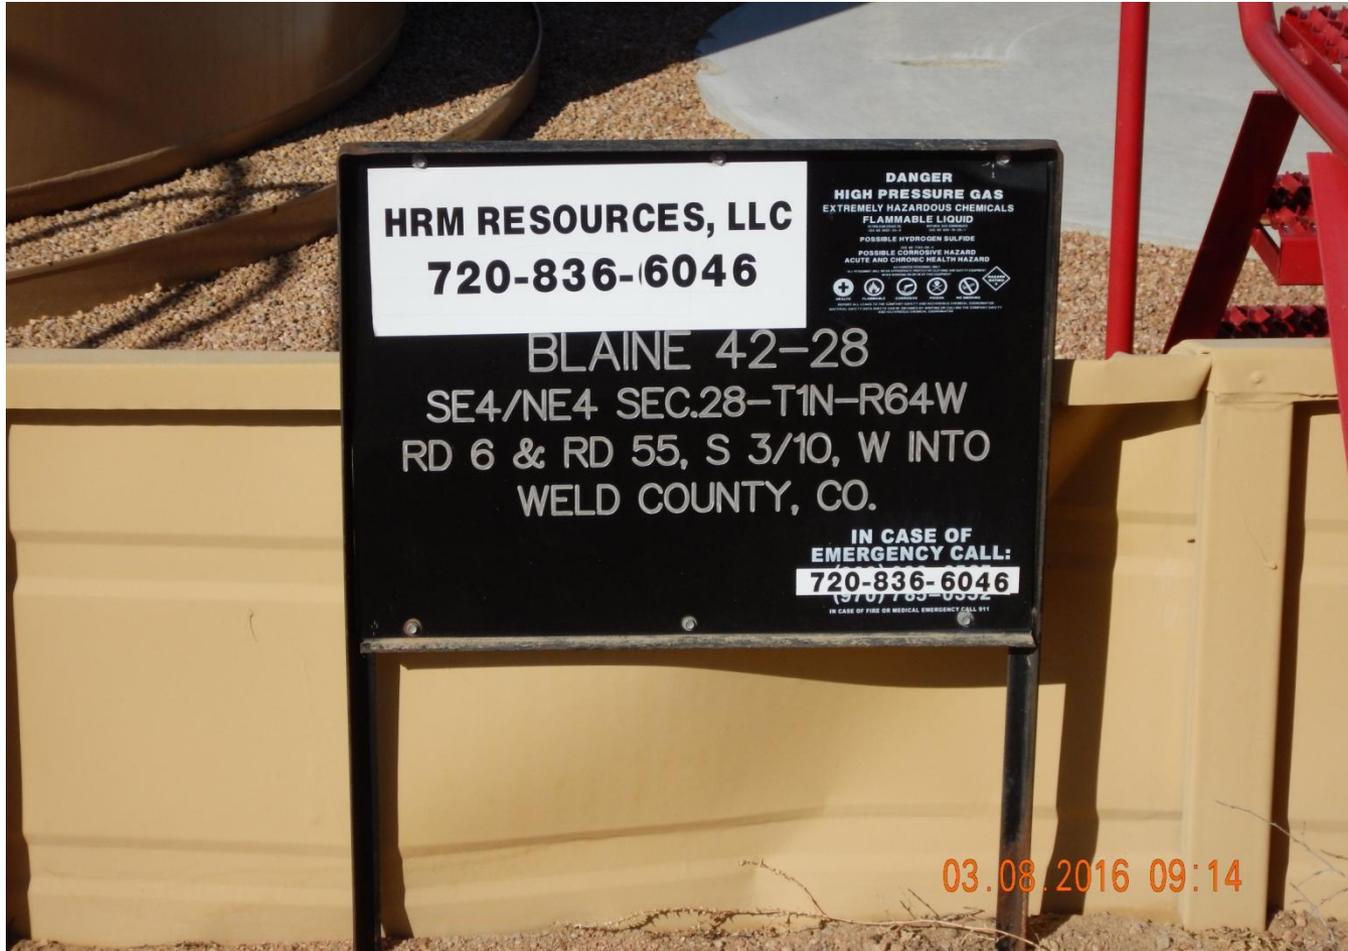
Photo 1. Photo taken of Tank Battery sign, servicing Blaine 42-28 (API# 123-10578).

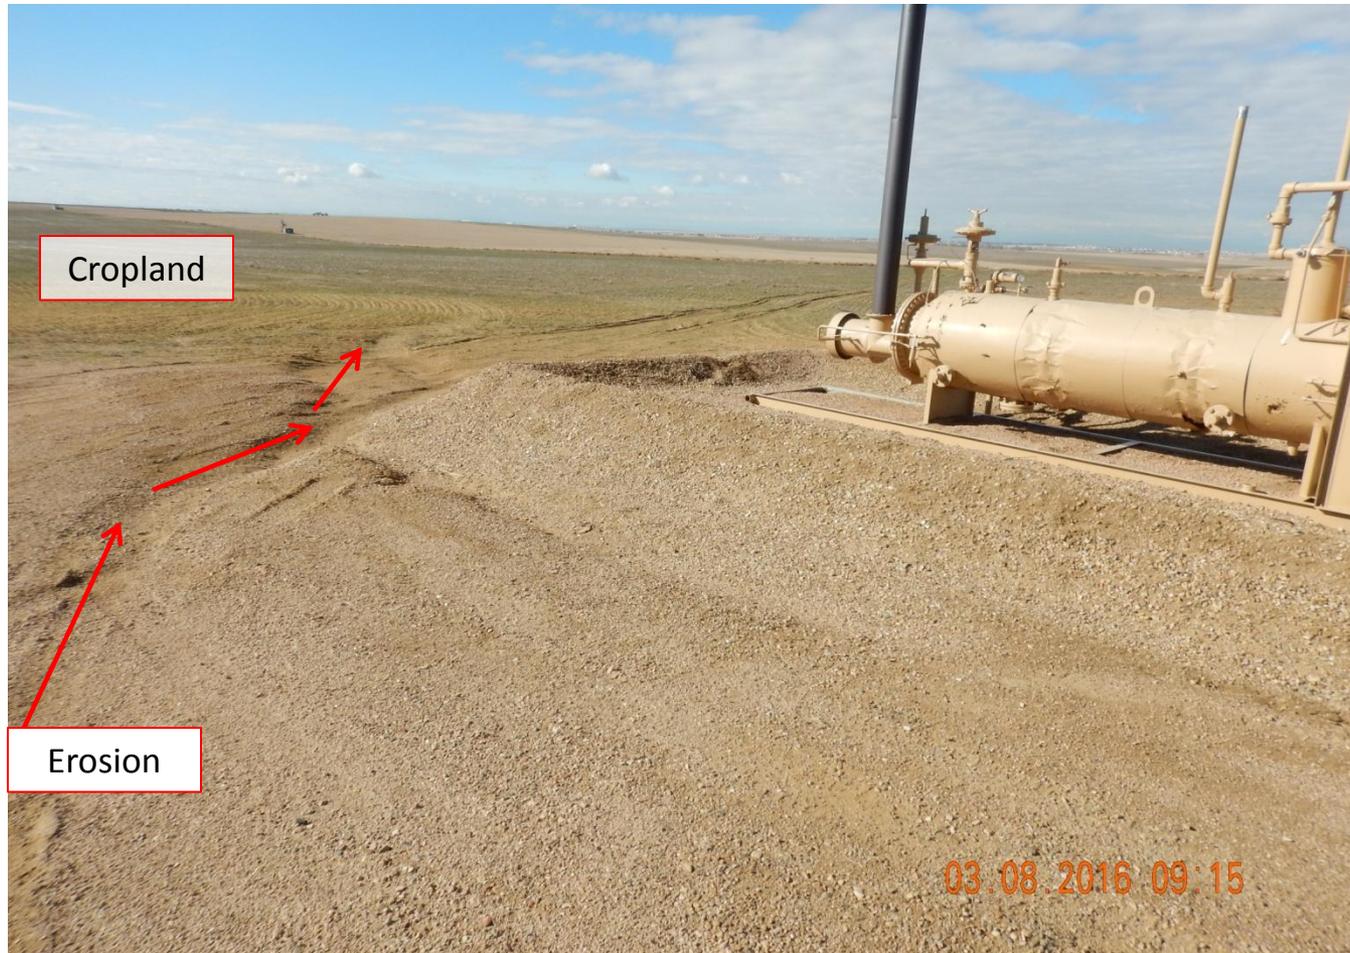
Photo 2. Photo taken from the southern tank battery location, facing Southwest. Need to control stormwater runoff that minimizes erosion and transport of sediment offsite per Rule 1002. Erosion and transport of sediment is occurring south, offsite, onto cropland.

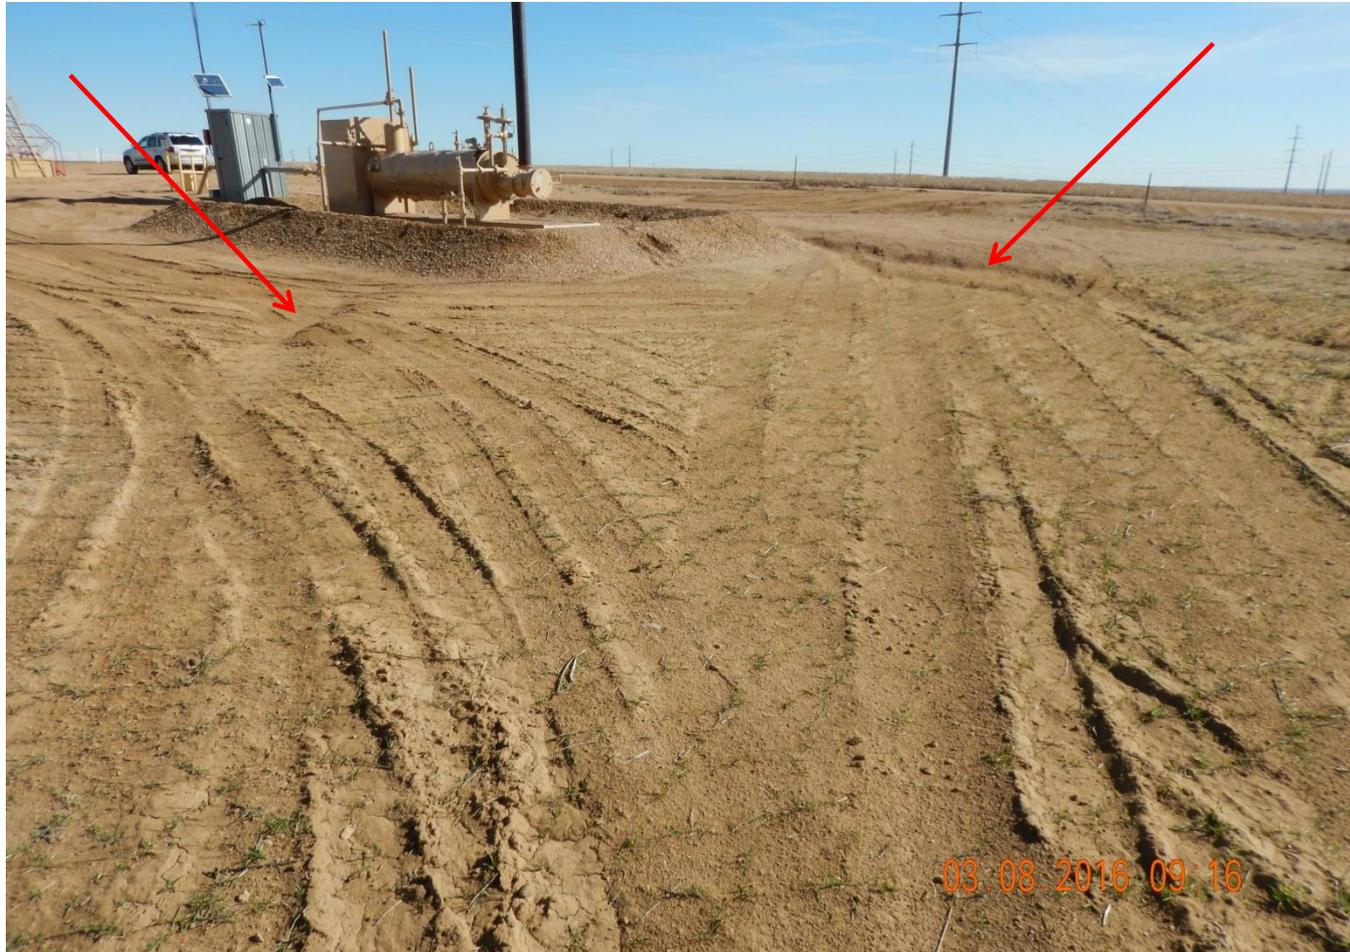
Photo 3. Photo taken from the southern tank battery location, facing Northeast. Need to control stormwater runoff that minimizes erosion and transport of sediment offsite per Rule 1002. Erosion and transport of sediment is occurring south, offsite, onto cropland.

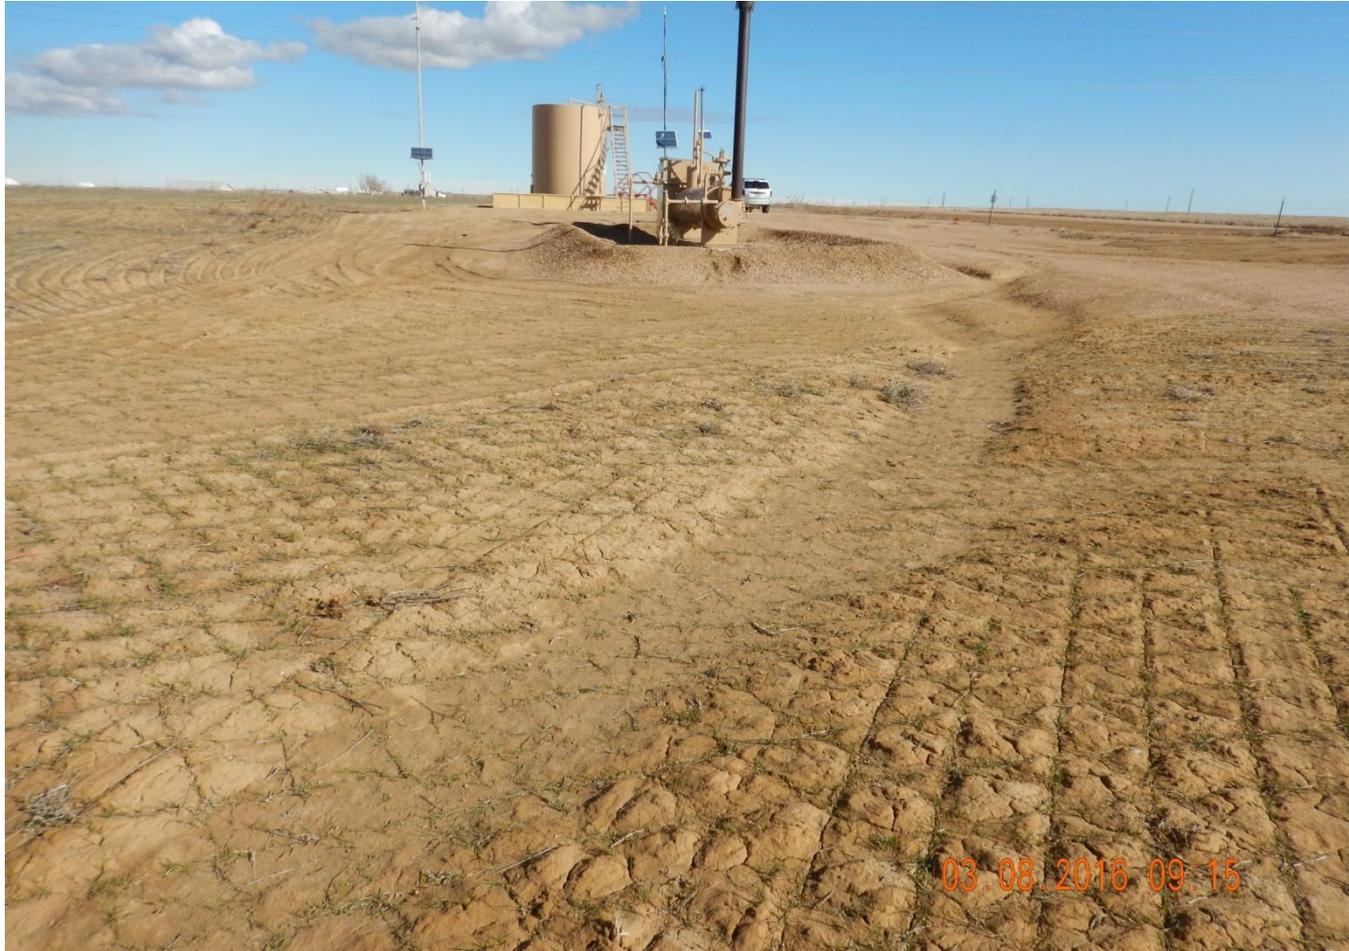
Photo 4. Photo taken from the south of tank battery location, facing North. Need to control stormwater runoff that minimizes erosion and transport of sediment offsite per Rule 1002. Erosion and transport of sediment is occurring south, offsite, onto cropland.
