## Interim Reclamation Inspection- Lease Road

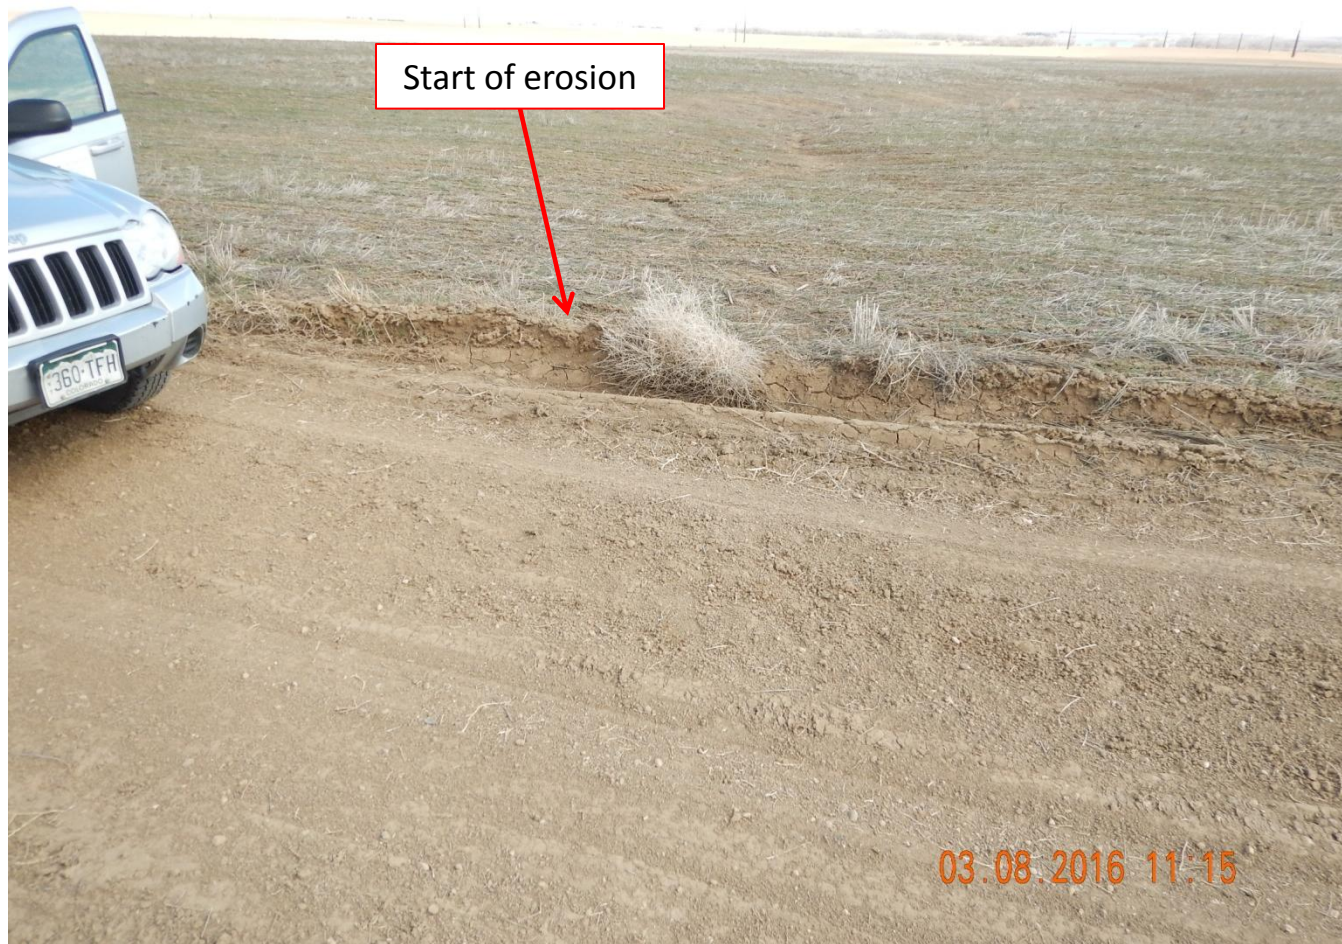
**Photo 1.** Photo taken from lease road, facing East. Need to control stormwater runoff that minimizes erosion and transport of sediment offsite per Rule 1002. Erosion and transport of sediment is occurring east, offsite, onto cropland.

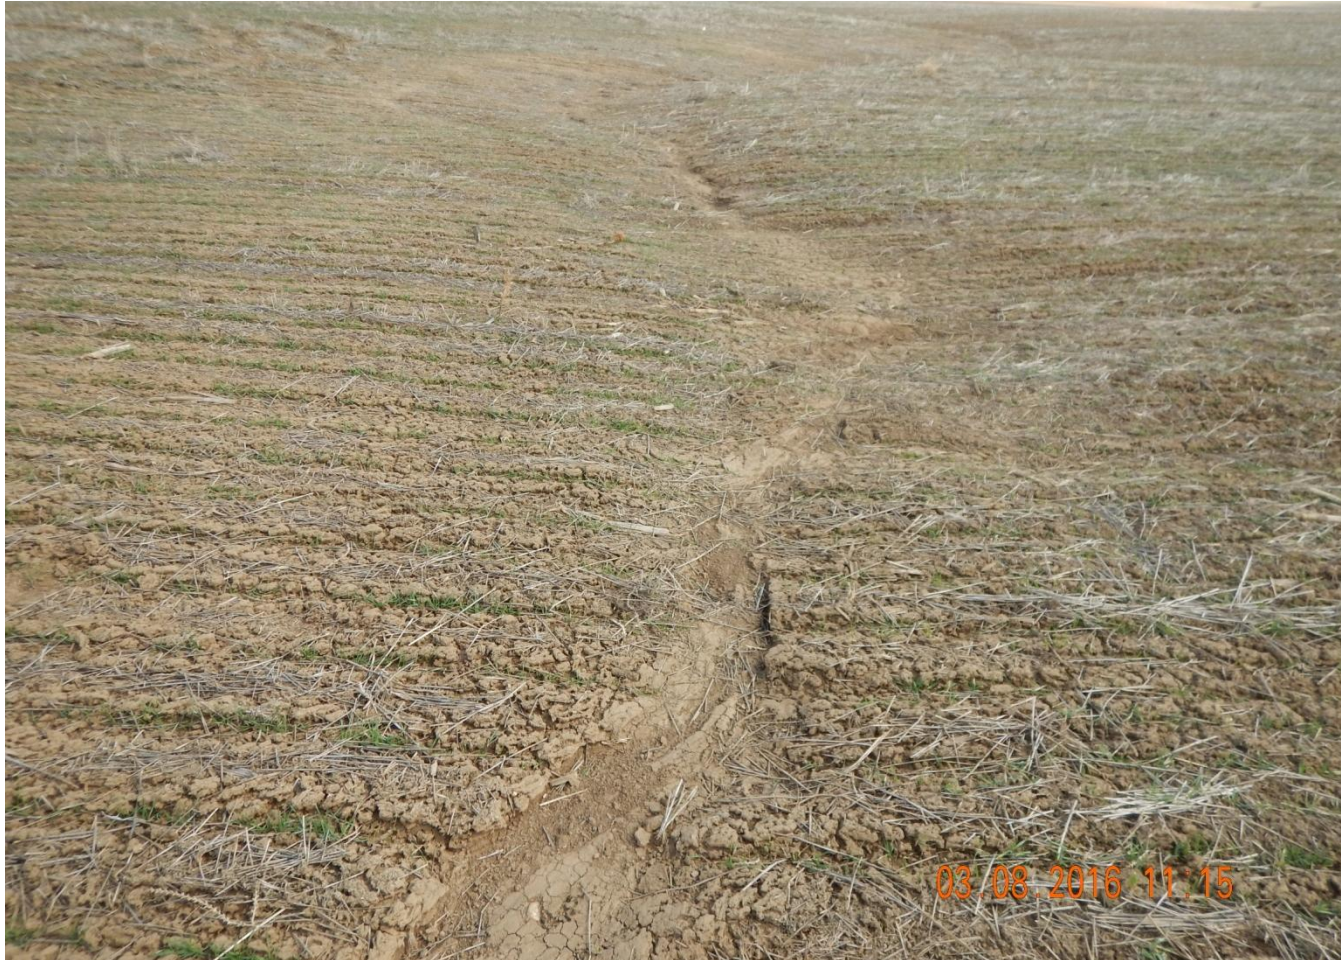
**Photo 2.** Photo taken east of lease road approximately 15 meters, facing East. Photo illustrating erosion and transport of sediment on cropland.

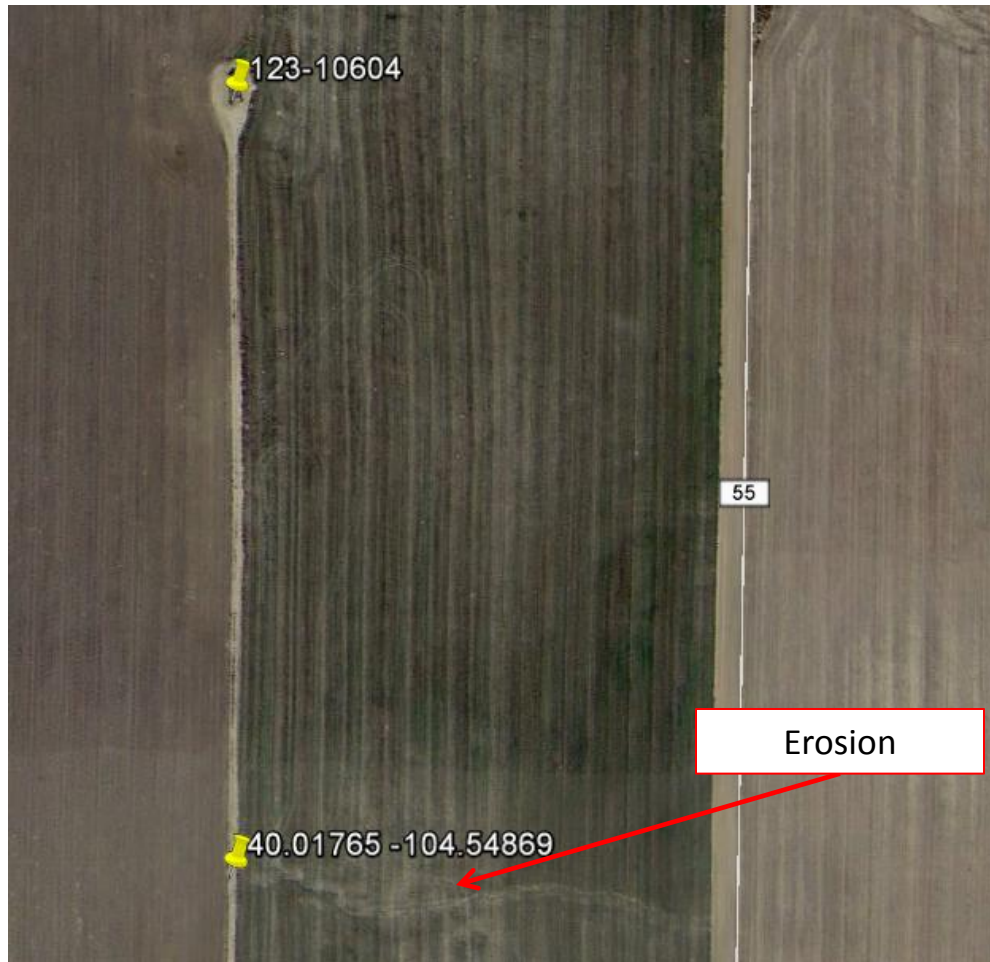
**Photo 3.** Google Earth aerial photo taken 10/9/2015. Erosion and transport of sediment initiates on the lease road and travels east through cropland.
