Love Ranch Centralized E&P Waste Annual Report  
Piceance Creek Facility  
Facility ID: 149012

Centralized E&P Waste Management Facility  
Love Ranch Evaporation Pond  
COGCC Facility No. 149012  
Rio Blanco County, Colorado

Reporting Year: 2015

Subject: Love Ranch Evaporation Pond (SWD Pond)  
2015 Annual Report  
Dam ID: C-1881  
Piceance Development Project  
SMA/KRW Project Number: 0606-09

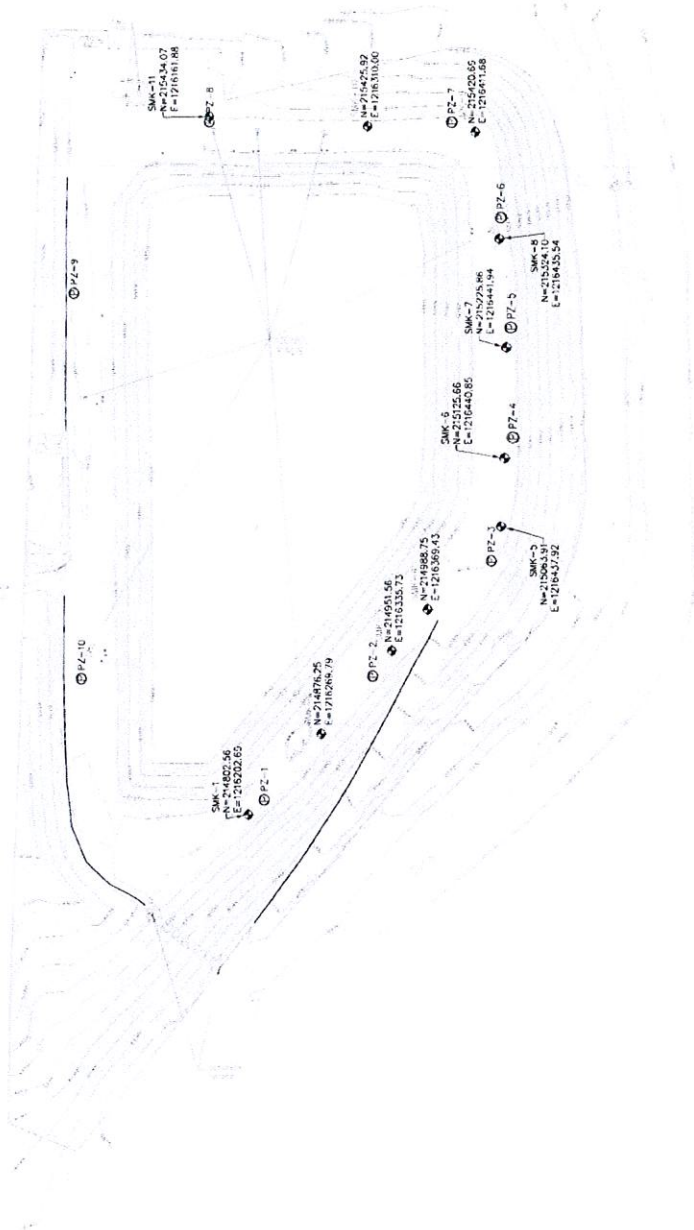
1. The settlement monuments were surveyed on October 13, 2015 using a Leica Series 1200 Differential GPS unit. Please see attached Figure 1 for a summary of settlement monitoring data to date, and to Attachment 1 for the location of the settlement monuments.
