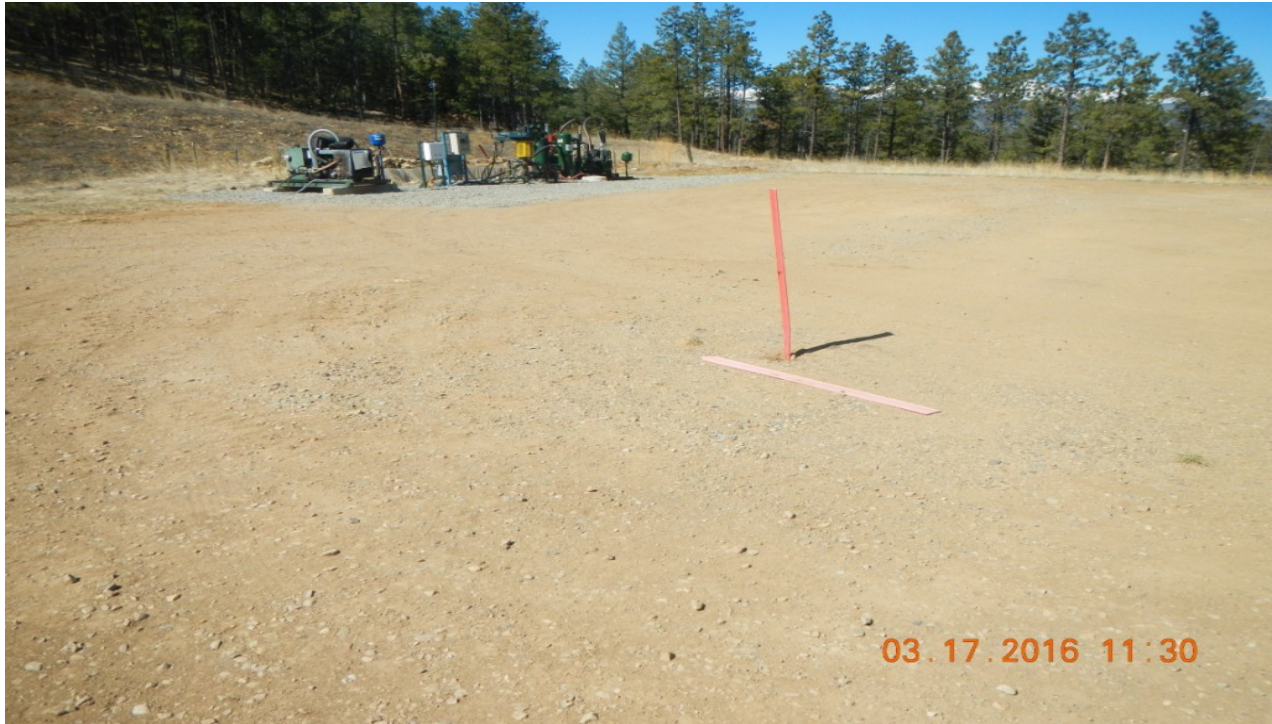
photo 1: Facing west toward the location.

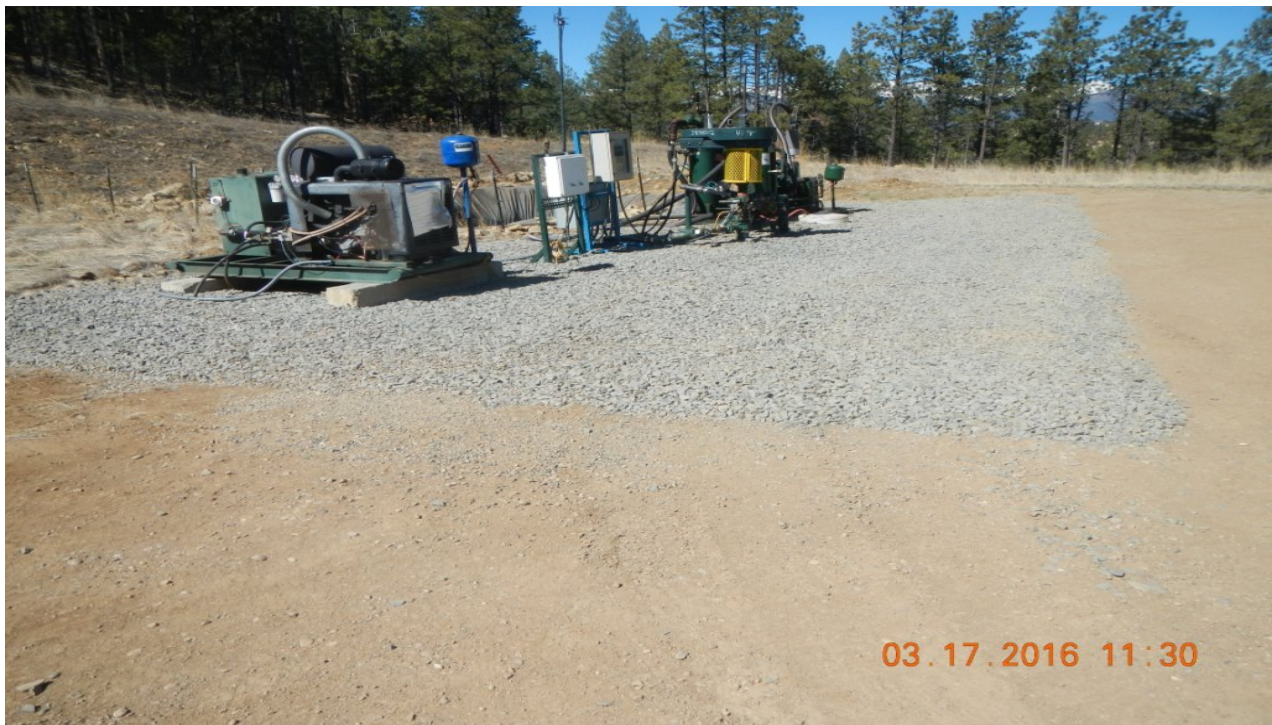
photo 2: Facing toward production equipment. New gravel has been placed around the equipment.

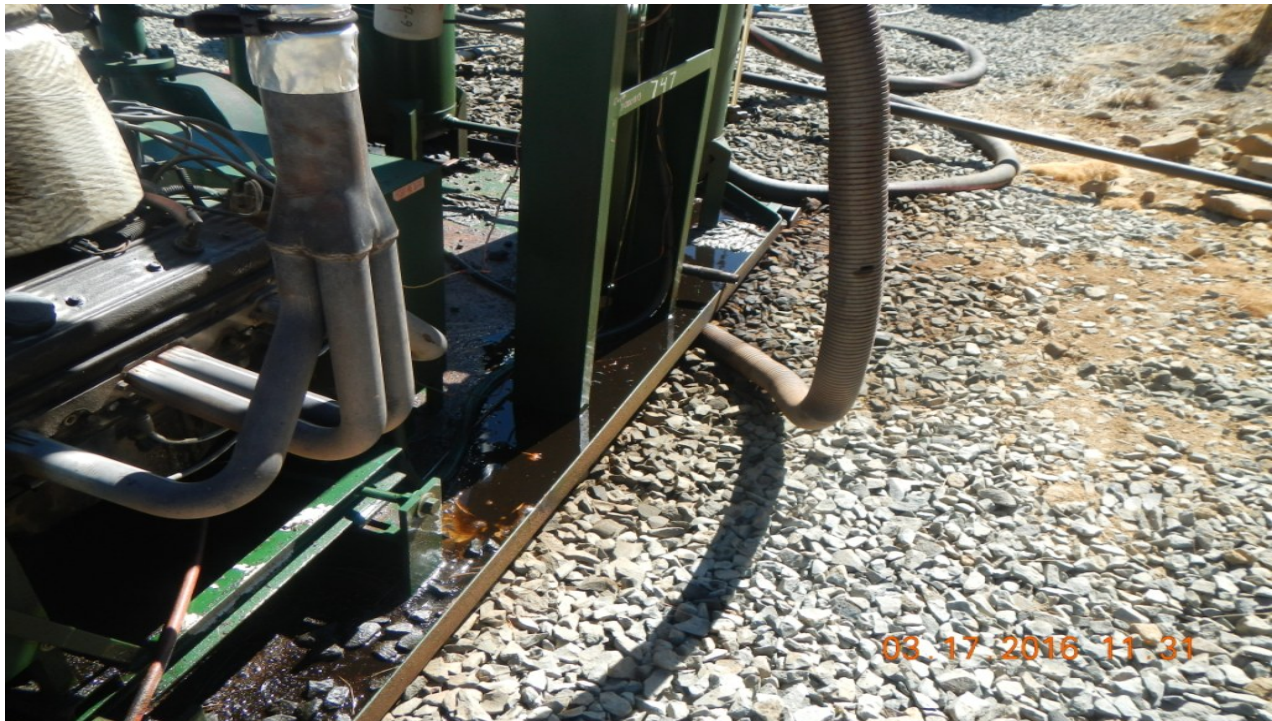
photo 3: Noticed oil on the skid of the separator. Pioneer employee nearby was notified.

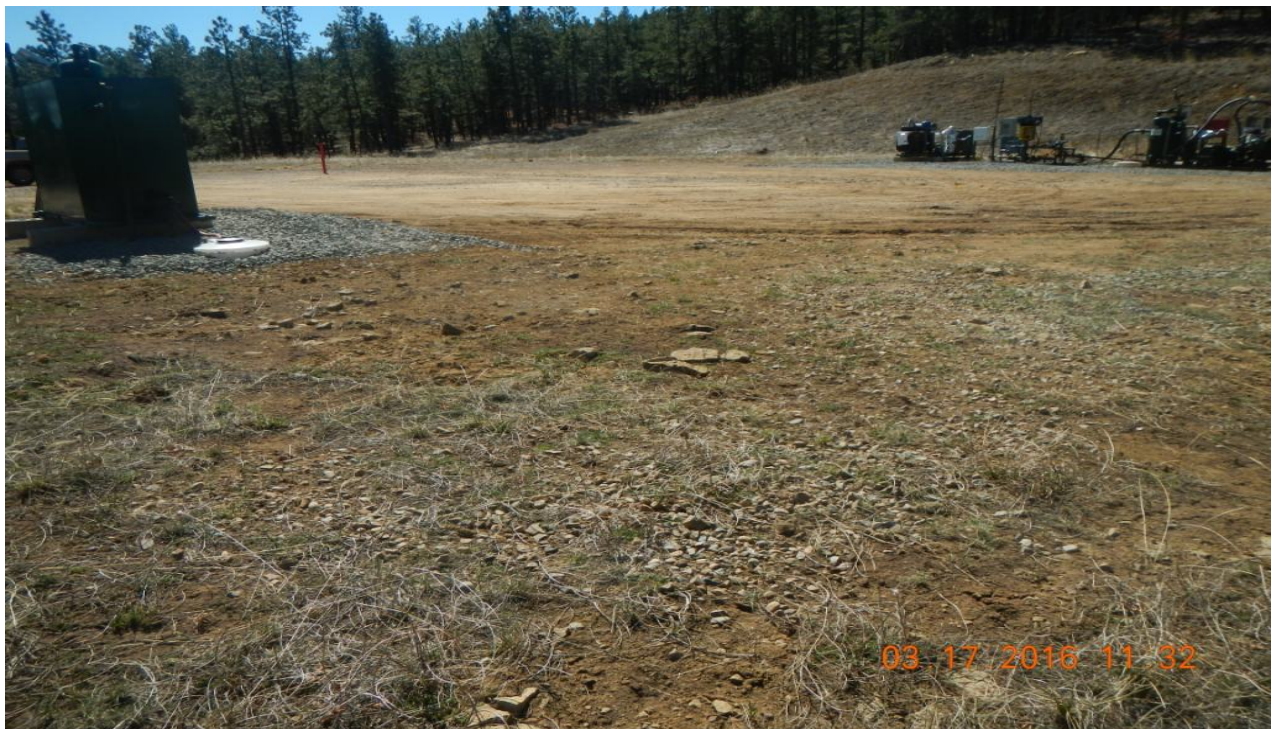
photo 4: Northwest corner of the location facing southeast.

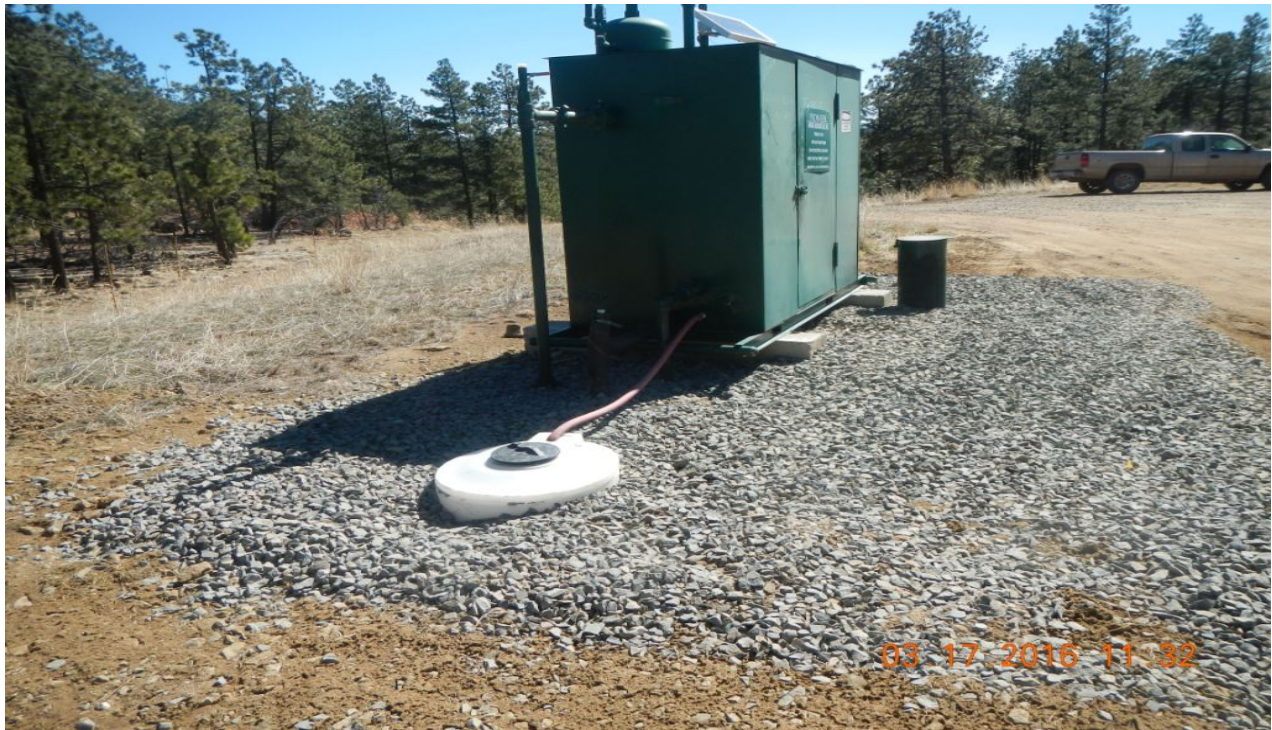
photo 5: North side of the location facing east.

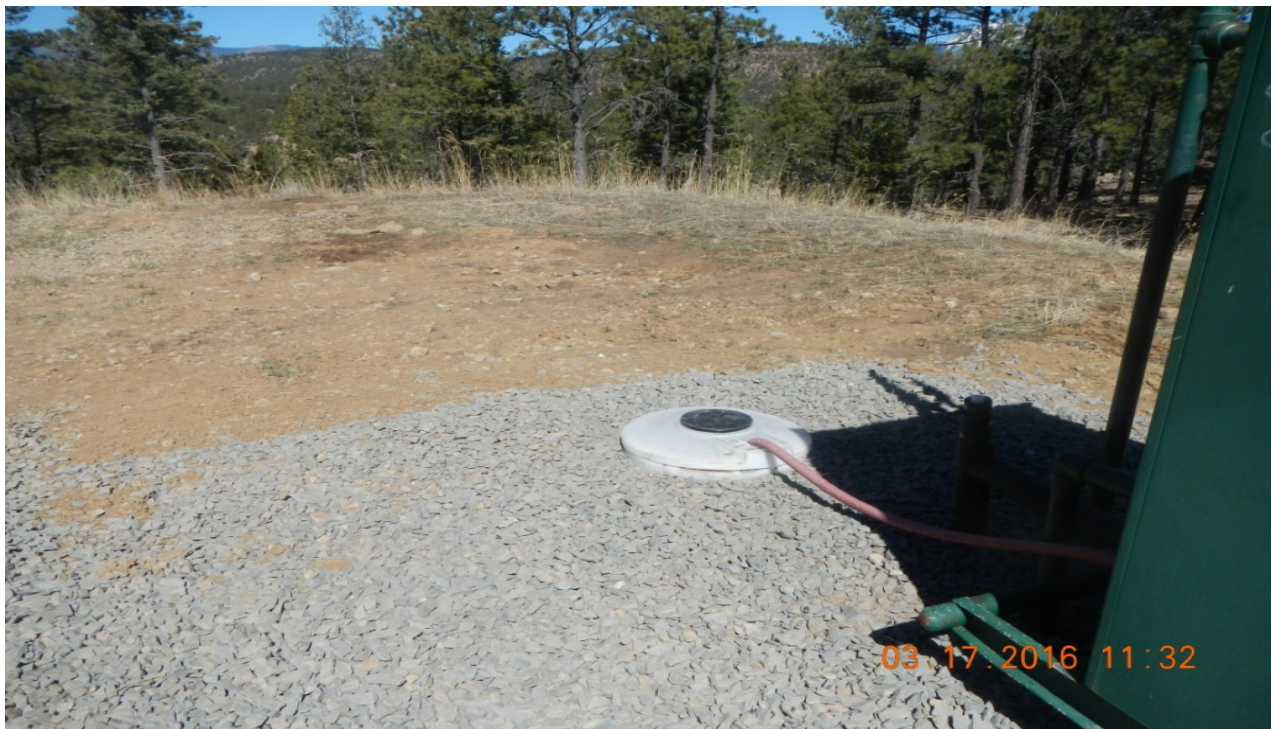
photo 6: Facing toward the northwest corner. Oil fluid noticed in the previous inspection appears to have been cleaned up.
