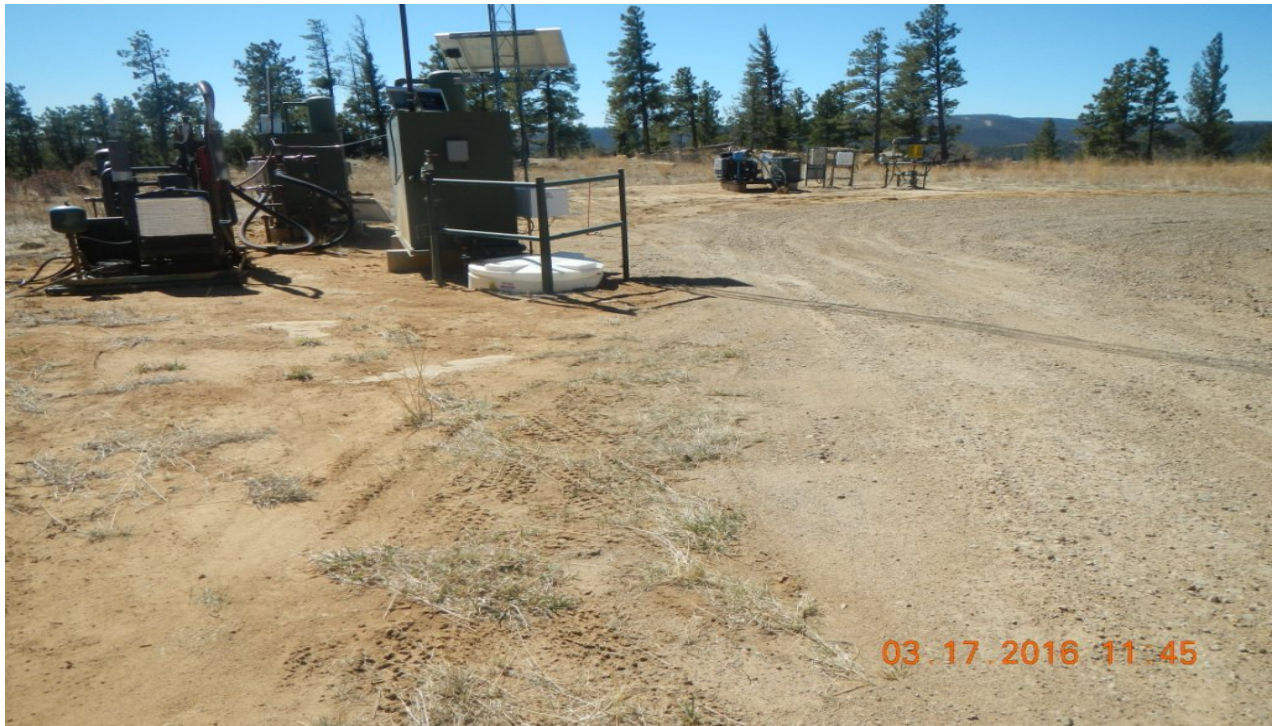
photo 1: Facing south toward the location.

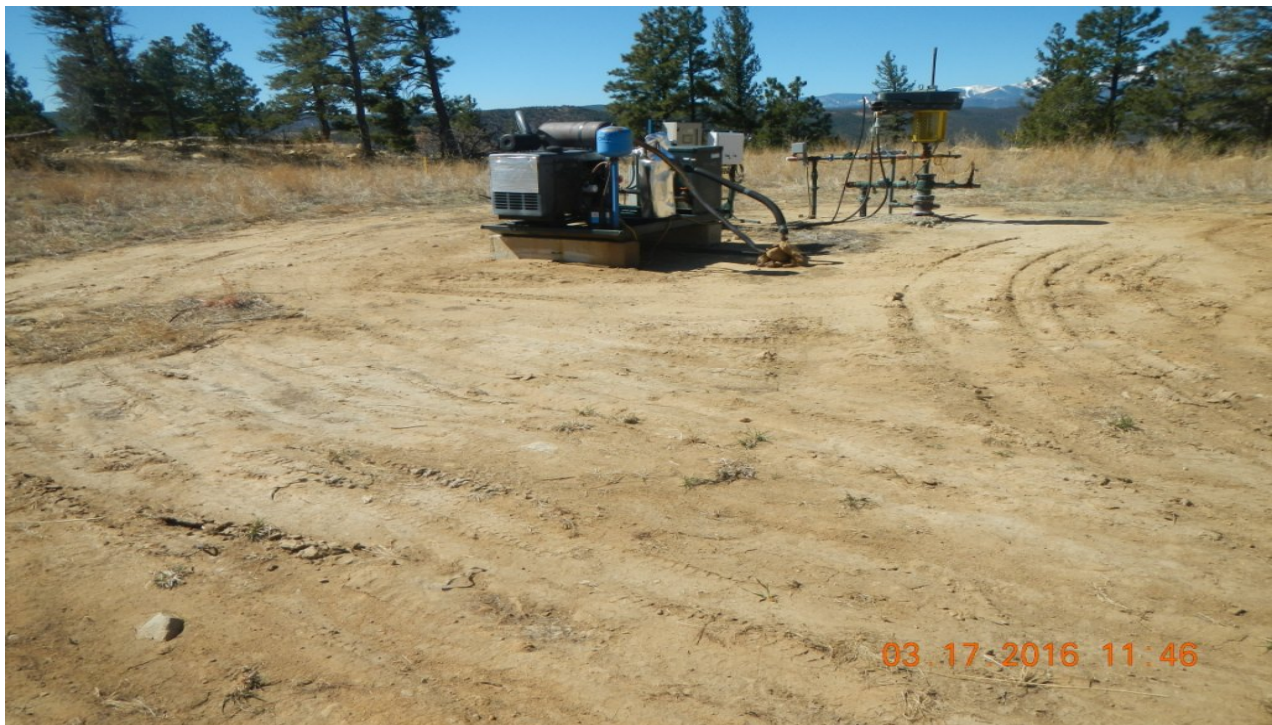
photo 2: Facing toward production equipment. New disturbance has been created around the equipment.

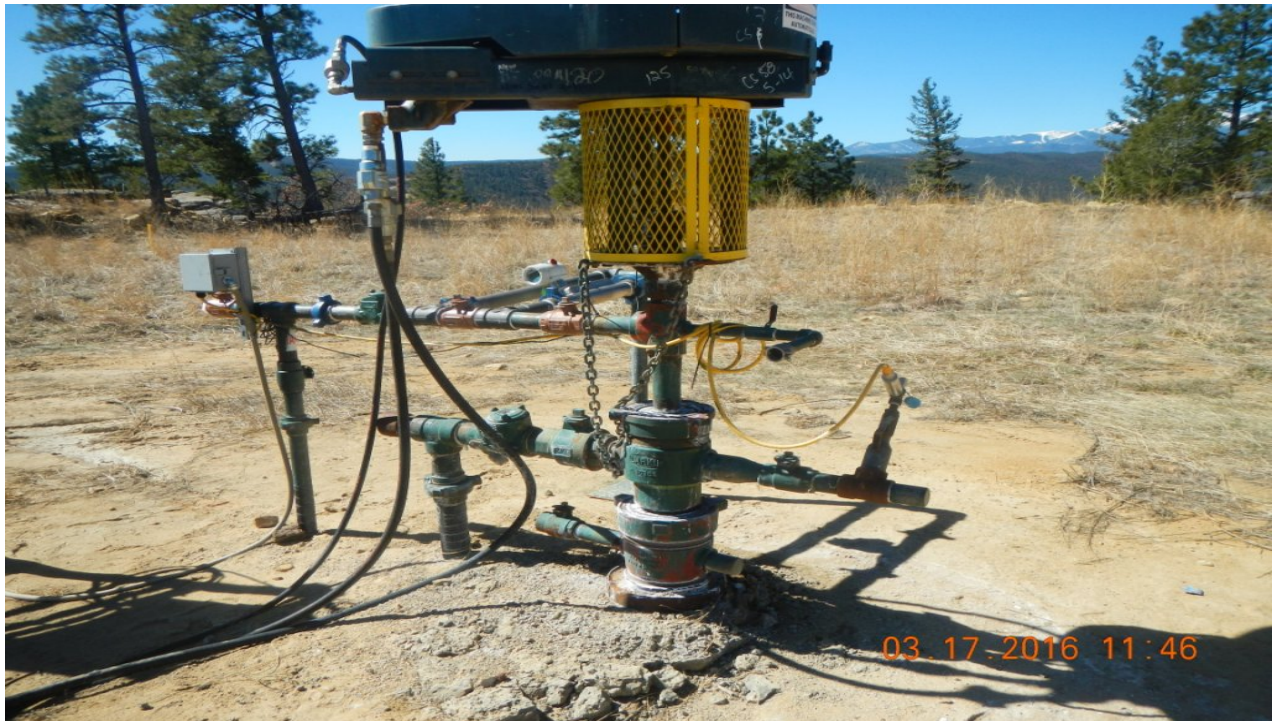
photo 3: Wellhead at the south side of the location. Water leak has been repaired.

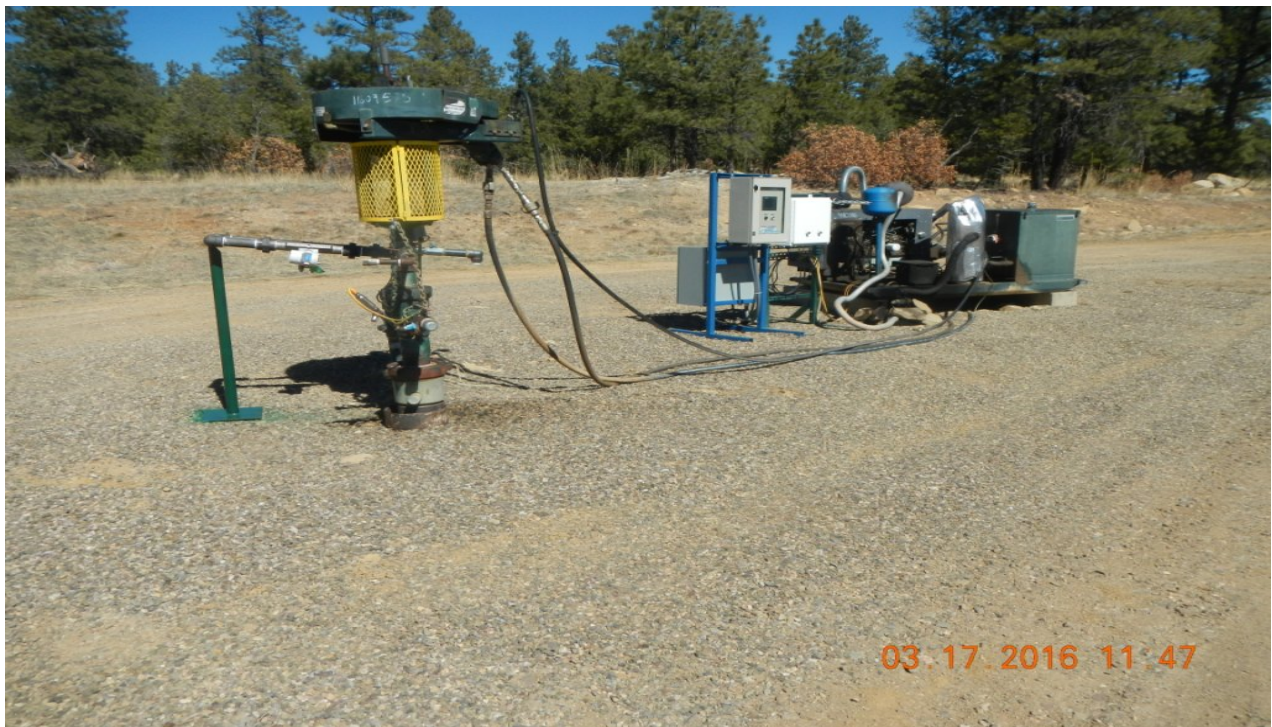
photo 4: Facing toward the wellhead at the north side of the location.
