March 16, 2016

Inspection Photos FRAM Operating Hamilton SI 029-06101

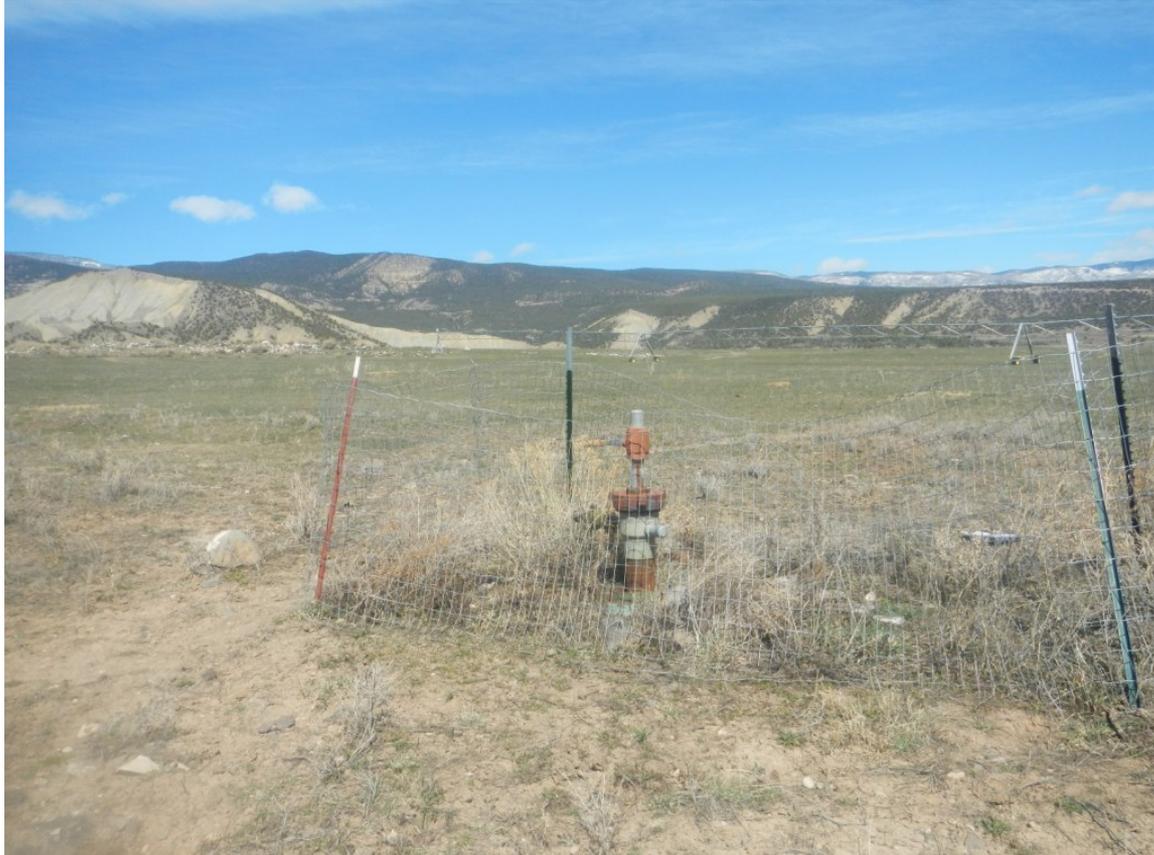
Photo#1: Overview of Location to North

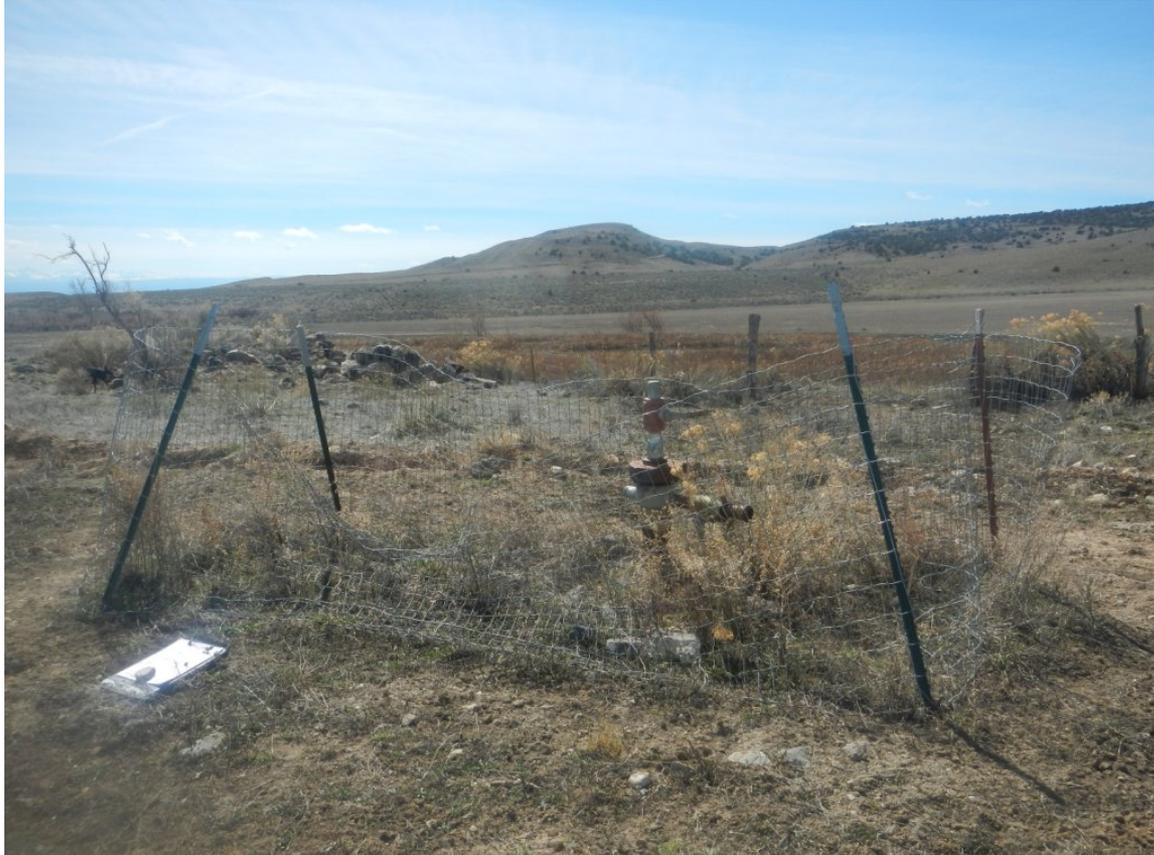
Photo#2: View of Location to South, showing sagging fence in disrepair.

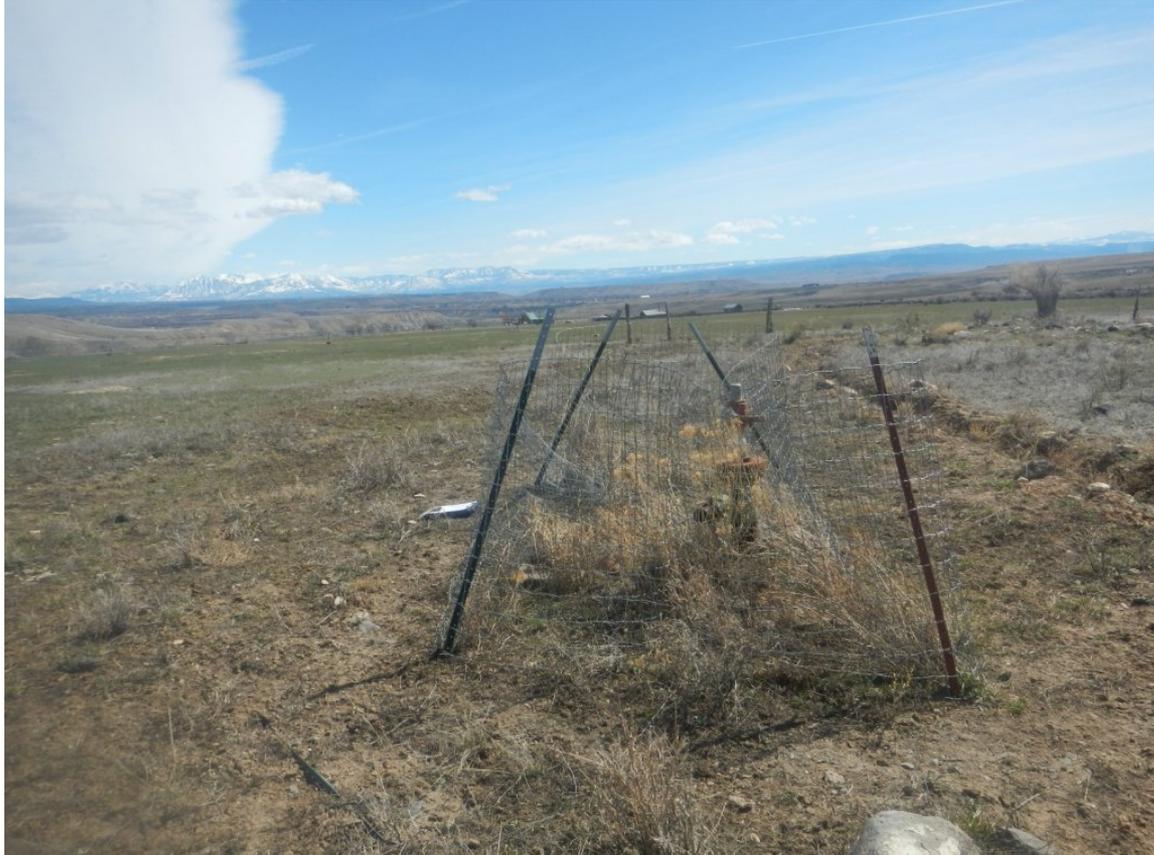
Photo#3: View of Well head to East

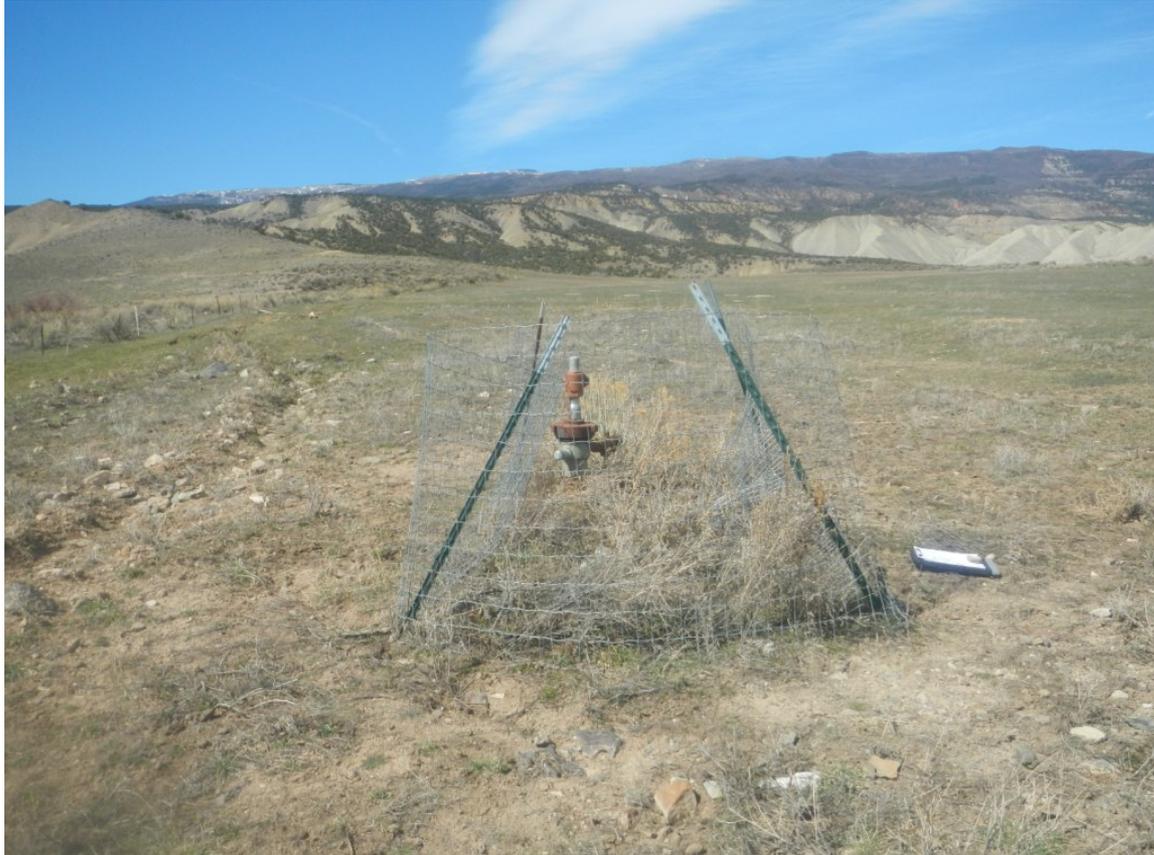
Photo#4: View West over Wellhead

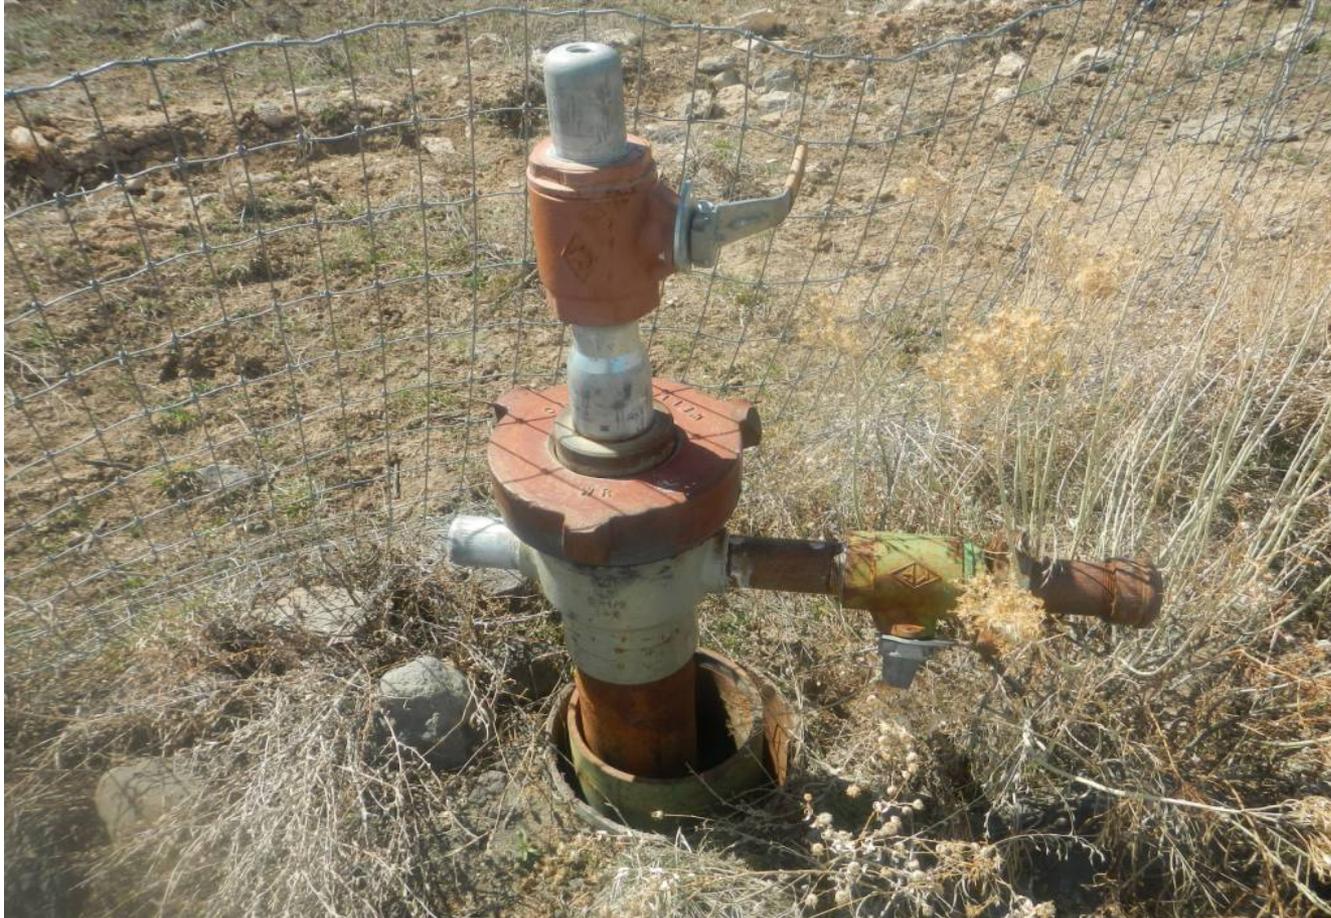
Photo#5: View of Wellhead showing open area between Conductor and Surface casing that needs to be covered.
