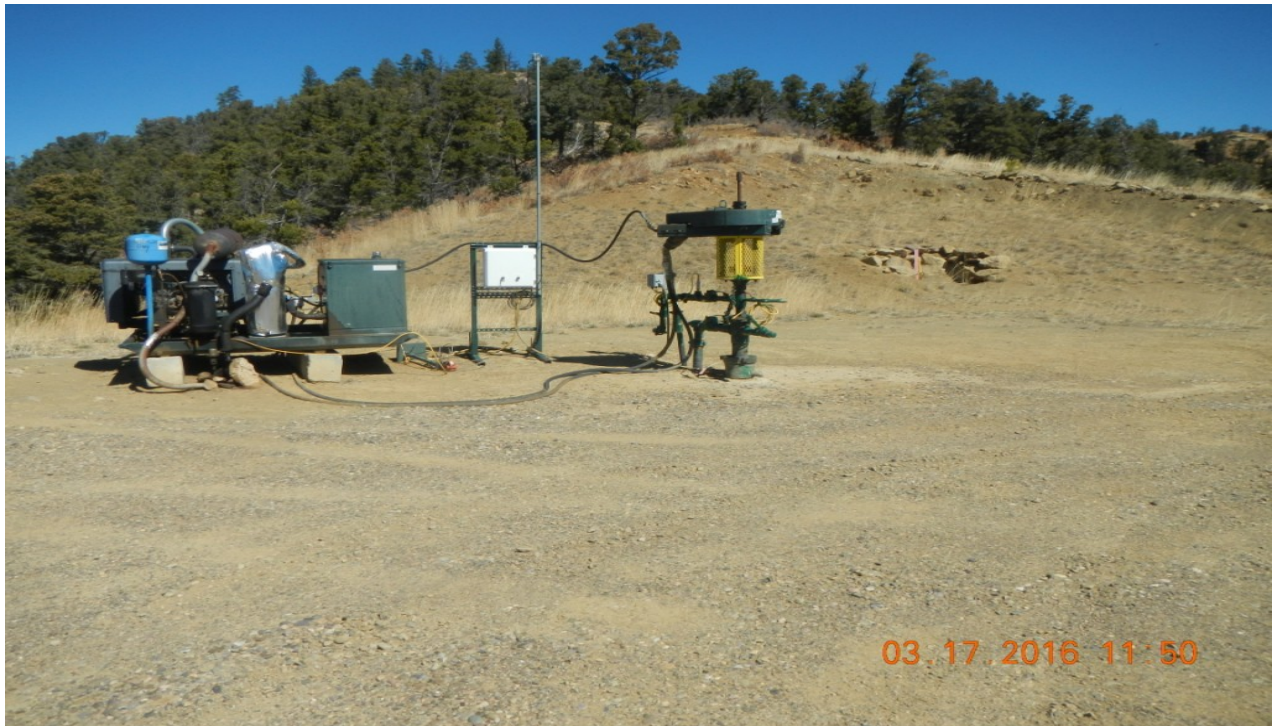
photo 1: Facing north toward the wellhead and equipment at the location.

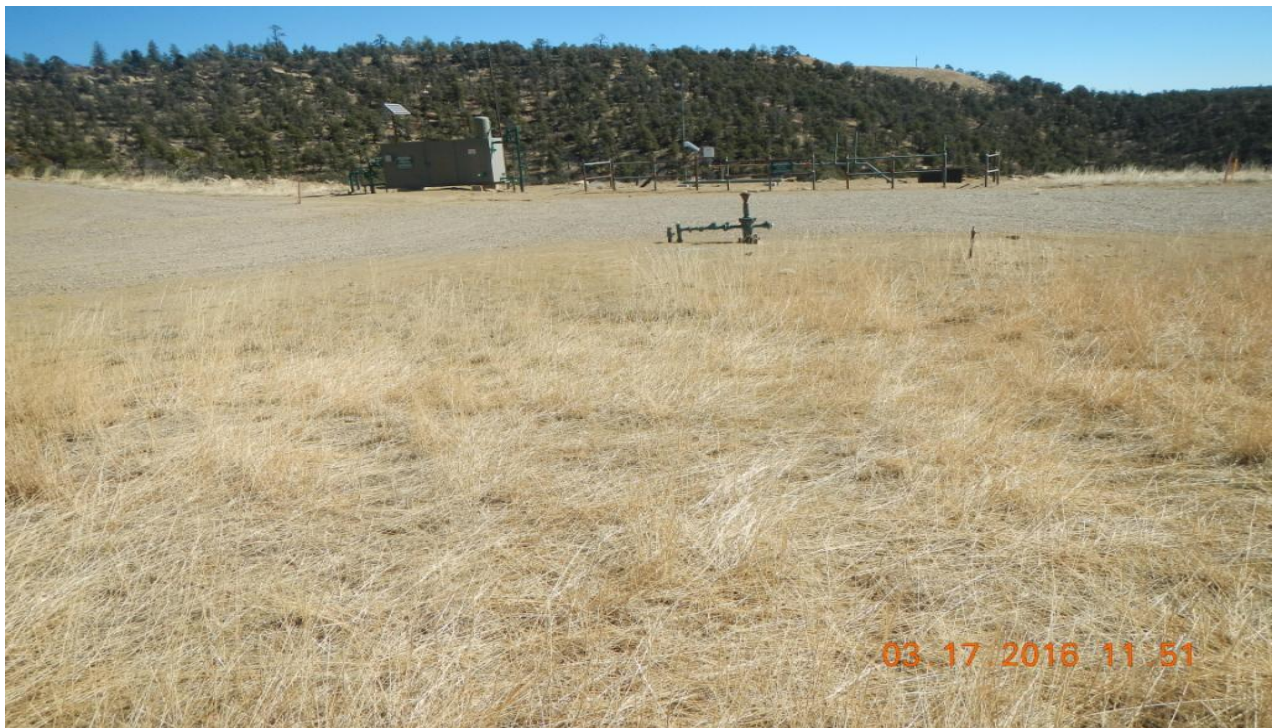
photo 2: West side of the location facing east.

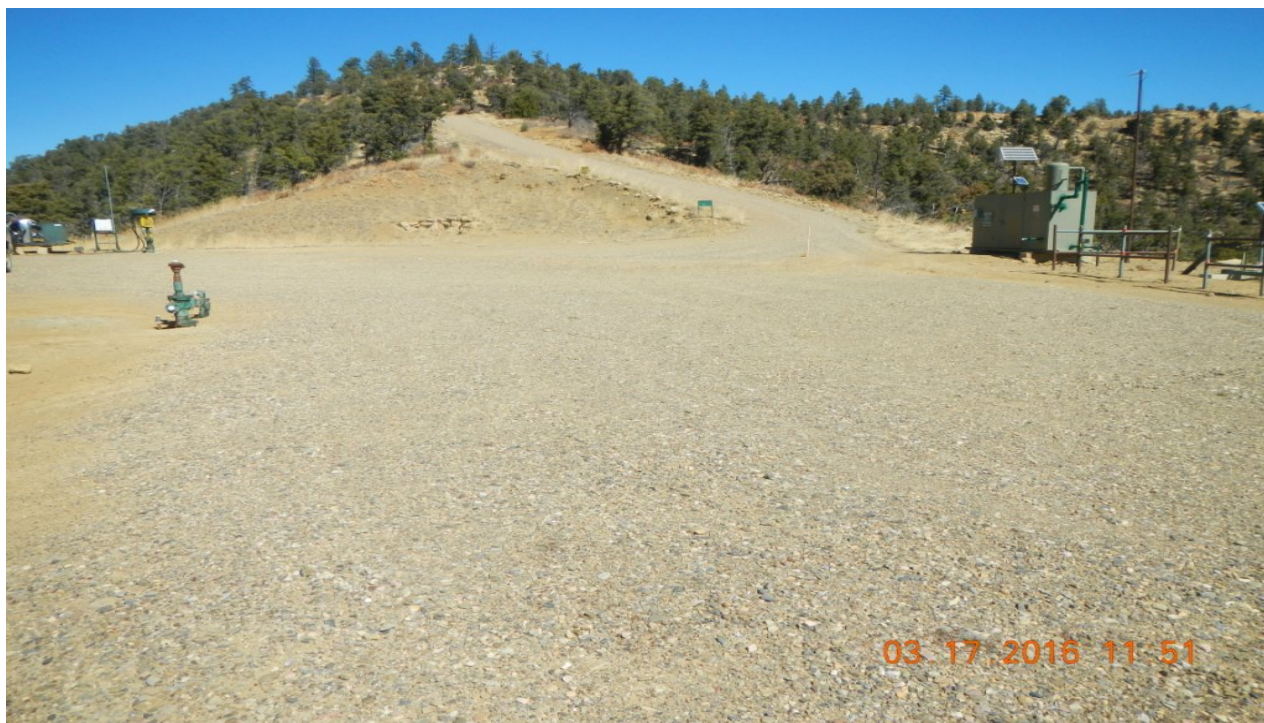
photo 3: South side of the location facing north.

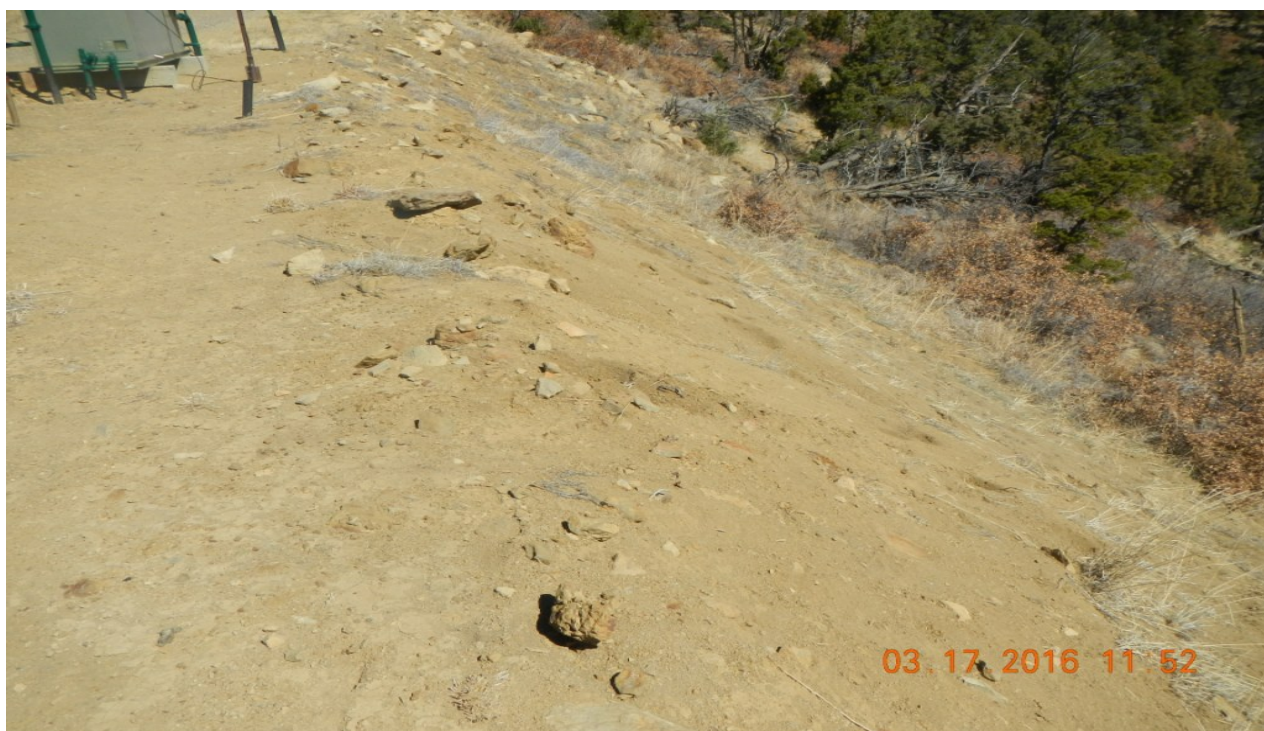
photo 4: East side of the location. The slope is not well stabilized in this area and may need additional BMP's installed.
