## Construction Inspection

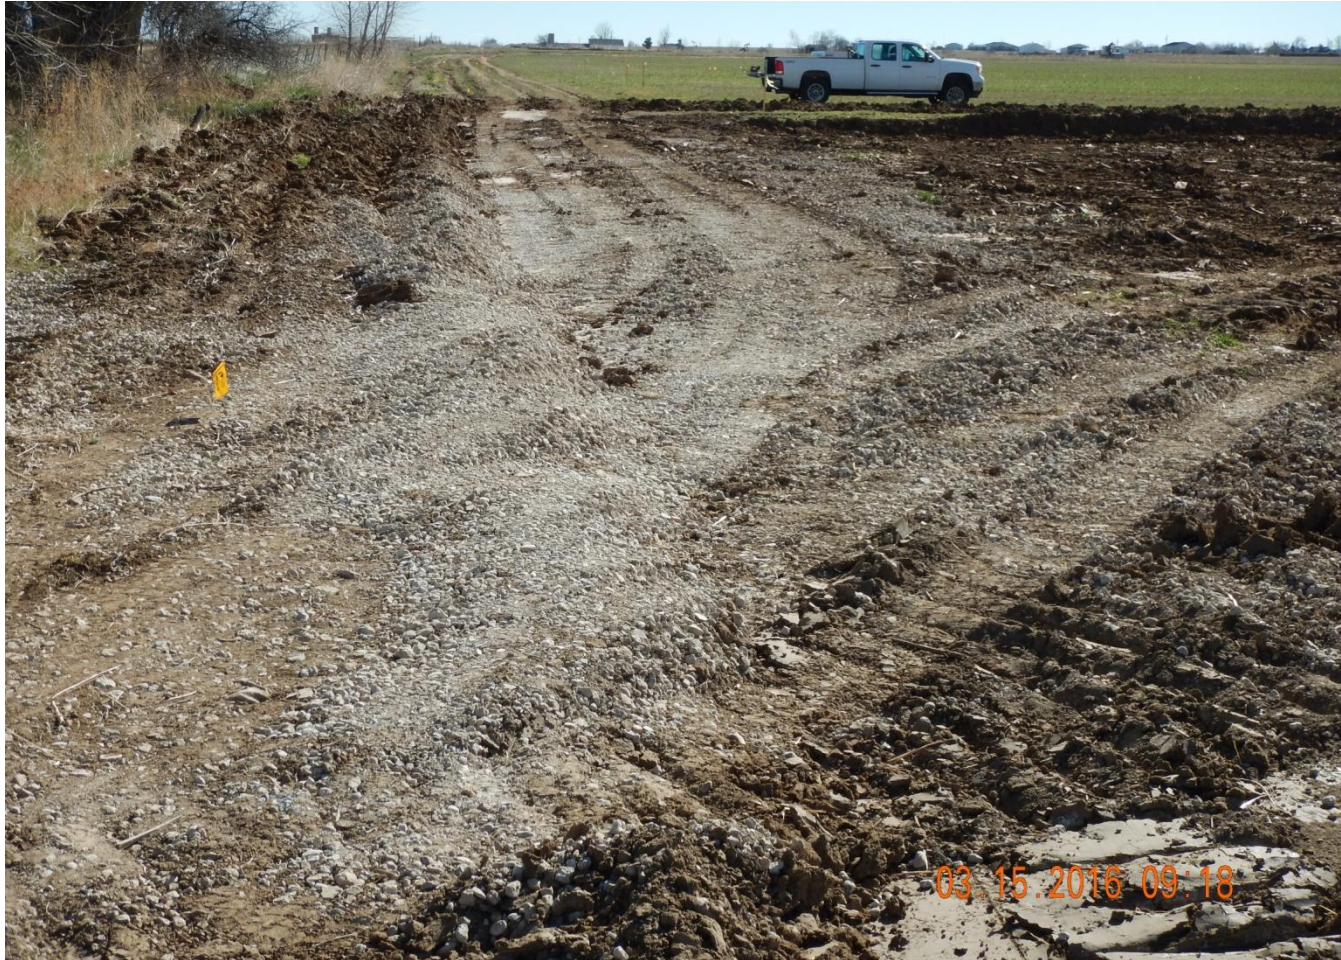
**Photo 1.** Photo taken from northern location (entrance), facing East. Stormwater and sediment control BMPs installed in center of photo (surface roughening).

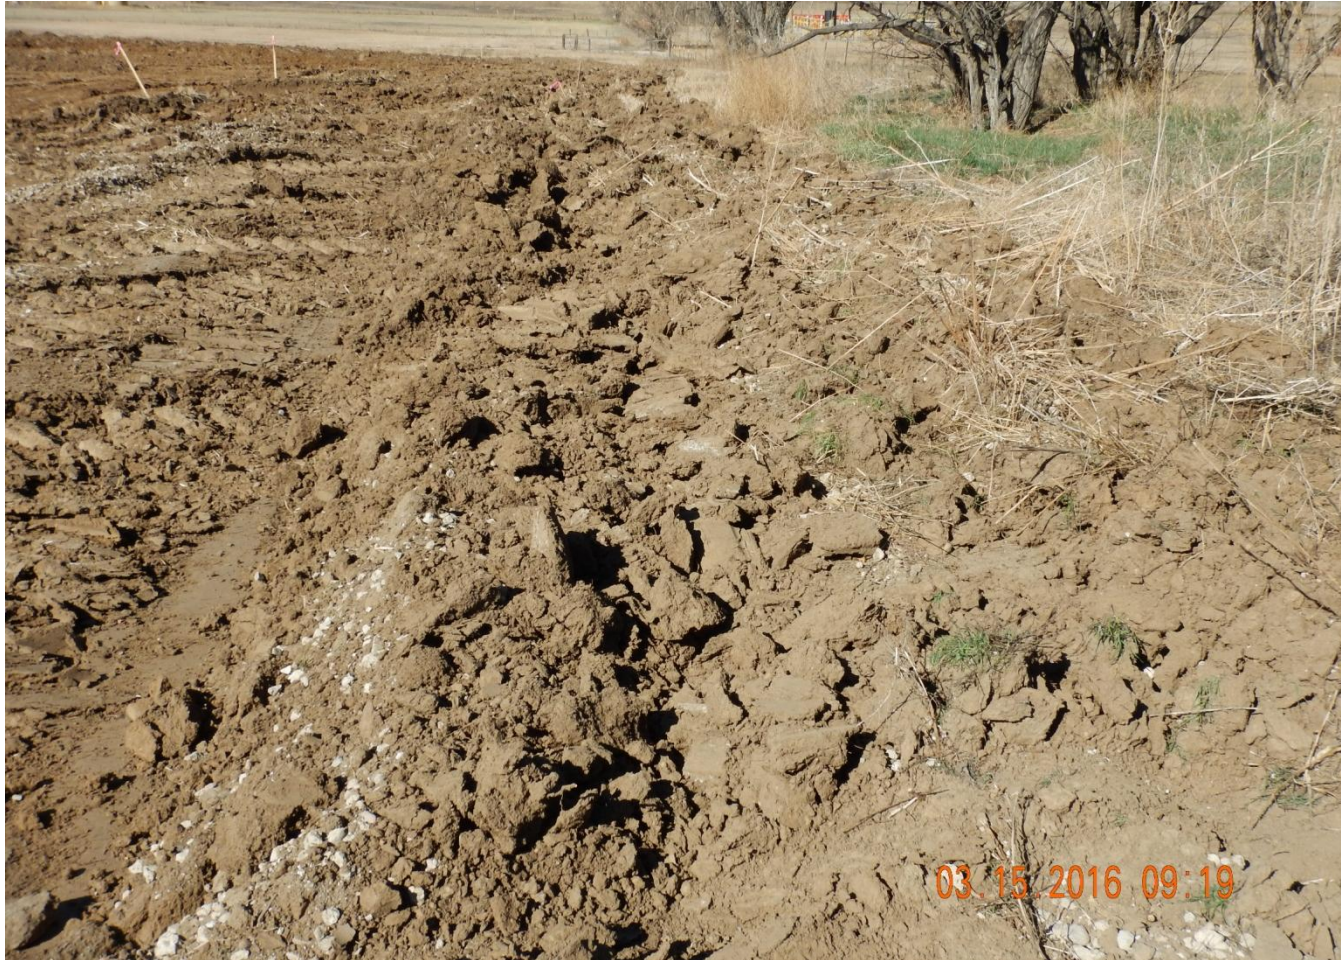
**Photo 2.** Photo taken from northern location (entrance), facing West. Stormwater and sediment control BMPs installed in center of photo (surface roughening).

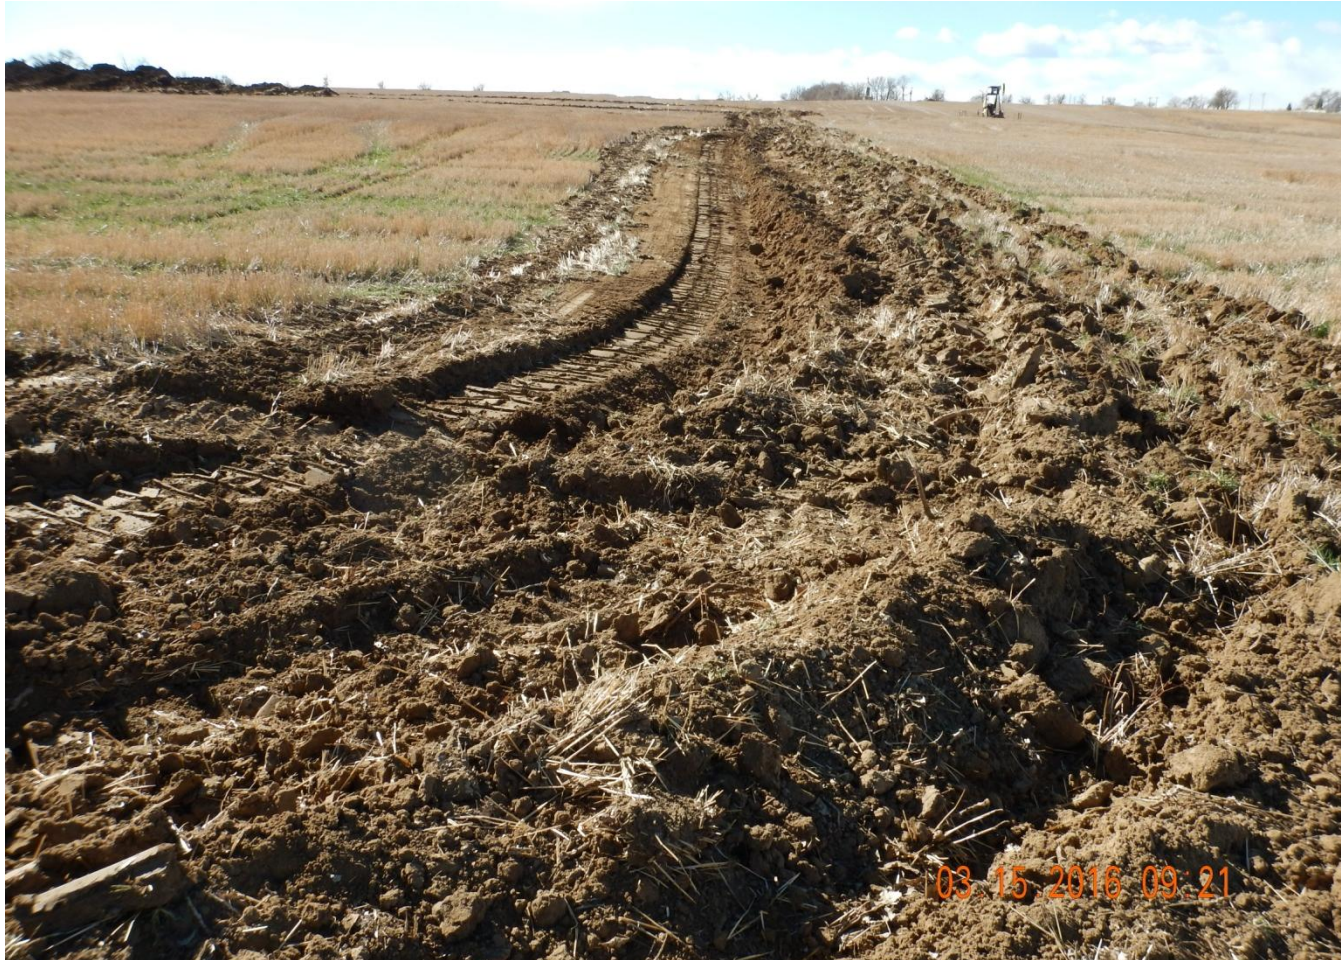
**Photo 3.** Photo taken from northwest location, facing South. Stormwater and sediment control BMPs installed in center of photo (ditch/berm and surface roughening).

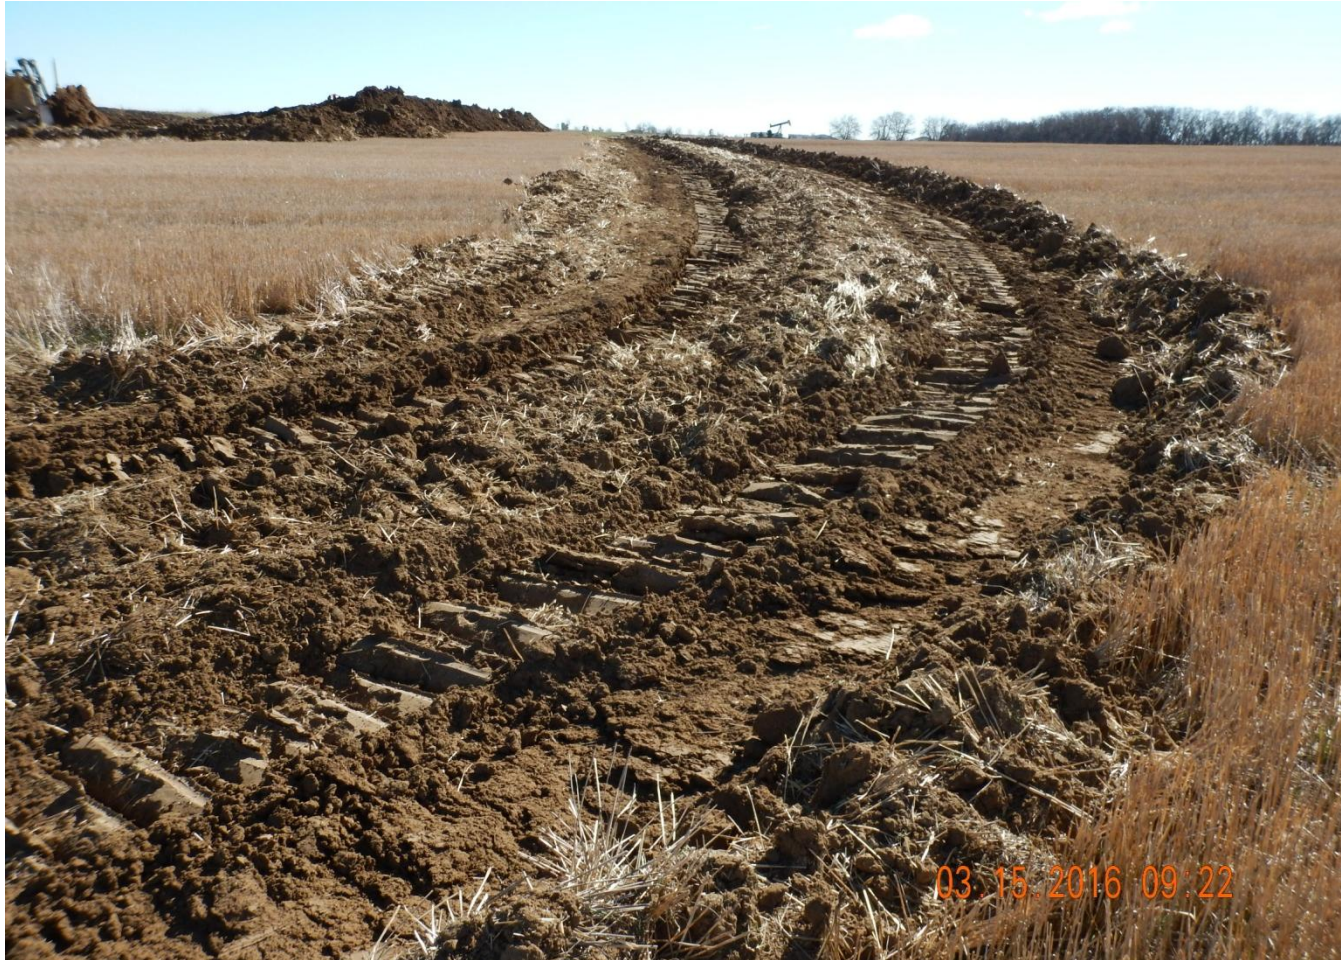
**Photo 4.** Photo taken from southwest location, facing East. Stormwater and sediment control BMPs installed in center of photo (ditch/berm and surface roughening).

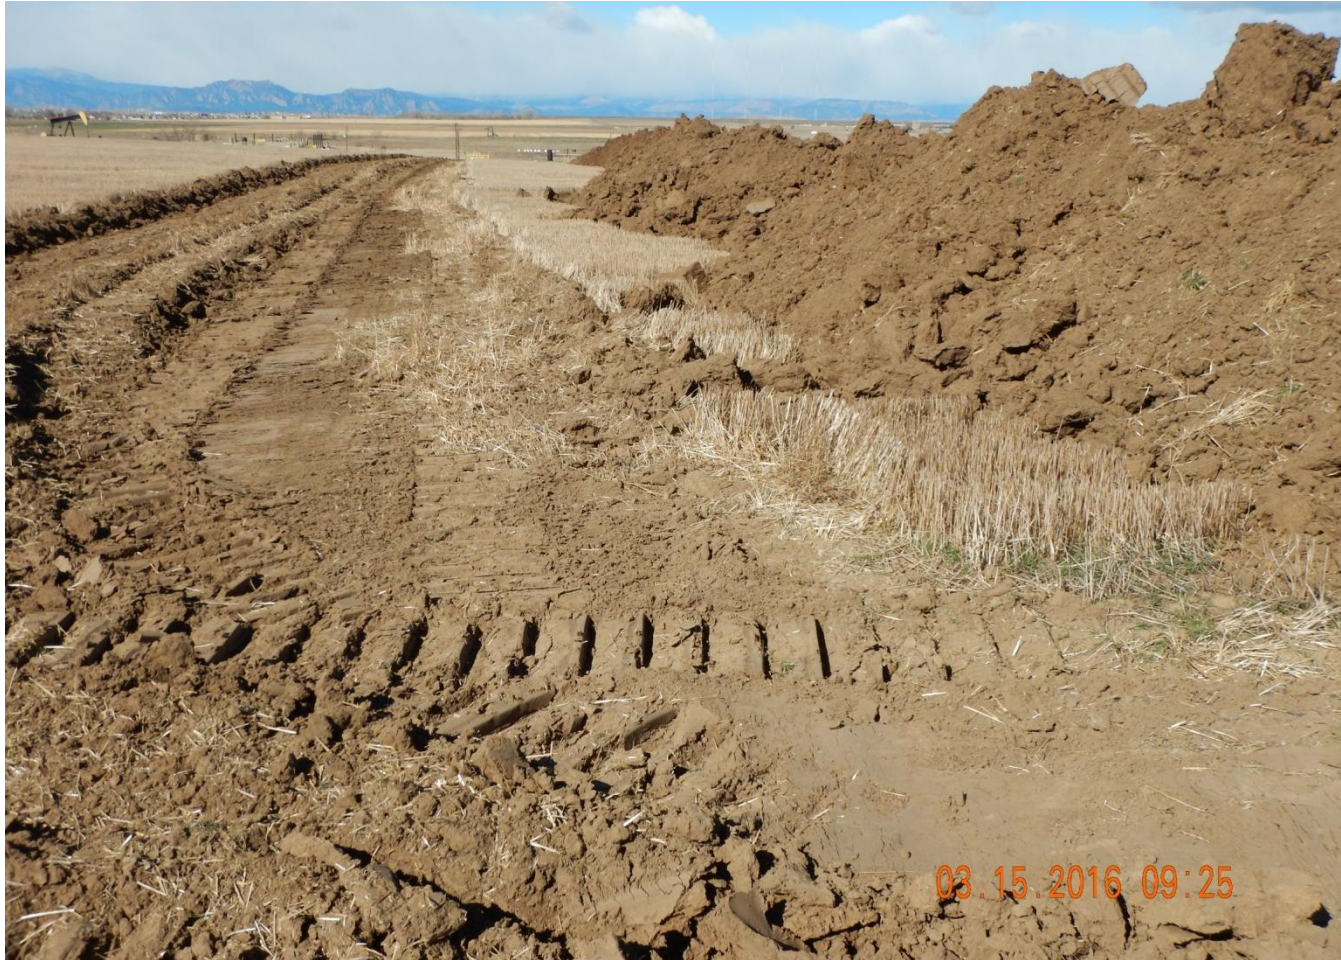
**Photo 5.** Photo taken from southeast location, facing West. Stormwater and sediment control BMPs installed in center of photo (ditch/berm and surface roughening).

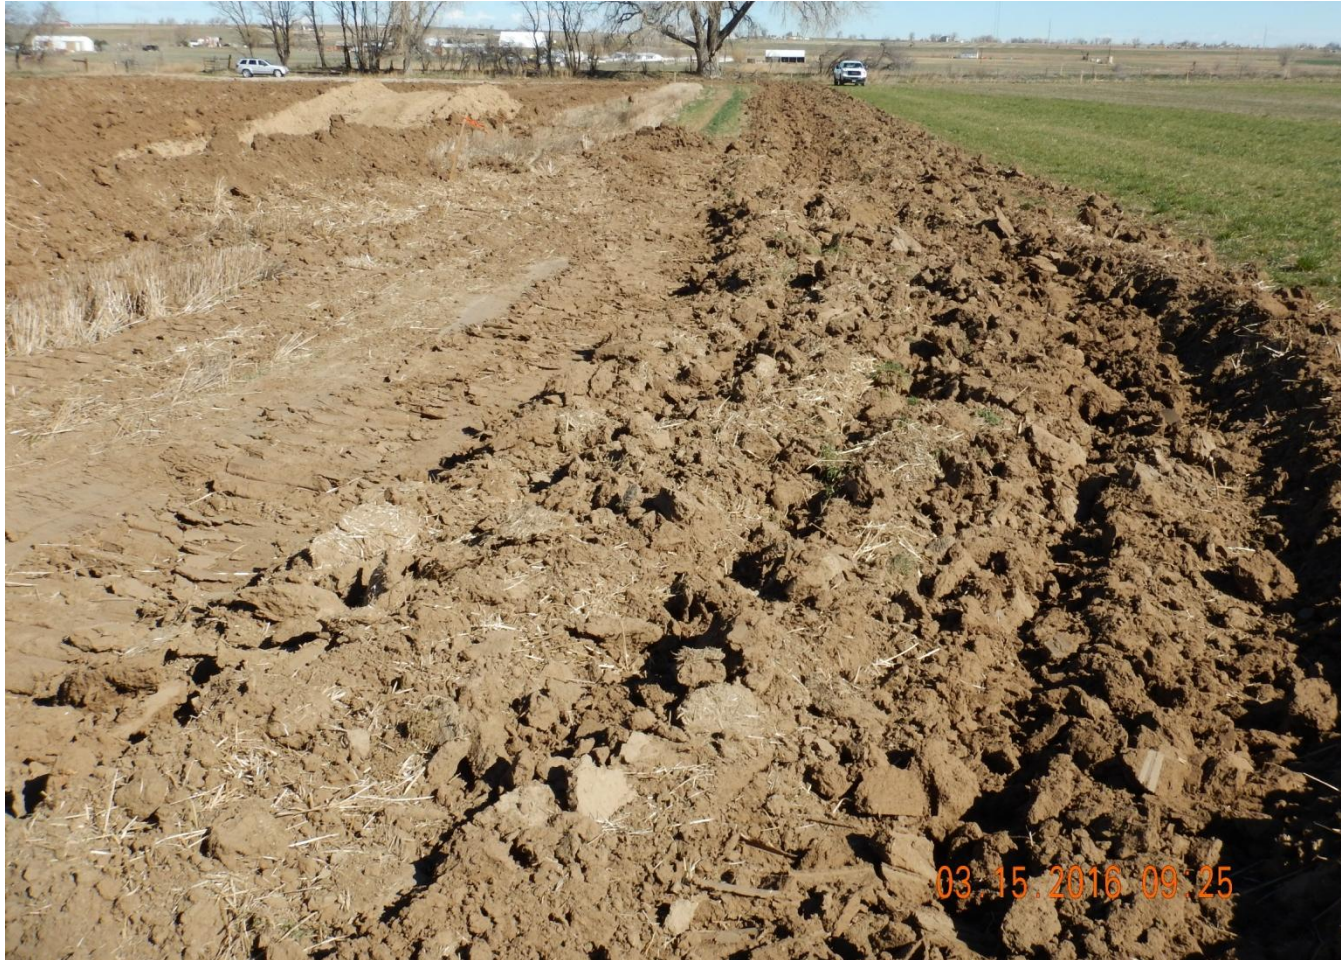
**Photo 6.** Photo taken from southeast location, facing North. Stormwater and sediment control BMPs installed in center of photo (surface roughening).

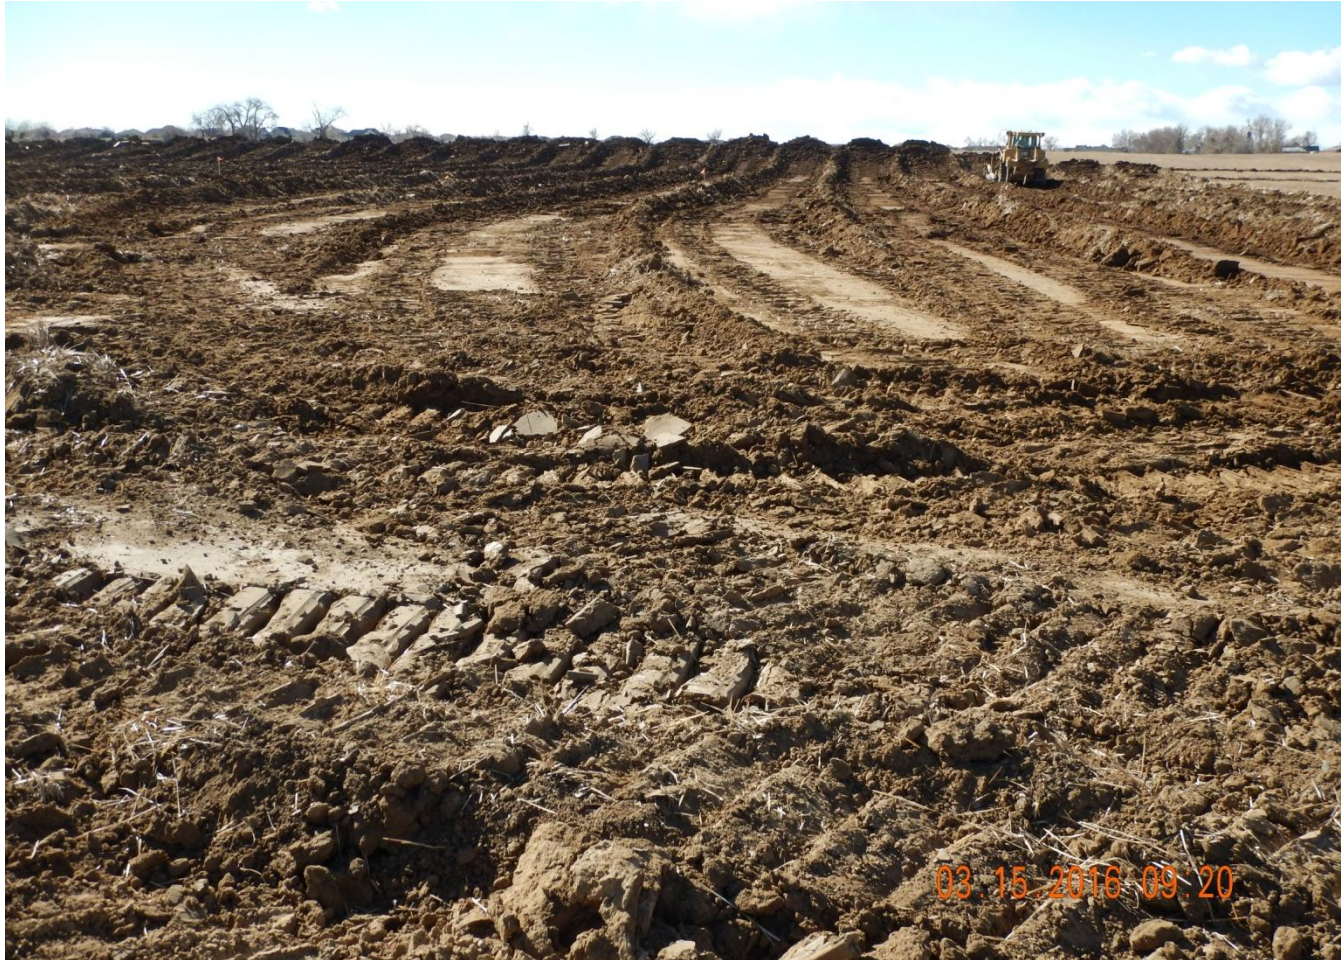
**Photo 7.** Photo taken from northern location, facing South. Topsoil salvage in process.
