Construction Inspection

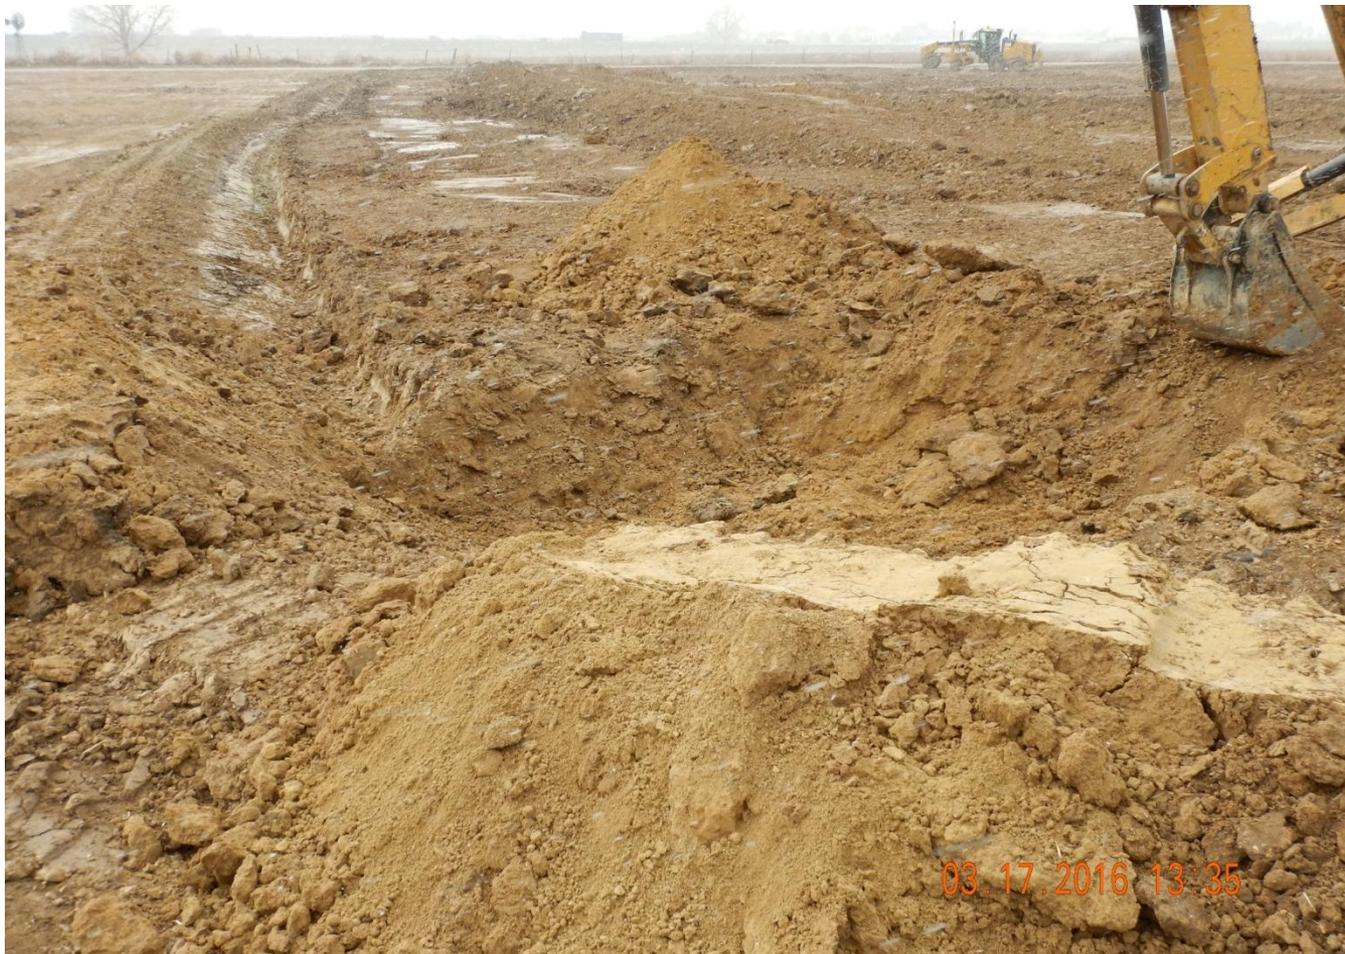
Photo 1. Photo taken from southeast location, facing West. Stormwater and sediment control BMPs installed in center of photo (berm and ditch). Sediment trap under construction.

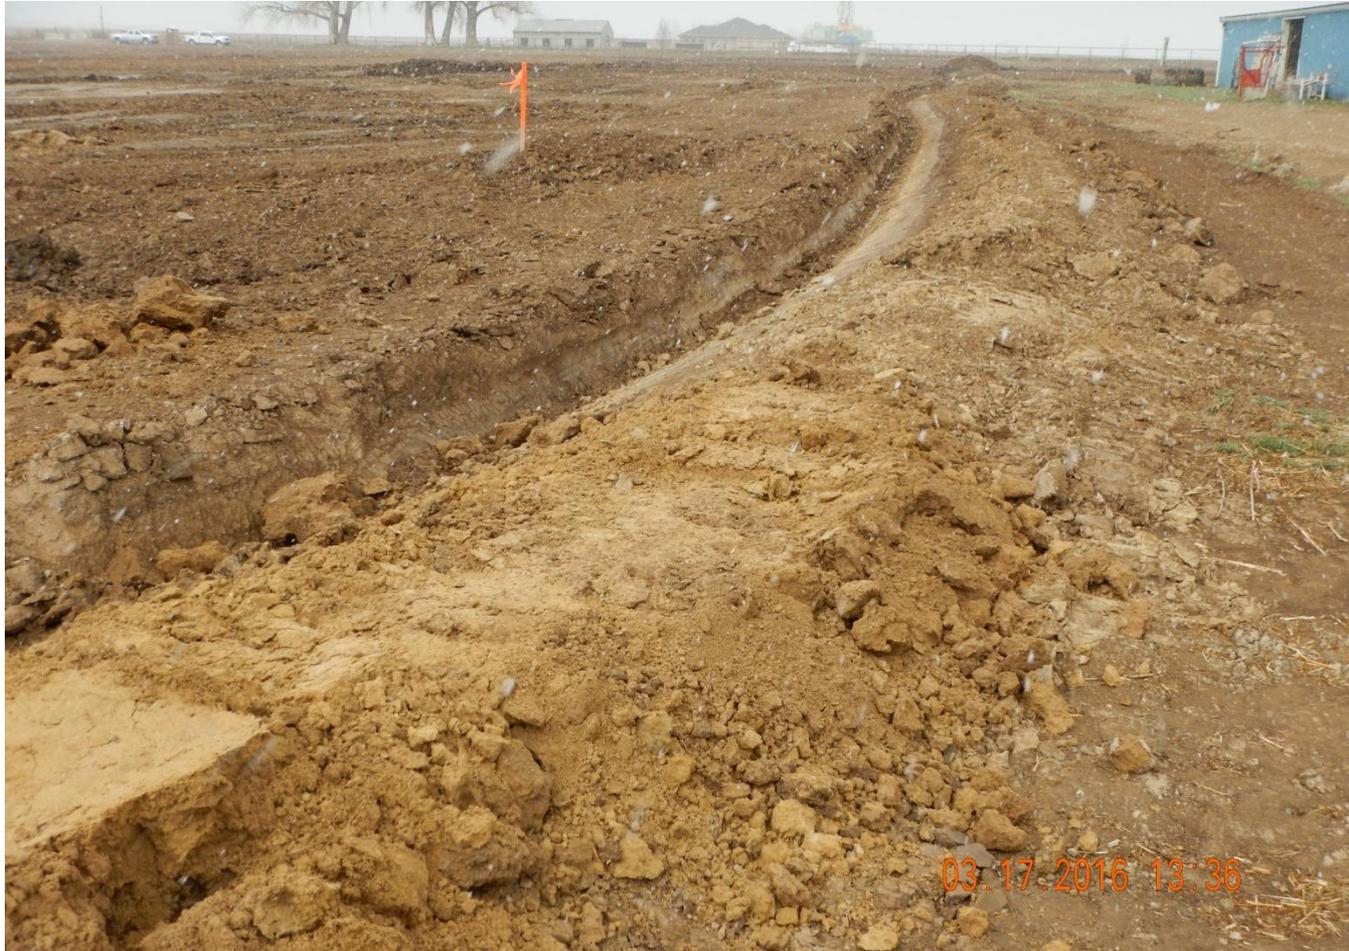
Photo 2. Photo taken from southeast location, facing North. Stormwater and sediment control BMPs installed in center of photo (berm and ditch).

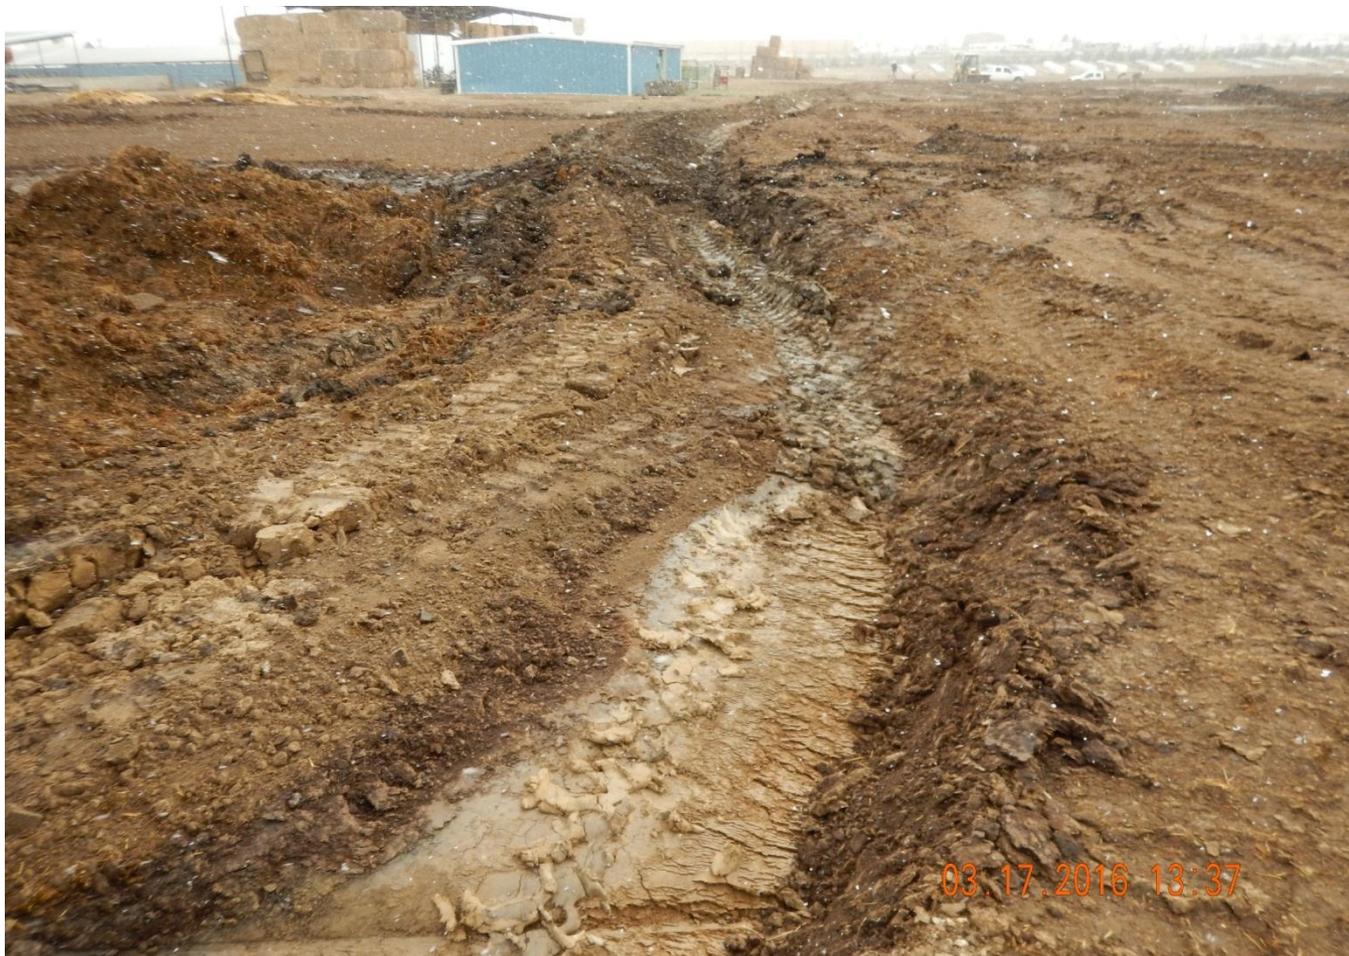
Photo 3. Photo taken from northeast location, facing South. Stormwater and sediment control BMPs installed in center of photo (berm and ditch).

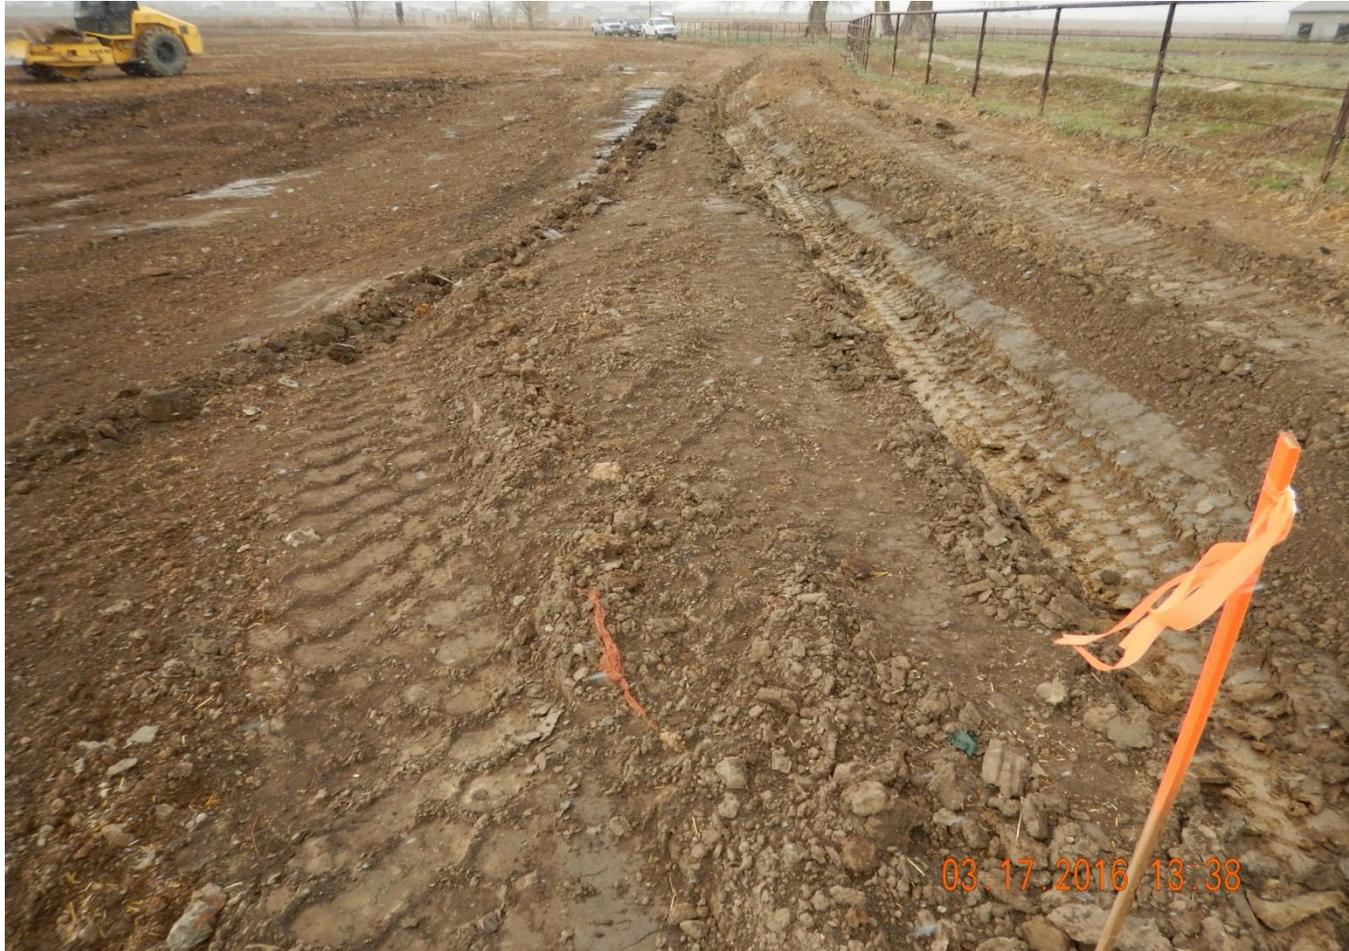
Photo 4. Photo taken from northeast location, facing West. Stormwater and sediment control BMPs installed in center of photo (berm and ditch).

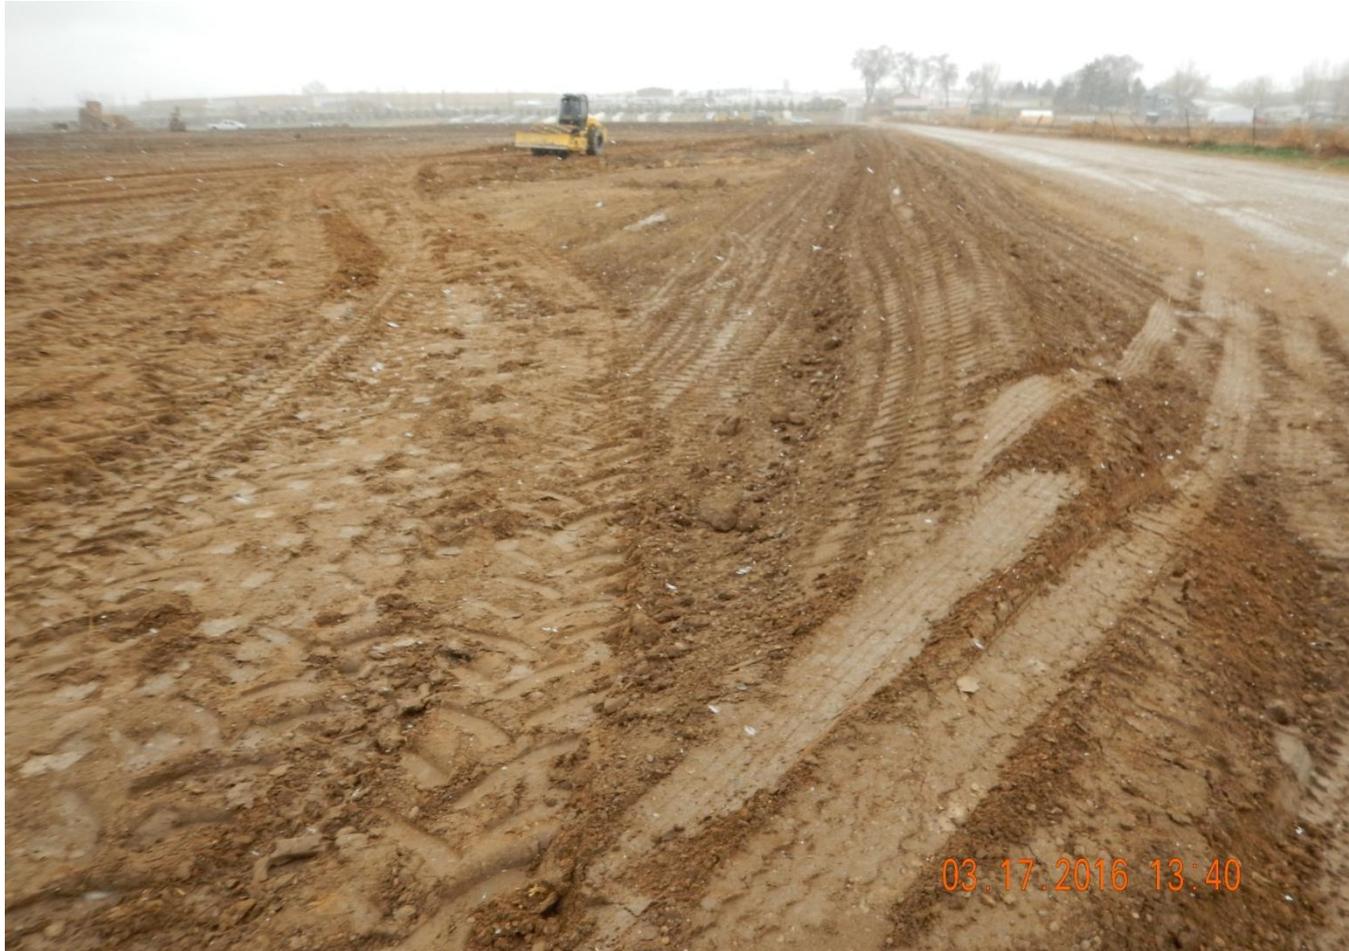
Photo 5. Photo taken from northwest location, facing South. Stormwater and sediment control BMPs installed in center of photo (berm and ditch).

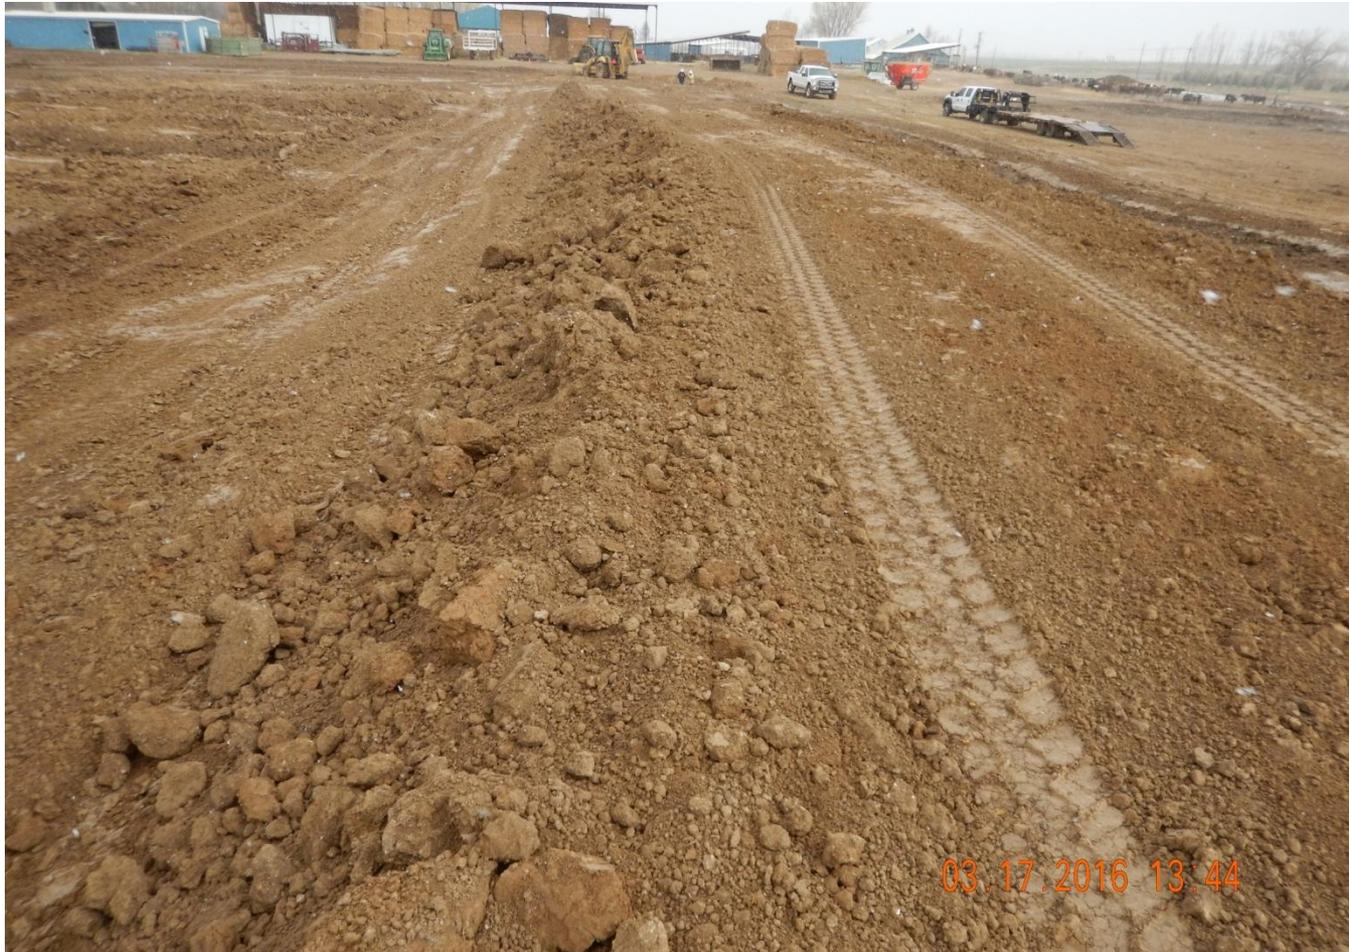
Photo 6. Photo taken from southwest location, facing East along topside of topsoil stockpile. Need to stabilize topsoil stockpile upon completion of construction activities.

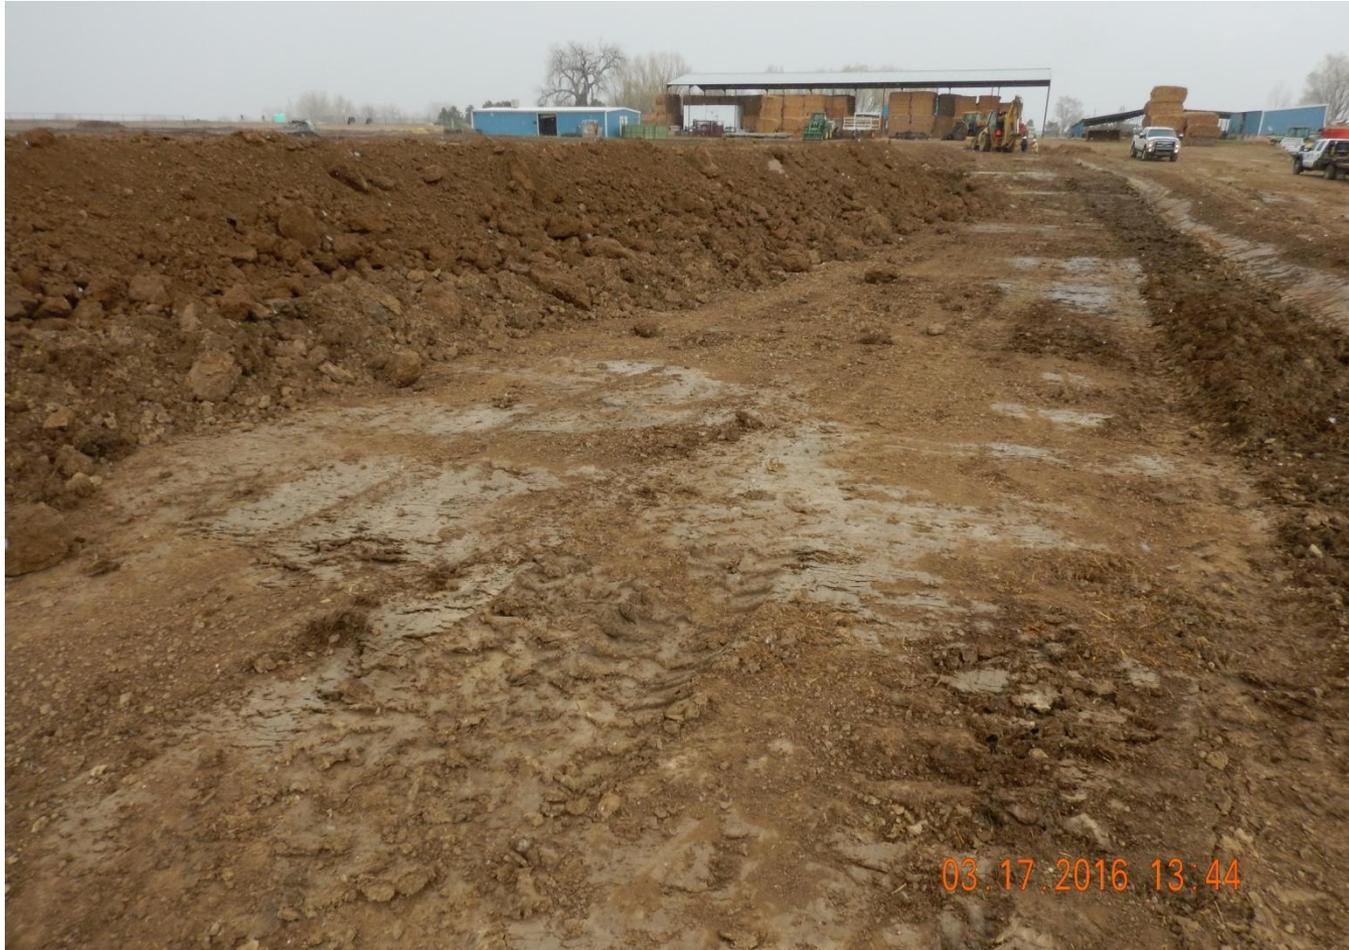
Photo 7. Photo taken from southwest location, facing Northeast along topsoil stockpile. Need to stabilize topsoil stockpile upon completion of construction activities.

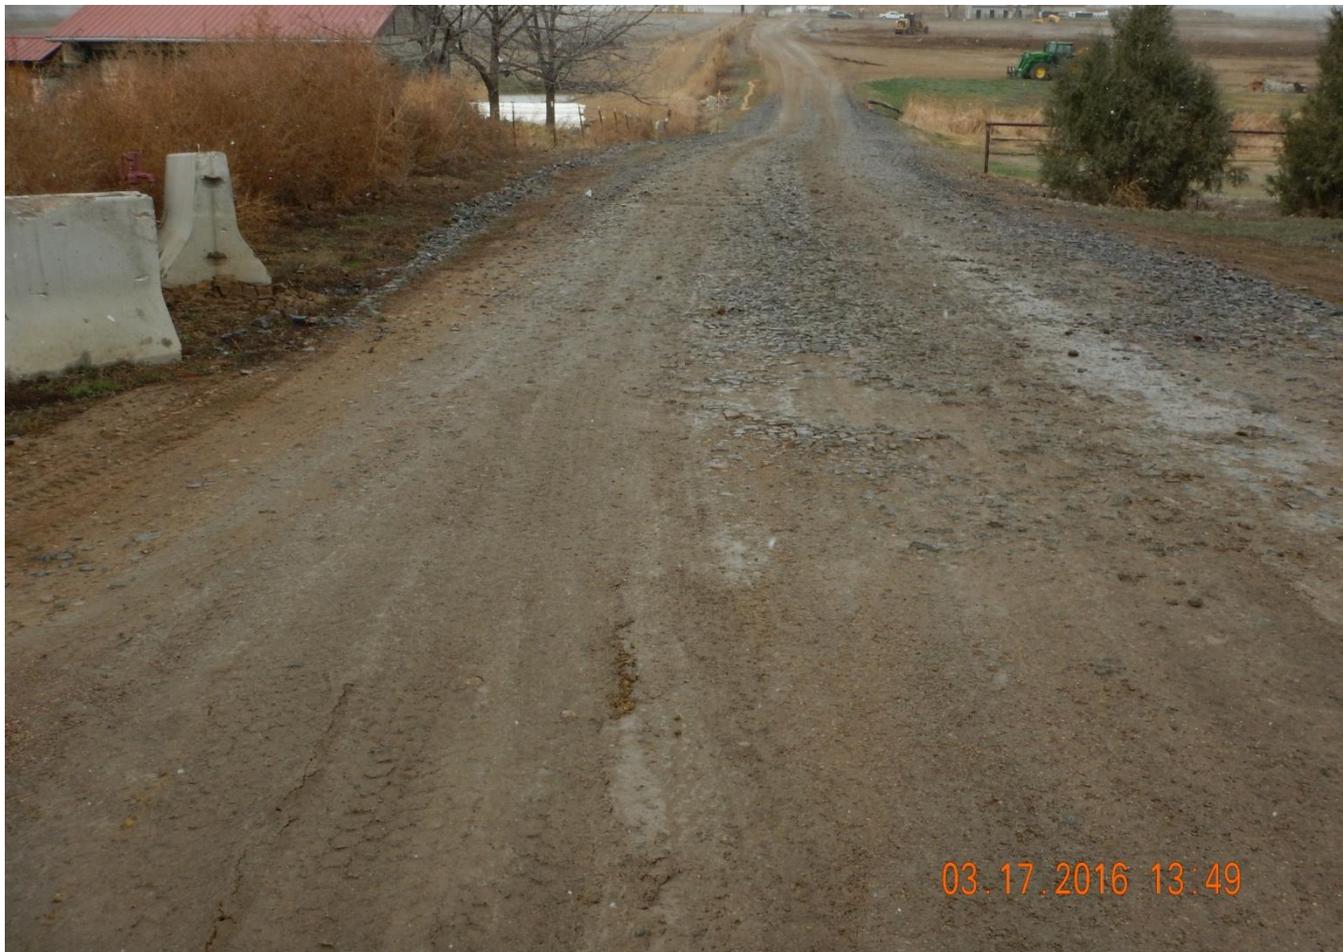
Photo 8. Photo taken from entrance of location, facing North. Vehicle tracking pad in place. May need to fluff vehicle tracking pad to minimize sediment leaving location.

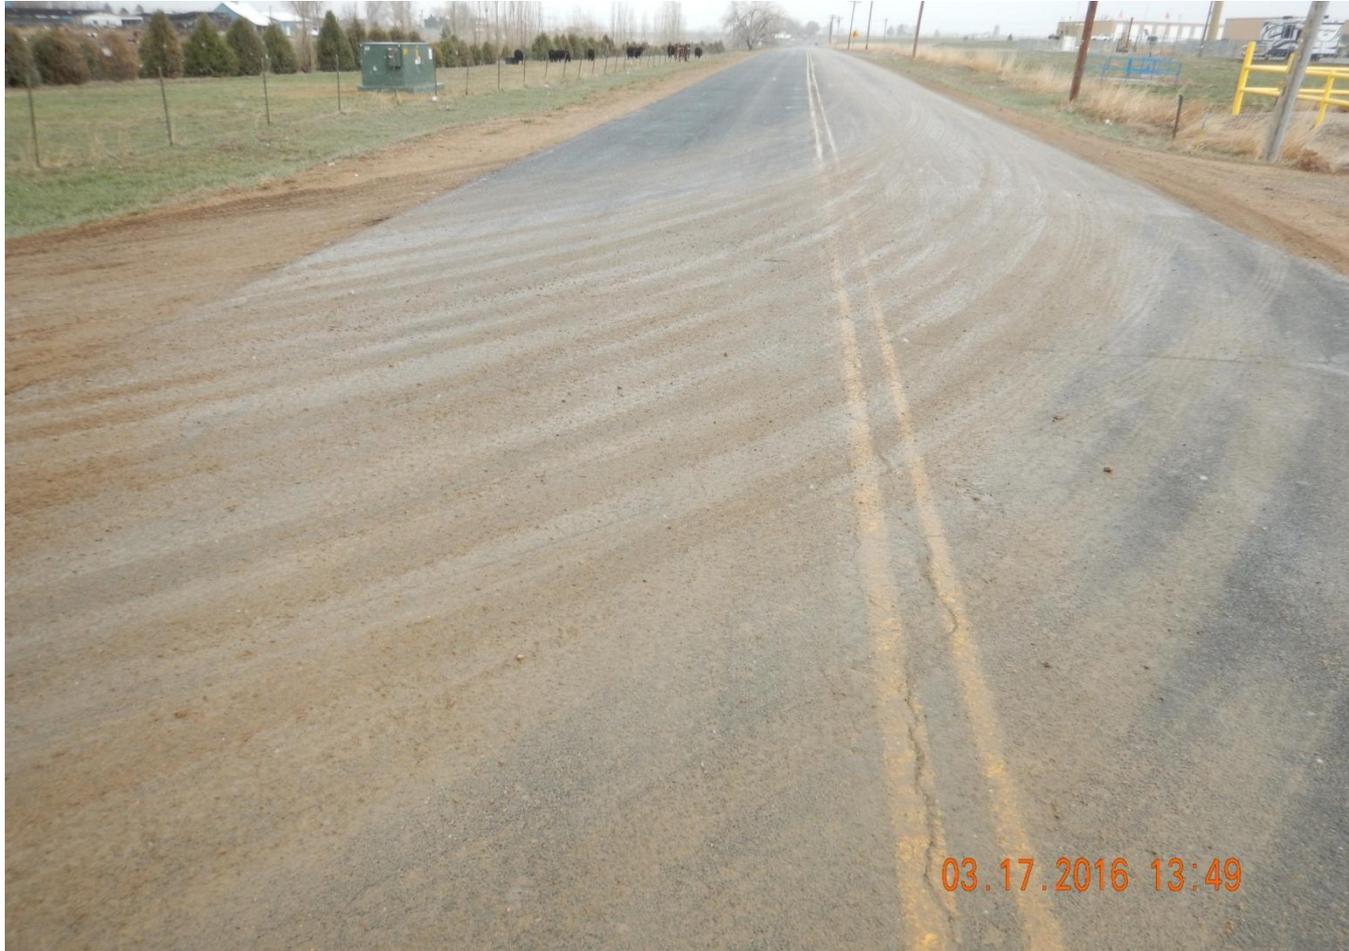
Photo 9. Photo taken from entrance of location, facing East along Adams Avenue. May need to fluff vehicle tracking pad to minimize sediment leaving location and/or street sweeper to control potential sediment discharges if sediment accumulates on Adams Avenue.
