Interim Reclamation Inspection

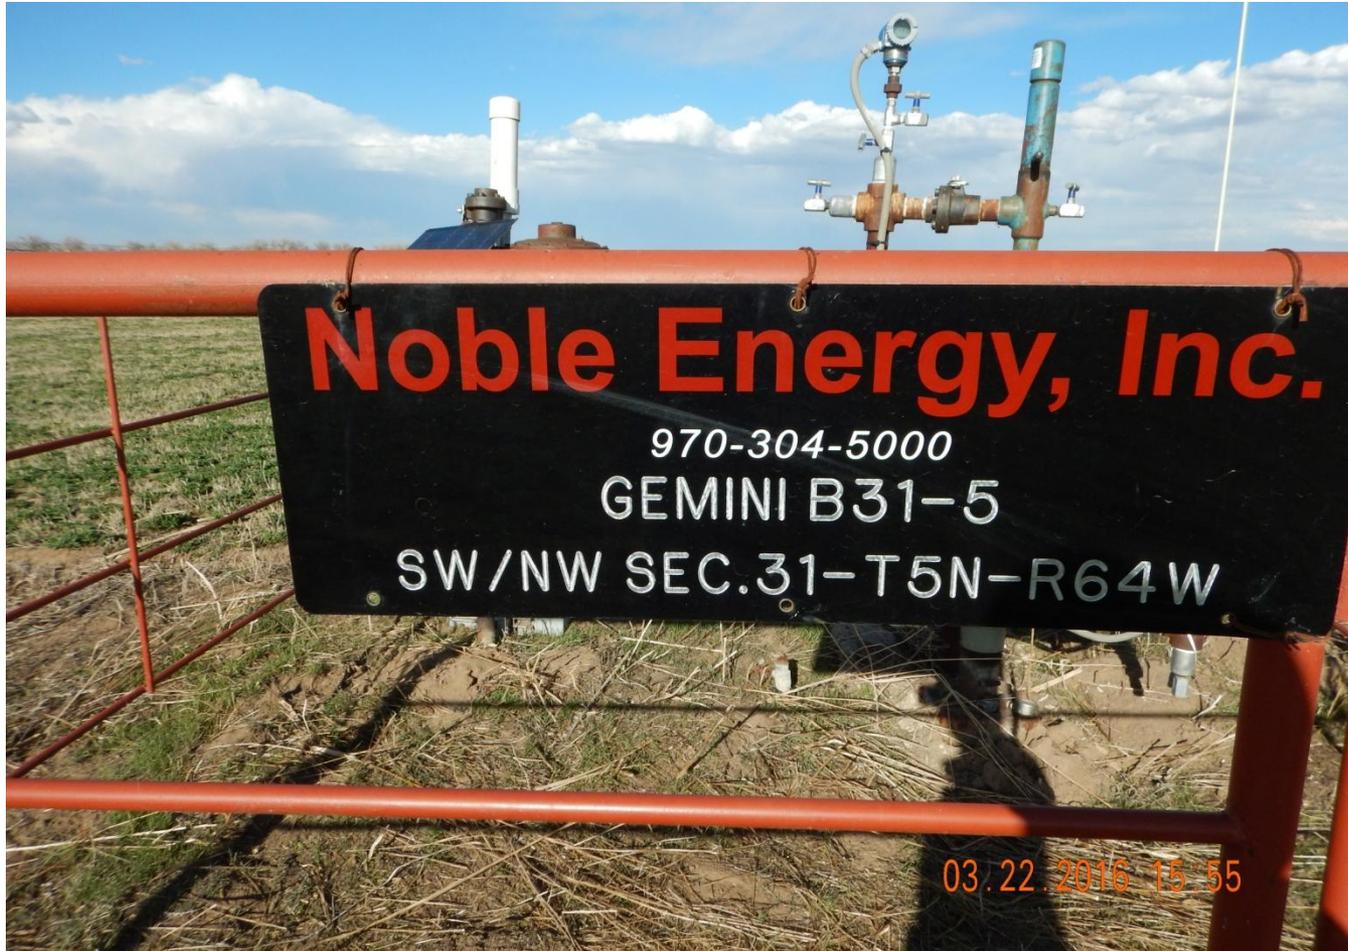
Photo 1. Photo taken of PR well sign for API 123-13722.

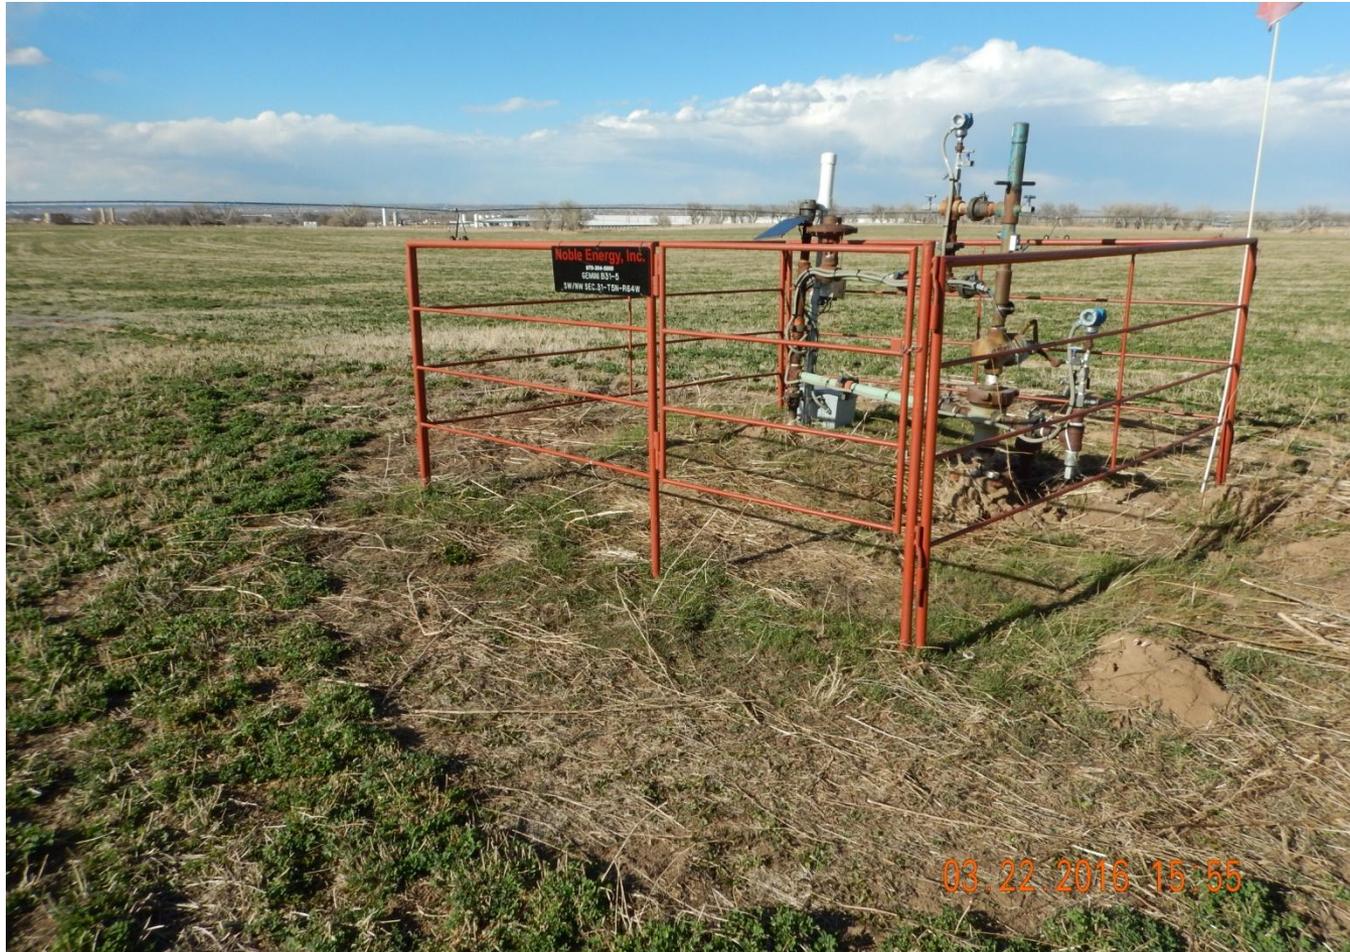
Photo 2. Photo taken south of location, facing North. Weeds have been removed from around wellhead.
