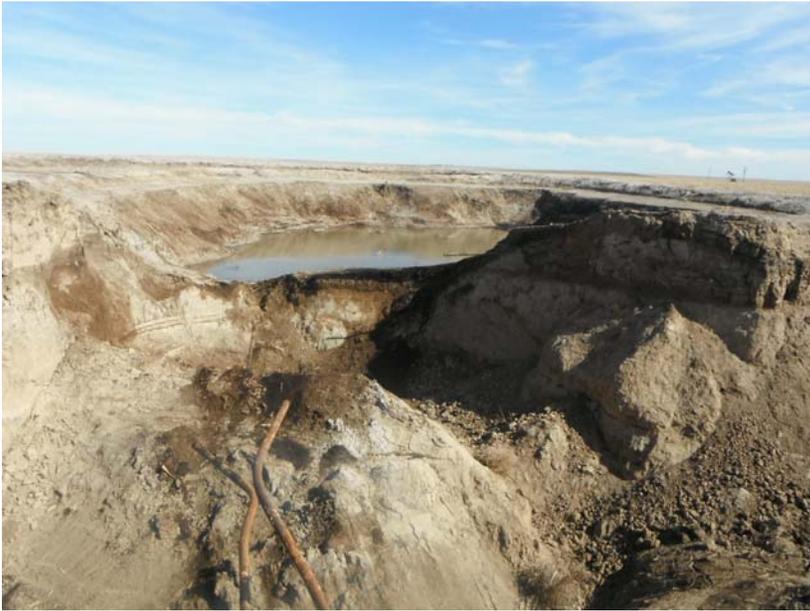
Current condition looking east

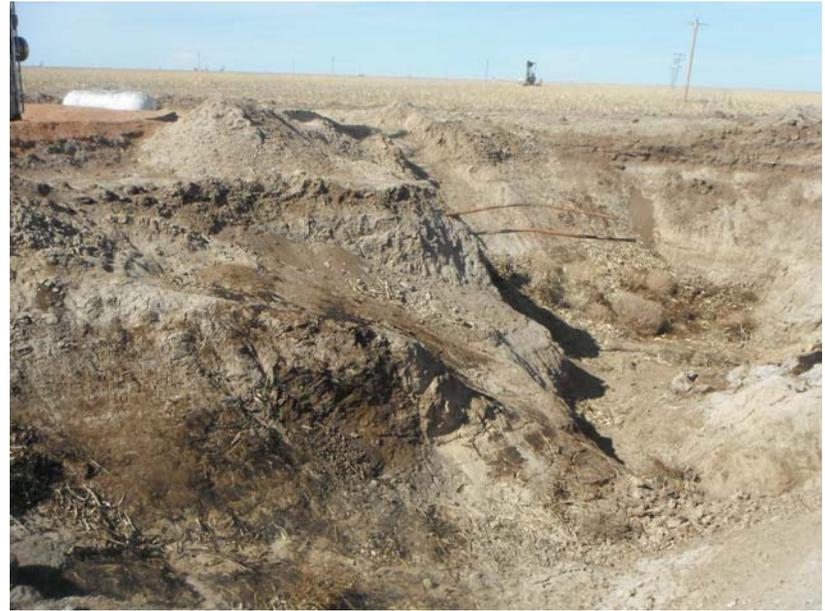
Looking south

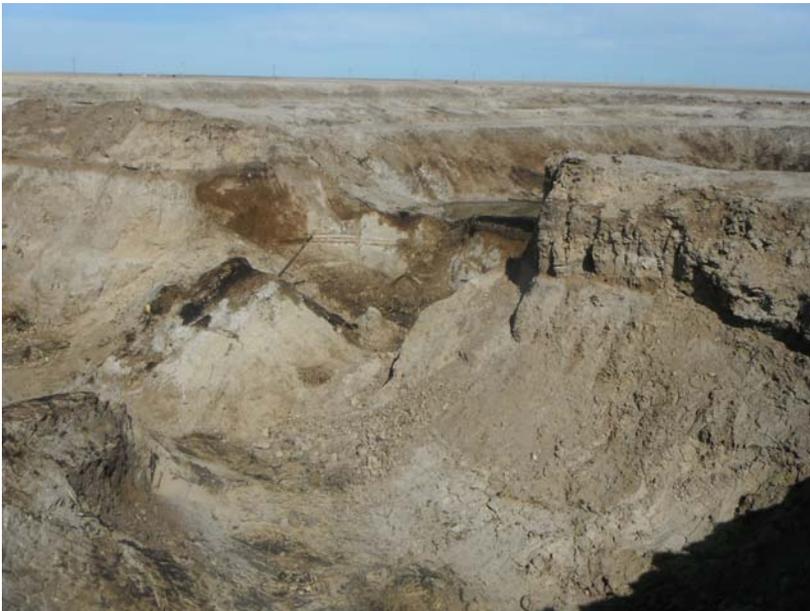
Former skim pit bottom conditions

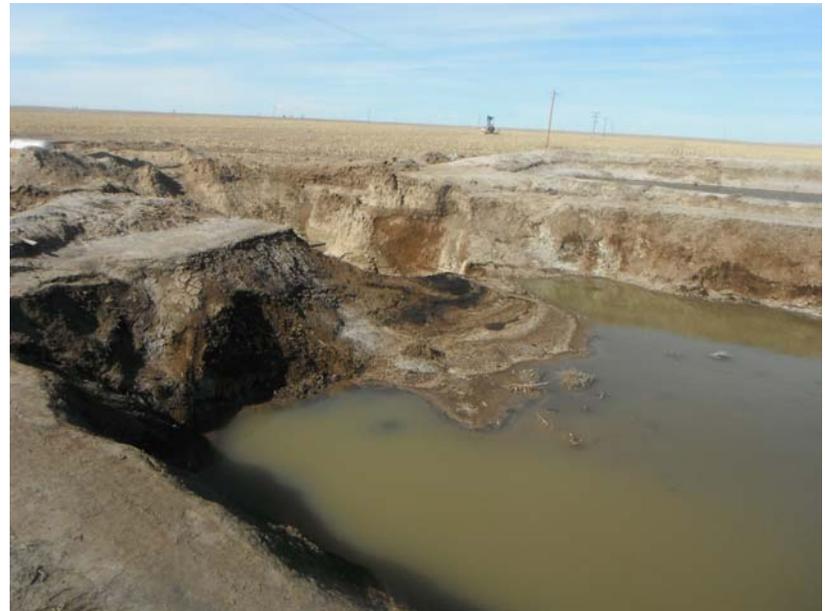
Breached wall and existing evaporation pit
