Interim Reclamation Inspection

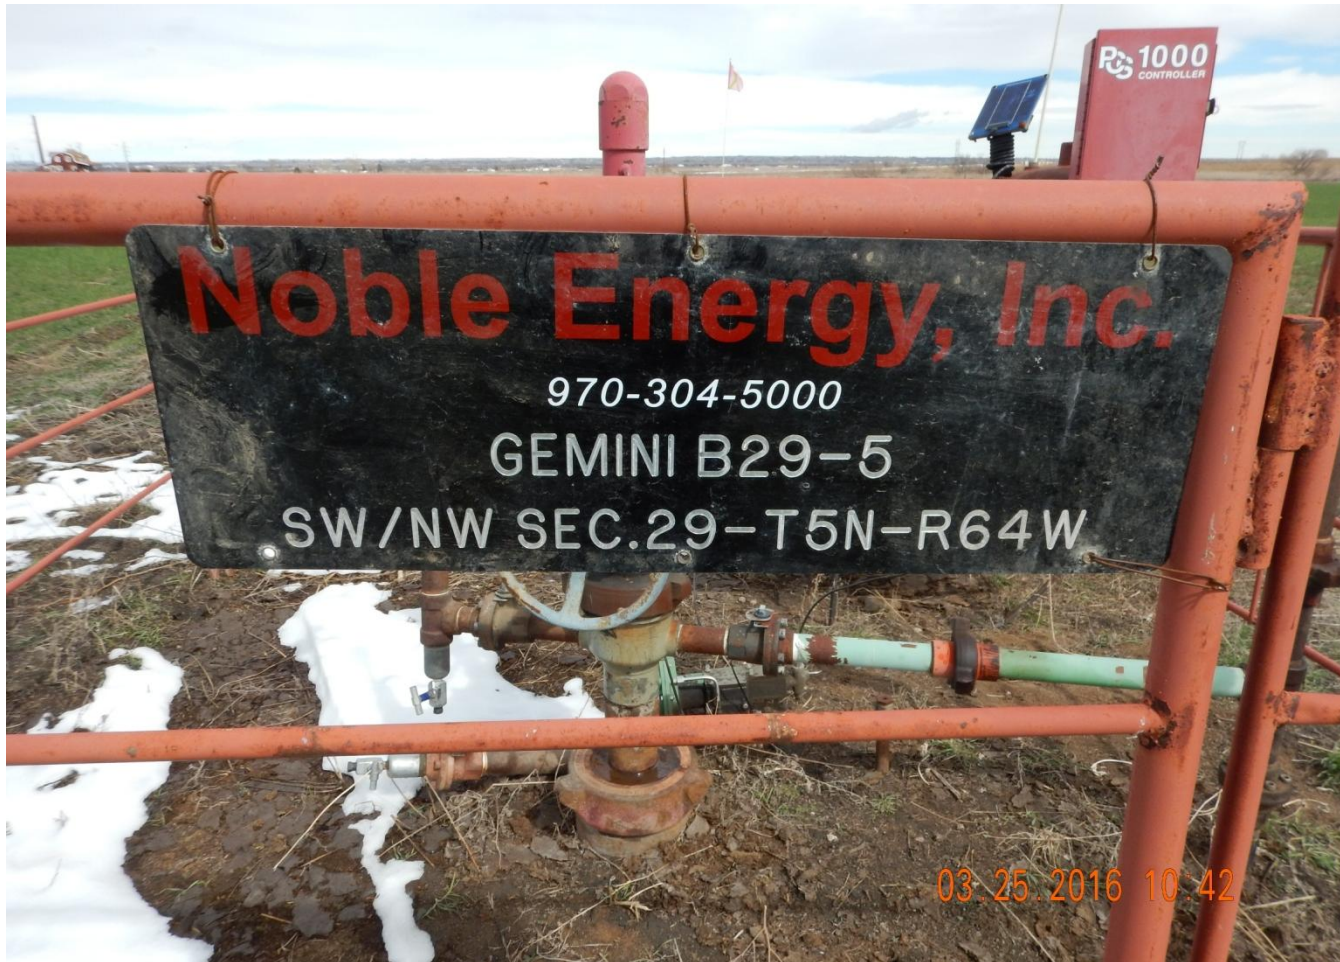
Photo 1. Photo taken of PR well sign for API 123-13697.

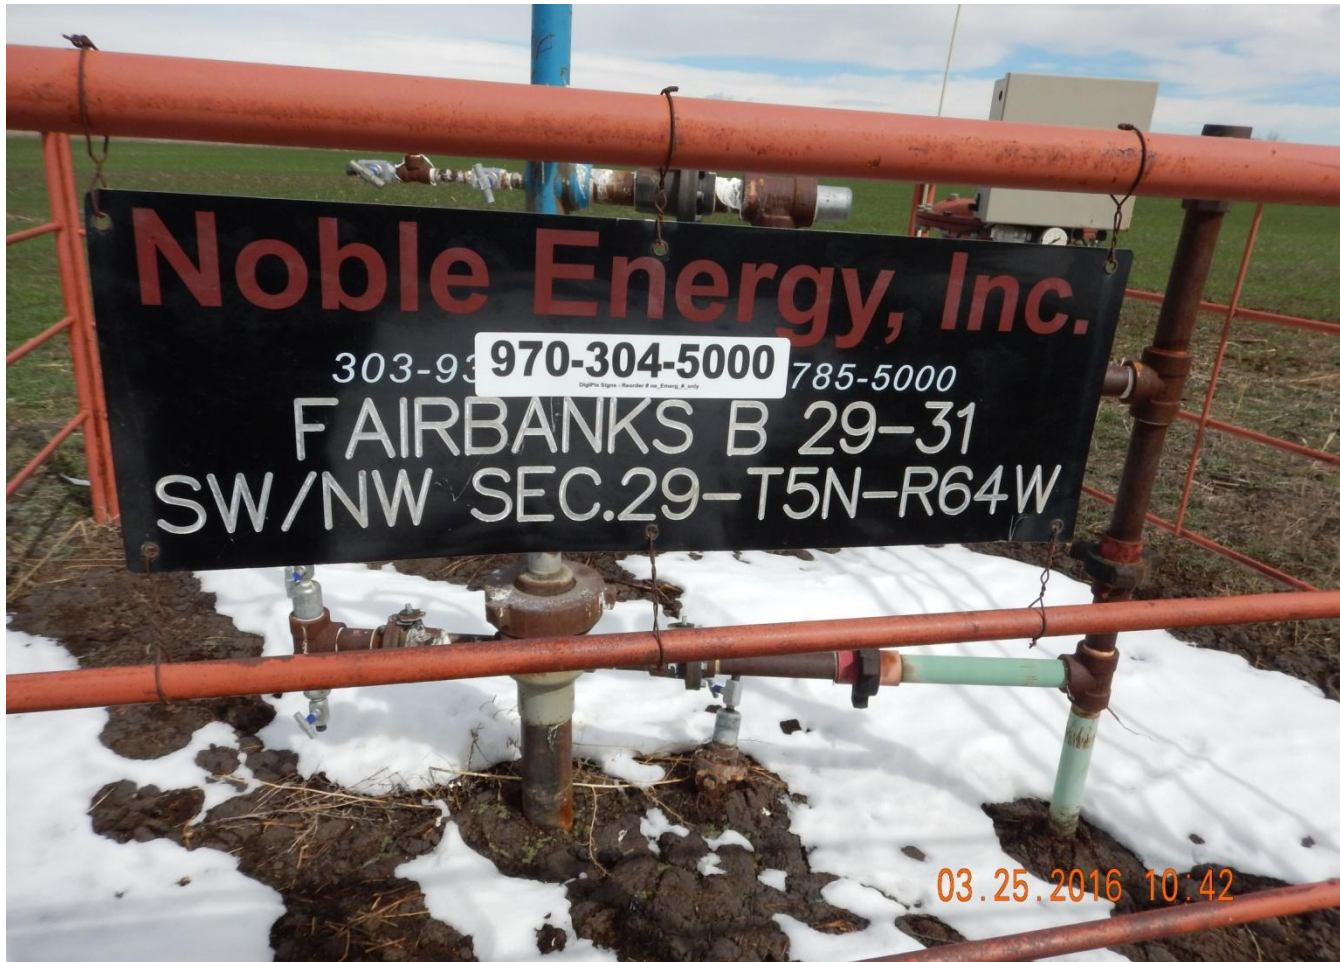
Photo 2. Photo taken of PR well sign for API 123-25680.

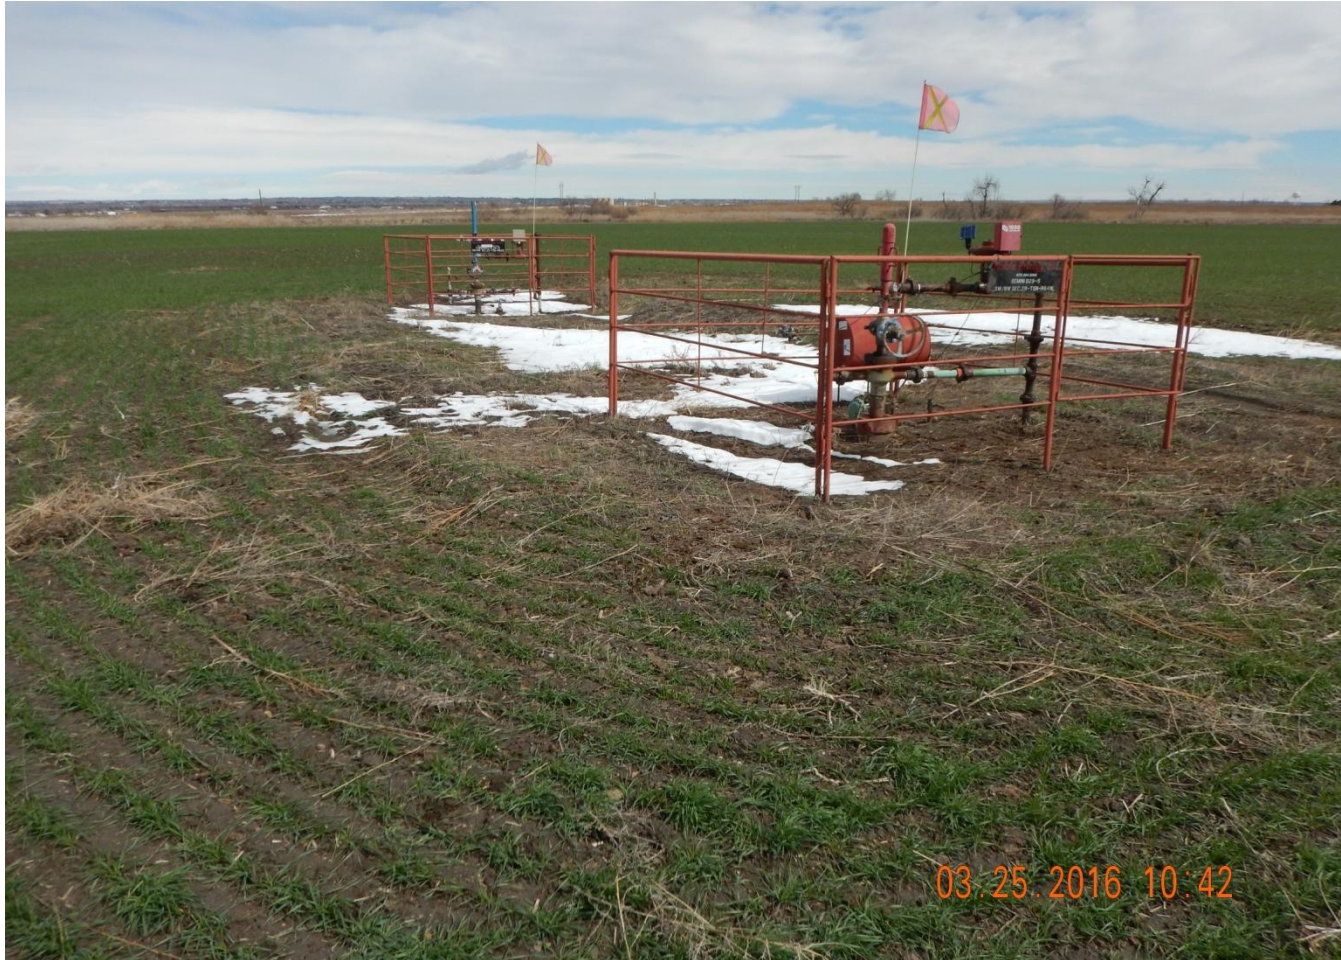
Photo 3. Photo taken southwest of location, facing Northeast. Weeds have been removed from around wellhead.
