**MARATHON OIL COMPANY
NOTICE OF COMPLETION REPORT FOR
INTERIM RECLAMATION OF
596-35D**

January 20, 2012

**InterTech Environmental & Engineering, LLC
743 Horizon Court, Suite 110
Grand Junction, Colorado 81506**

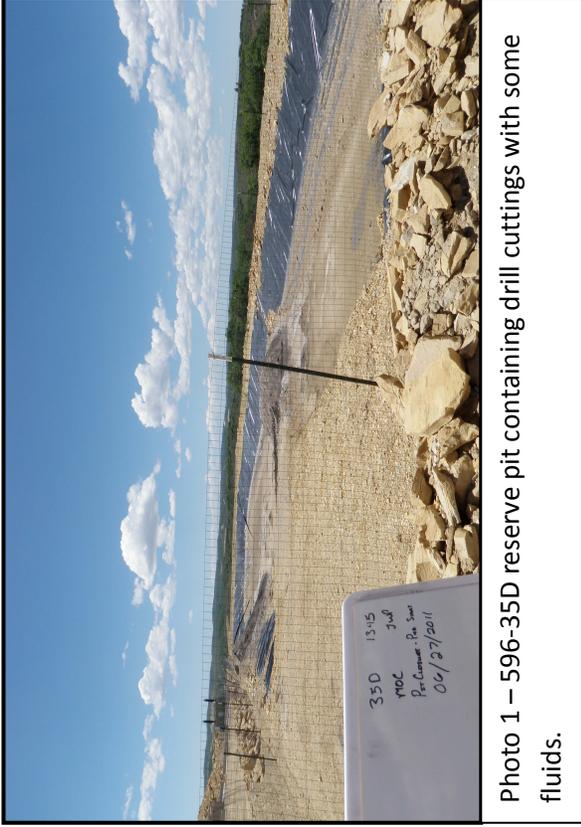
This report covers the activities associated with the closure of the on-site reserve pit at Marathon Oil Company's 596-35D well pad. At the time of the initial site visit, the pit contained what appeared to be drill cuttings and fluid (Photo 1, Appendix A).

Photo 1 – 596-35D reserve pit containing drill cuttings with some fluids.

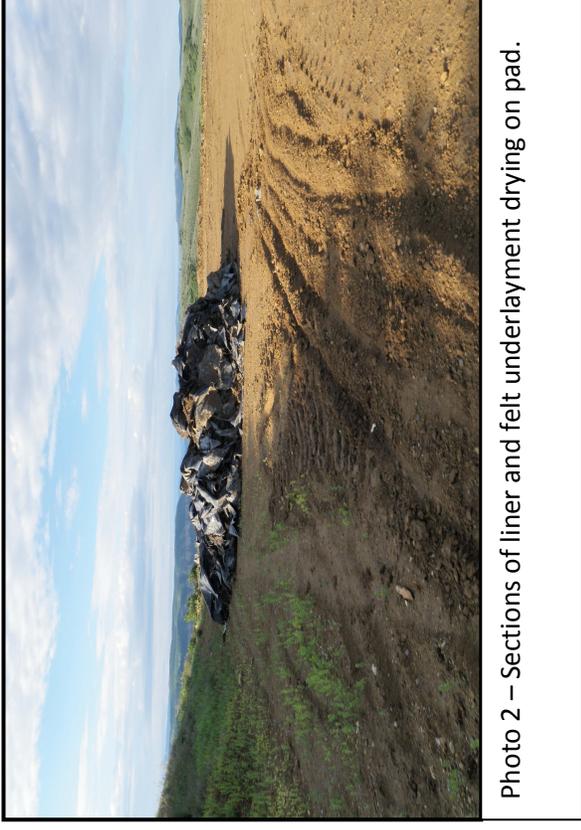
The pit liner and felt materials were extracted using a track hoe after the mixing and removal of the pit's contents. Any debris or liquid remaining on the liner as it was removed was shaken-off, and the sections of liner were laid on the pad to dry (Photo 2). Once the liner material was dry, Bolton Construction, in association with Knupp Transportation, loaded and transported the liner to ECDC in East Carbon, Utah, for disposal.

Photo 2 – Sections of liner and felt underlayment drying on pad.

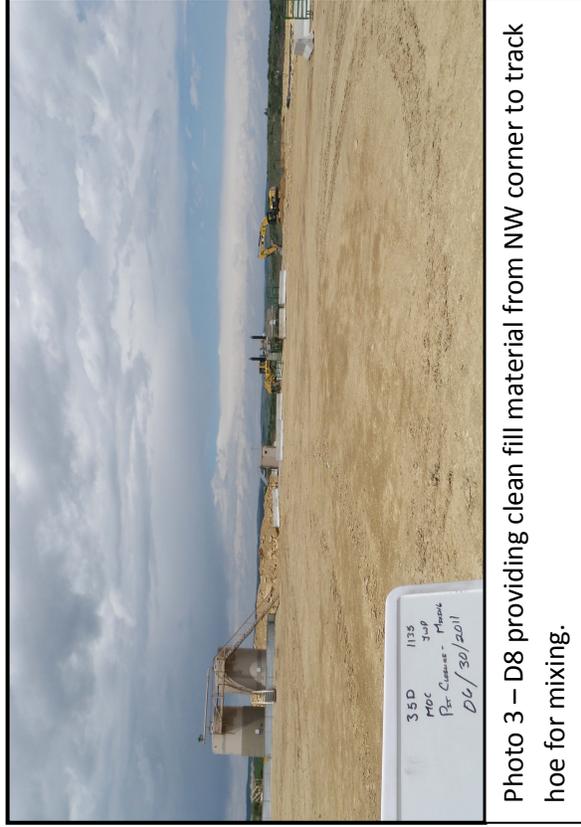
Photo 3 – D8 providing clean fill material from NW corner to track hoe for mixing.

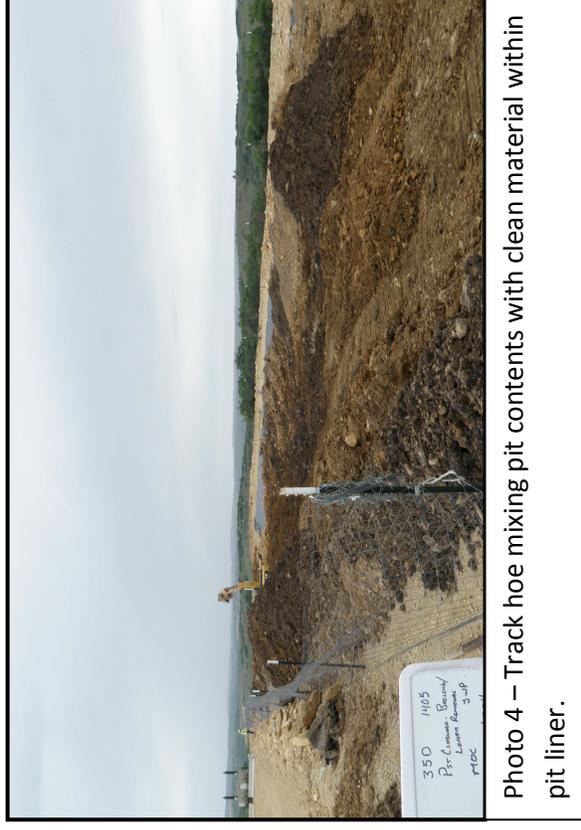
The mixing of pit contents with clean soil occurred inside of the pit prior to pit liner removal. Native soil was obtained from portions of the pad slated for removal during re-contouring activities necessary for interim reclamation. A bulldozer was used to push soil from the pad's northwest corner onto its interior surface where it could be used as clean material for mixing with the pit's contents (Photo 3). After a pile of clean soil had been established on the pad, the clean soil was systematically added to the cuttings inside of the pit using an excavator to turn and mix the materials (Photo 4). Mixing efforts did not affect the integrity of the pit liner.

Photo 4 – Track hoe mixing pit contents with clean material within pit liner.

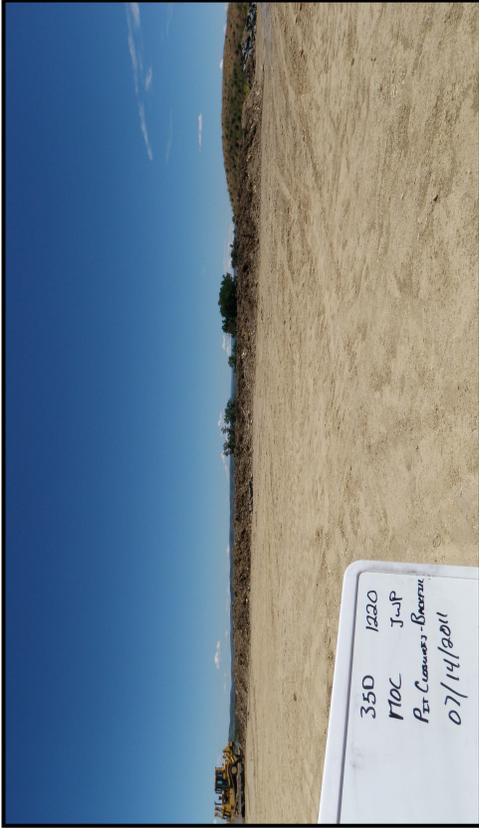
Photo 5 – D8 rolling material to achieve homogenous mixture.

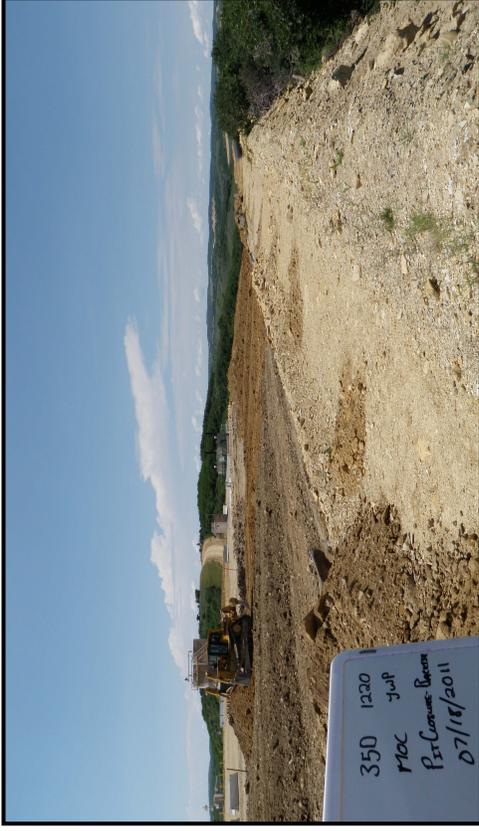
Photo 6 – D8 rolling material to achieve homogenous mixture.

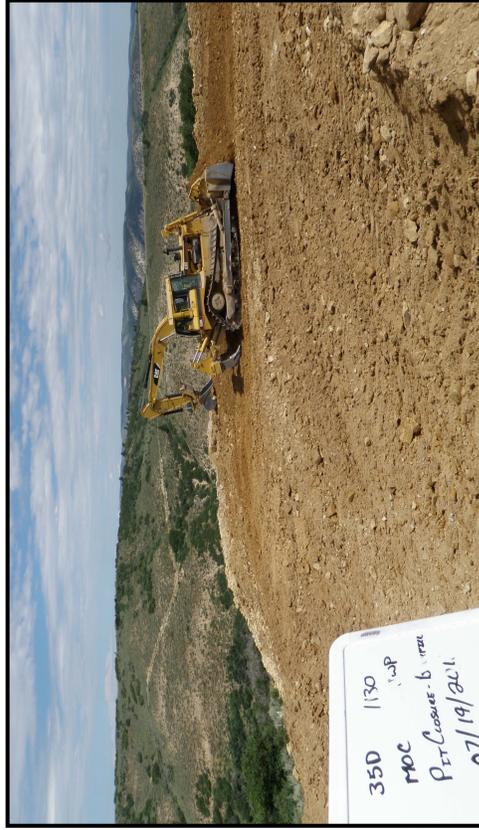
Backfilling of the excavation was achieved by placing the 1:1 mixture of clean soil and cuttings back into the excavation (Photo 7). The mixed material was placed load-by-load into the excavation with each load being thoroughly compacted using the tracks of a dozer. This process continued until the excavation was completely filled.

Photo 7 – D8 and track hoe backfilling pit and beginning to contour slopes.

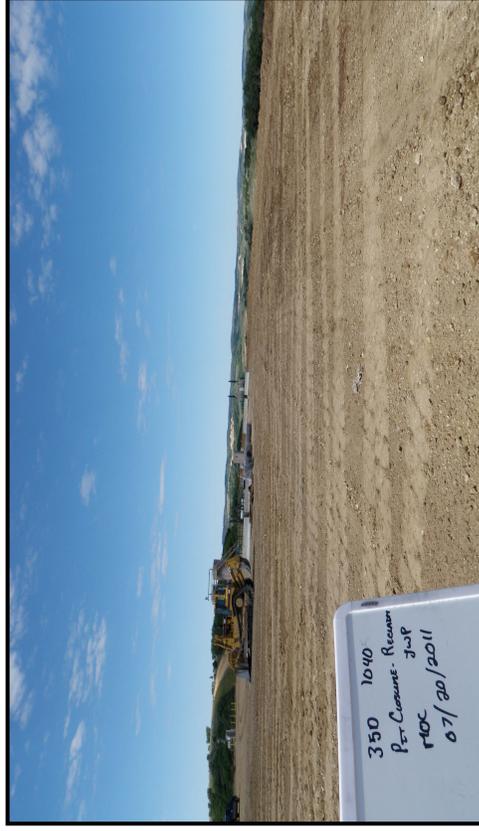
Once the excavation had been backfilled, areas of the well pad no longer required for production were roughly graded to their original contour (Photo 8). These re-contoured areas were then top-soiled, thereby mitigating the potential effects of physical parameters on reclamation success. Backfilling and re-contouring operations concluded on July 20, 2011.

Photo 8 – Well pad after pit closure and reclamation.
