**MARATHON OIL COMPANY
NOTICE OF COMPLETION REPORT FOR
INTERIM RECLAMATION OF
596-31C**

January 20, 2012

**Marathon Oil Company
743 Horizon Court, Suite 220
Grand Junction, Colorado 81506**

**InterTech Environmental & Engineering, LLC
743 Horizon Court, Suite 110
Grand Junction, Colorado 81506**

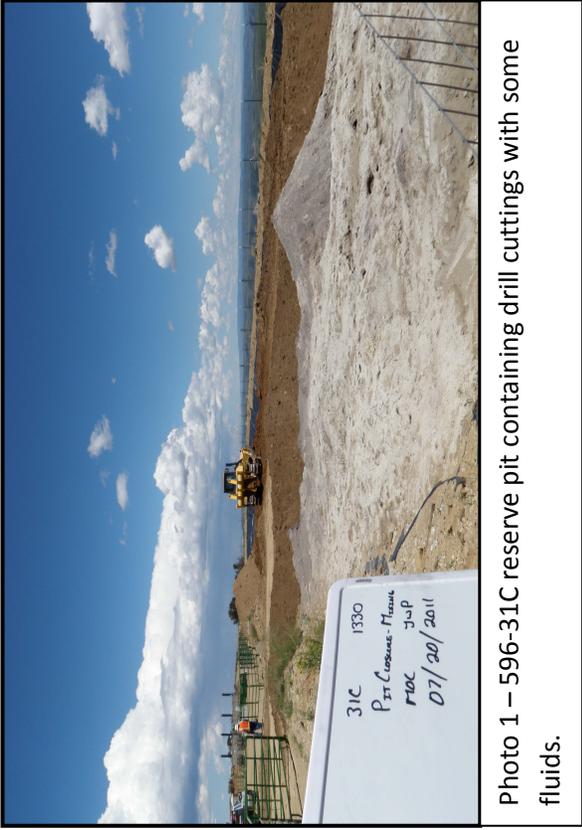
This report covers the activities associated with the closure of the on-site reserve pit at Marathon Oil Company's 596-31C well pad. At the time of the initial site visit, the pit contained what appeared to be drill cuttings and fluid (Photo 1, Appendix A).

Photo 1 – 596-31C reserve pit containing drill cuttings with some fluids.

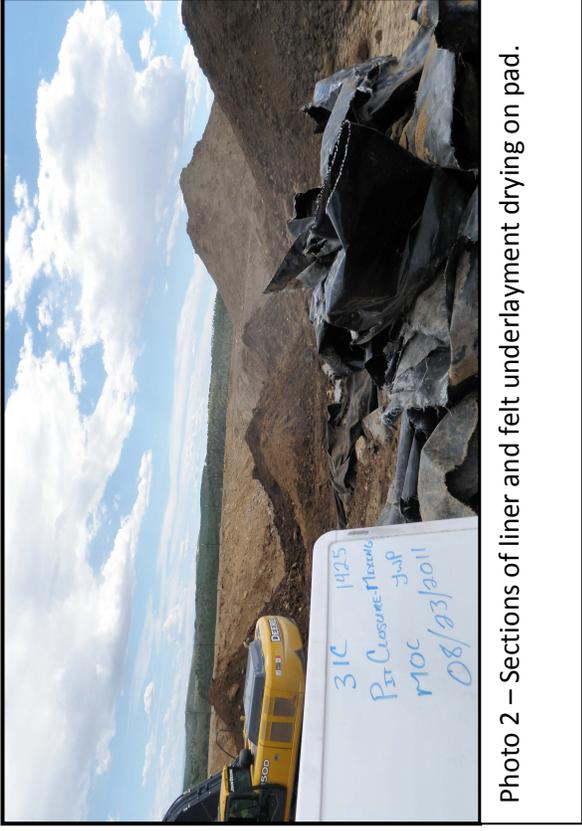
Photo 2 – Sections of liner and felt underlayment drying on pad.

The pit liner and felt materials were extracted using a track hoe after the mixing and removal of the pit's contents. Any debris or liquid remaining on the liner as it was removed was shaken-off, and the sections of liner were laid on the pad to dry (Photo 2). Once the liner material was dry, Jacobs, in association with Production Transport (PT), loaded and transported the liner to ECDC in East Carbon, Utah, for disposal.

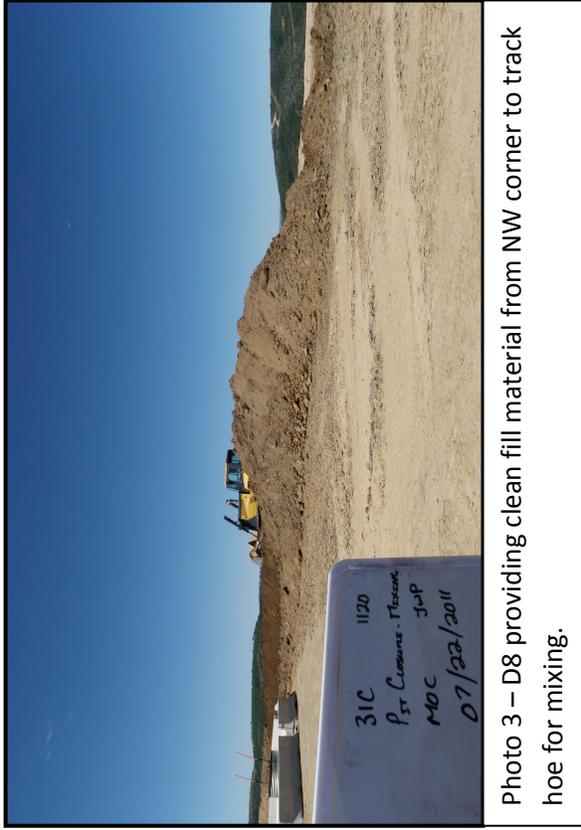
Photo 3 – D8 providing clean fill material from NW corner to track hoe for mixing.

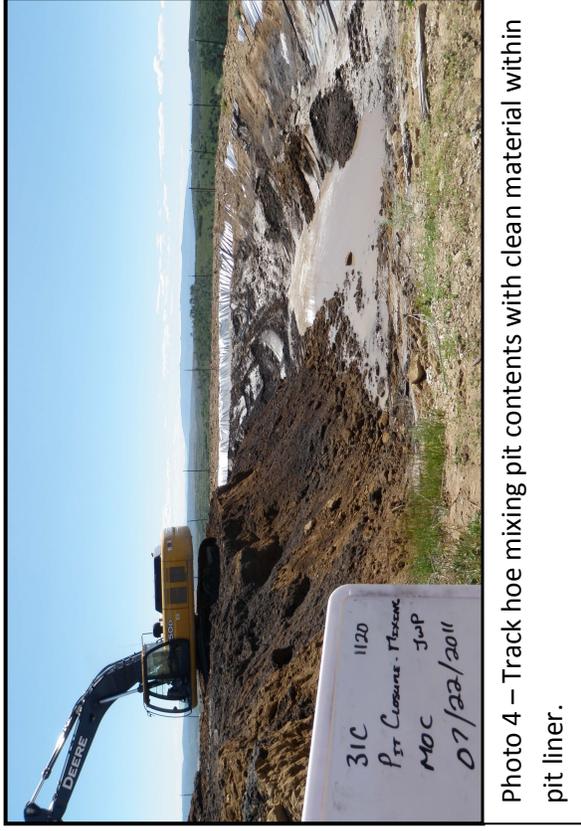
Photo 4 – Track hoe mixing pit contents with clean material within pit liner.

The mixing of pit contents with clean soil occurred inside of the pit prior to pit liner removal. Native soil was obtained from portions of the pad slated for removal during re-contouring activities necessary for interim reclamation. A bulldozer was used to push soil from the pad's western fill slope onto its interior surface where it could be used as clean material for mixing with the pit's contents (Photo 3). After a pile of clean soil had been established on the pad, the clean soil was systematically added to the cuttings inside of the pit using an excavator to turn and mix the materials (Photo 4). Mixing efforts did not affect the integrity of the pit liner.
