**MARATHON OIL COMPANY  
NOTICE OF COMPLETION REPORT FOR  
INTERIM RECLAMATION OF  
697-12A**

*January 20, 2012*

**InterTech Environmental & Engineering, LLC  
743 Horizon Court, Suite 110  
Grand Junction, Colorado 81506**

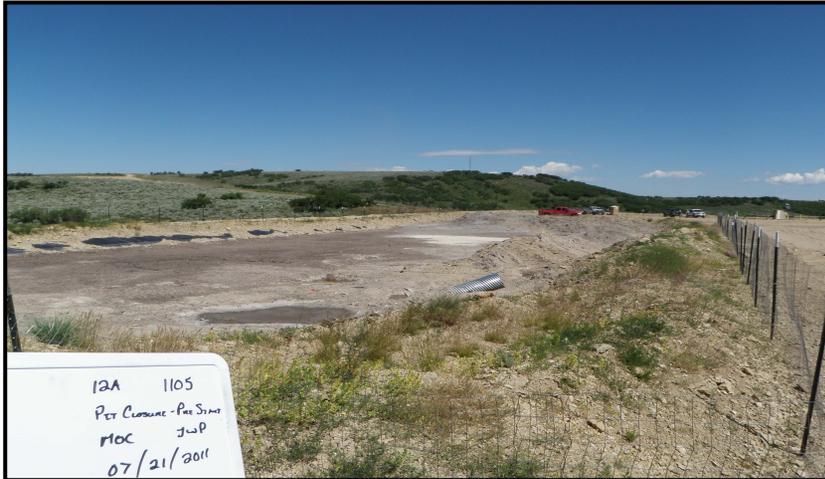
This report covers the activities associated with the closure of the on-site reserve pit at Marathon Oil Company's 697-12A well pad. At the time of the initial site visit, the pit contained what appeared to be drill cuttings and fluid (Photo 1, Appendix A).

Photo 1 – 697-12A reserve pit containing drill cuttings with some fluids.

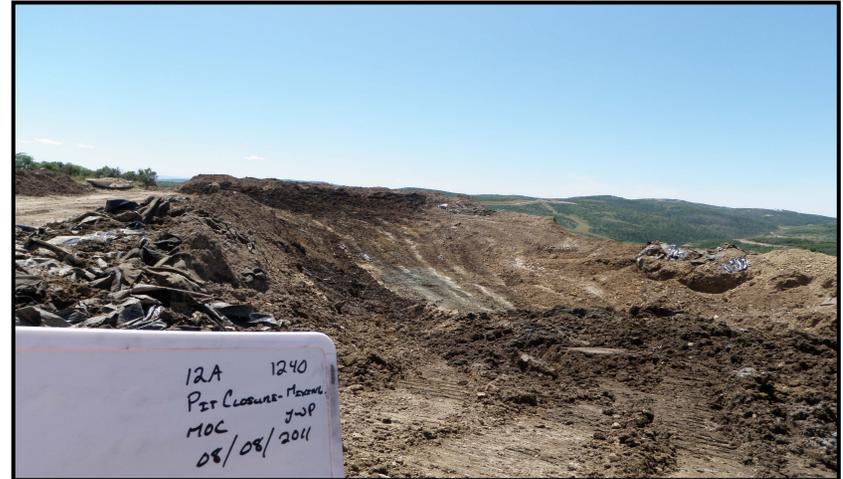
The pit liner and felt materials were extracted using a track hoe after the mixing and removal of the pit's contents. Any debris or liquid remaining on the liner as it was removed was shaken-off, and the sections of liner were laid on the pad to dry (Photo 2). Once the liner material was dry, Moody Construction, in association with Production Transport, loaded and transported the liner to ECDC in East Carbon, Utah, for disposal.

Photo 2 – Sections of liner and felt underlayment drying on pad.

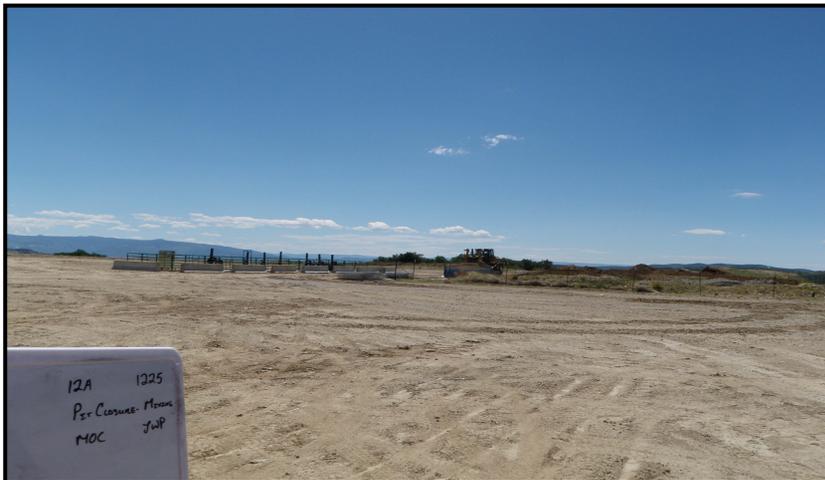
Photo 3 – D8 providing clean fill material from sW corner to track hoe for mixing.

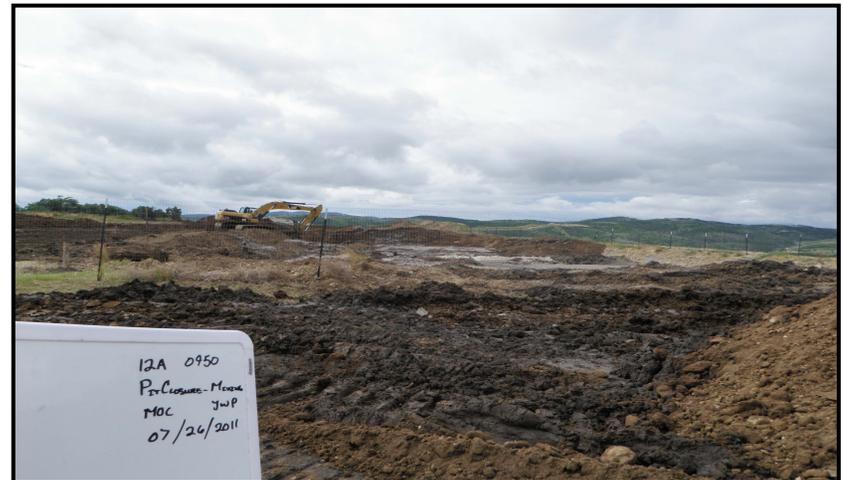
using an excavator to turn and mix the materials (Photo 4). Mixing efforts did not affect the integrity of the pit liner.

Photo 4 – Track hoe mixing pit contents with clean material within pit liner.

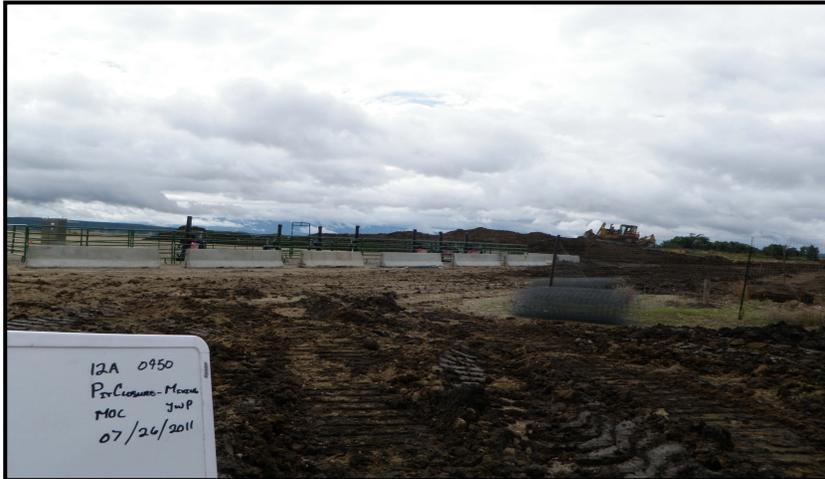
12A 0950  
PIT CLOSURE - MIXING  
MOC JWP  
07/26/2011

Photo 5 – D8 rolling material to achieve homogenous mixture.

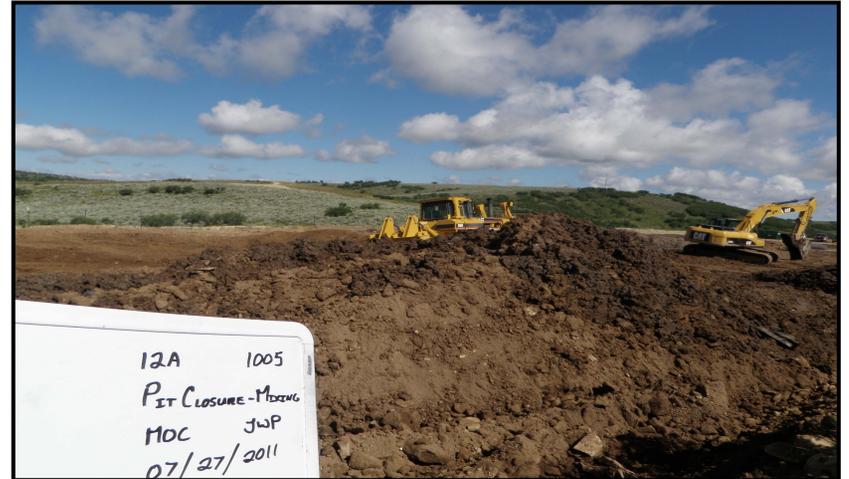
12A 1005  
PIT CLOSURE - MIXING  
MOC JWP  
07/27/2011

Photo 6 – D8 rolling material to achieve homogenous mixture.

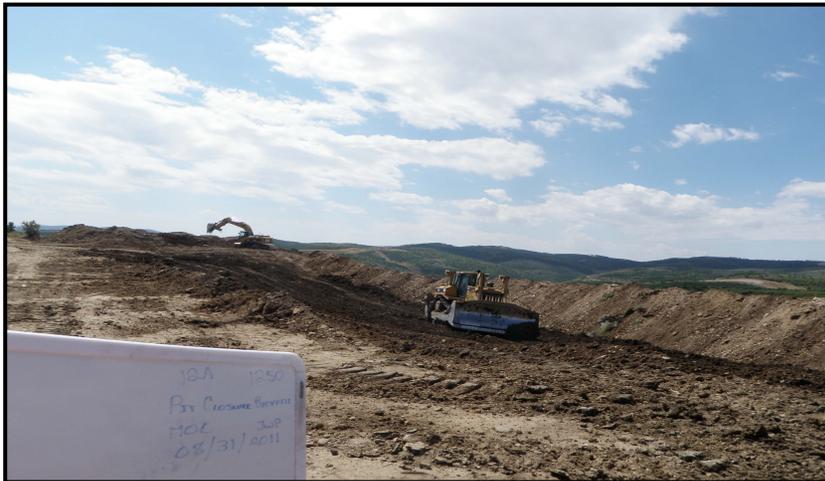
12A 1050  
PIT CLOSURE - BACKFILL  
MOC JWP  
08/31/2011

Backfilling of the excavation was achieved by placing the 1.5:1 mixture of clean soil and cuttings back into the excavation (Photo 7). The mixed material was placed load-by-load into the excavation with each load being thoroughly compacted using the tracks of a dozer. This process continued until the excavation was completely filled.

Photo 7 – Pit during backfilling operations.

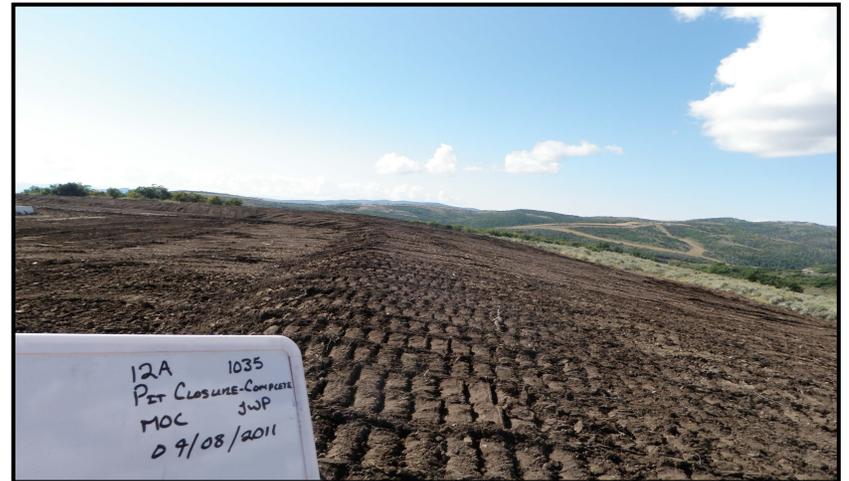
12A 1035  
PIT CLOSURE - COMPLETE  
MOC JWP  
09/08/2011

Once the excavation had been backfilled, areas of the well pad no longer required for production were roughly graded to their original contour (Photo 8). These re-contoured areas were then top-soiled, thereby mitigating the potential effects of physical parameters on reclamation success. Backfilling and re-contouring operations concluded on September 8, 2011.

Photo 8 – Well pad after pit closure and reclamation.
