**MARATHON OIL COMPANY
NOTICE OF COMPLETION REPORT FOR
INTERIM RECLAMATION OF
697-28C**

January 20, 2012

**Marathon Oil Company
743 Horizon Court, Suite 220
Grand Junction, Colorado 81506**

**InterTech Environmental & Engineering, LLC
743 Horizon Court, Suite 110
Grand Junction, Colorado 81506**

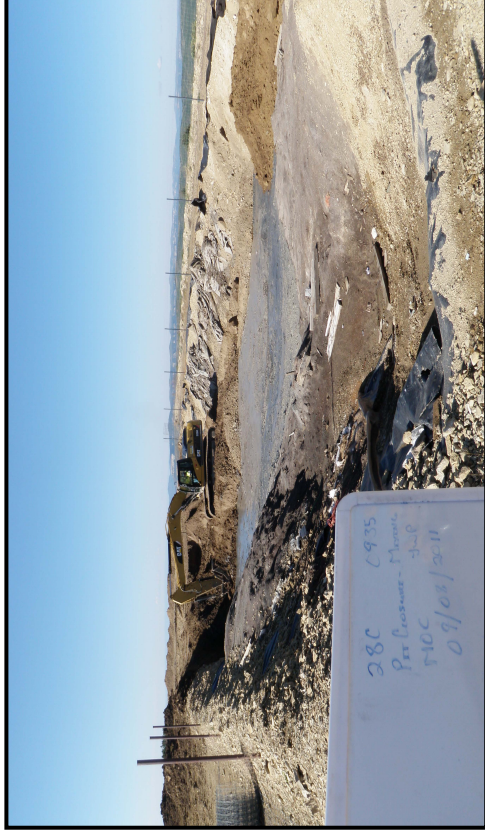
This report covers the activities associated with the closure of the on-site reserve pit at Marathon Oil Company's 697-28C well pad. At the time of the initial site visit, the pit contained what appeared to be drill cuttings and fluid (Photo 1, Appendix A).

Photo 1 – 697-21A reserve pit containing drill cuttings with some fluids.

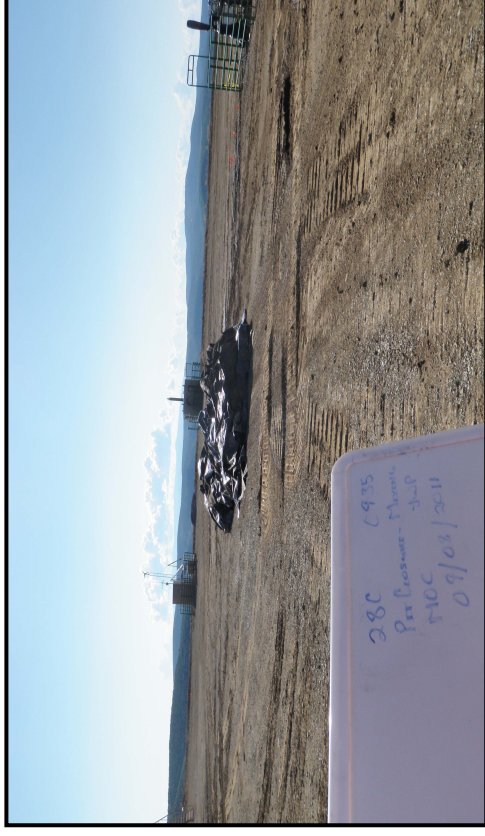
The pit liner and felt materials were extracted using a track hoe after the mixing and removal of the pit's contents. Any debris or liquid remaining on the liner as it was removed was shaken-off, and the sections of liner were laid on the pad to dry. Once the liner material was dry, Moody Construction, in association with Production Transport, loaded and transported the liner to ECDC in East Carbon, Utah, for disposal (Photo 2).

Photo 2 – Sections of liner and felt underlayment being loaded on transport for disposal.

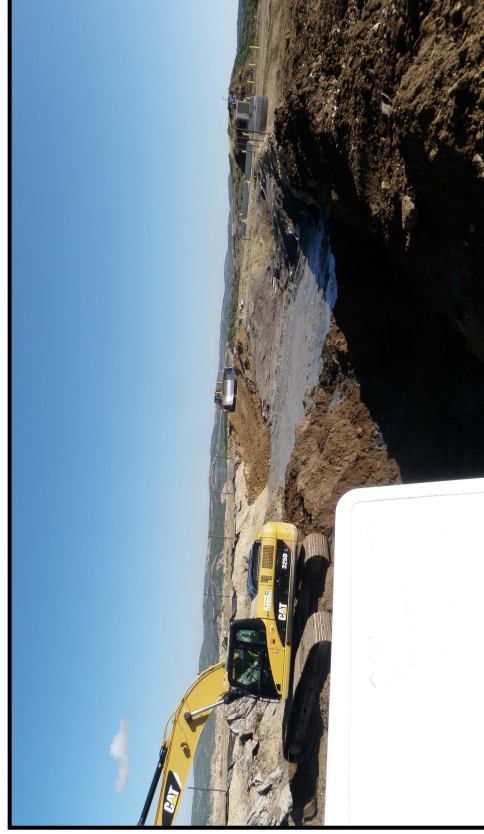
Photo 3 – D8 providing clean fill material from NW corner to track hoe for mixing.

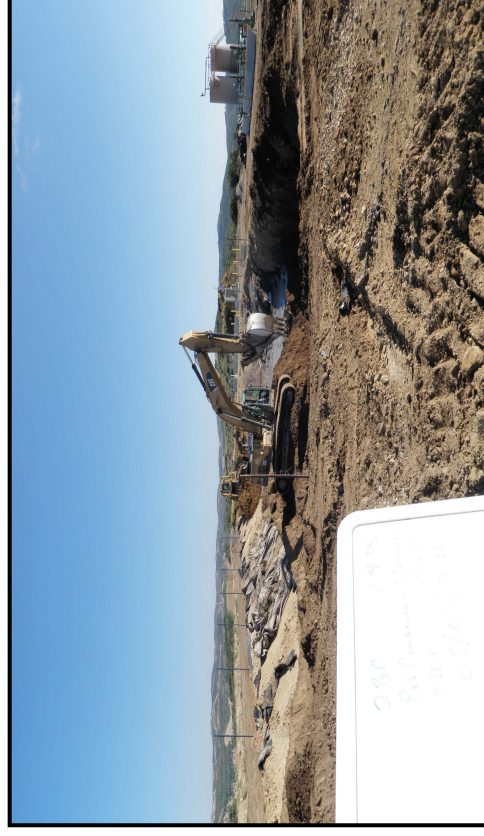
using an excavator to turn and mix the materials (Photo 4). Mixing efforts did not affect the integrity of the pit liner.

Photo 4 – Track hoe mixing pit contents with clean material within pit liner.

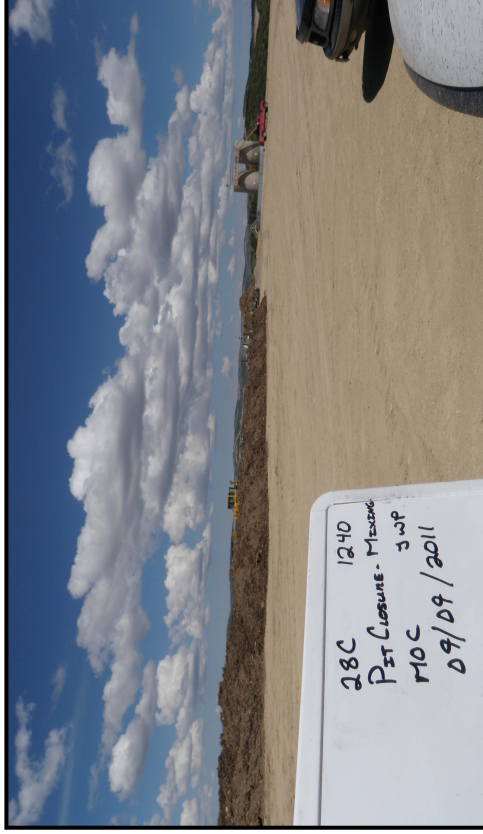
Photo 5 Front end loader rolling and mixing material on pad.

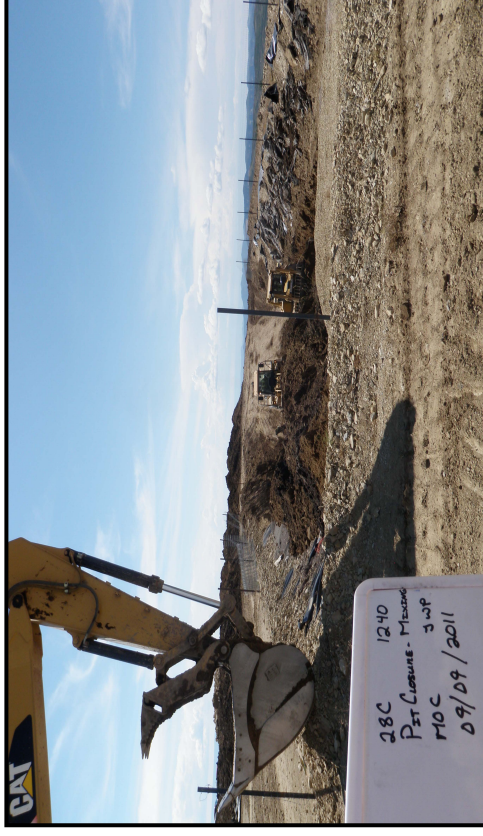
Photo 6 – D8 and front end loader mixing material.

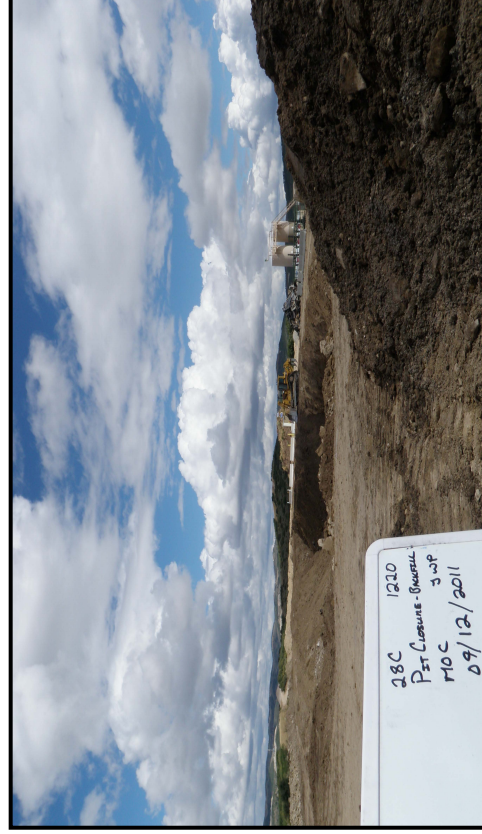
Backfilling of the excavation was achieved by placing the 4:1 mixture of clean soil and cuttings back into the excavation (Photo 7). The mixed material was placed load-by-load into the excavation with each load being thoroughly compacted using the tracks of a dozer. This process continued until the excavation was completely filled.

Photo 7 – Pit during backfilling operations.

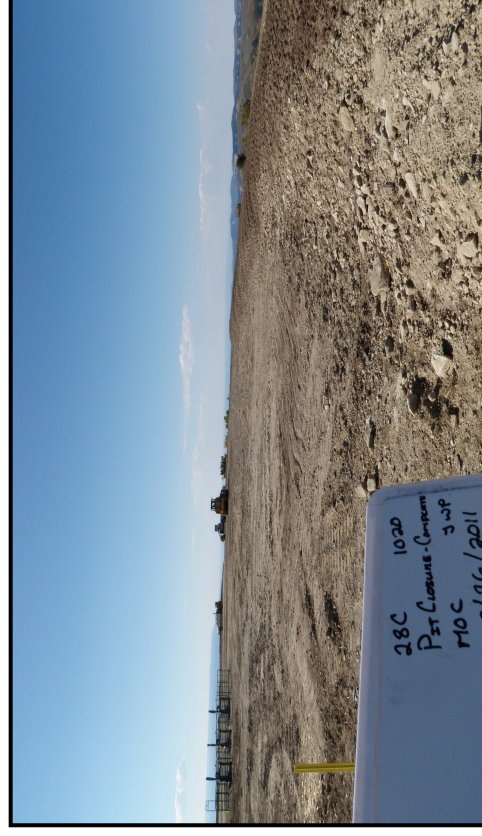
Once the excavation had been backfilled, areas of the well pad no longer required for production were roughly graded to their original contour (Photo 8). These re-contoured areas were then top-soiled, thereby mitigating the potential effects of physical parameters on reclamation success. Backfilling and re-contouring operations concluded on September 16, 2011.

Photo 8 – Well pad after pit closure and reclamation.
