## Interim Reclamation Inspection

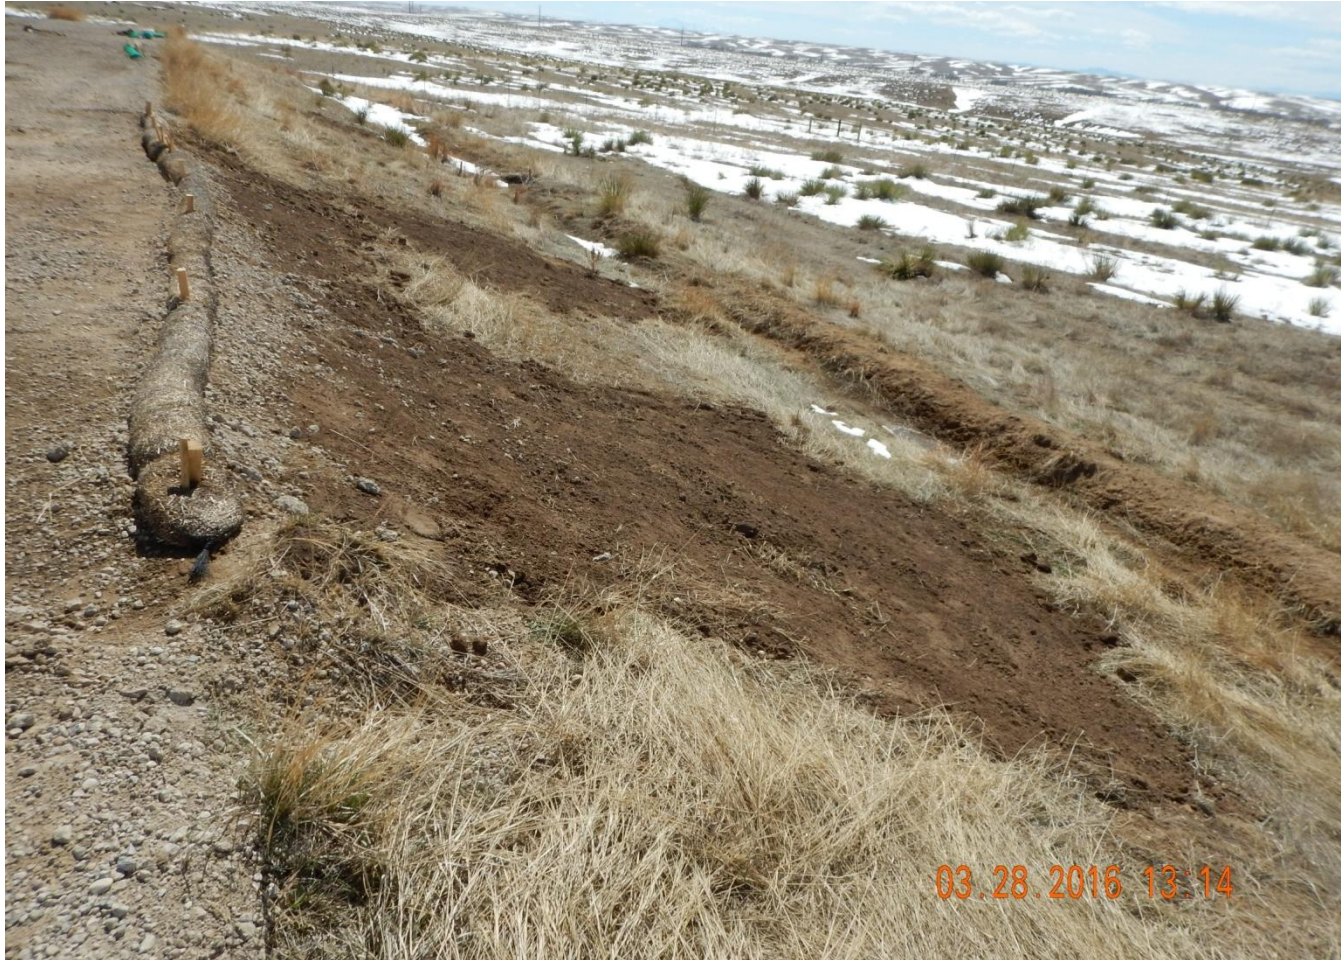
**Photo 1.** Photo taken from northwest location, facing Southwest. Wattles have been reinstalled along the western perimeter of the location.

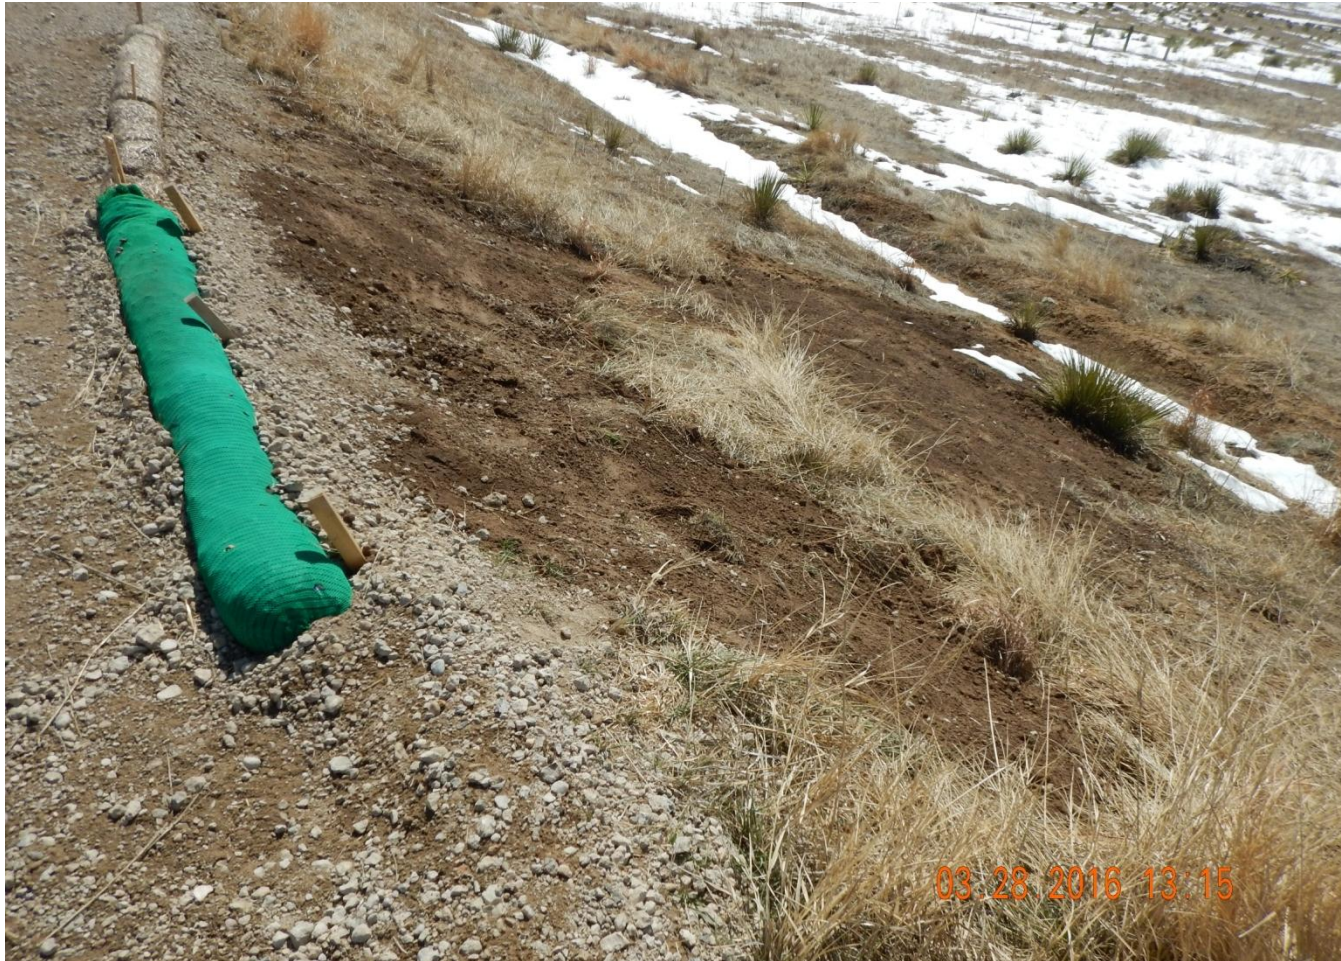
**Photo 2.** Photo taken from western location, facing Southwest. Wattles have been reinstalled along the western perimeter of the location.

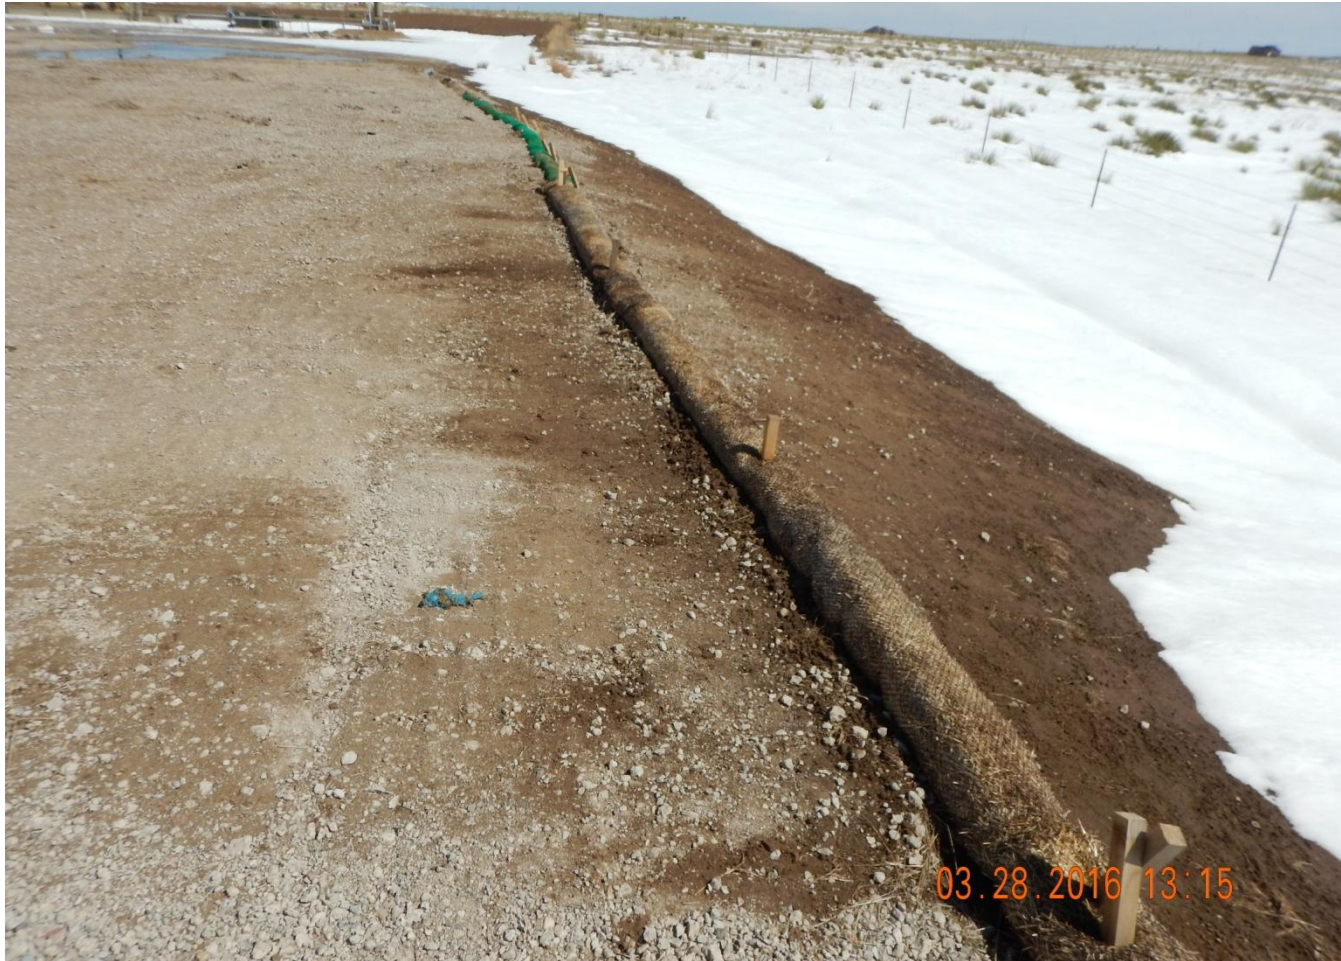
**Photo 3.** Photo taken from southwest location, facing South. Wattles have been reinstalled along the western perimeter of the location.

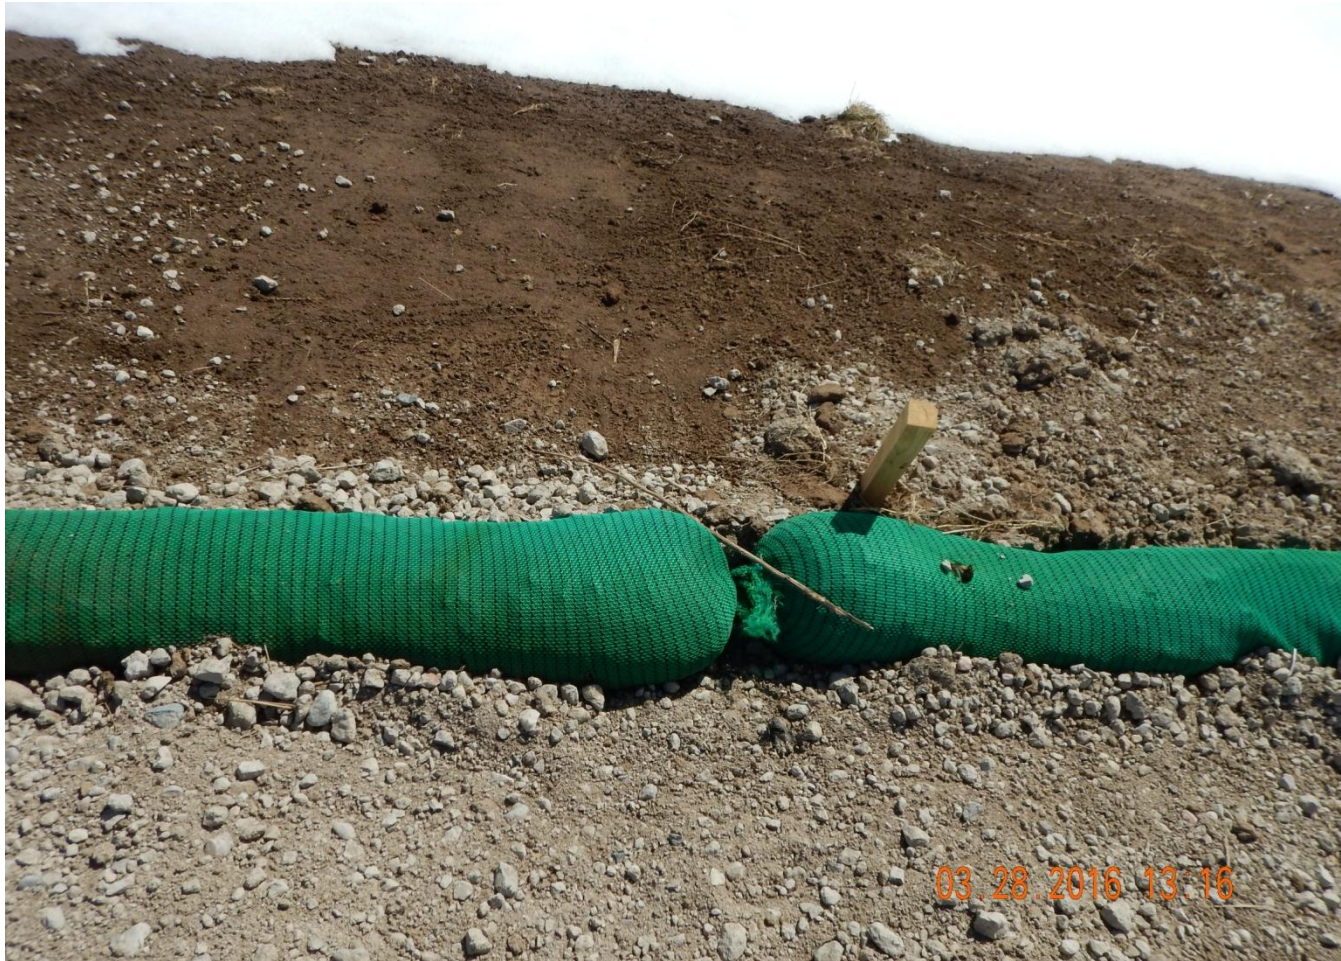
**Photo 4.** Photo taken from western location. Wattles have been reinstalled along the western perimeter of the location. Overlapping wattles behind each other can be helpful to control sediment. Otherwise, wattles must butt the second wattle tightly against the first wattle.
