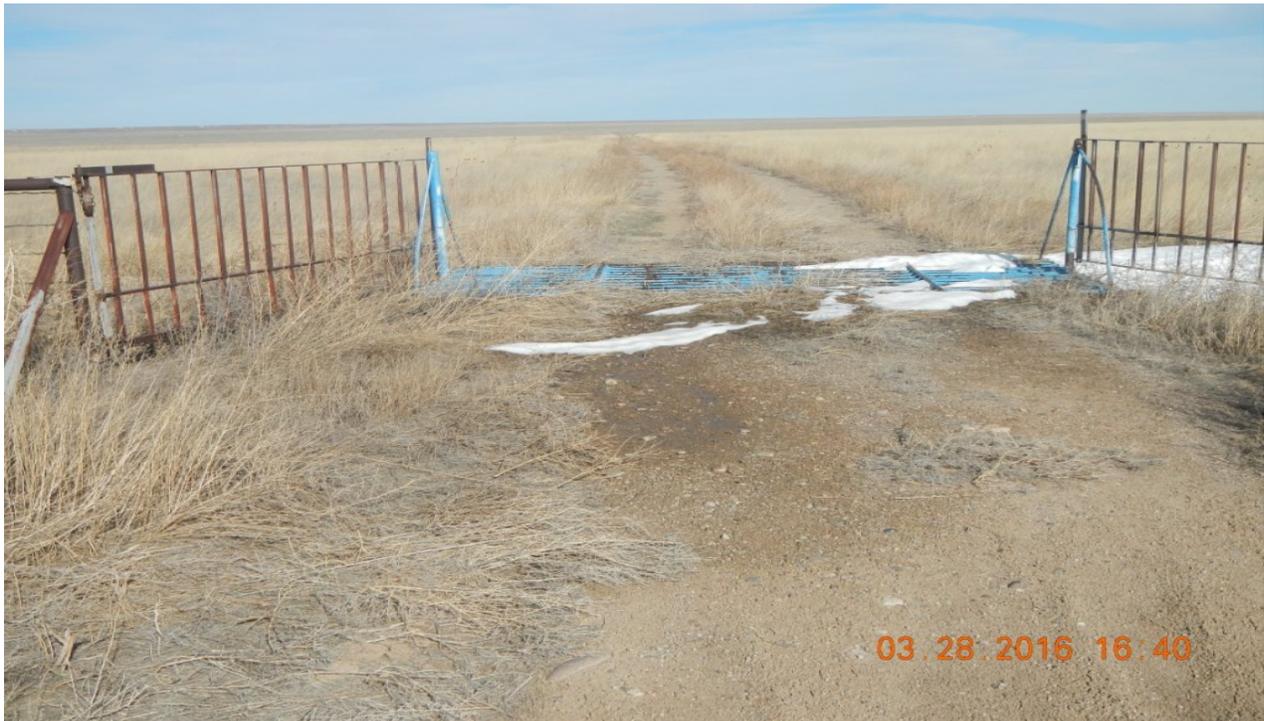
photo 1: Facing east towards the access road standing at county road 63.

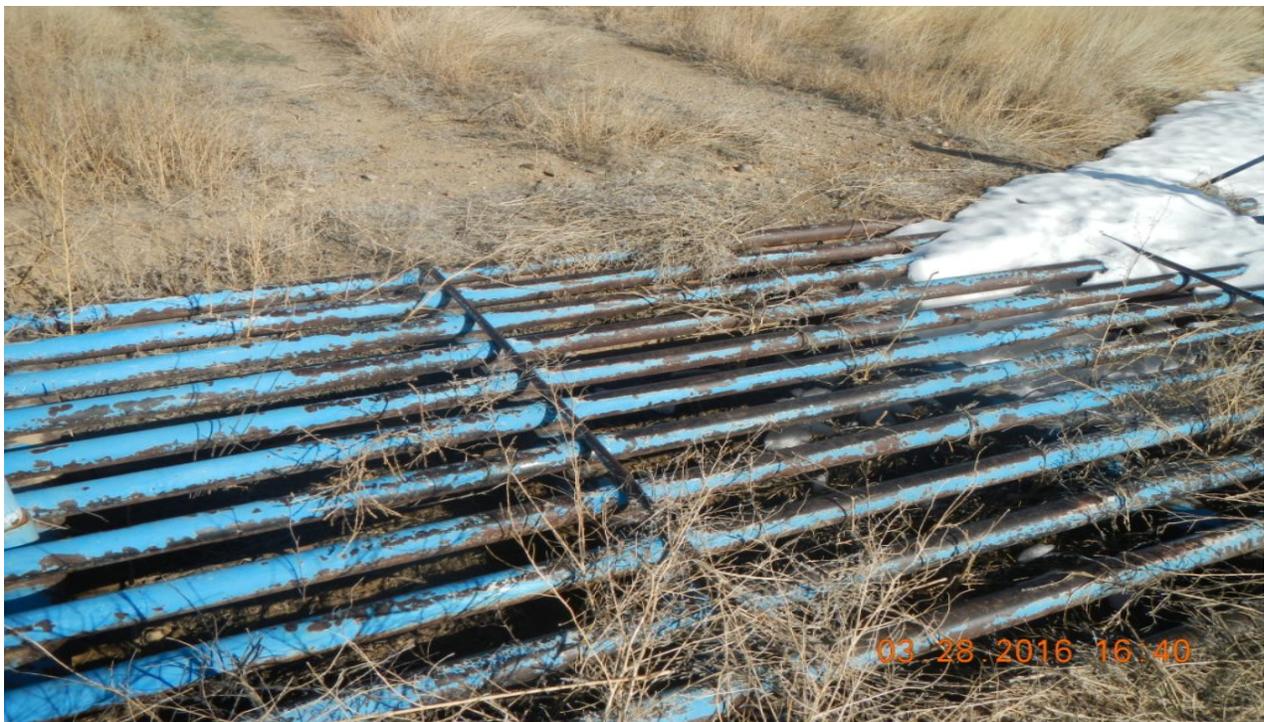
photo 2: Cattle guard is not filled with sediment and no maintenance issues were noticed.

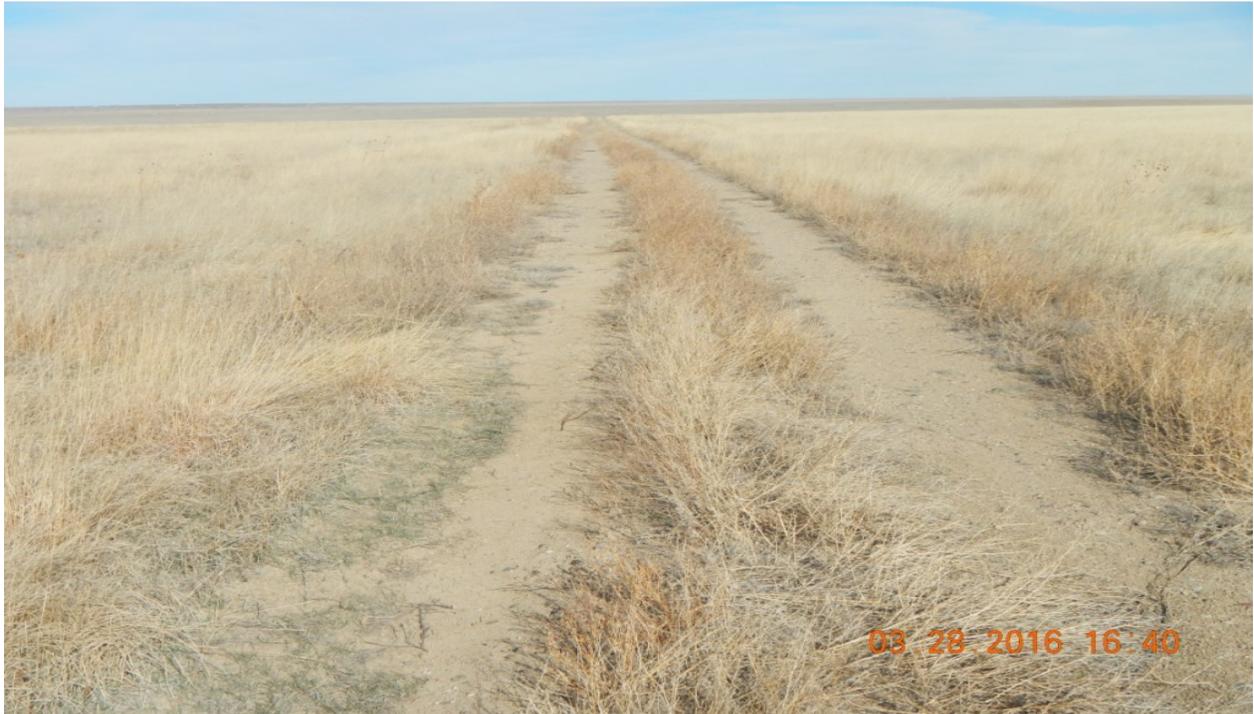
photo 3: Facing east along the access road.

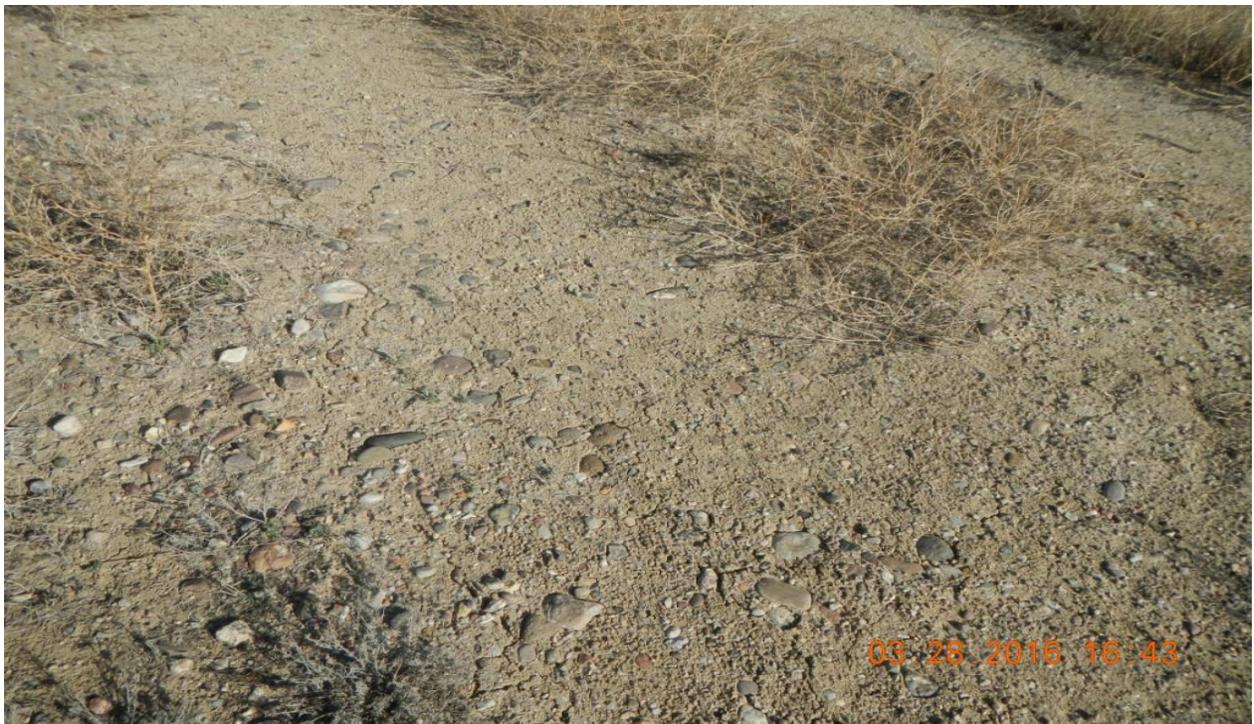
photo 4: View of the road base material along the access road.

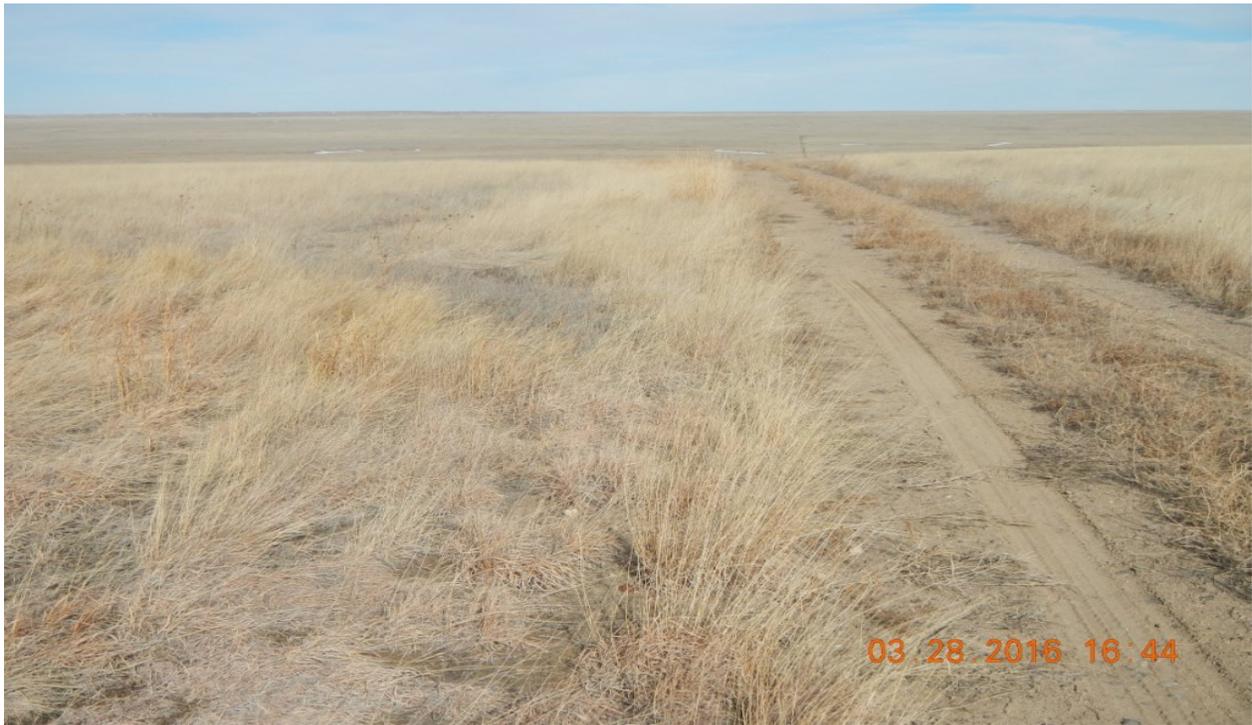
photo 5: Facing east showing surrounding pasture vegetation along the access road.

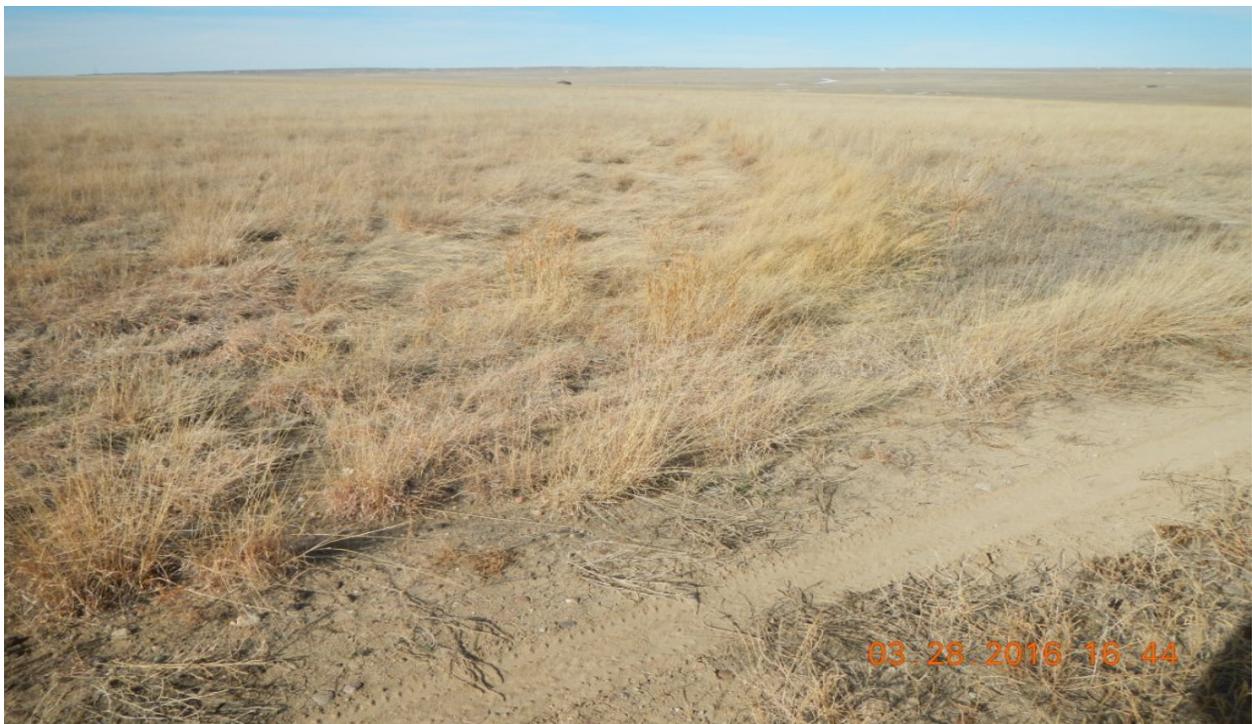
photo 6: Facing northeast from the access road toward the vegetated drainage ditch which is directed out into the pasture.

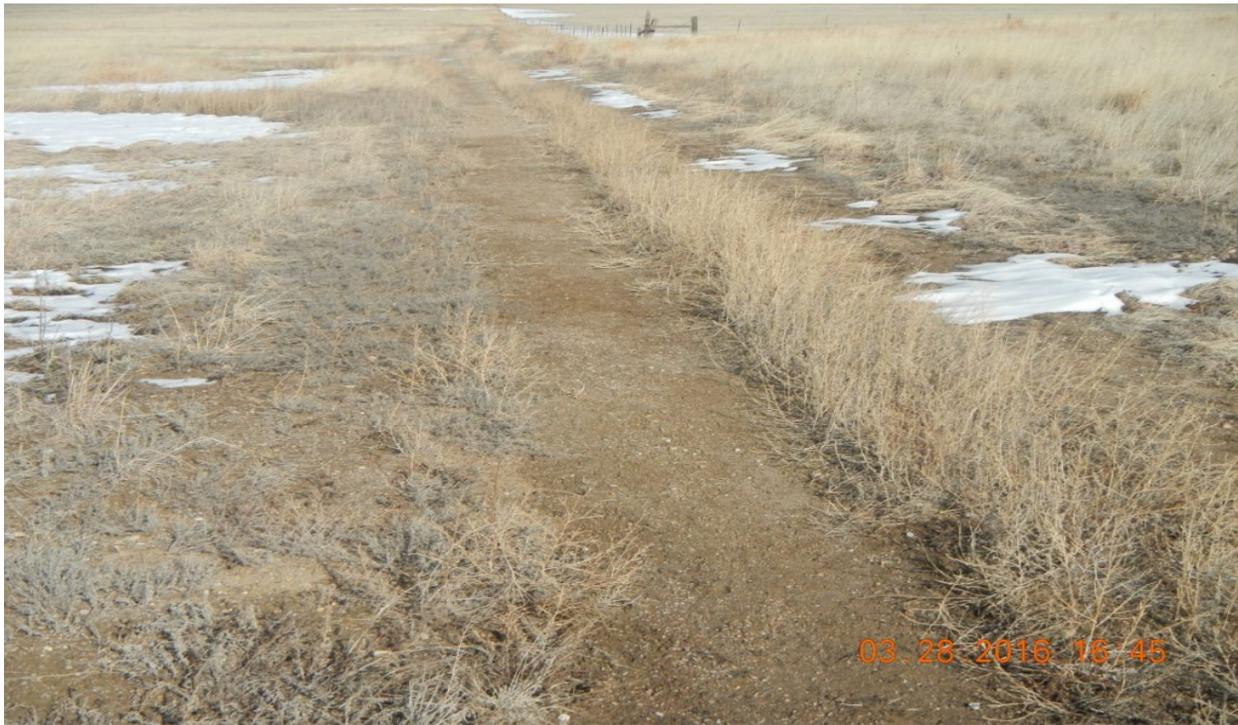
photo 7: Facing east along the access road.

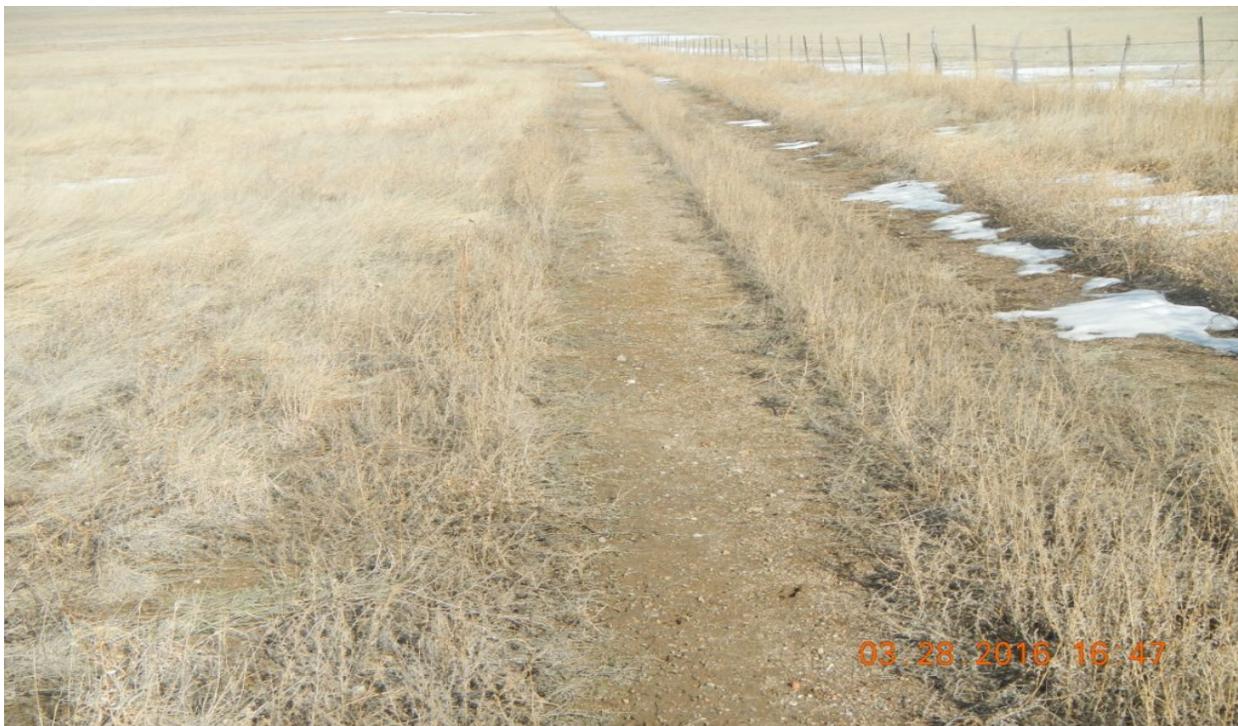
photo 8: Facing east along the access road.

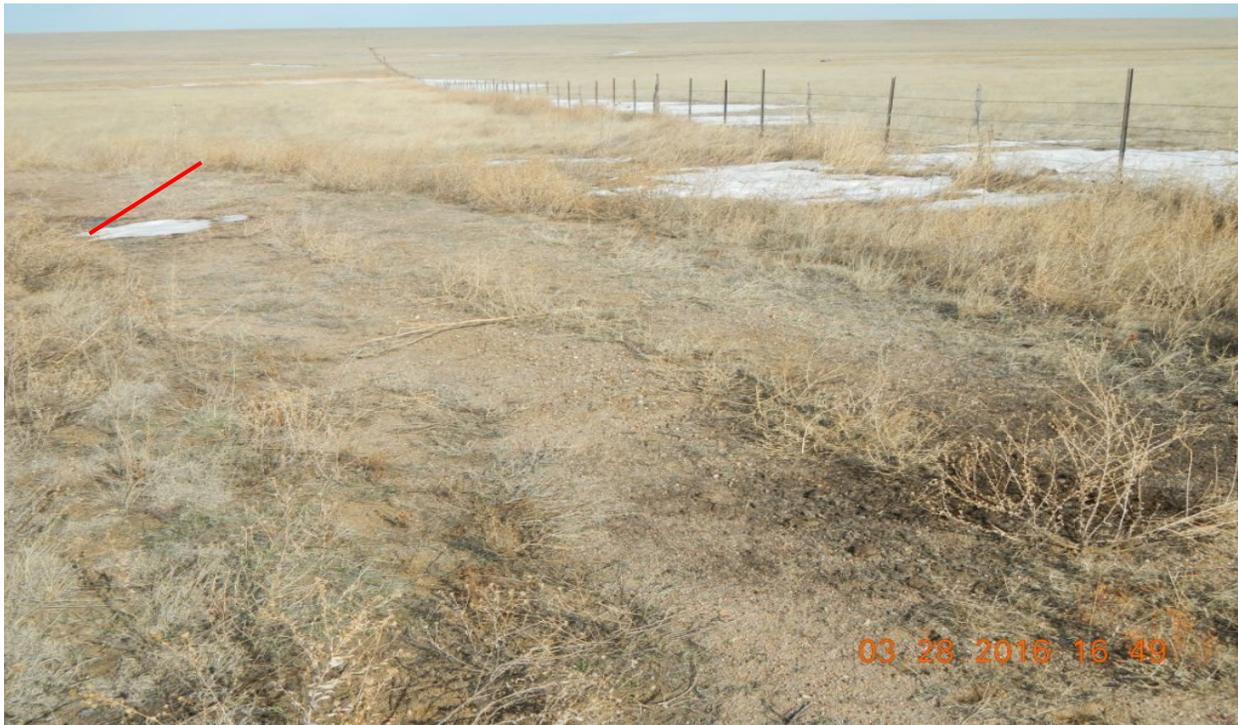
photo 9: Facing east toward the point where access road turns north to the location. Red line indicates approximate point where reclamation work appears to begin.

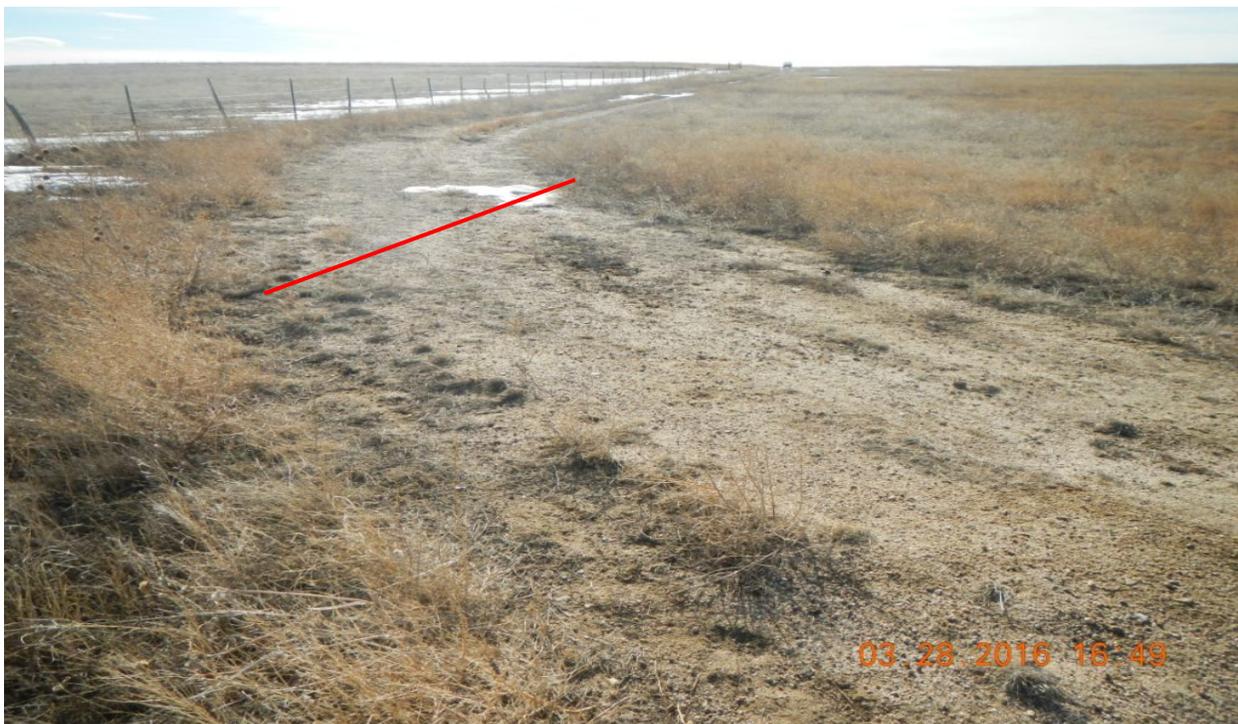
photo 10: Facing back towards the west at the access road. Red line indicates approximate point where reclamation work appears to begin.

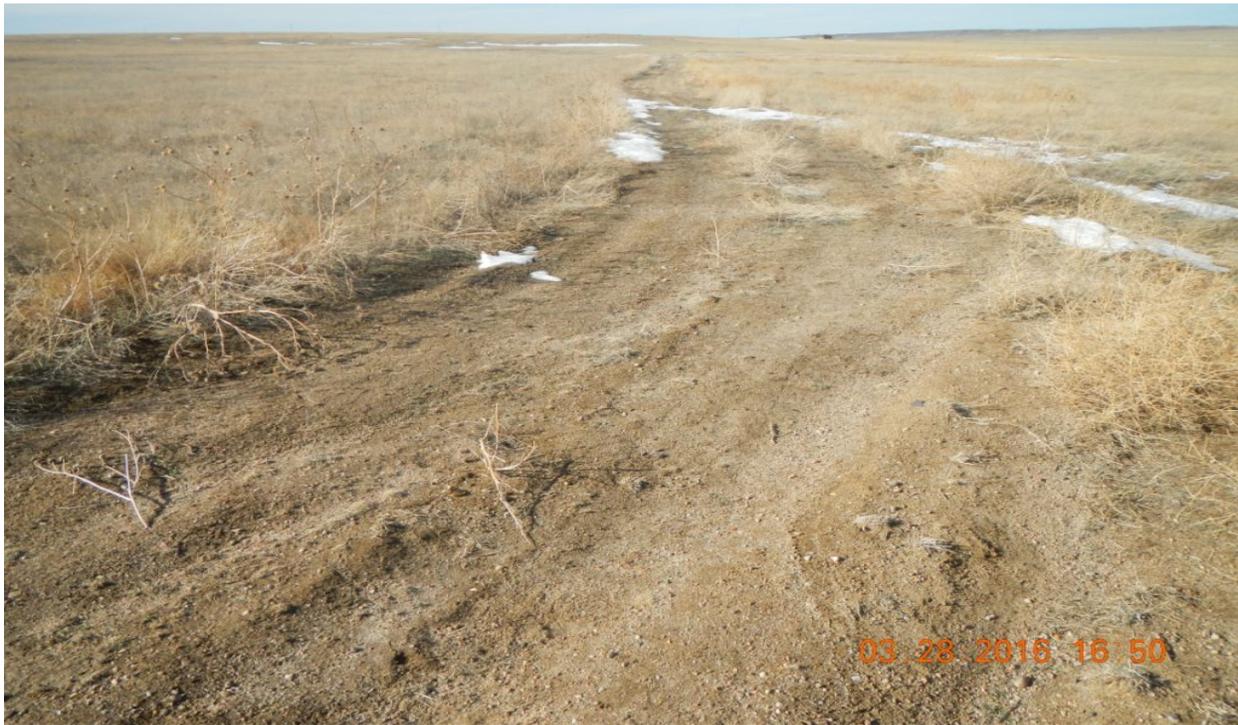
photo 11: Facing north along the former access road. Access road turns to the north at this point.

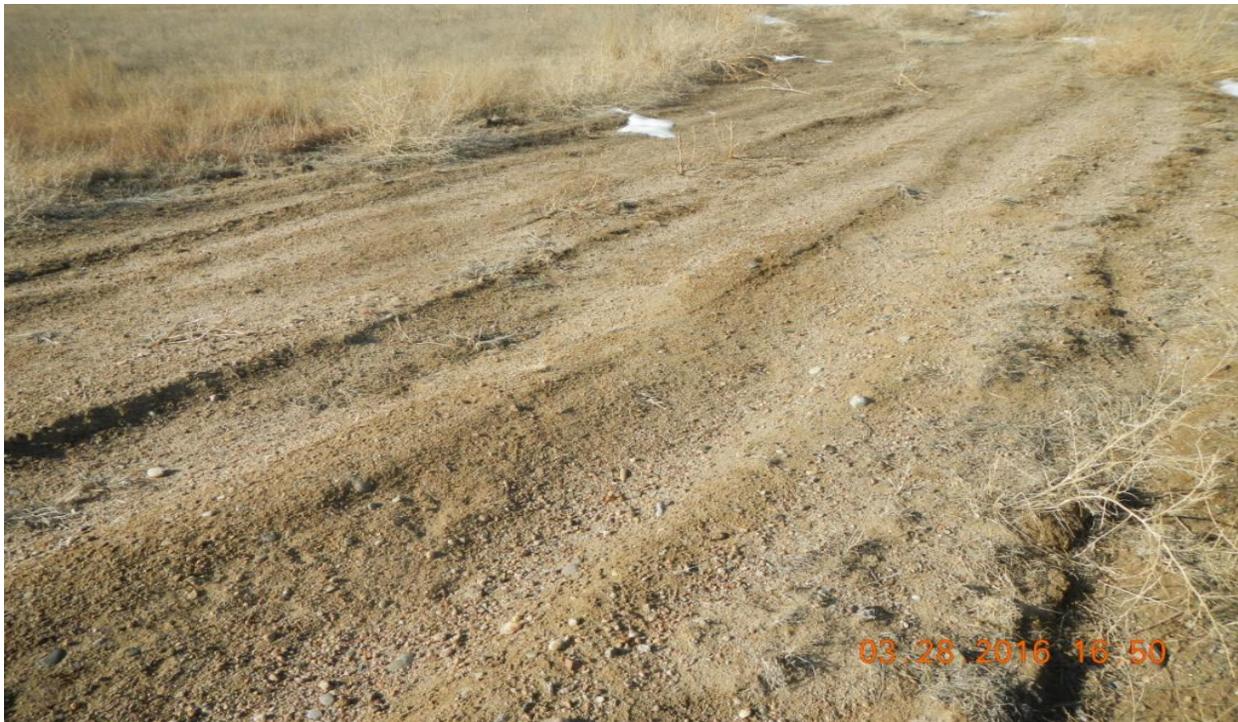
photo 12: It appears that the access road was ripped and decompacted starting at this point which goes north toward the location.

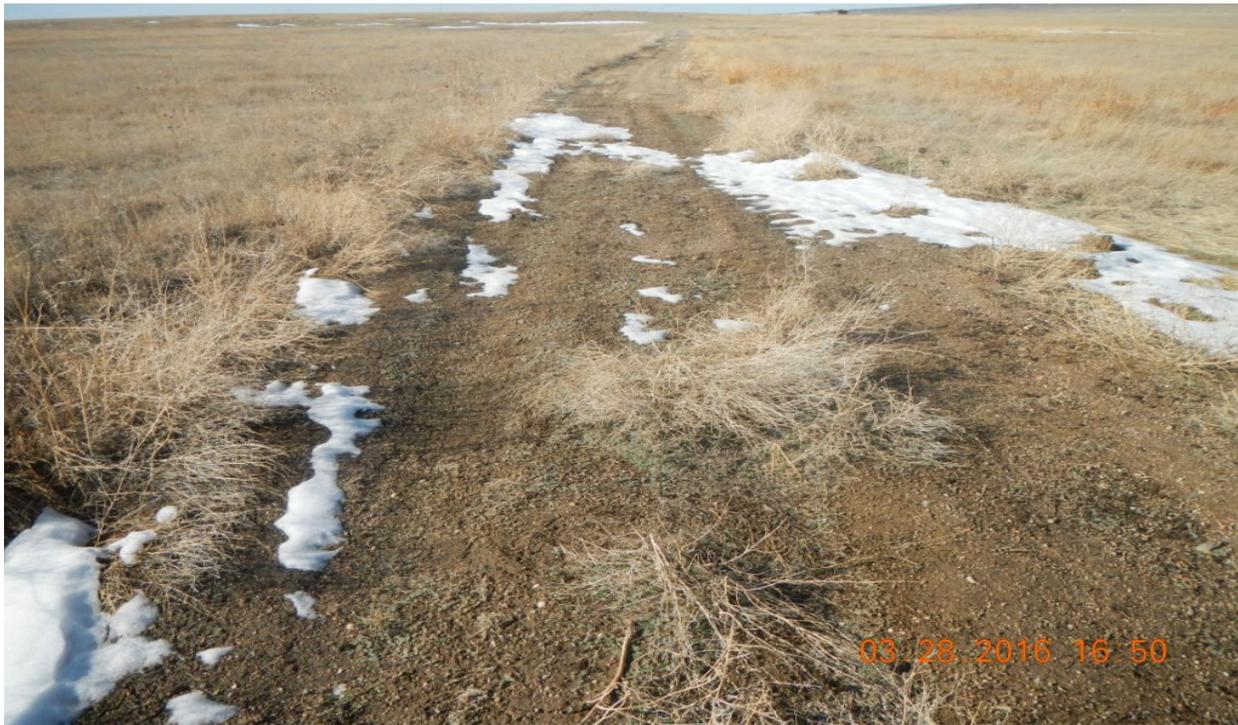
photo 13: Facing north along the former access road.

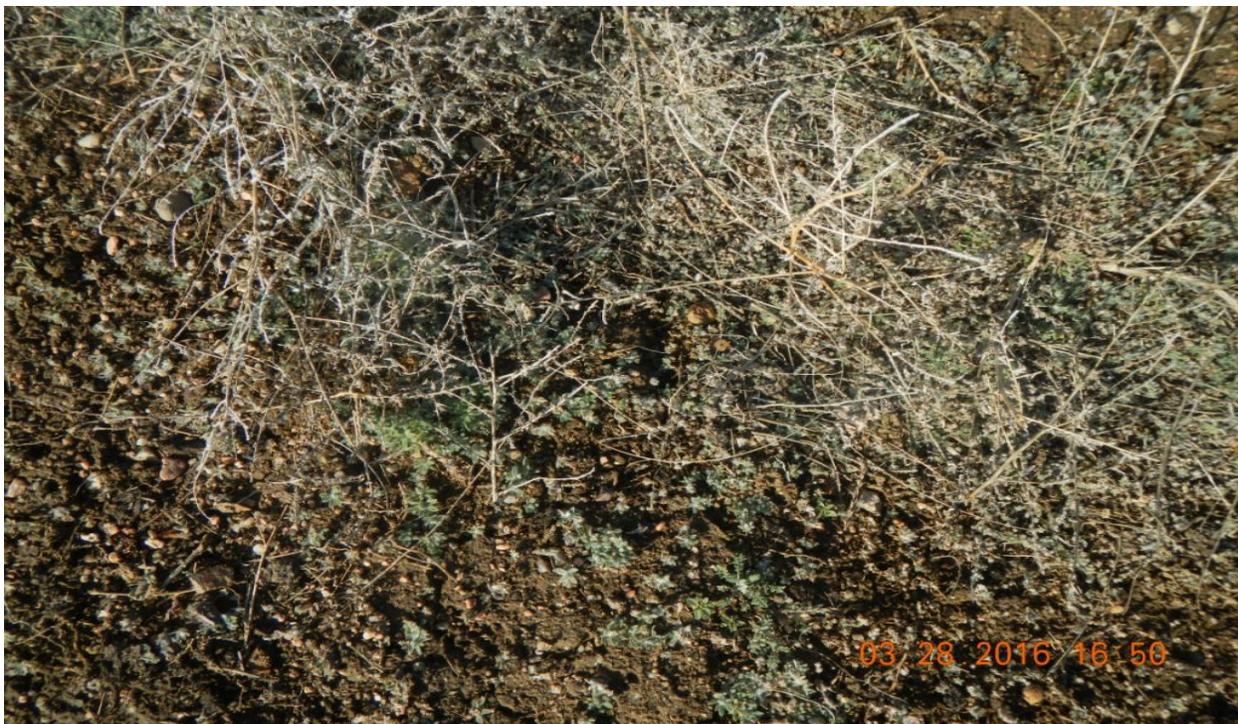
photo 14: Noticed vegetation germination which appears to be an undesirable species (Kochia).

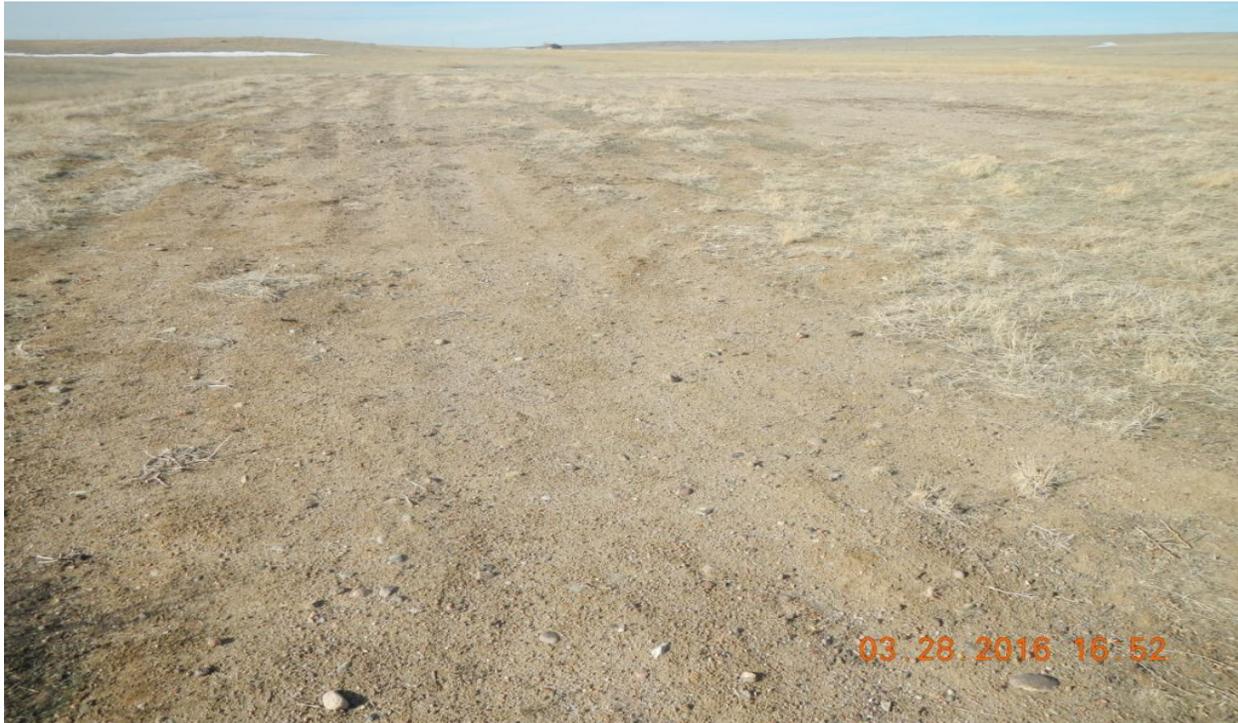
photo 15: Facing north toward the location.

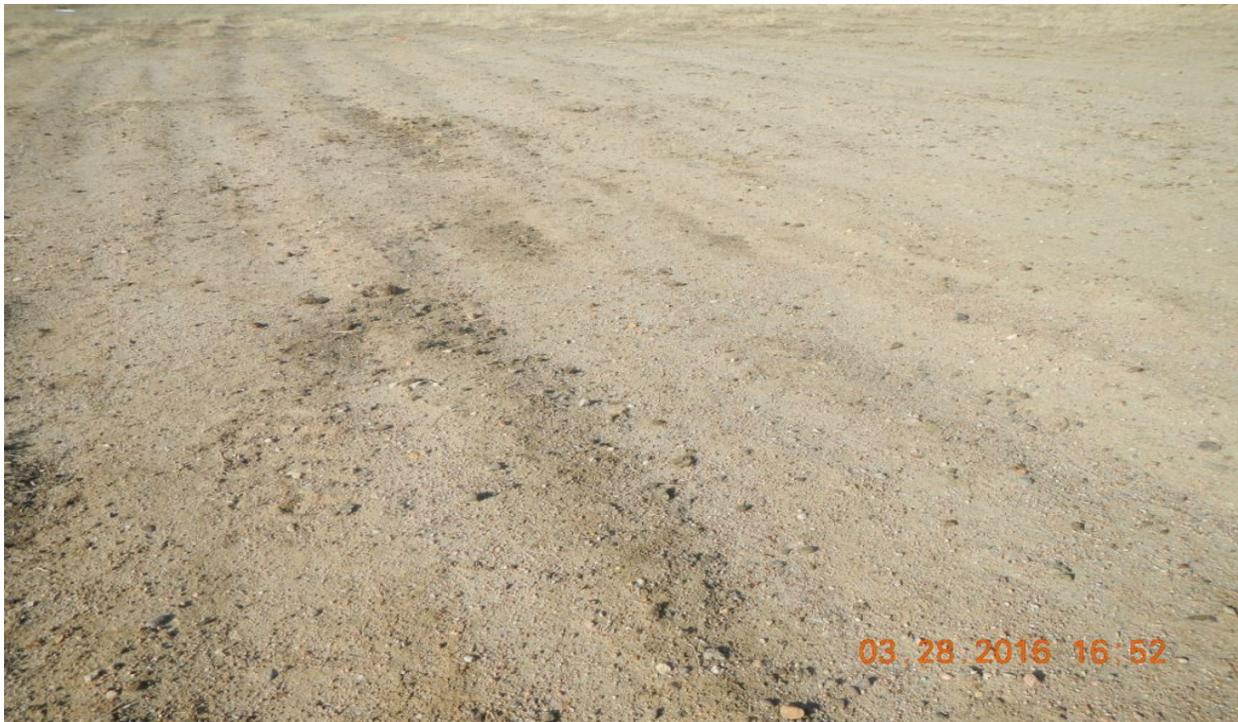
photo 16: Center of the location facing northeast. Did not notice vegetation germination in this area.

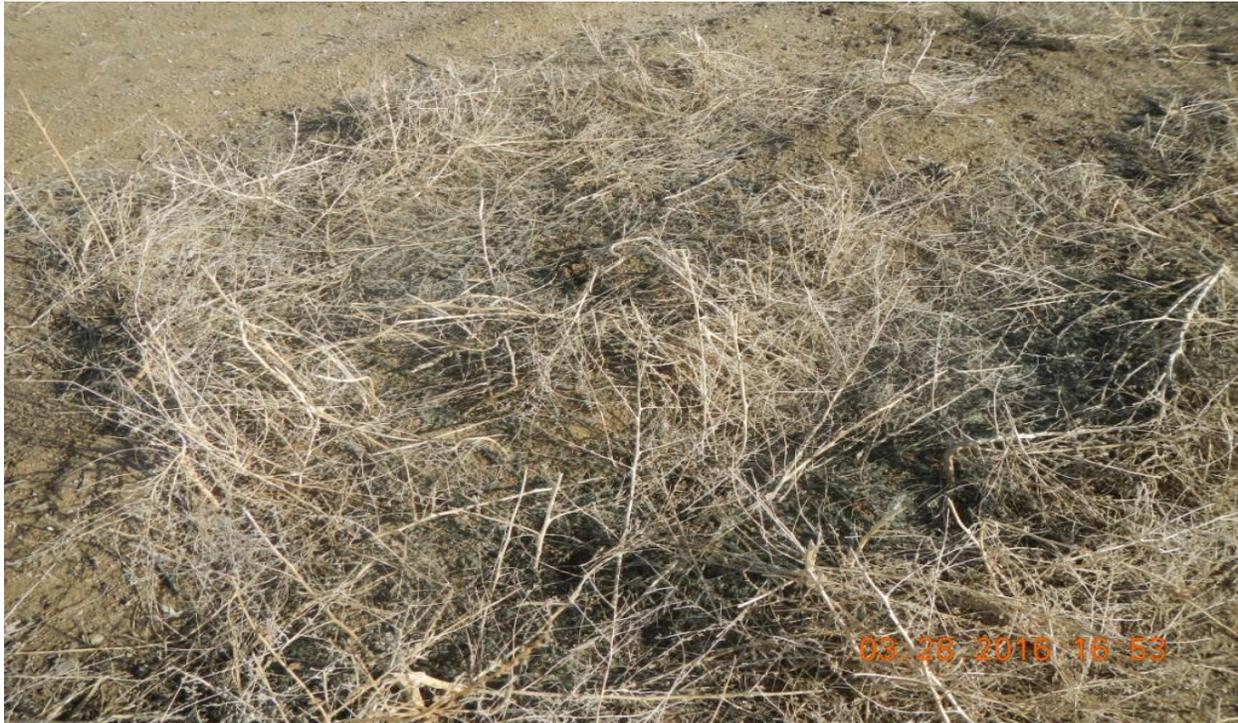
photo 17: Noticed weed debris (Kochia) with Kochia beginning to germinate under this debris.

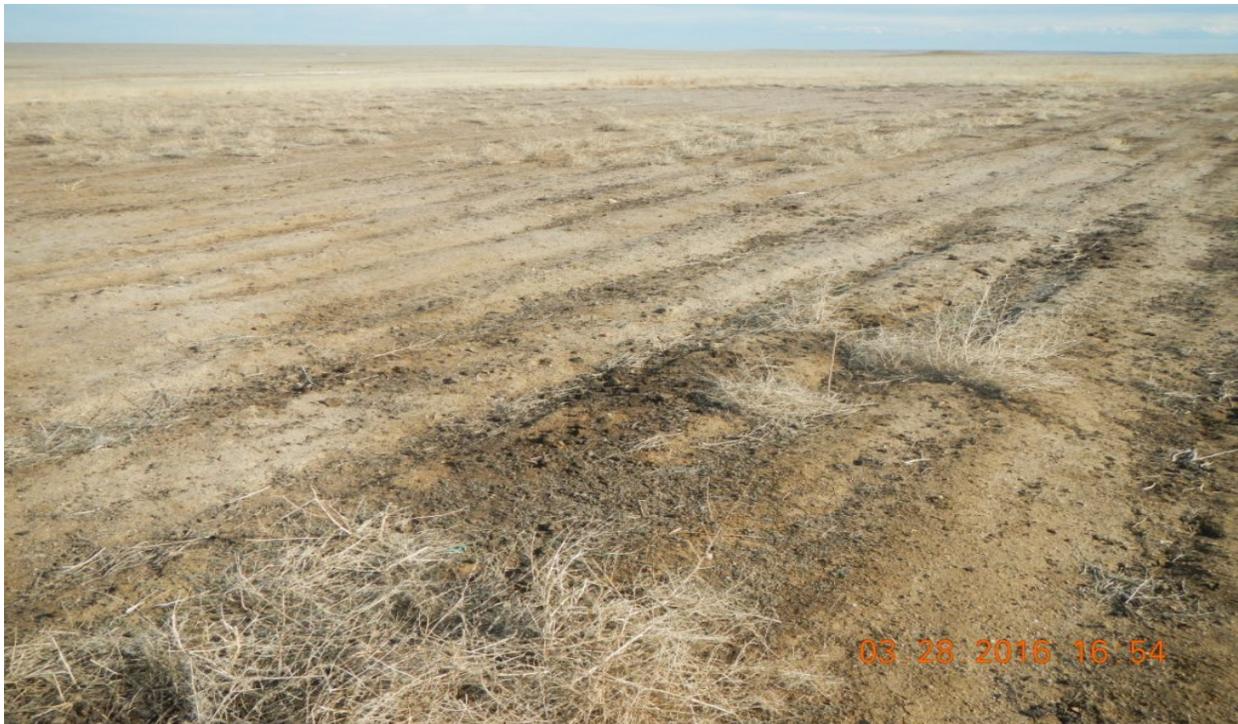
photo 18: Northwest corner of the location facing southeast toward the location.

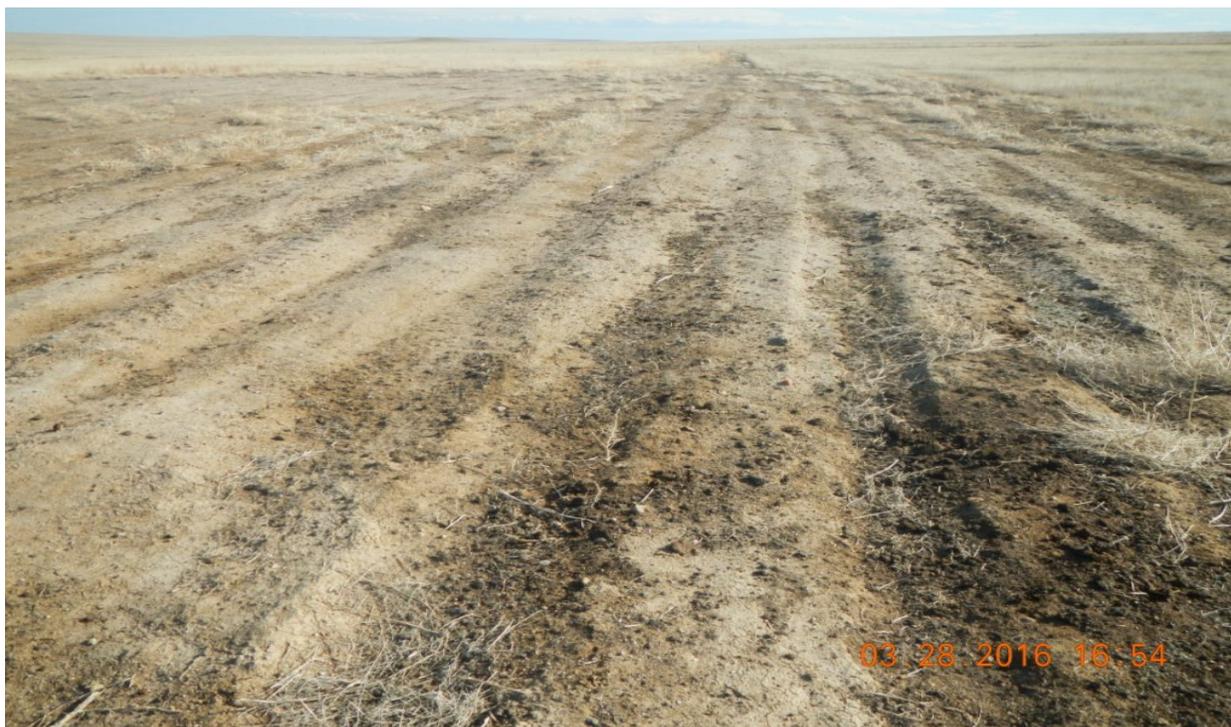
photo 19: Northwest corner of the location facing south toward the location.

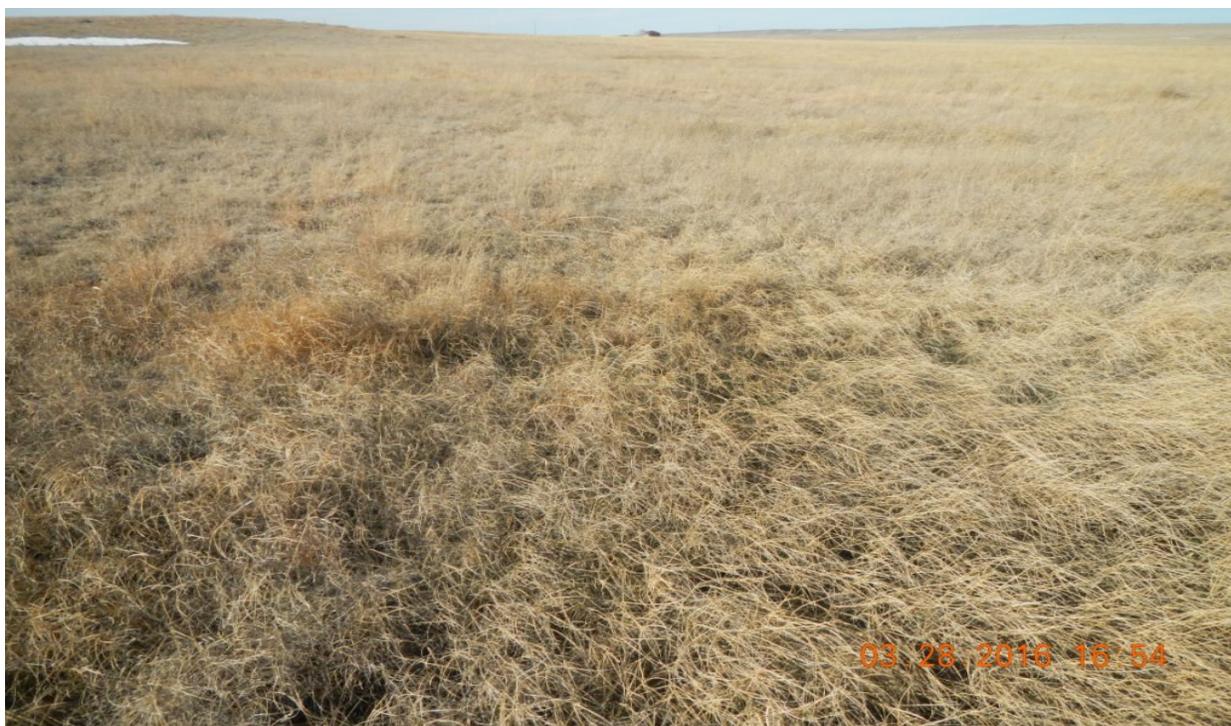
photo 20: Facing north toward the surrounding undisturbed pasture.
