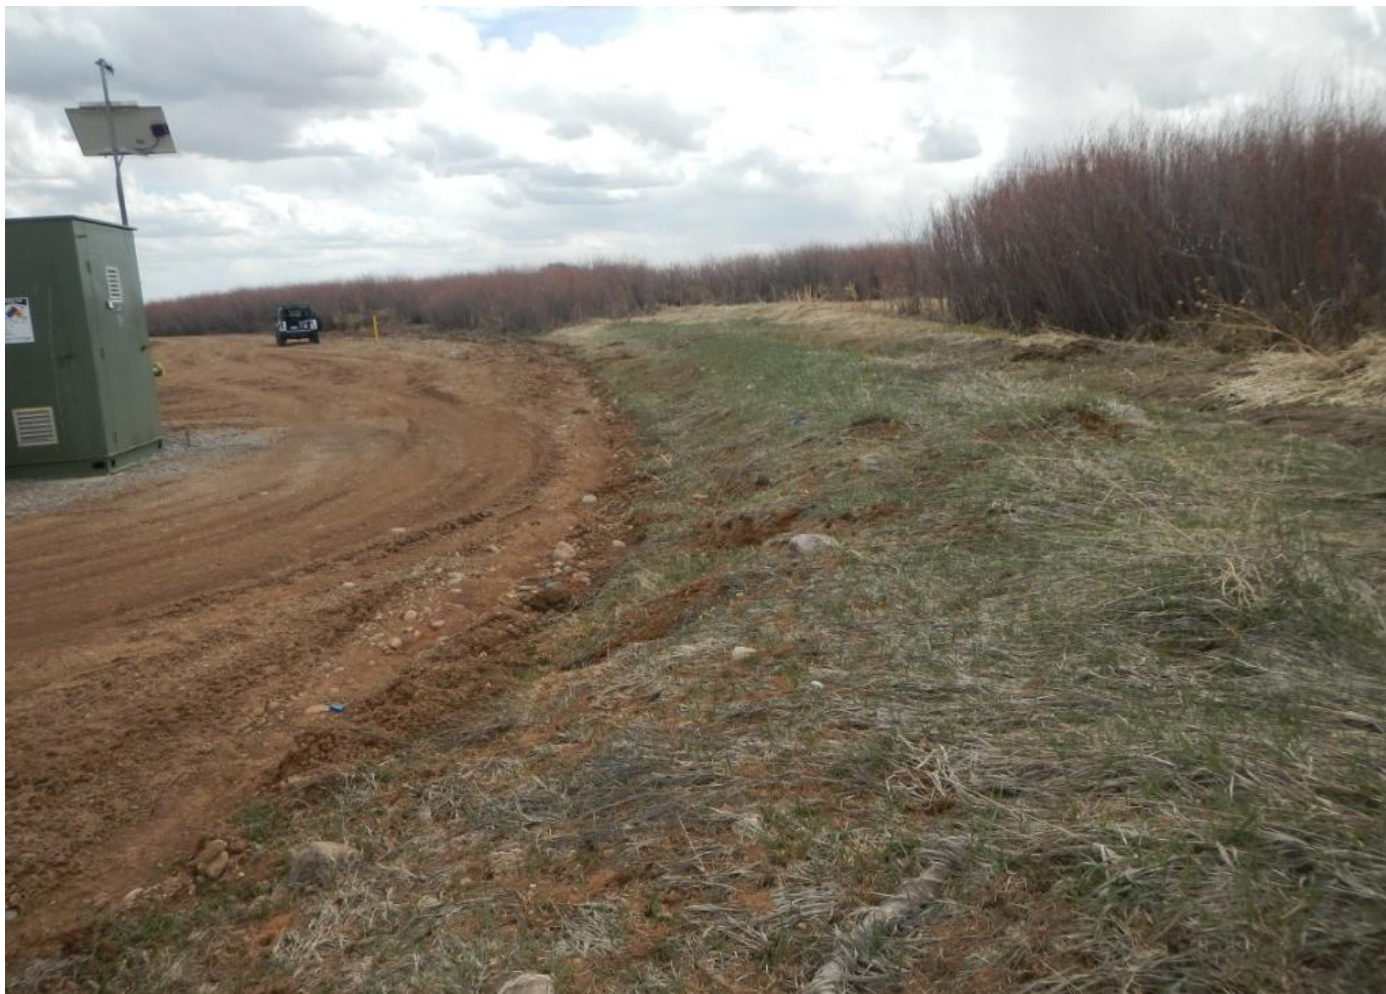
Photo 1. View of the western portion of the project area from the northwestern corner facing southward. An irrigation ditch runs adjacent to the western edge. Revegetation is largely comprised of soft brome (*Bromus inermis*).

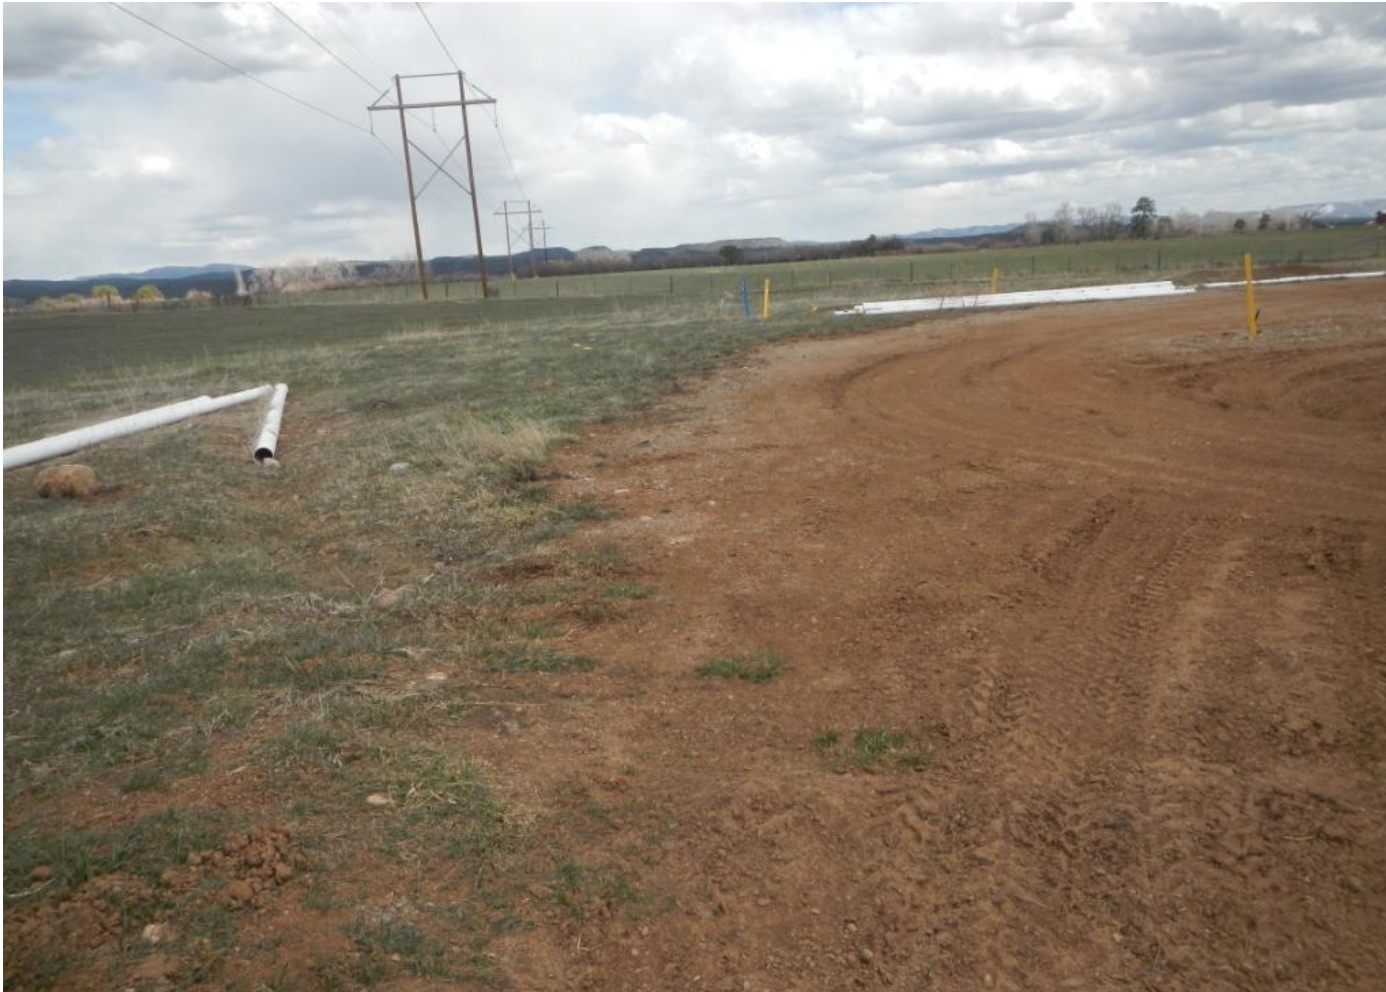
Photo 3. View of the northern portion of the project area from the northwestern corner facing eastward. Irrigation pipe is being stored in the northern and eastern portions of the interim reclamation area.
