Construction Inspection

4/8/2016

Operator: True Oil LLC

Location ID: 445216

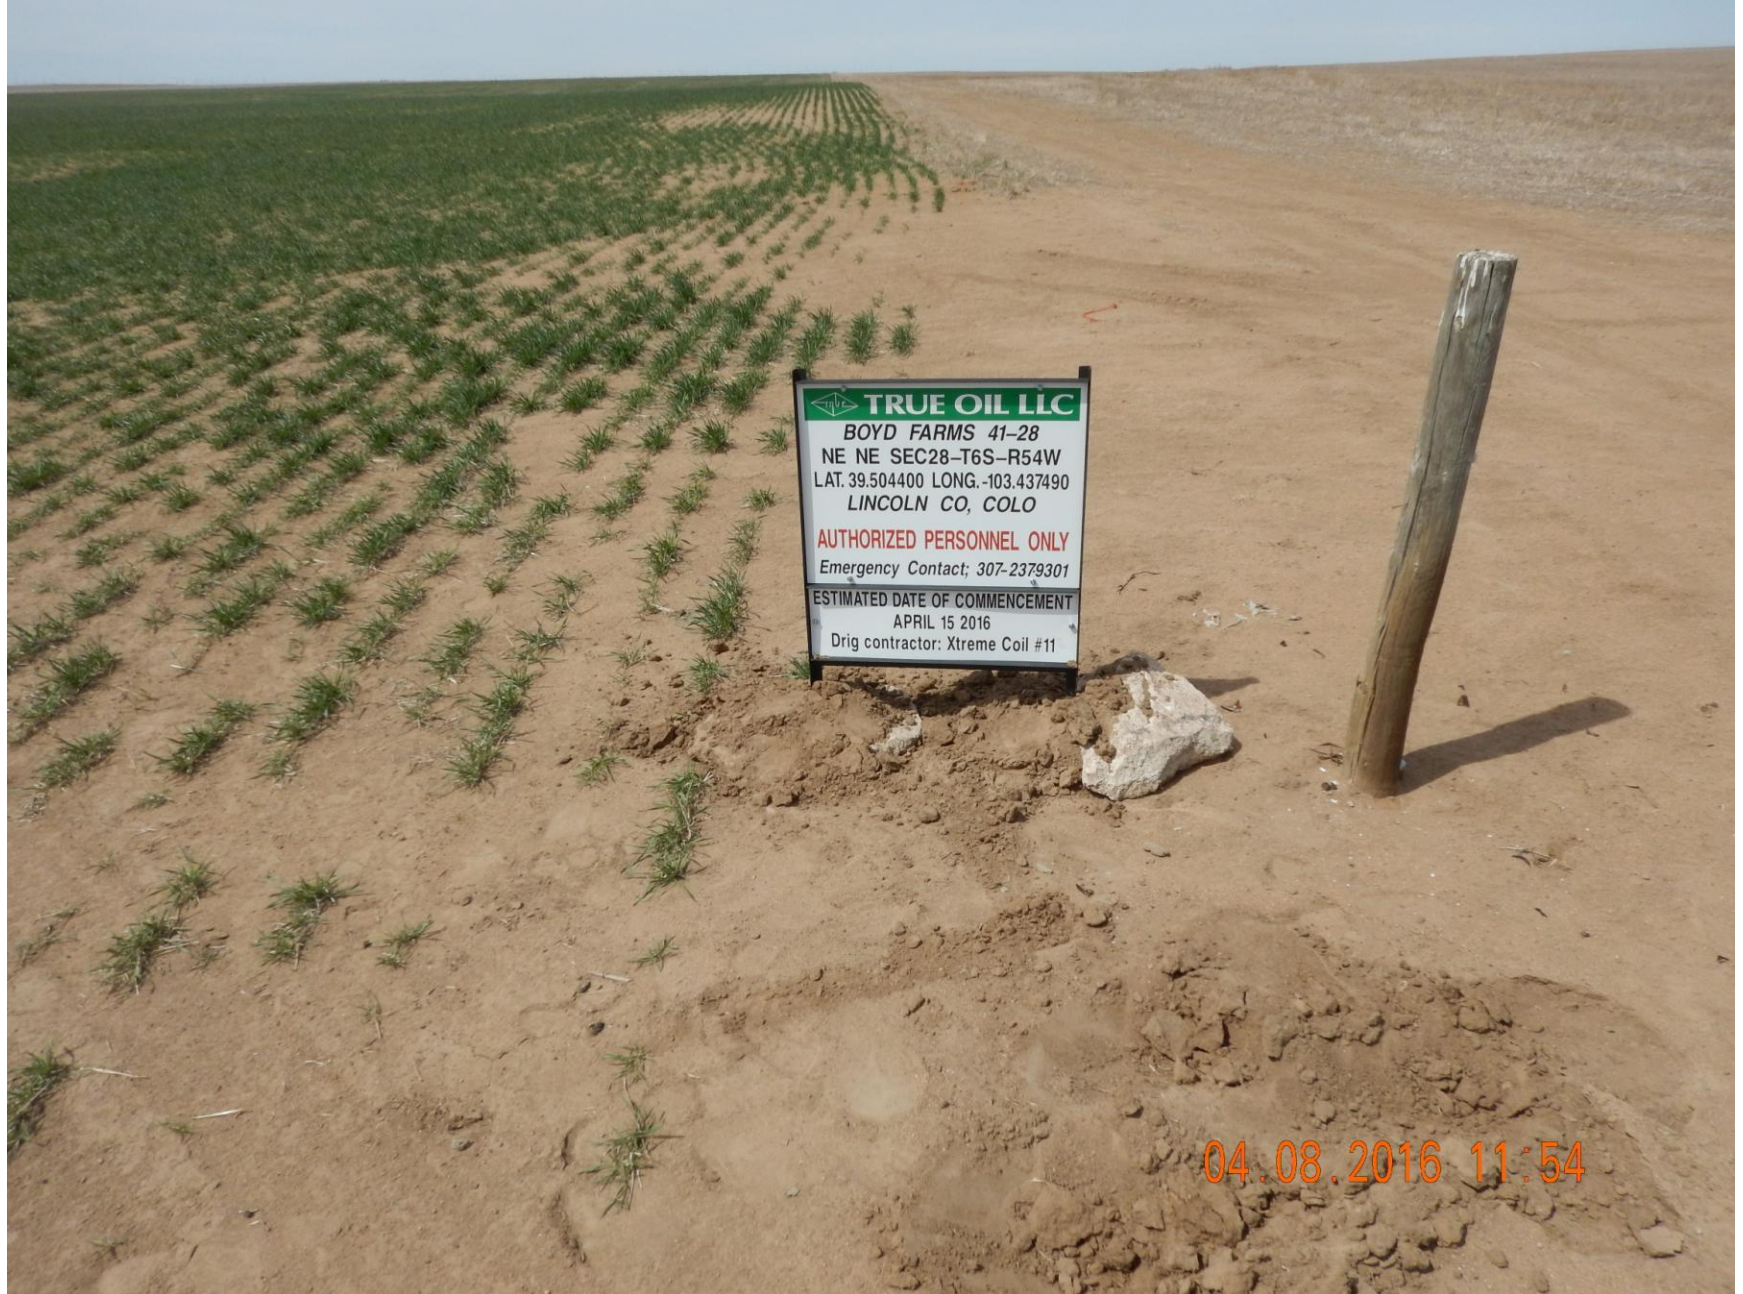
Figure 1: Photo taken northeast of the location on access road. Photo shows location sign.

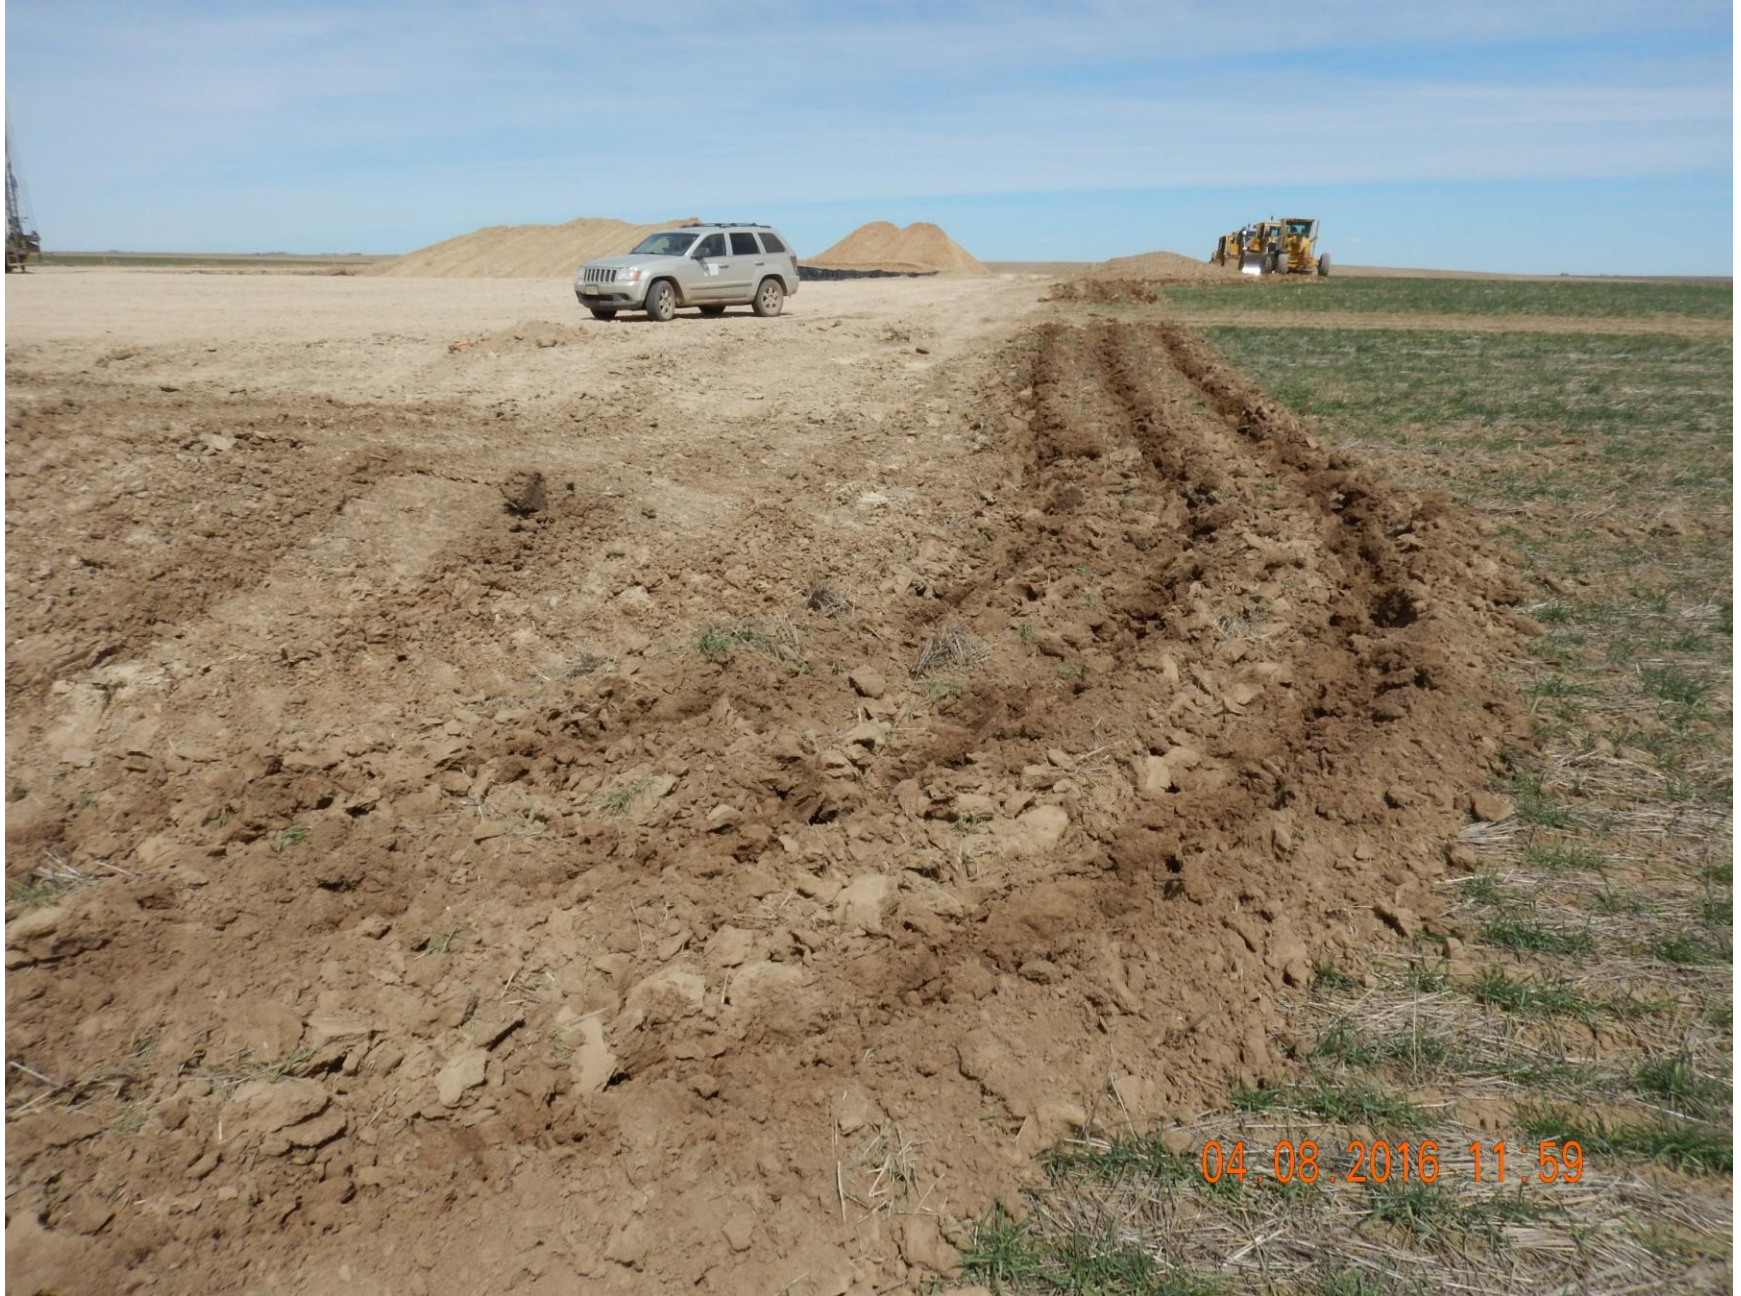
Figure 2: Photo taken from the southeast corner of the location, facing north. Photo shows Ditch/Berm /Surface roughening stormwater and sediment control BMP along the eastern perimeter.

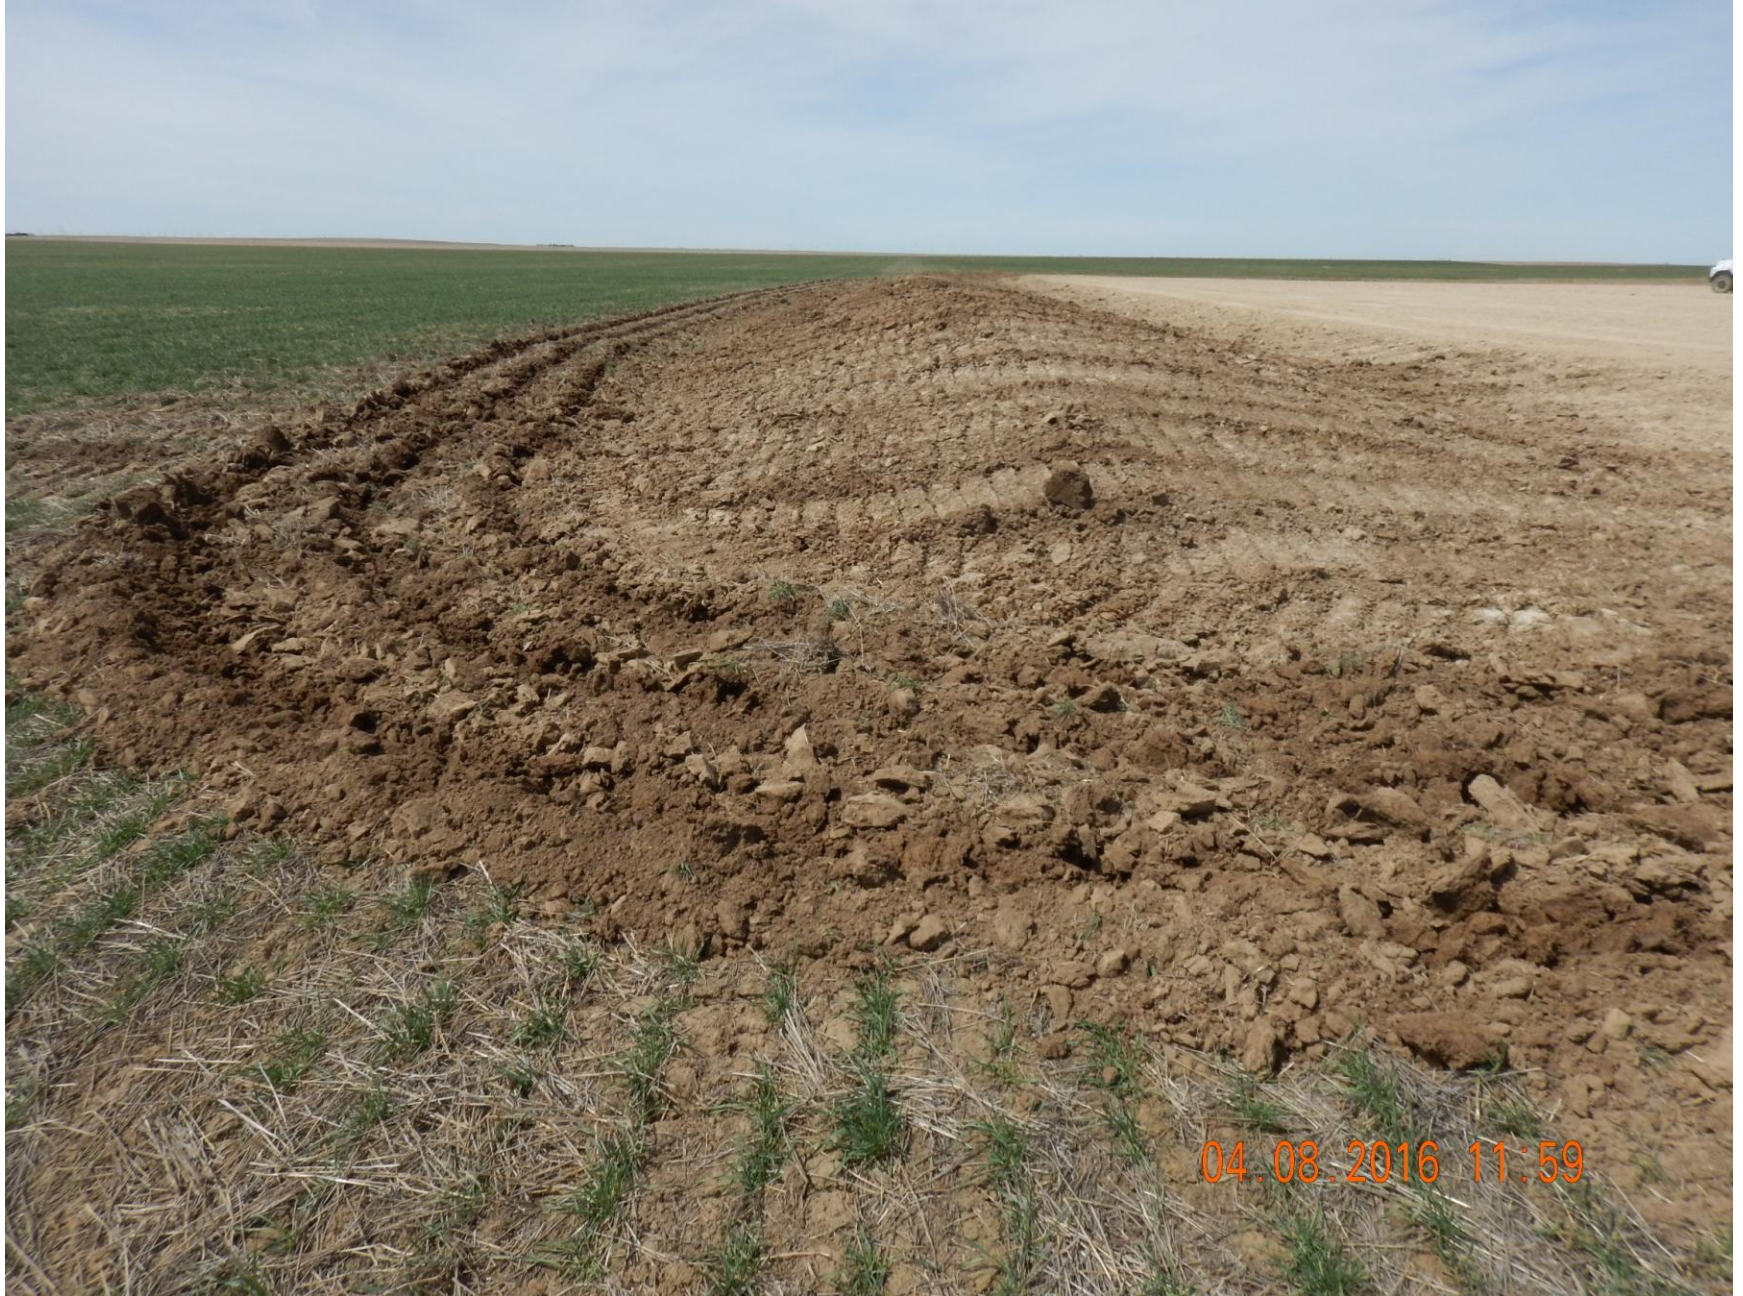
Figure 3: Photo taken from the southeast corner of the location, facing west. Photo shows Ditch/Berm /Surface roughening stormwater and sediment control BMP along the southern perimeter.

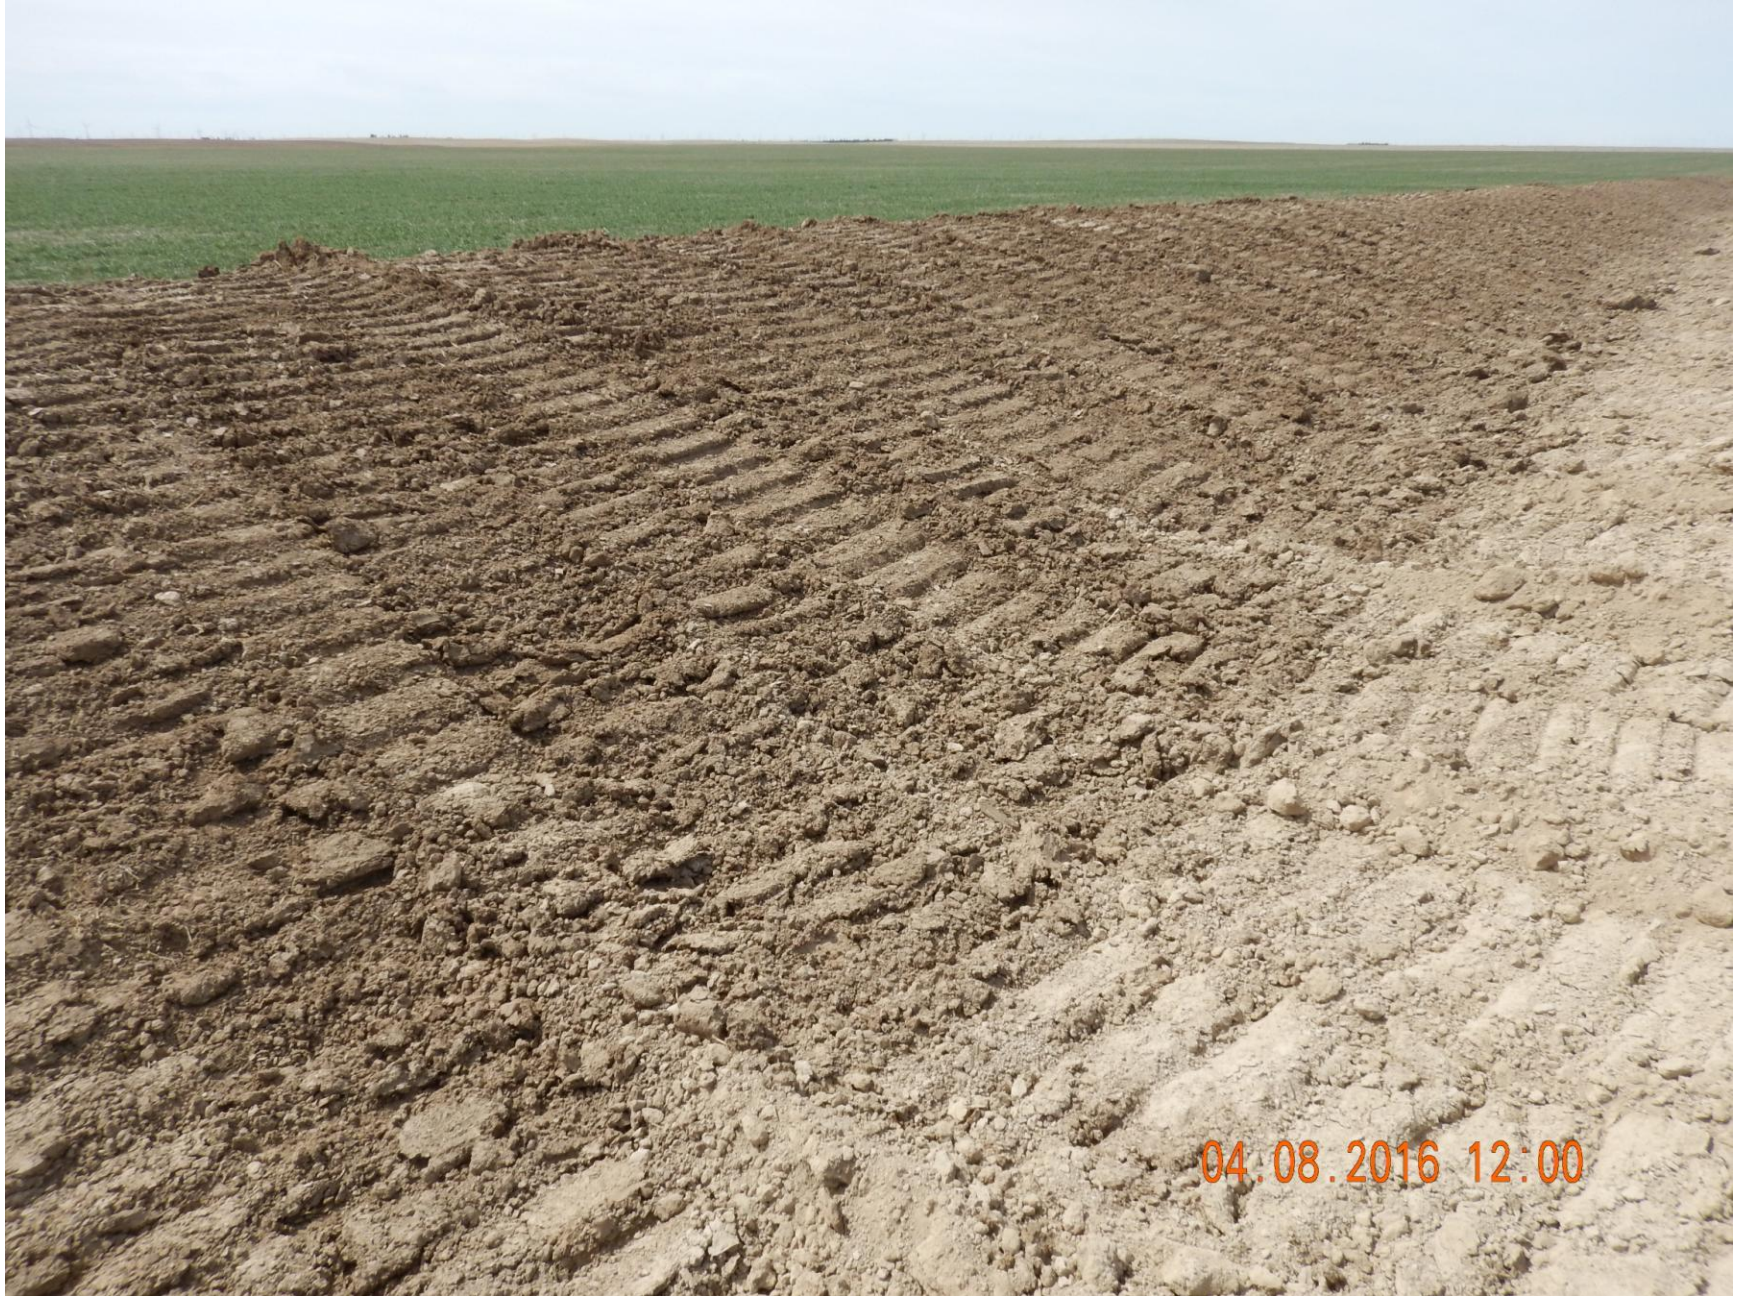
Figure 4: Photo taken from the south end of the location. Photo shows tracking BMP along topsoil ditch/berm.

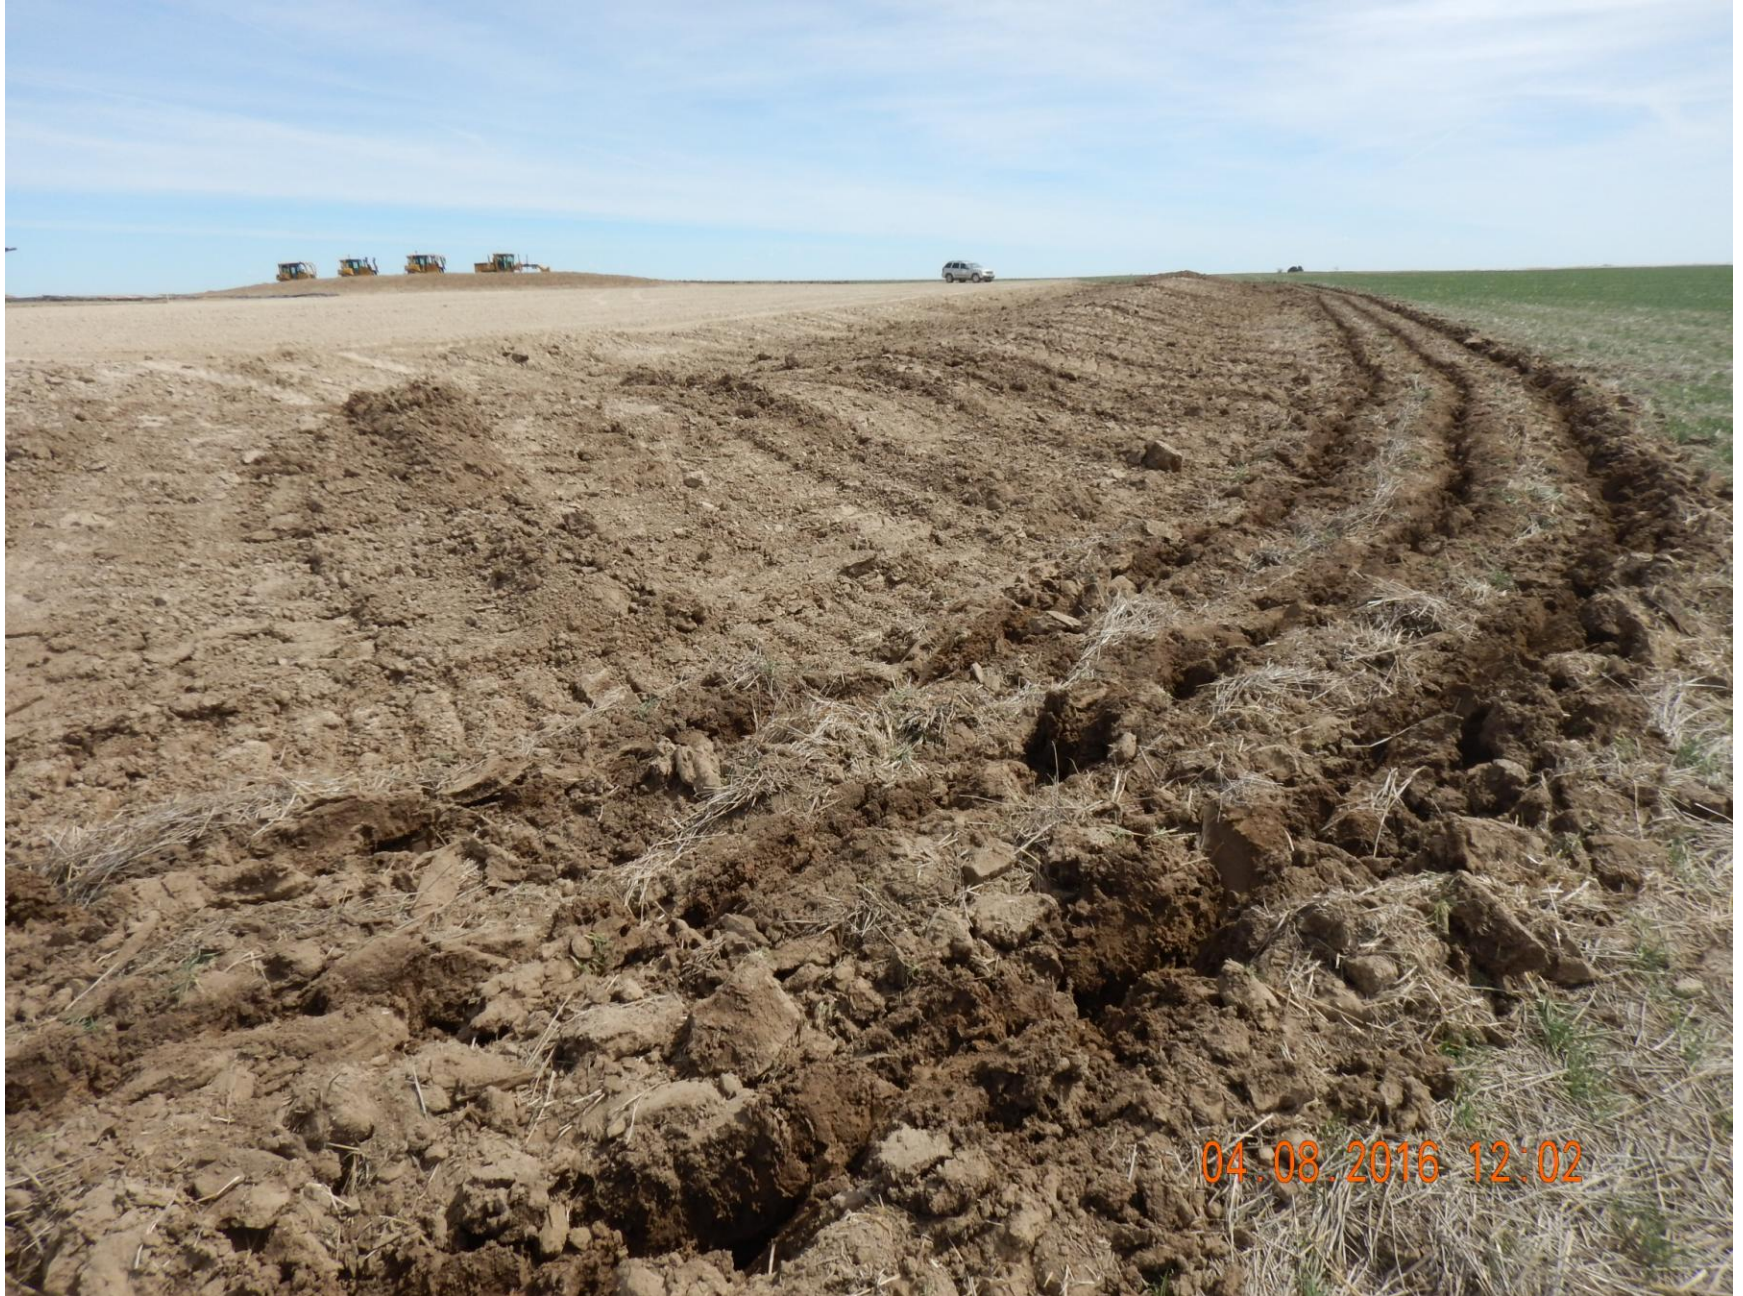
Figure 5: Photo taken from the southwest corner of the location, facing east. Photo shows Ditch/Berm /Surface roughening stormwater and sediment control BMP along the southern perimeter..

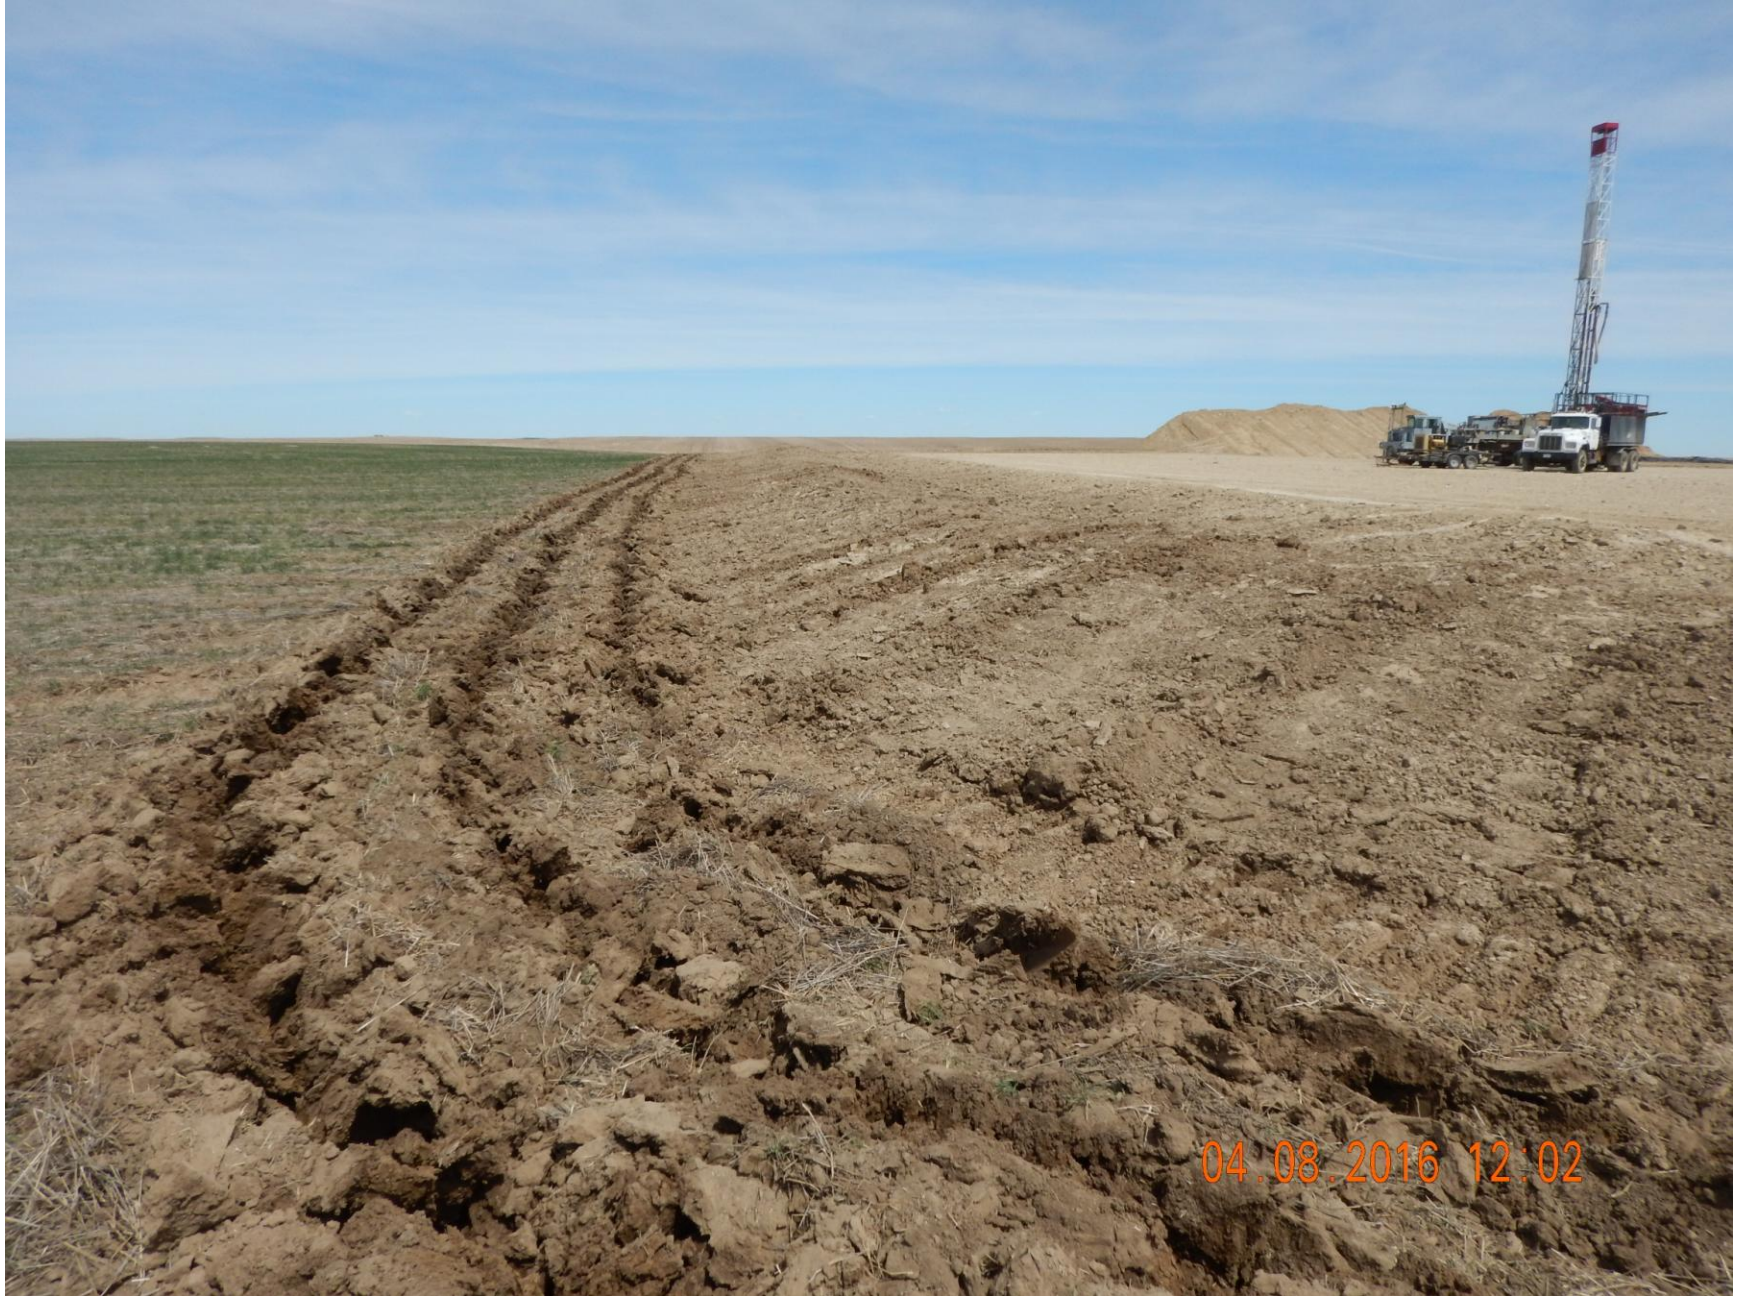
Figure 6: Photo taken from the southwest corner of the location, facing north. Photo shows Ditch/Berm /Surface roughening stormwater and sediment control BMP along the western perimeter.

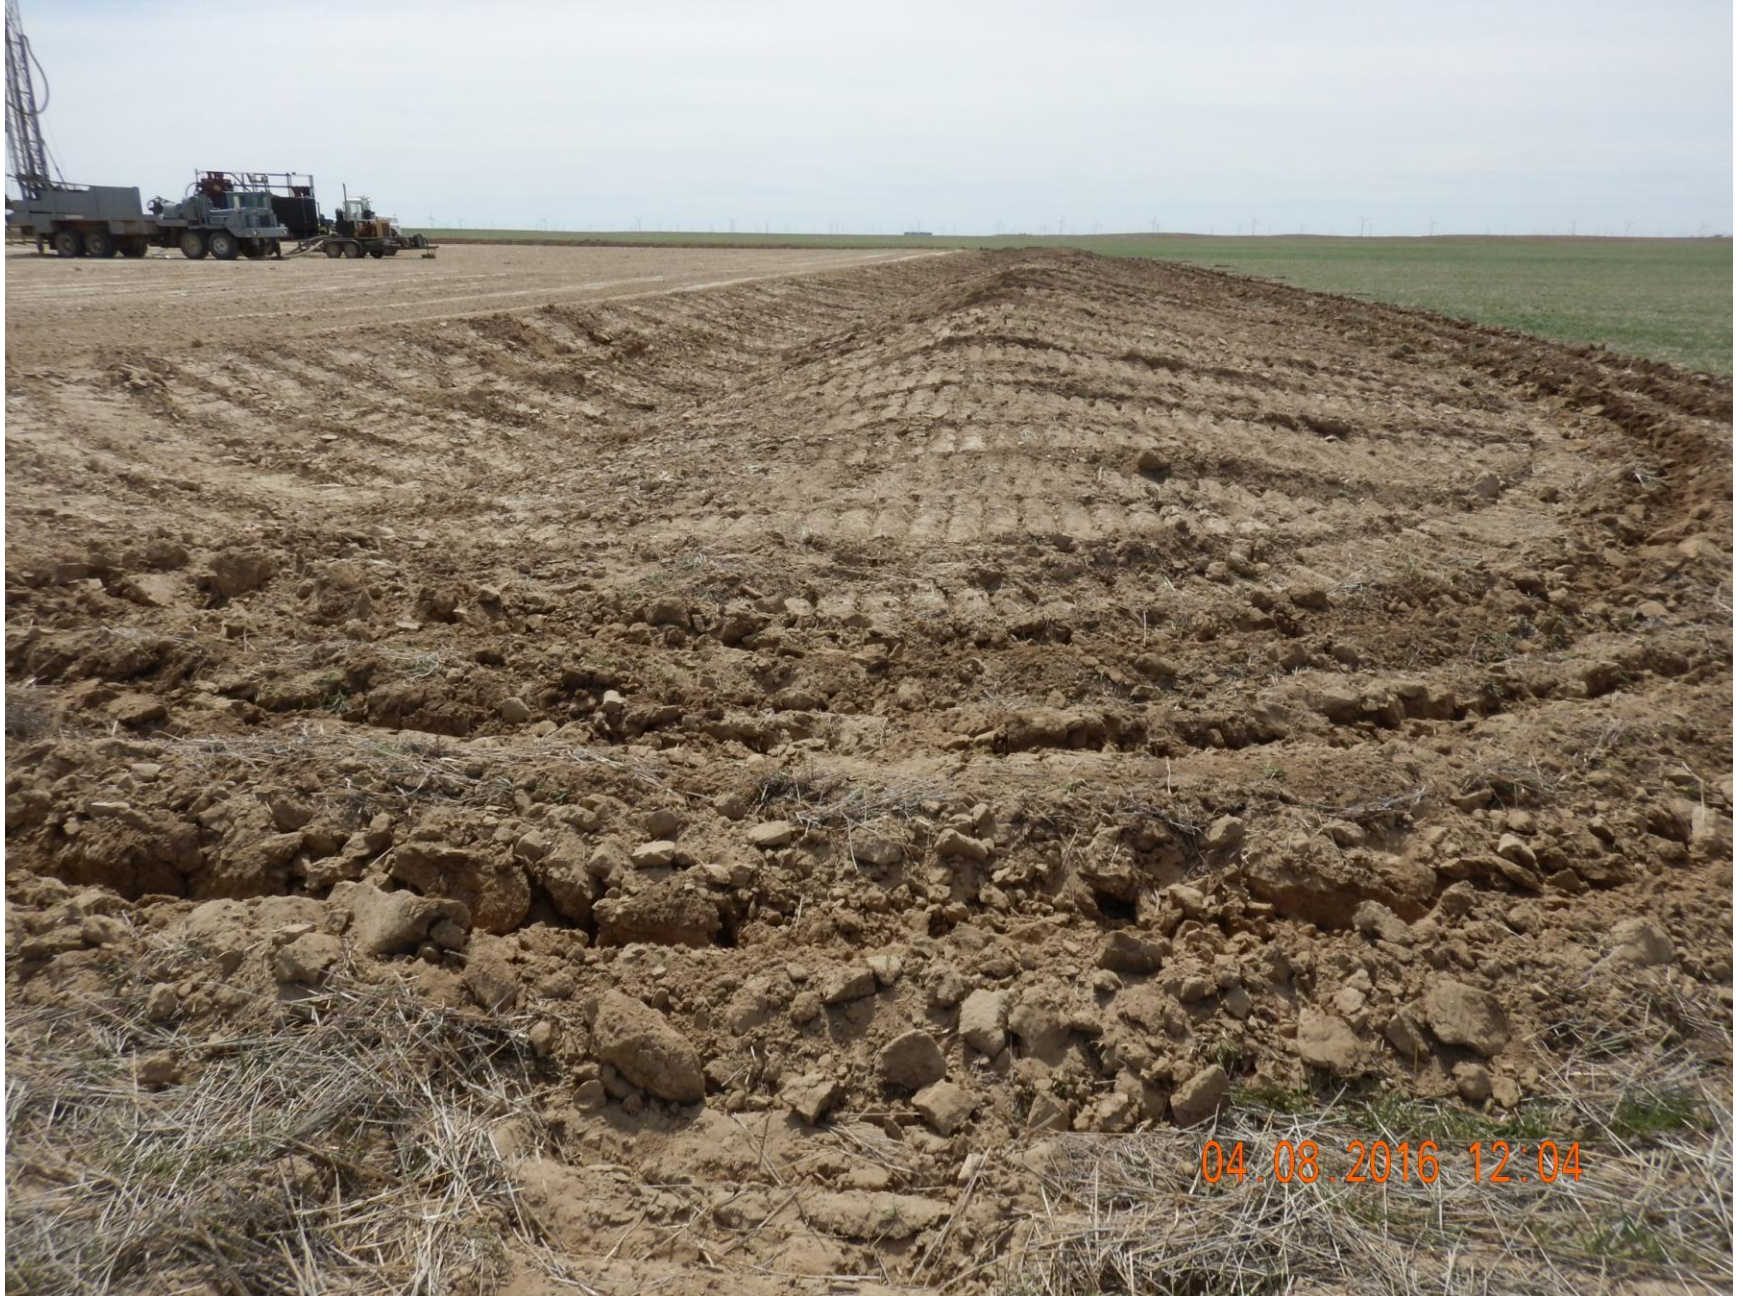
Figure 7: Photo taken from the northwest corner of the location, facing south. Photo shows Ditch/Berm/Surface roughening stormwater and sediment control BMP along the western perimeter.

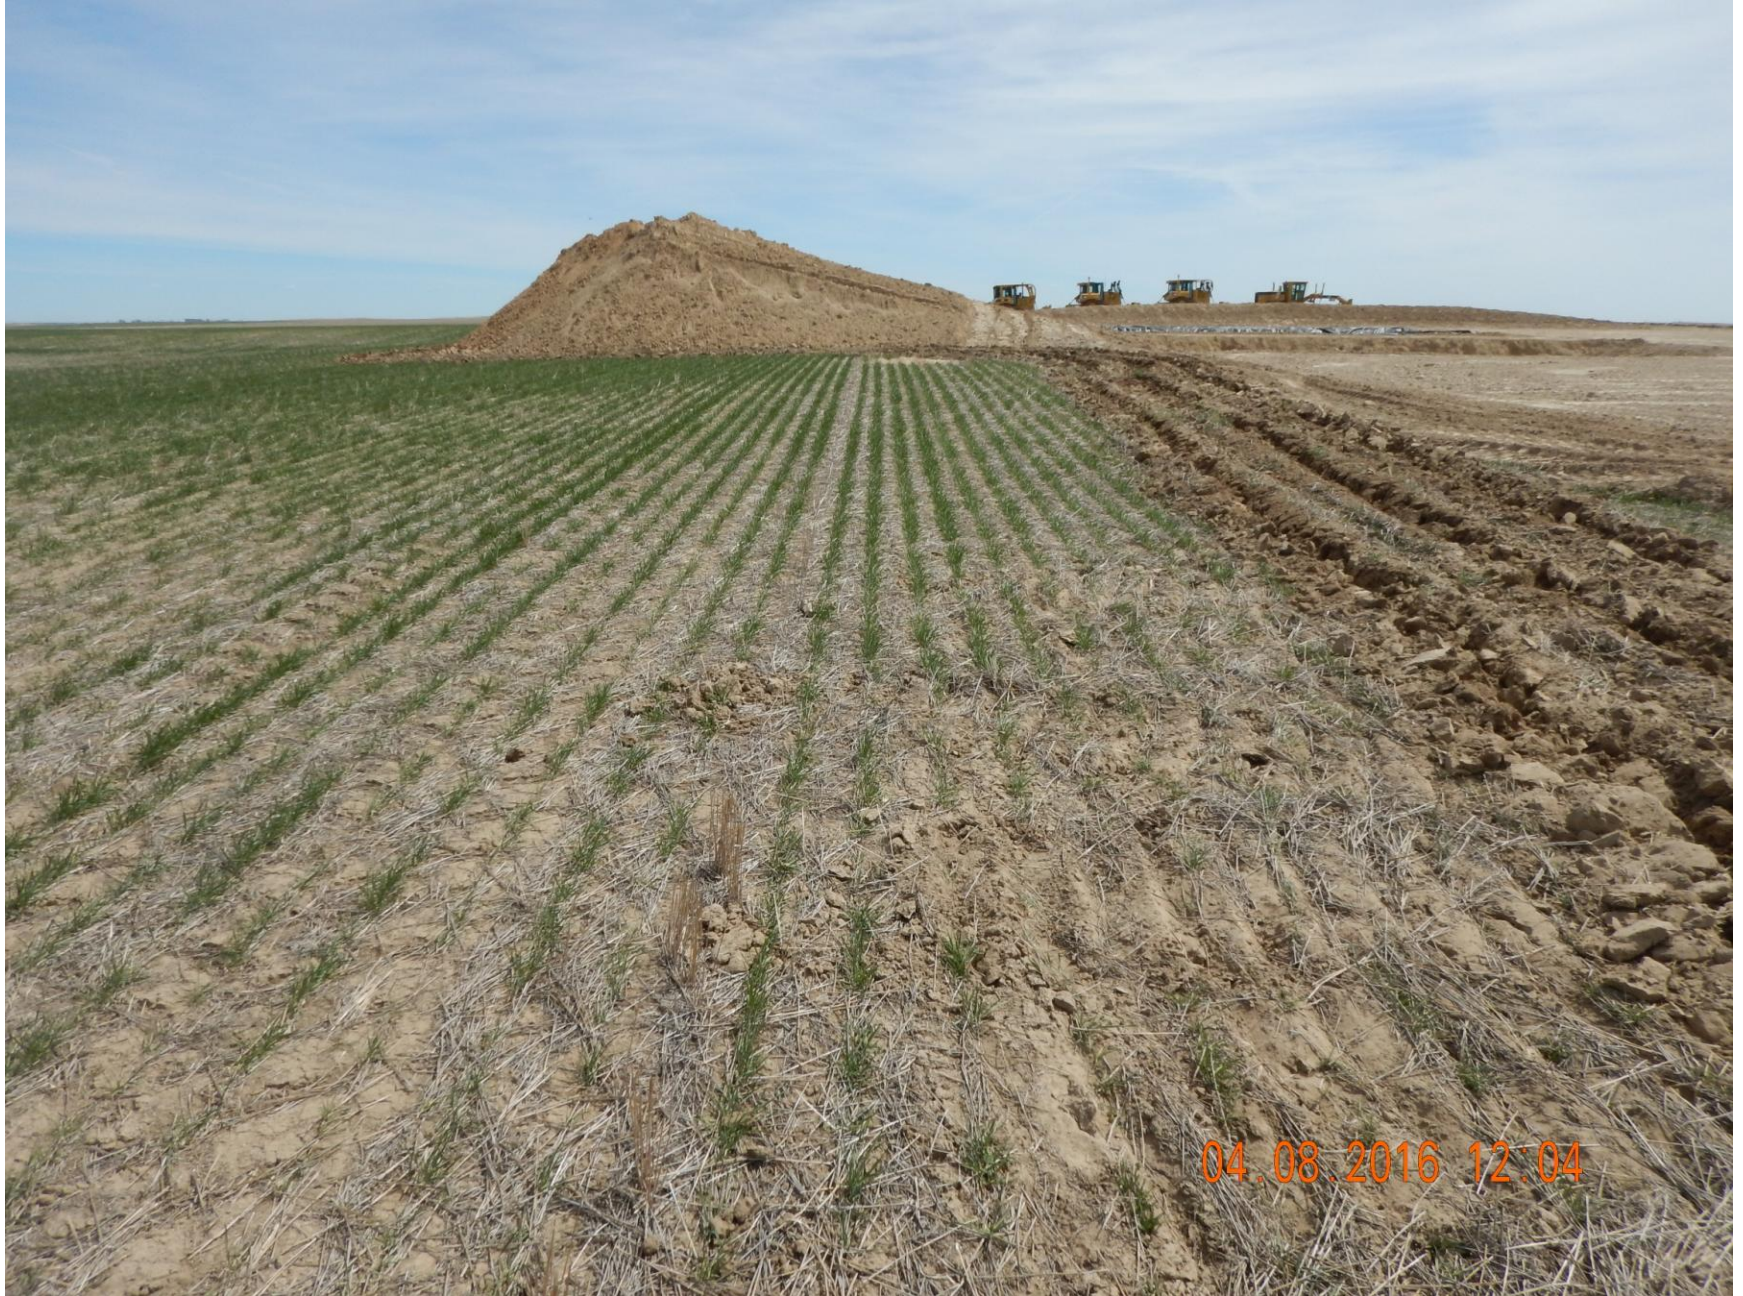
Figure 8: Photo taken from the northwest corner of the location, facing east. Photo shows surface roughening as the sole stormwater and sediment control BMP along the northern perimeter.

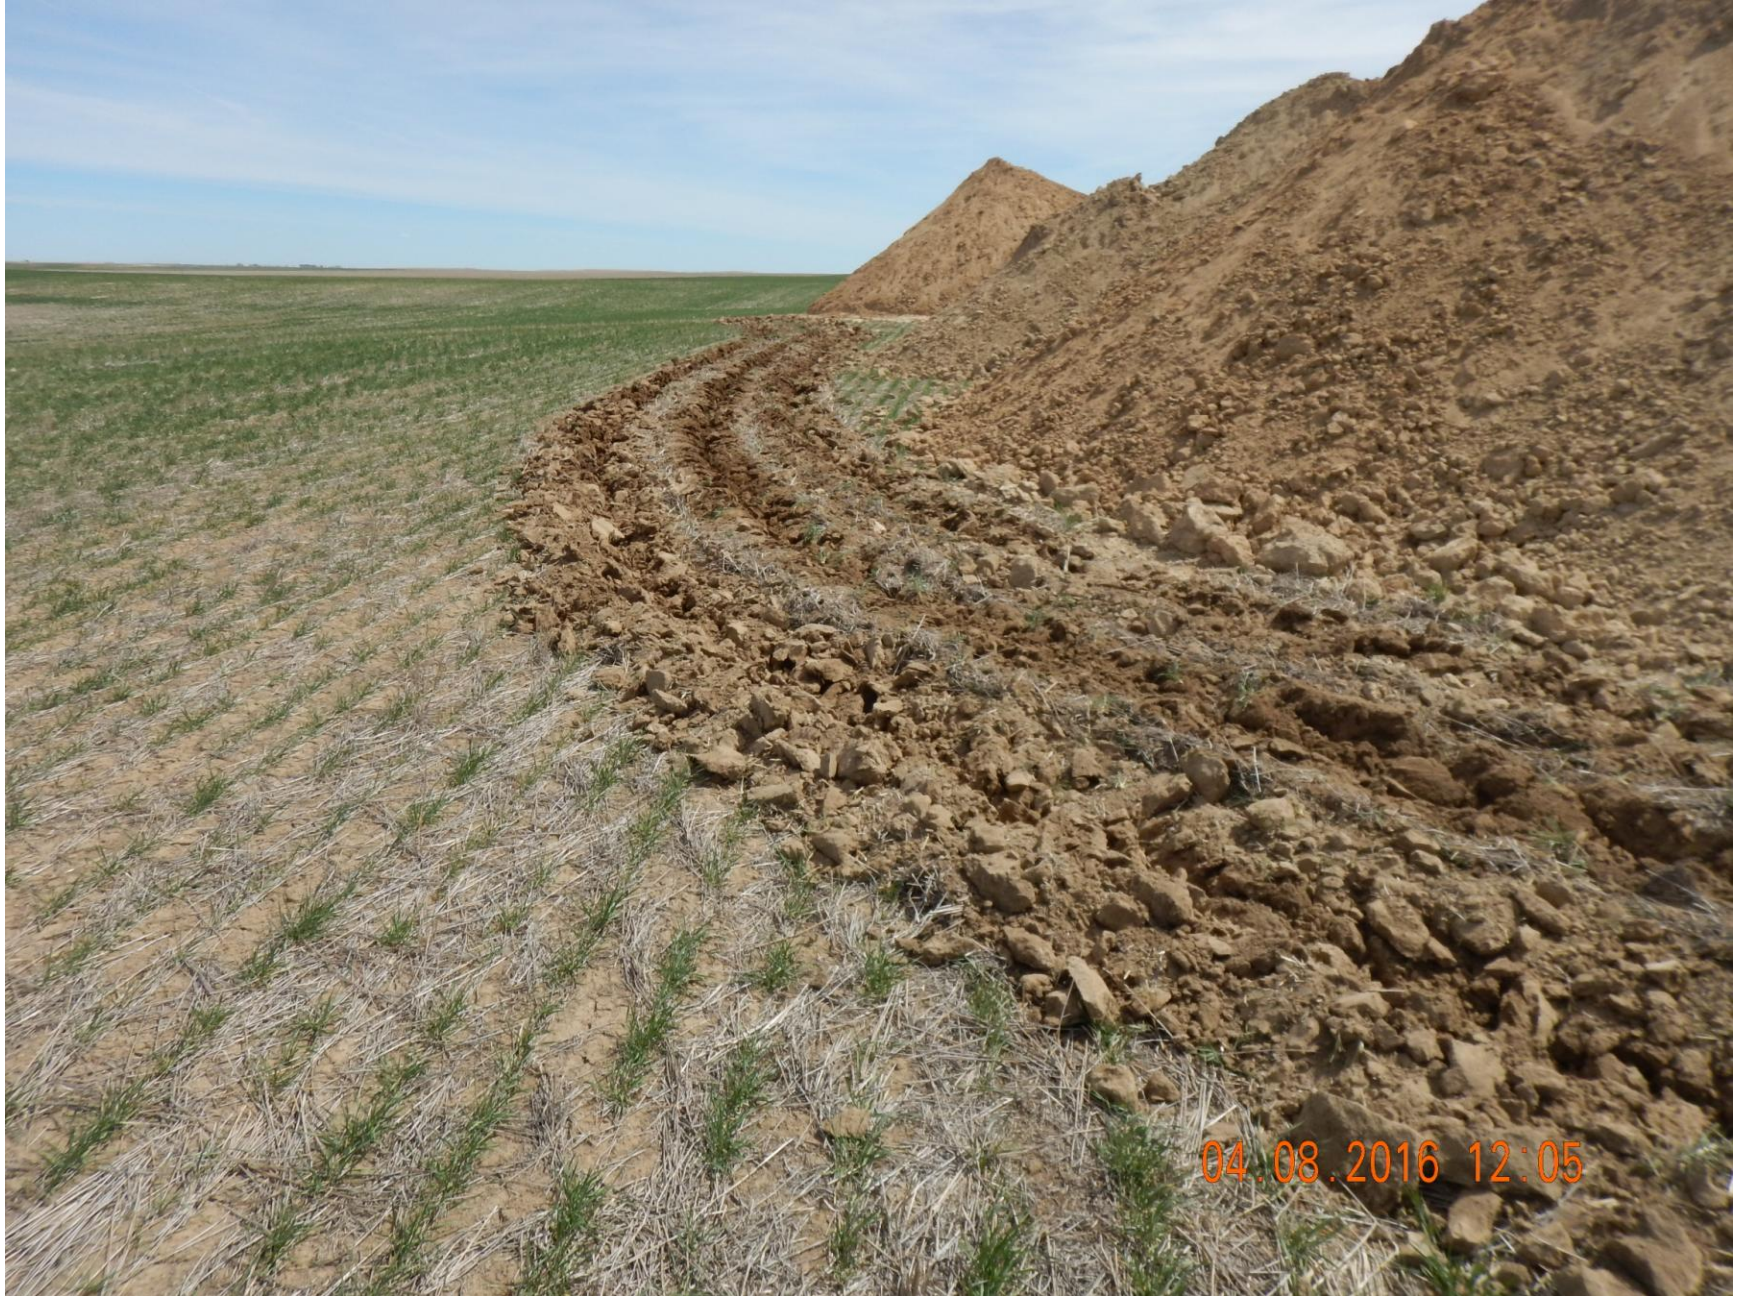
Figure 9: Photo taken from soil stockpile on the north end of the location, facing east. Photo shows surface roughening as the sole stormwater and sediment control BMP along soil stockpile and northern perimeter. Surface roughening should be used in conjunction with other BMPs such as silt fences, wattles, ditch/berm, etc....

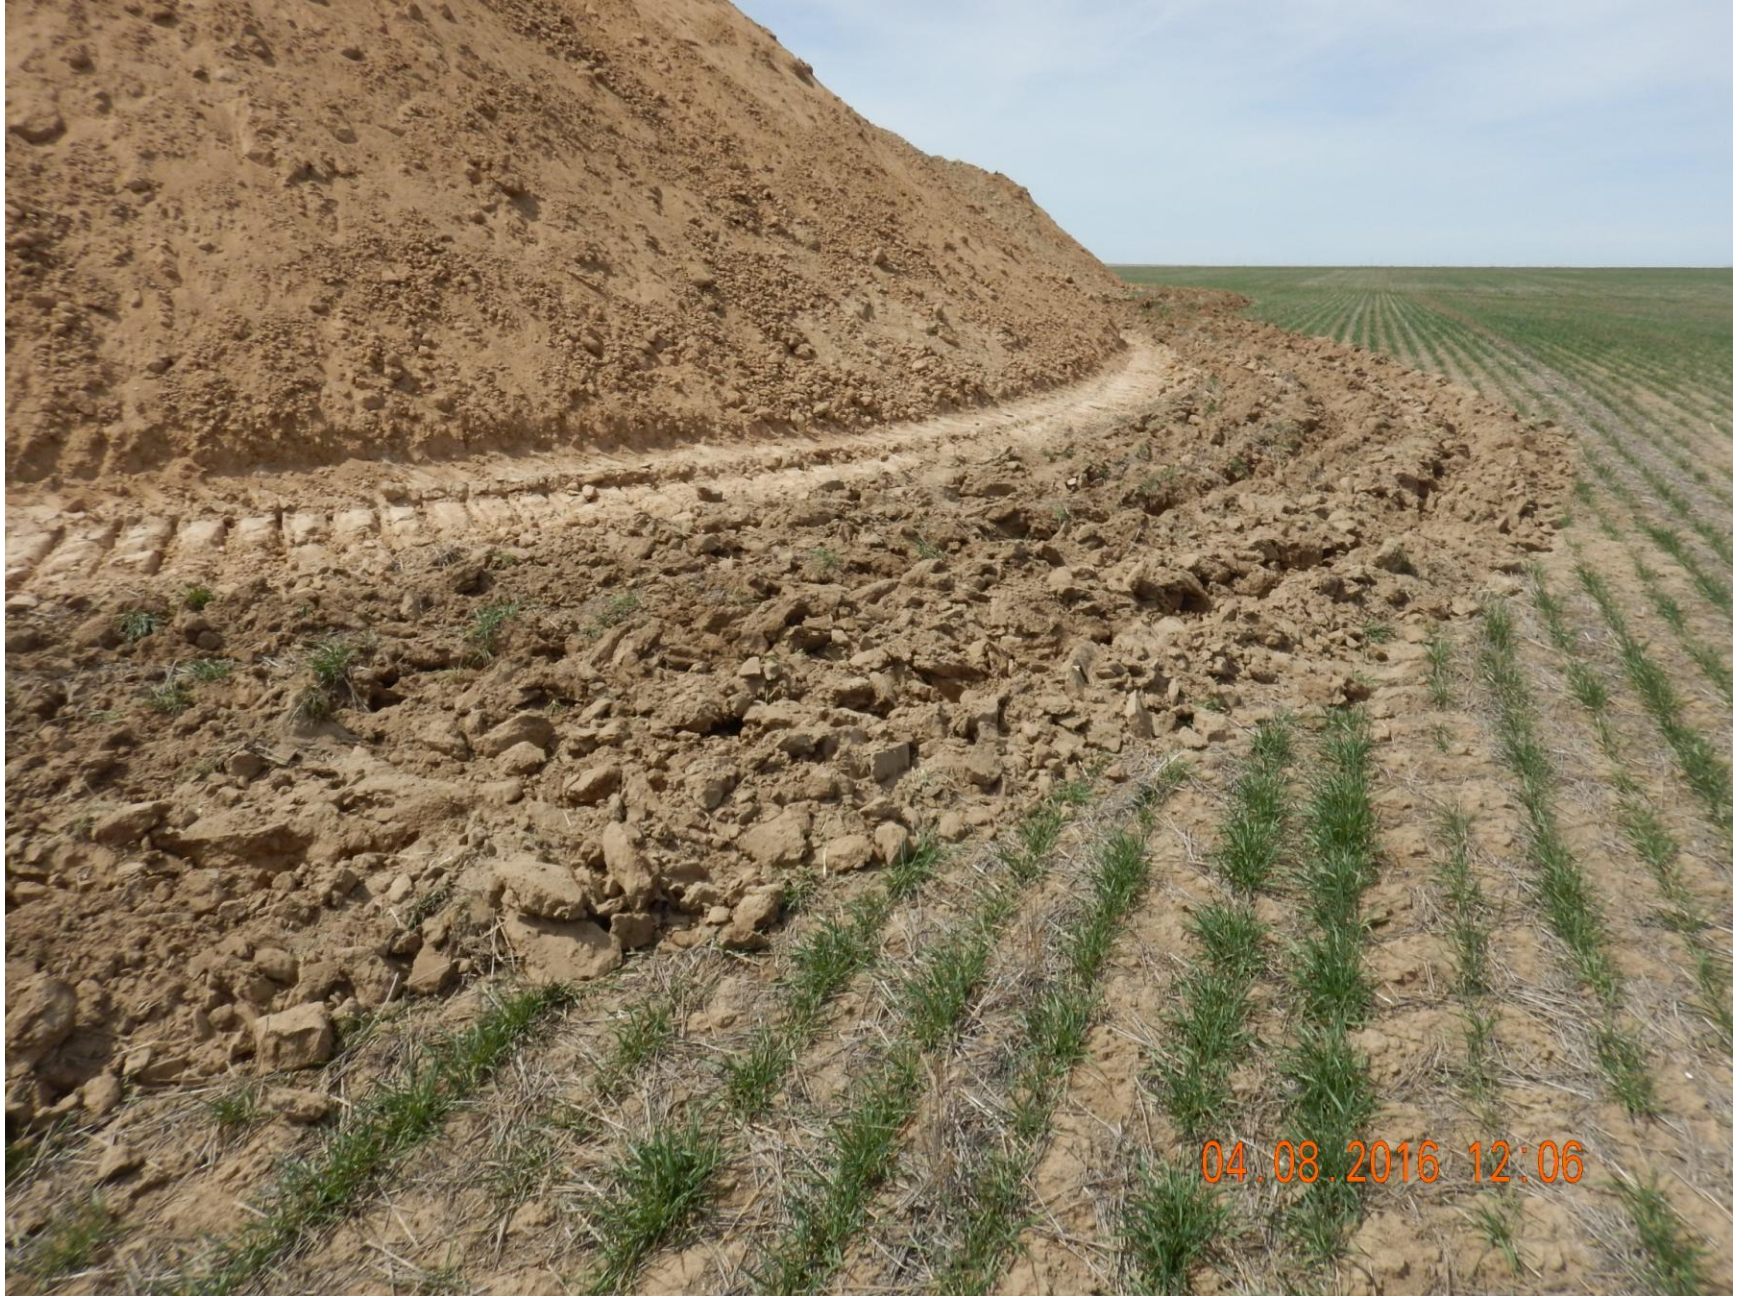
Figure 10: Photo taken from soil stockpile on the northeast end of the location, facing west. Photo shows surface roughening as the sole stormwater and sediment control BMP along soil stockpile and northern perimeter. Surface roughening should be used in conjunction with other BMPs such as silt fences, wattles, ditch/berm, etc....
