Construction Inspection

4/8/2016

Operator: True Oil LLC

Location ID: 445216

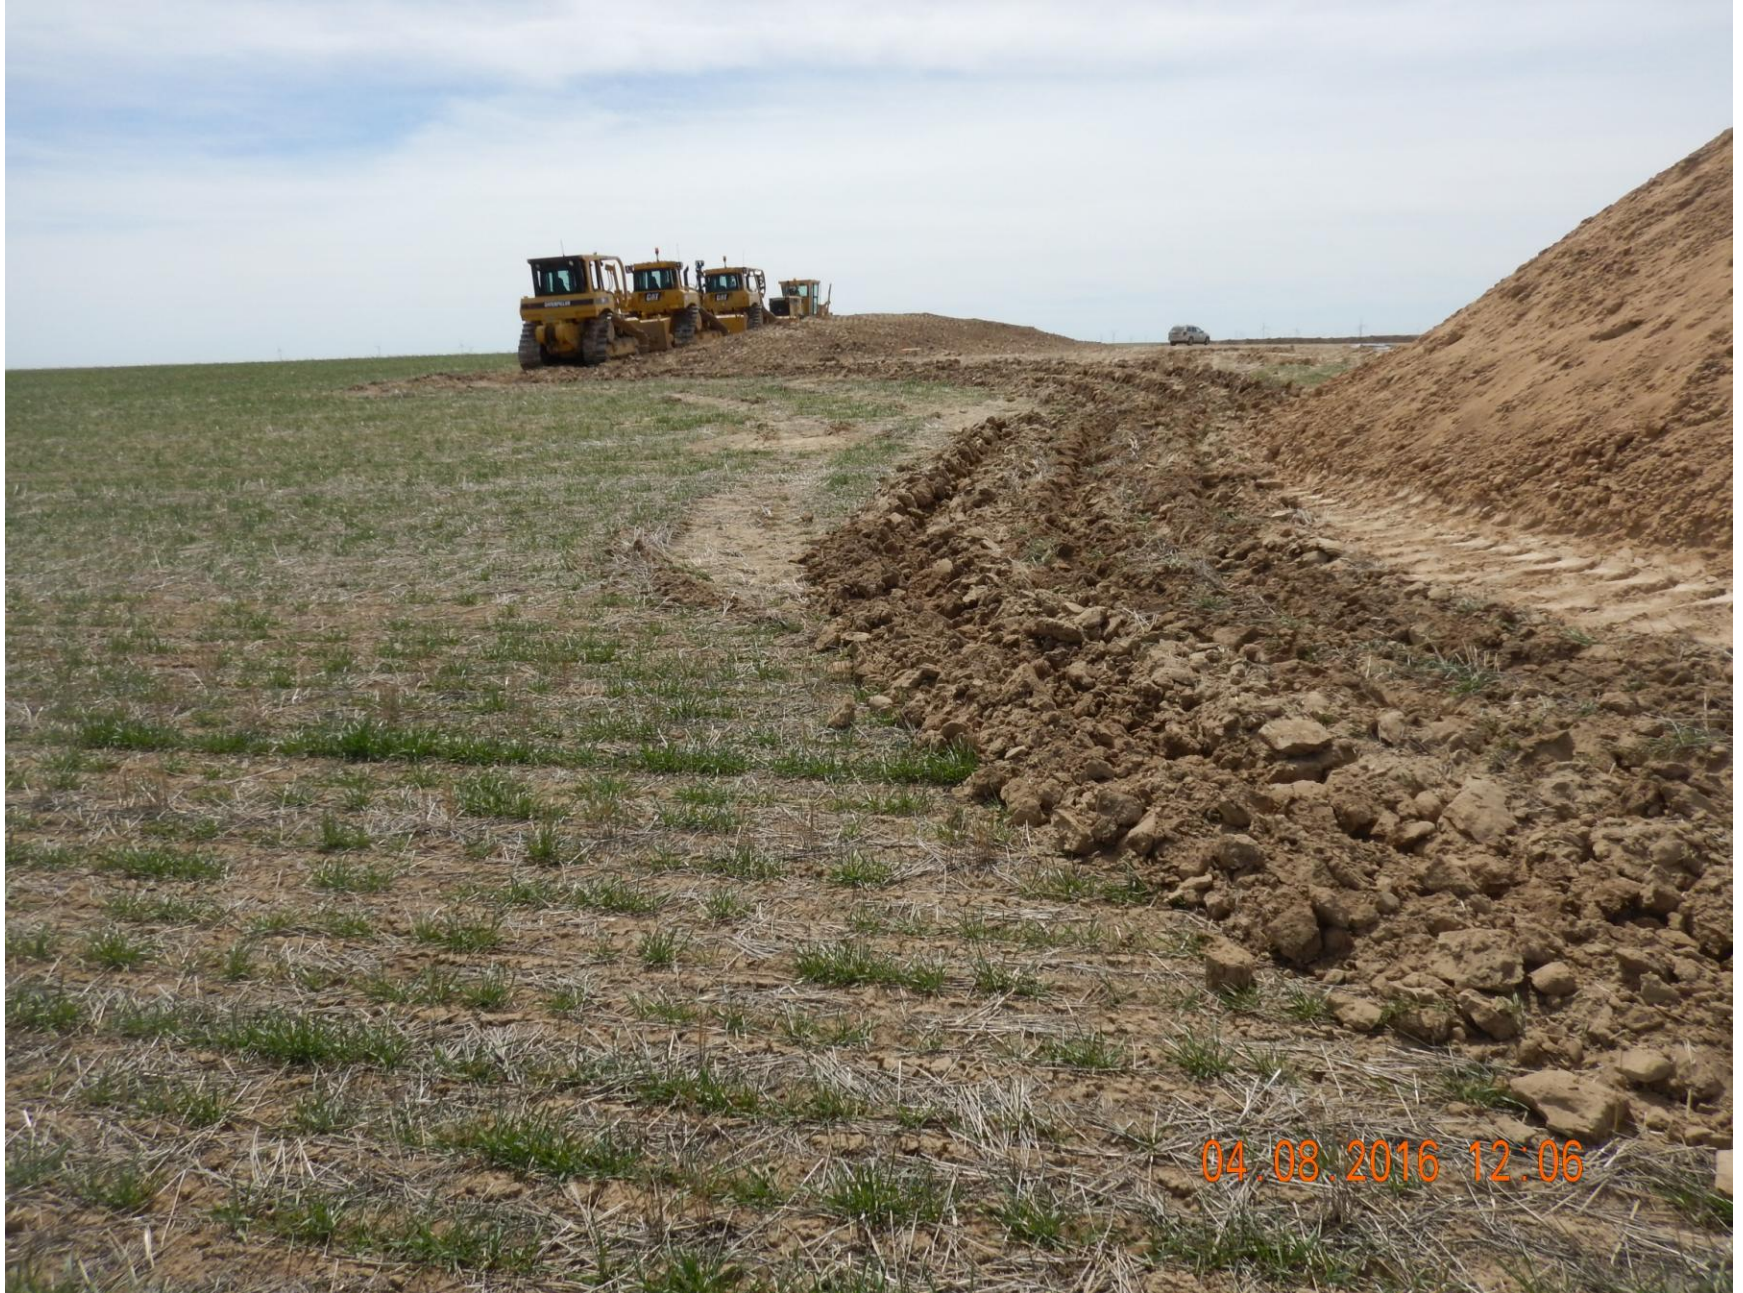
Figure 11: Photo taken from soil stockpile on the north end of the location, facing southeast. Photo shows surface roughening as the sole stormwater and sediment control BMP along soil stockpile. Surface roughening should be used in conjunction with other BMPs such as silt fences, wattles, ditch/berm, etc...

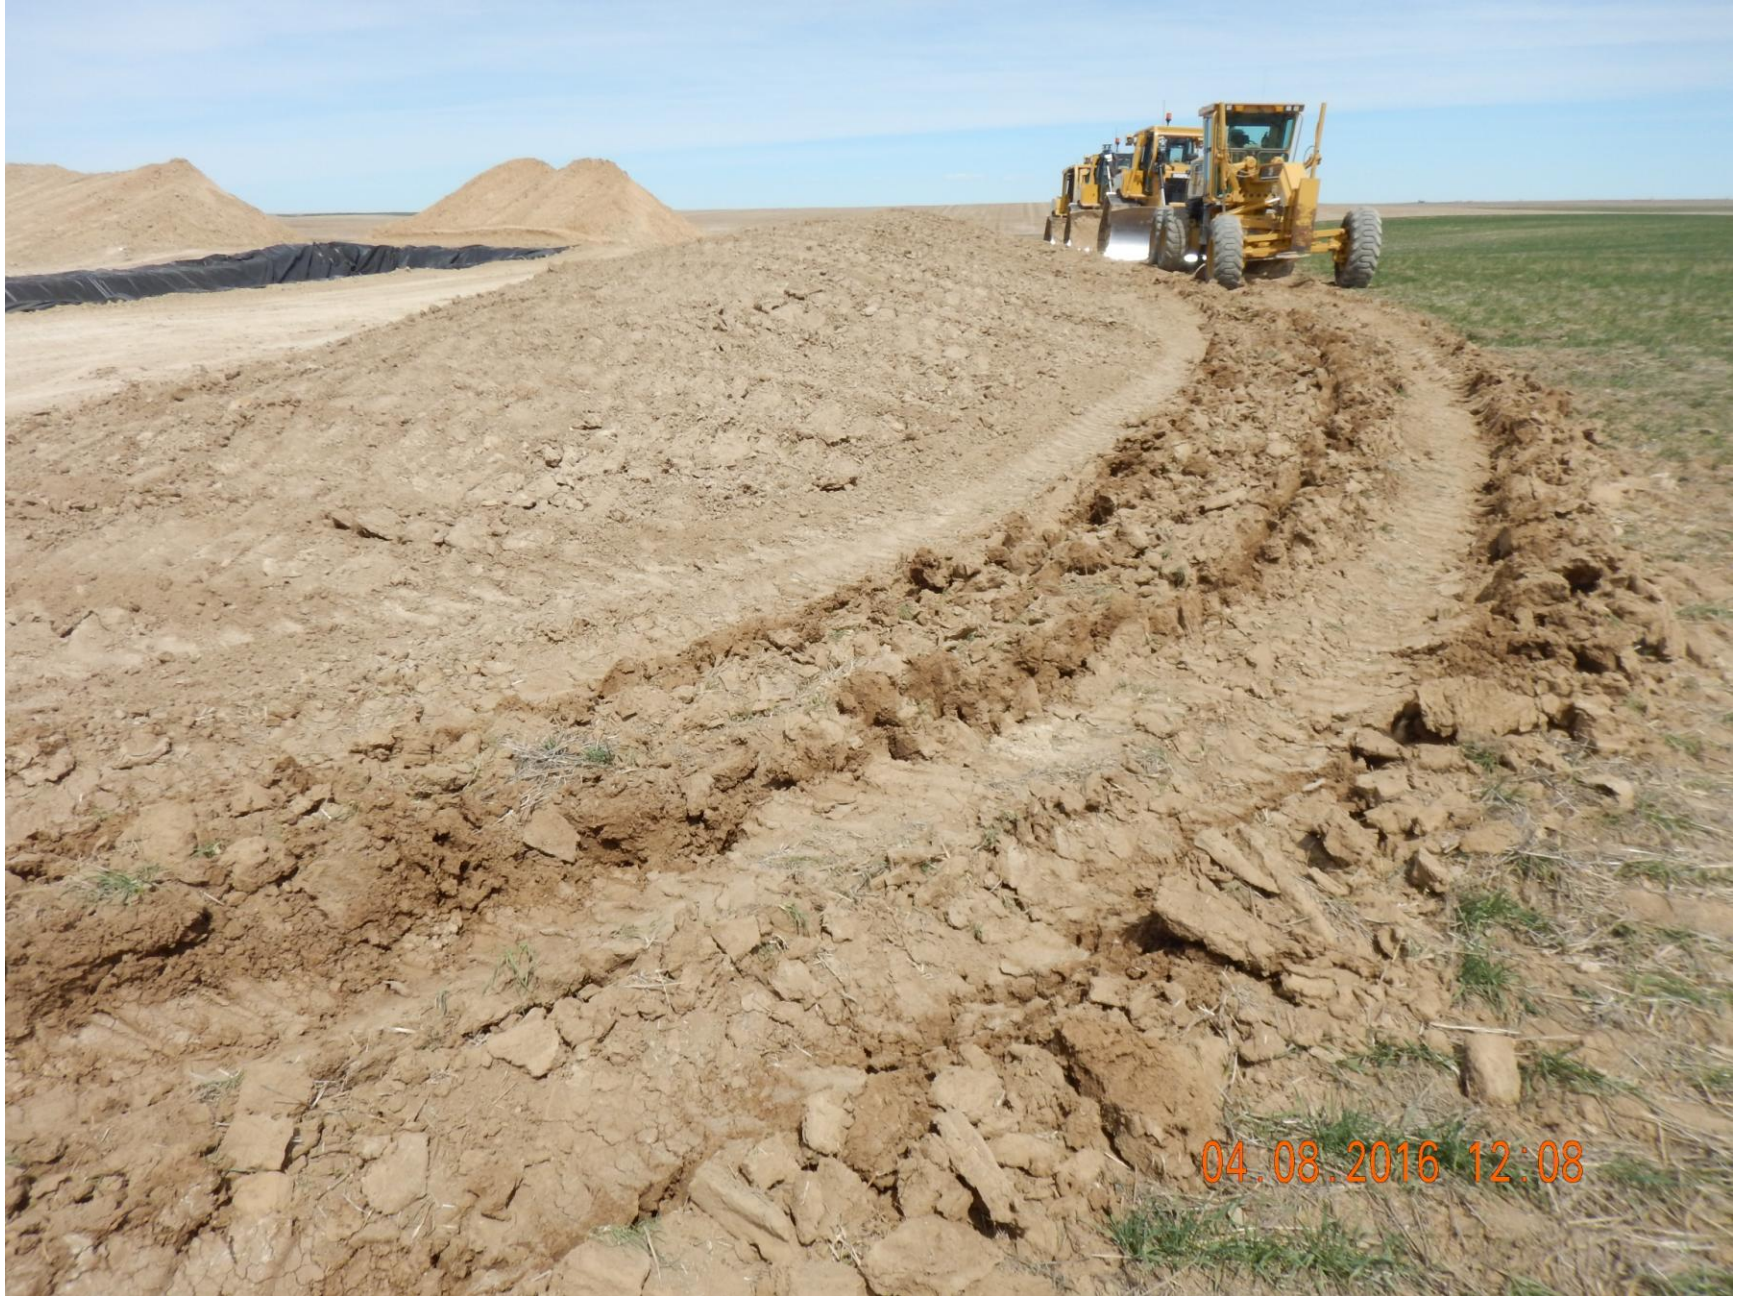
Figure 12: Photo taken from the east end of the location, facing north. Photo shows Ditch/Berm /Surface roughening stormwater and sediment control BMP along the eastern perimeter. .

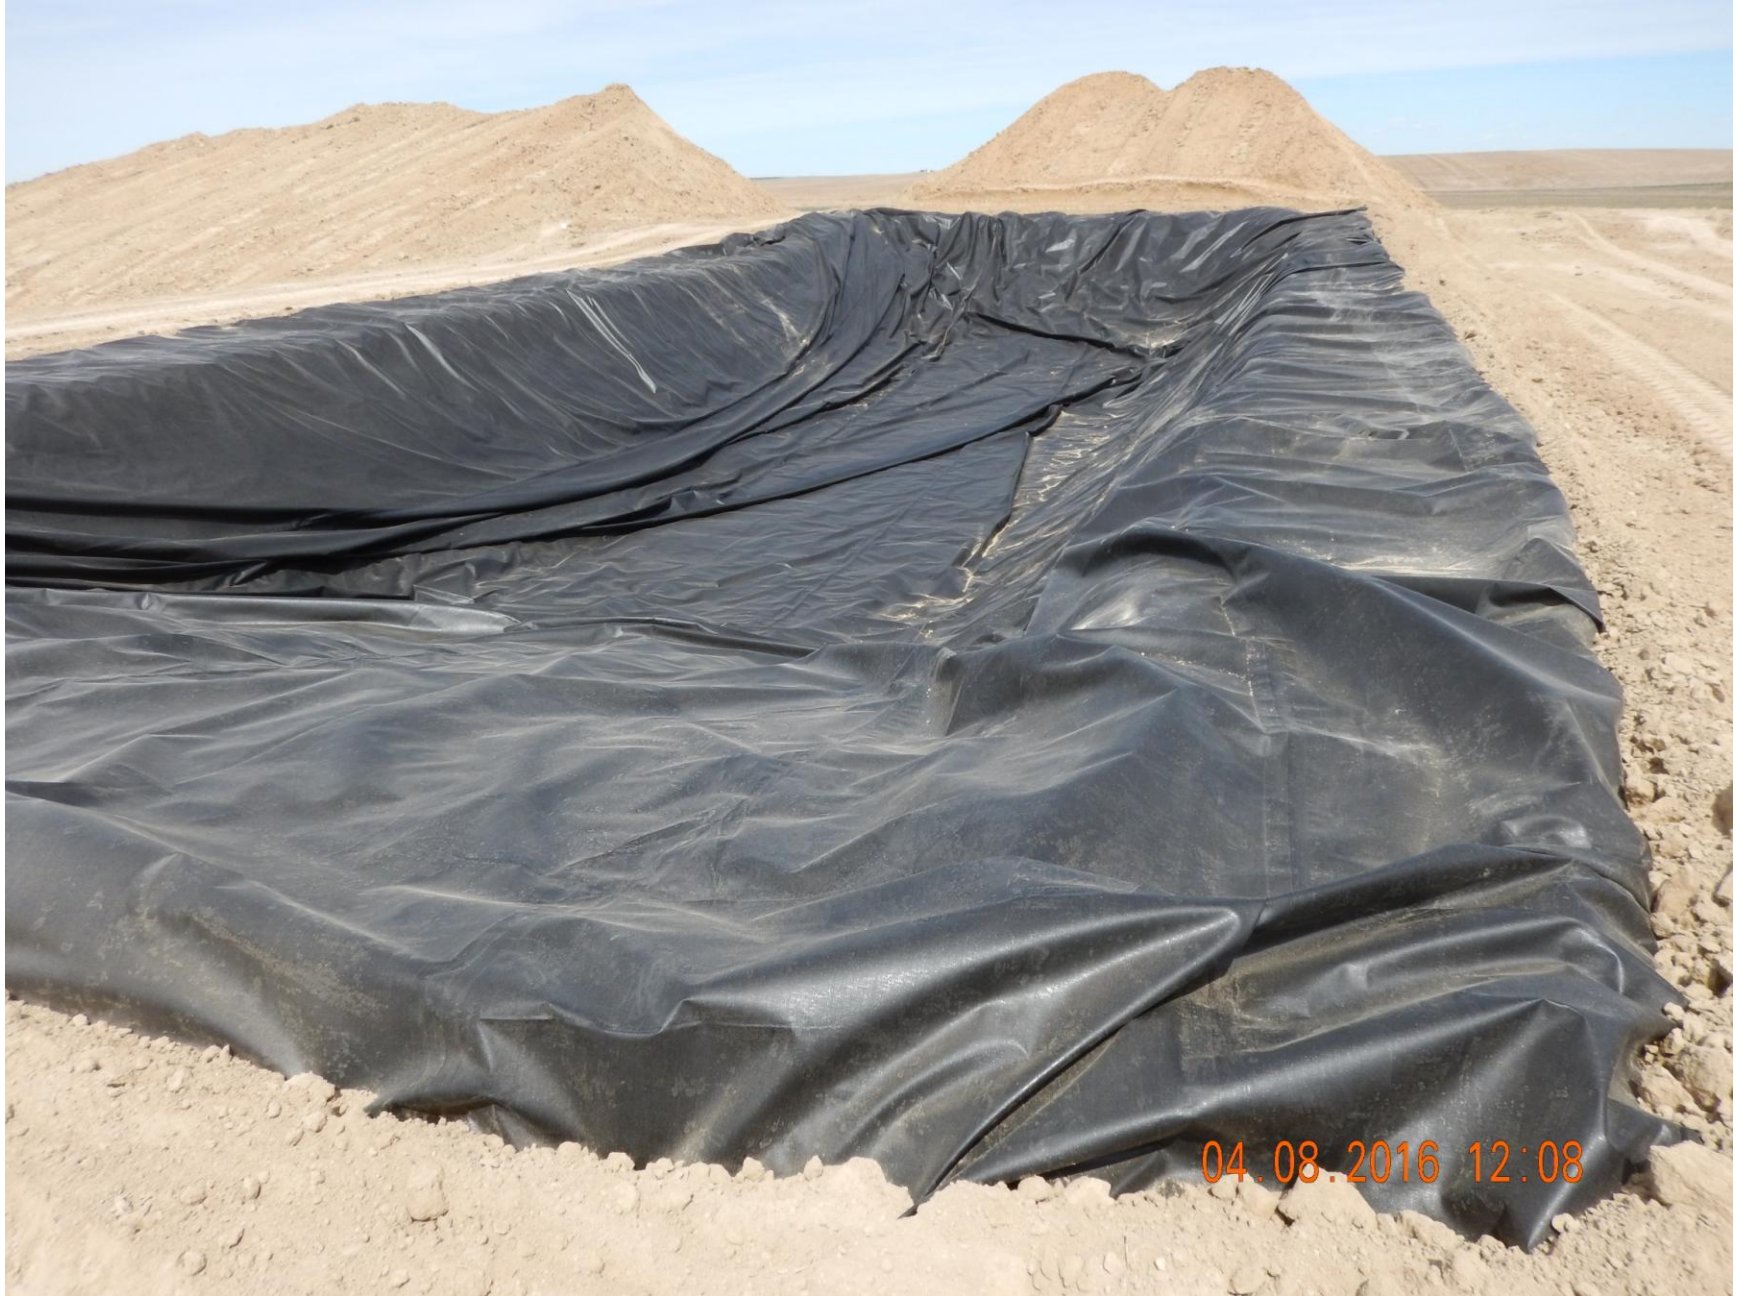
Figure 1: Photo taken from the northeast end of the project area, facing north. Photo shows freshwater pit with liner, and soil stockpile (likely from pit) in back ground.

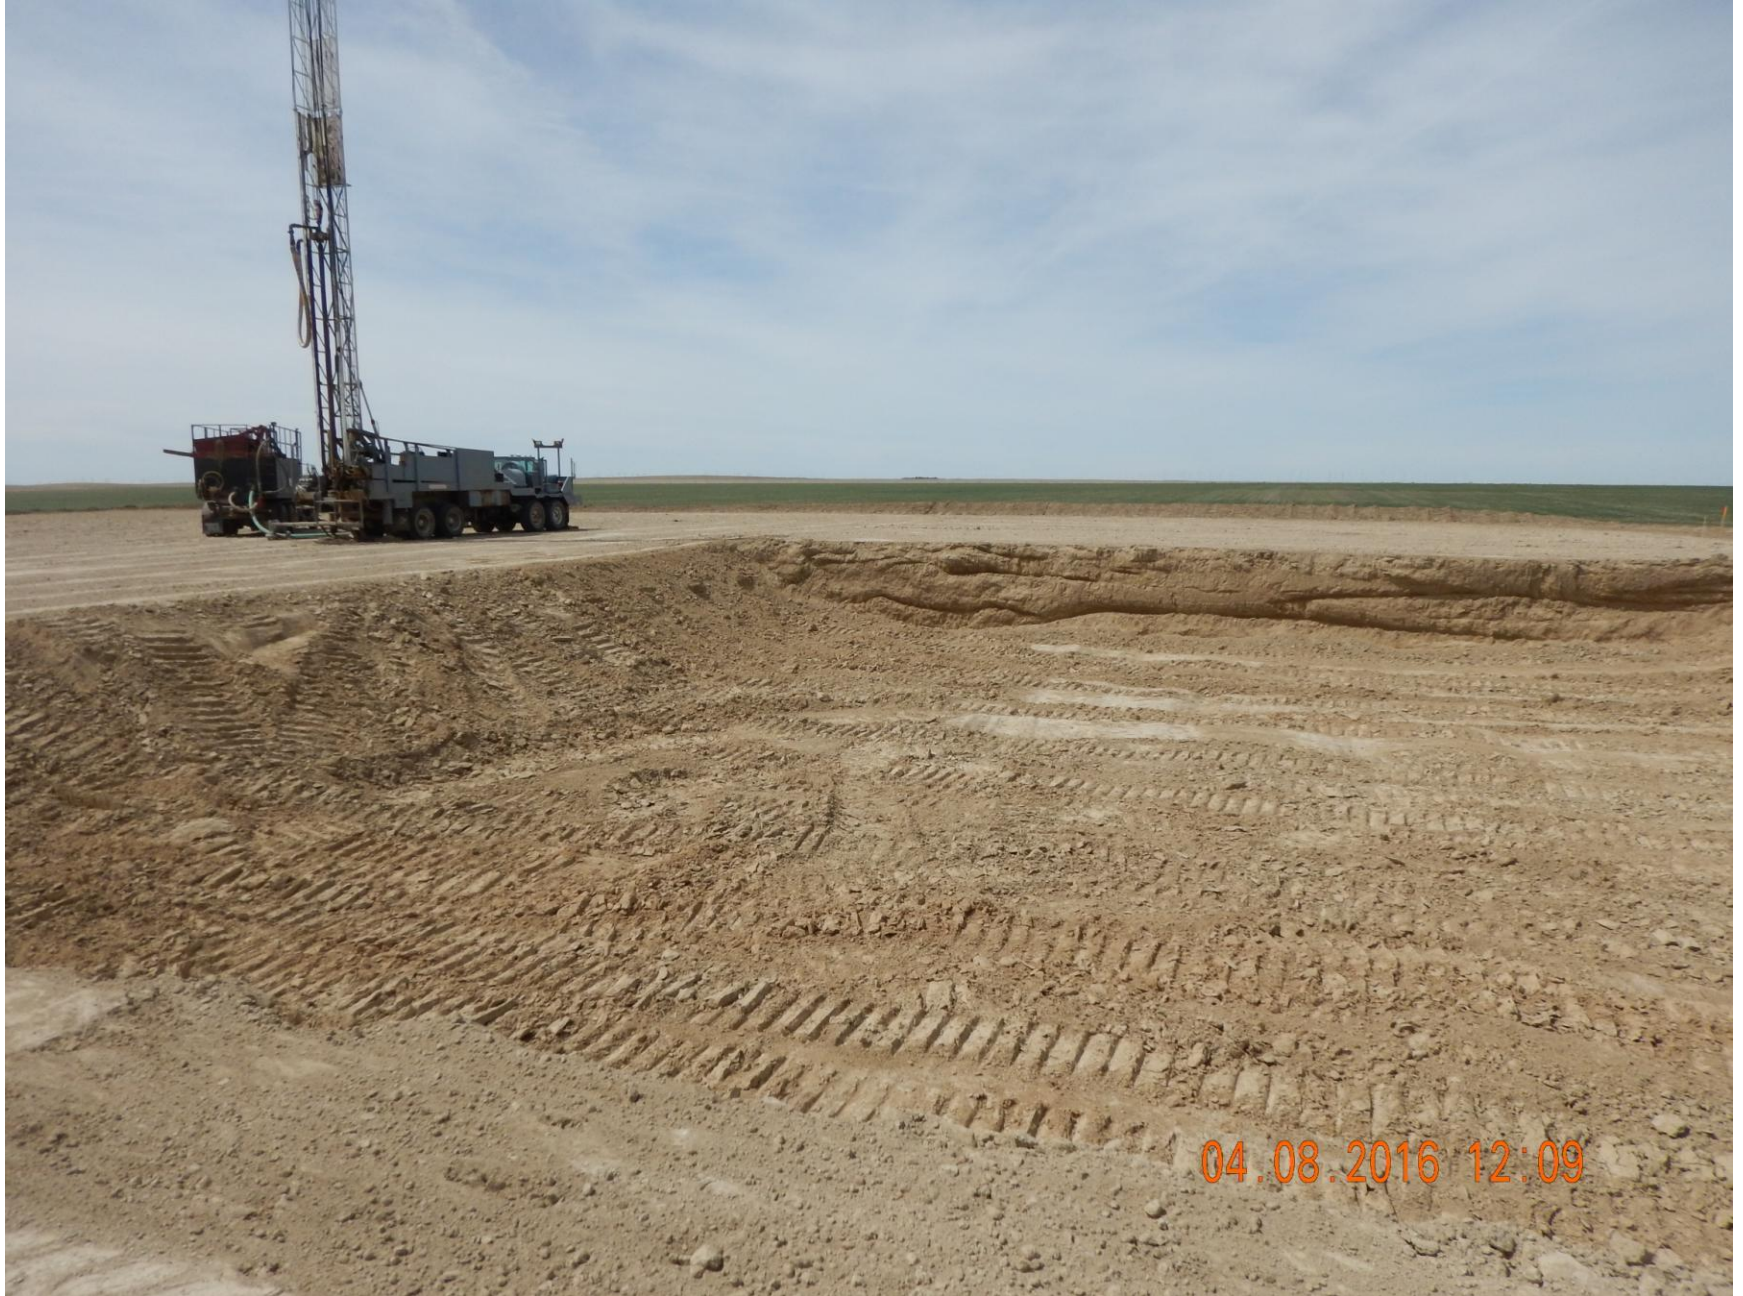
Figure 14: Photo taken from the north end of the project area, facing southwest. Photo shows main reserve pit (center of photo), and well construction in process.
