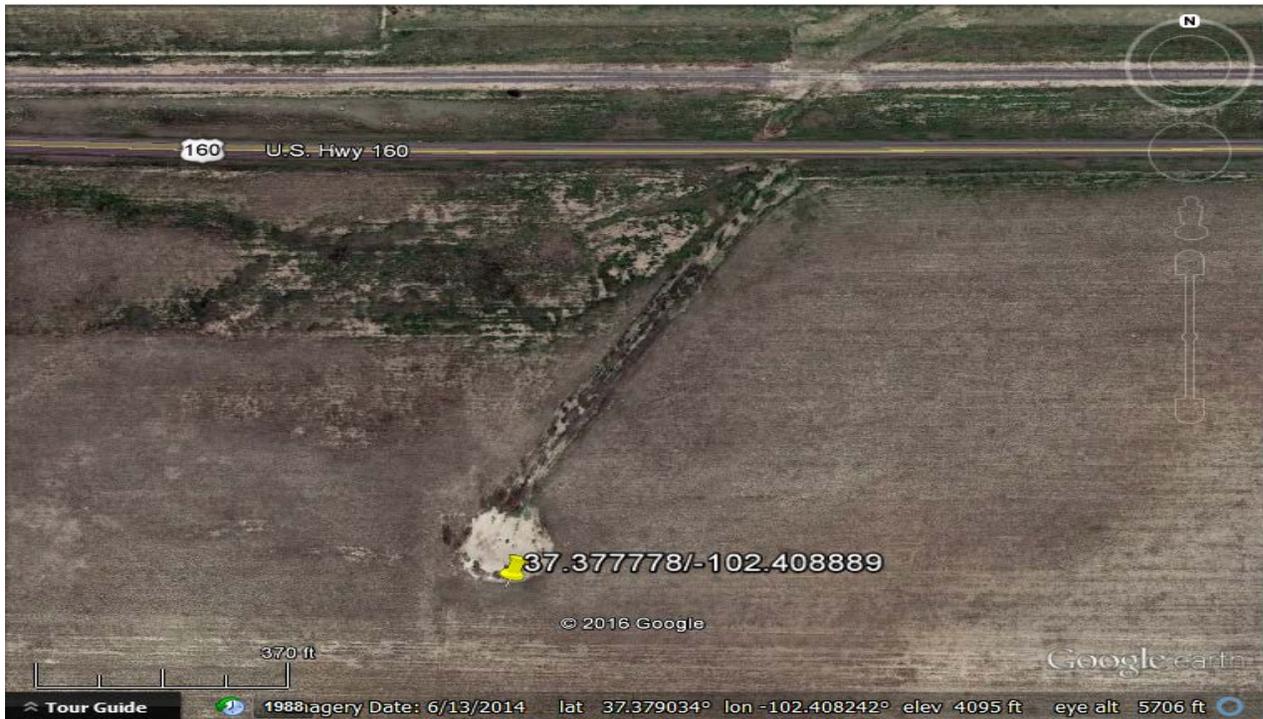
photo 1: Aerial image of the location taken on 6/13/2014.

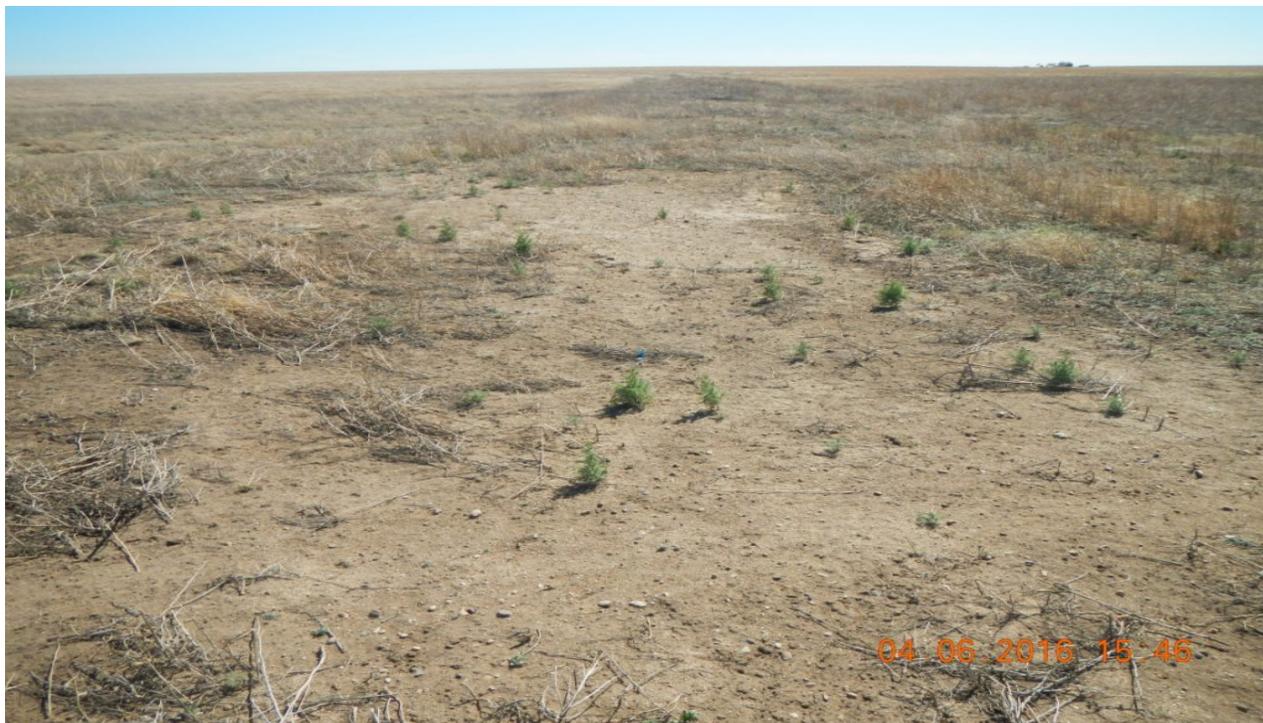
photo 2: Beginning of the access road facing southwest.

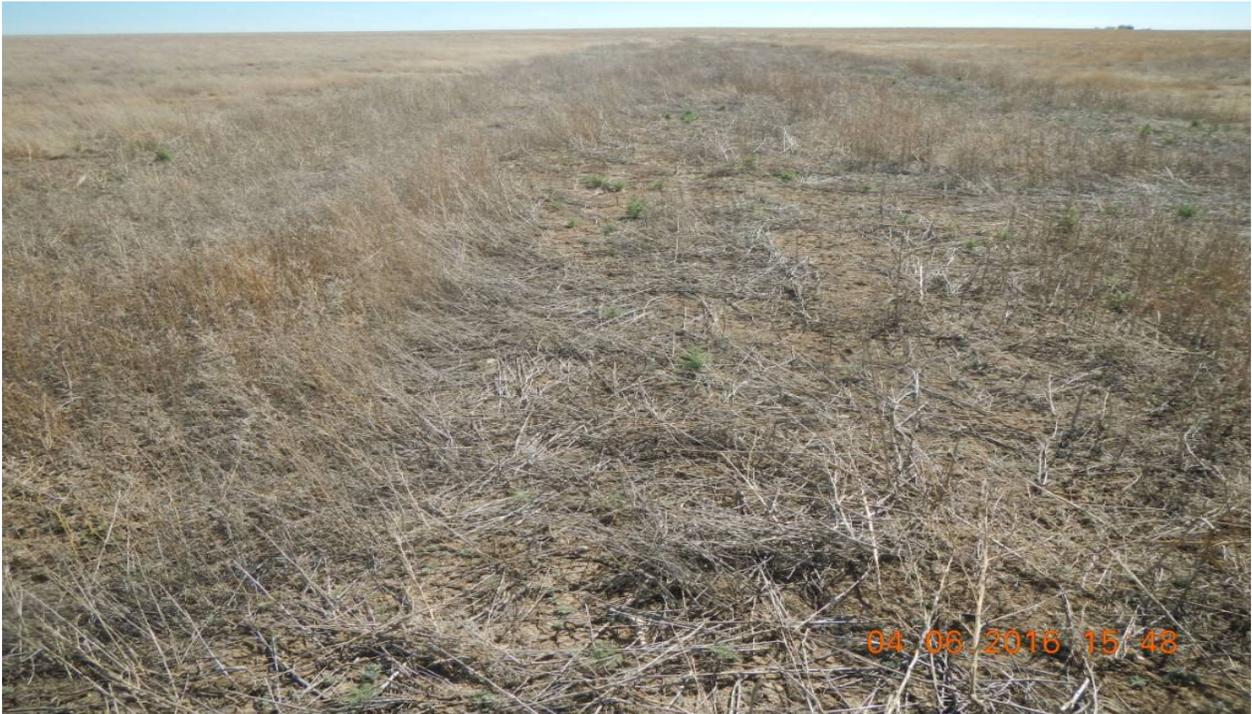
photo 3: Facing southwest along the access road. There is undesirable vegetative debris that is present.

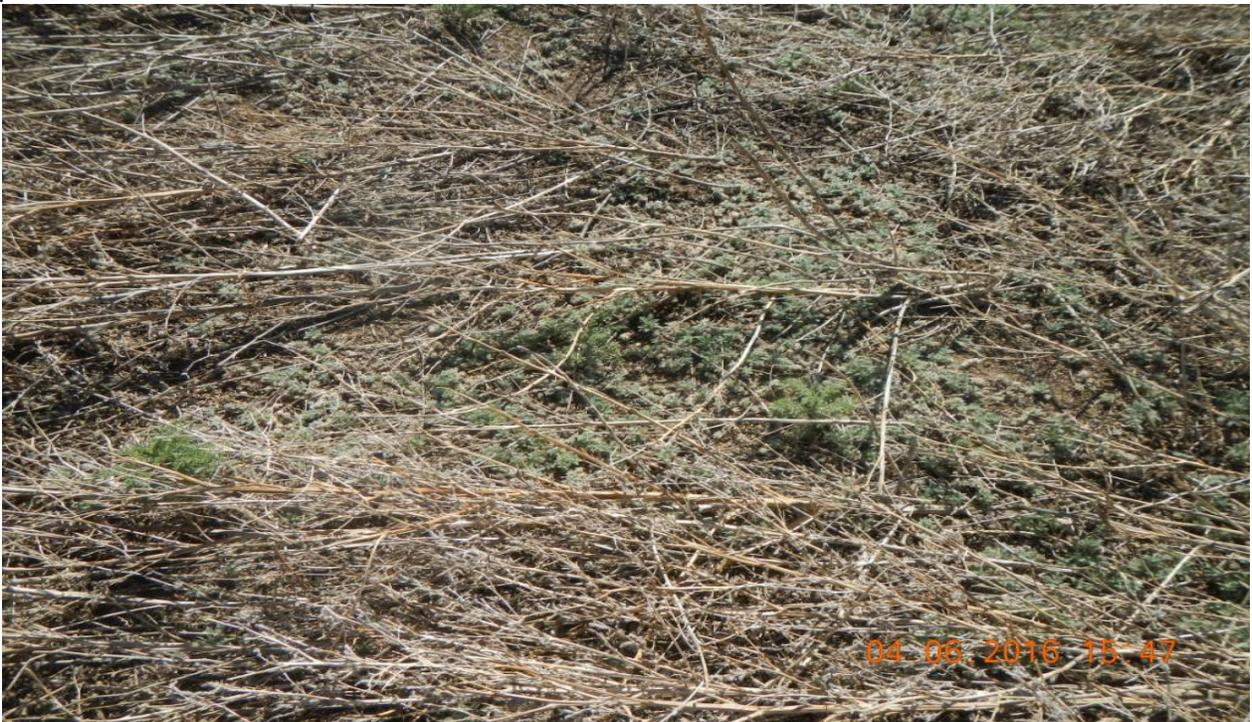
photo 4: View of undesirable vegetative debris with undesirable vegetation (Kochia) beginning to germinate along the access road.

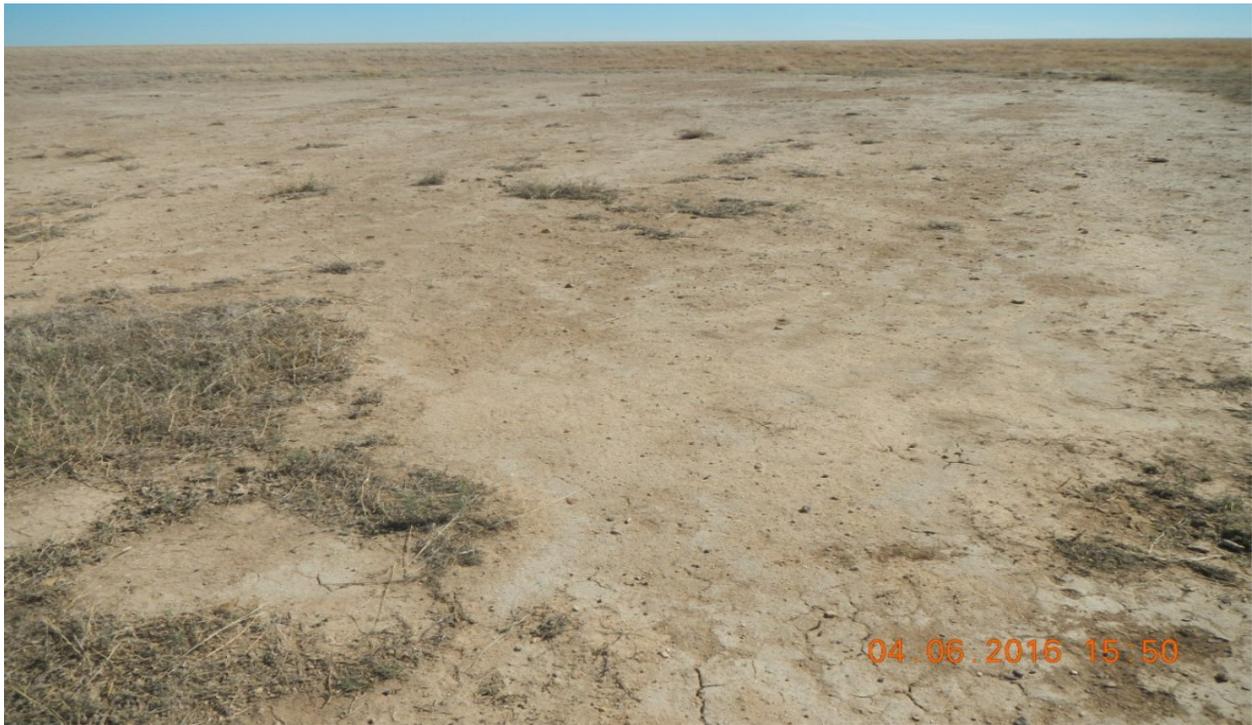
photo 5: North side of the location facing south. Location bare of vegetation approx. 120'x120'.

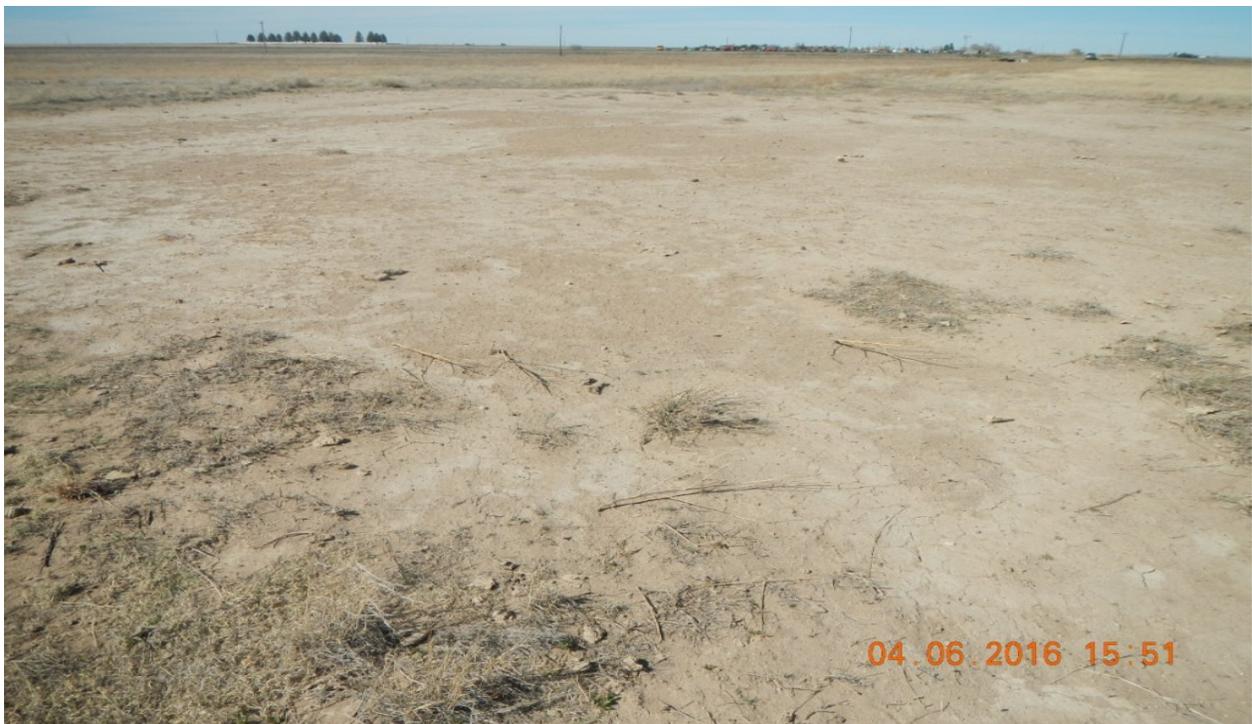
photo 6: South side of the location facing north. Location bare of vegetation approx. 120'x120'.

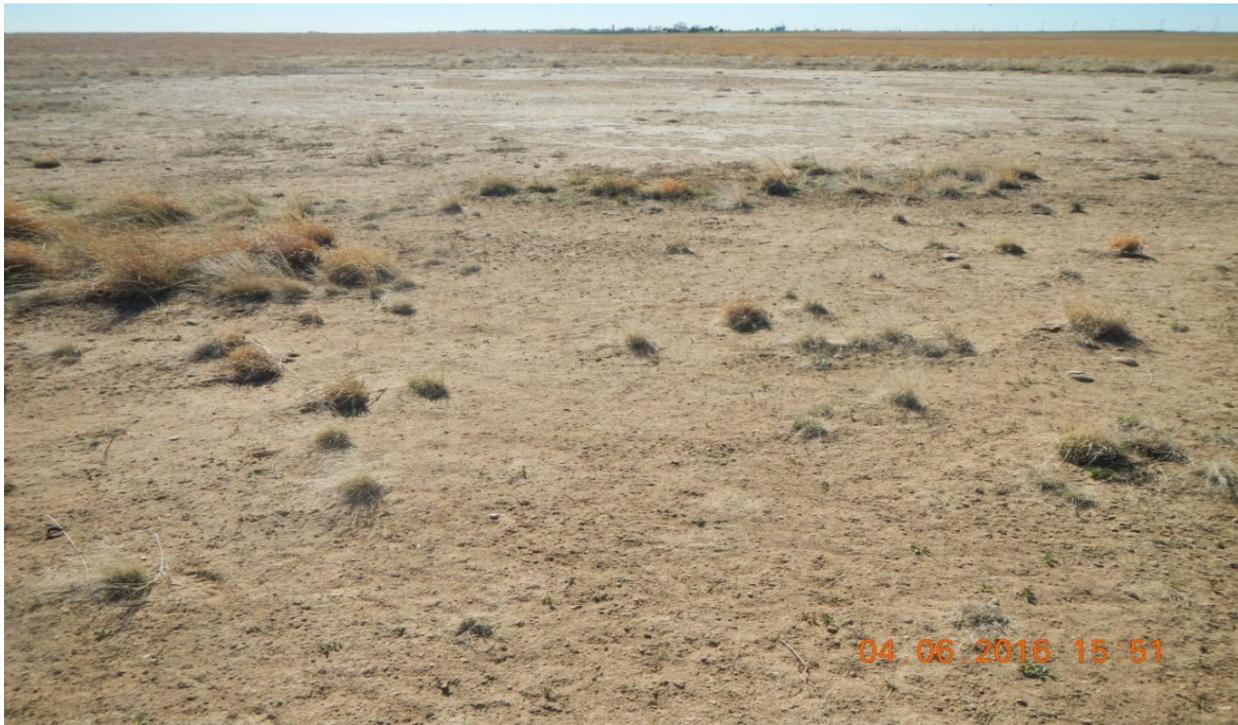
photo 7: East side of the location facing west. Location bare of vegetation approx. 120'x120'.

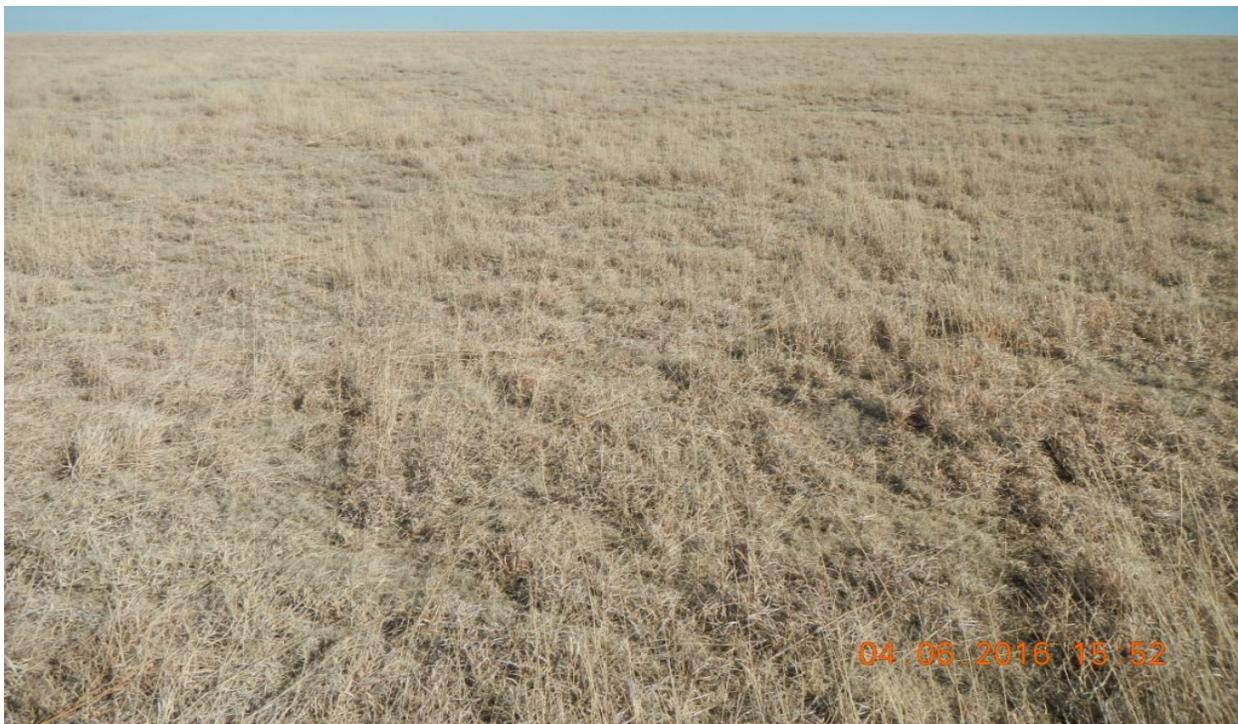
photo 8: Facing east at the surrounding undisturbed pasture.
