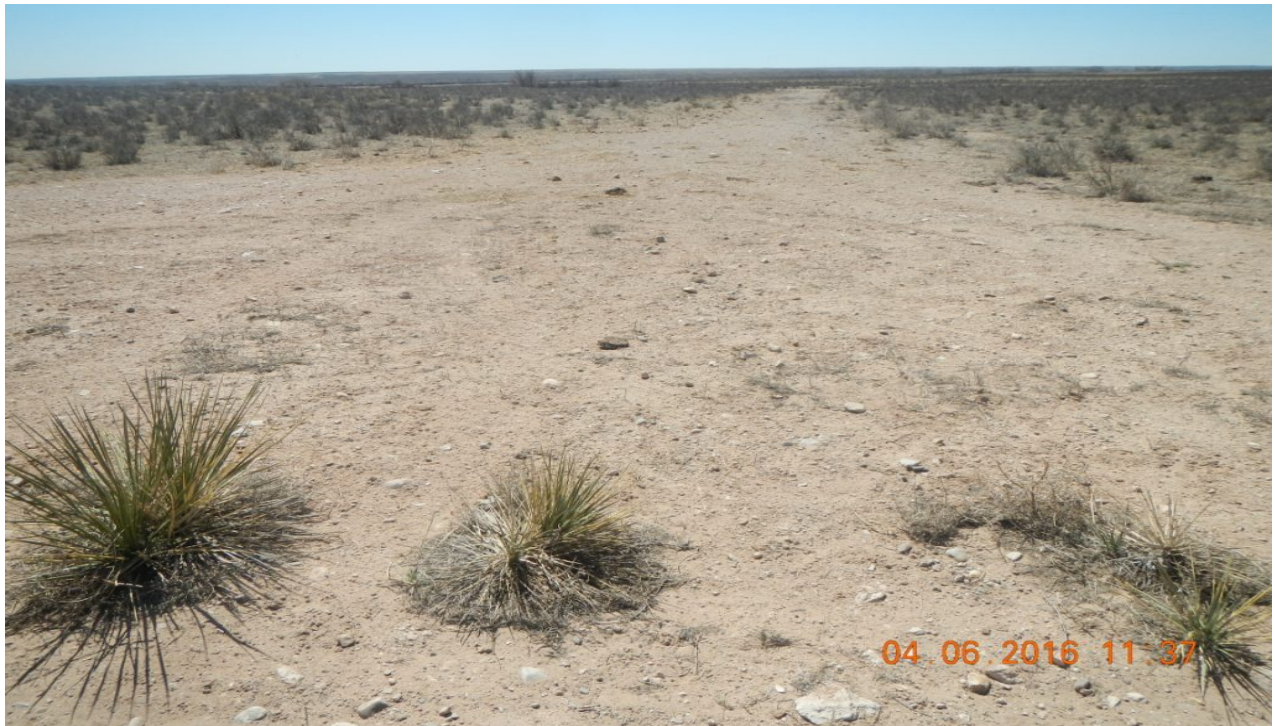
photo 1: Facing south at the beginning of the access road.

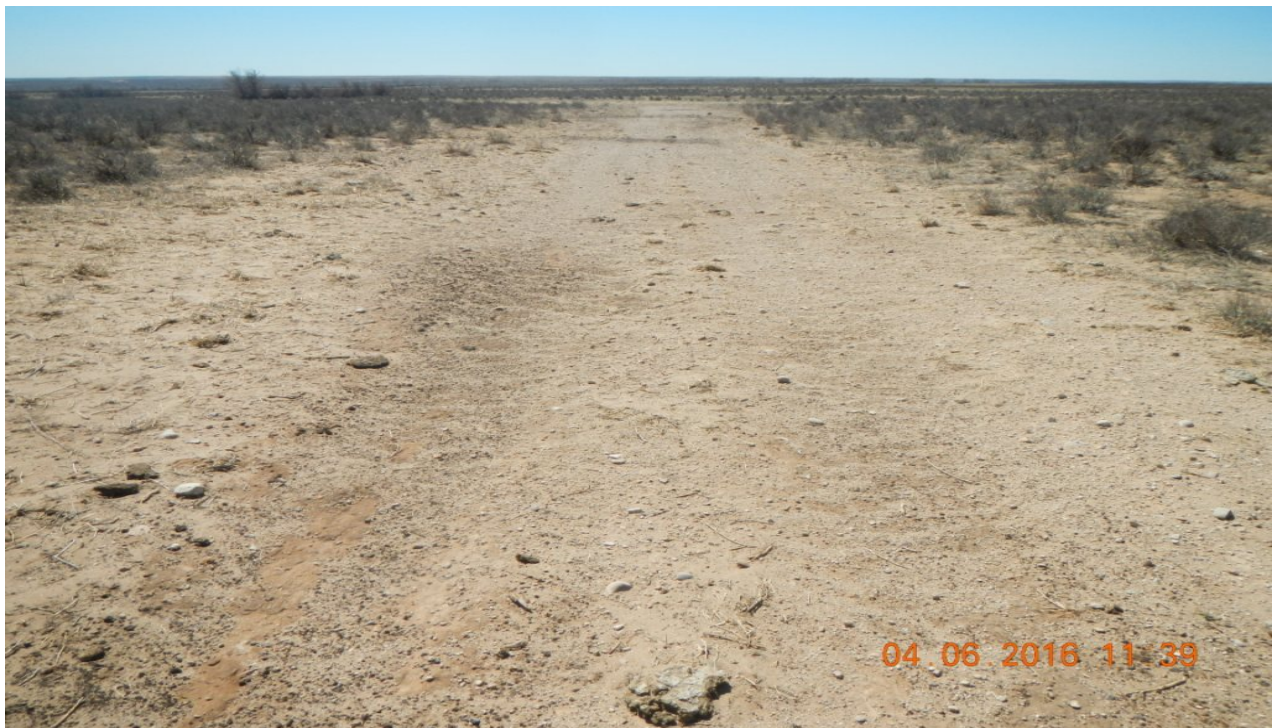
photo 2: Facing south along the access road which has not been reclaimed.

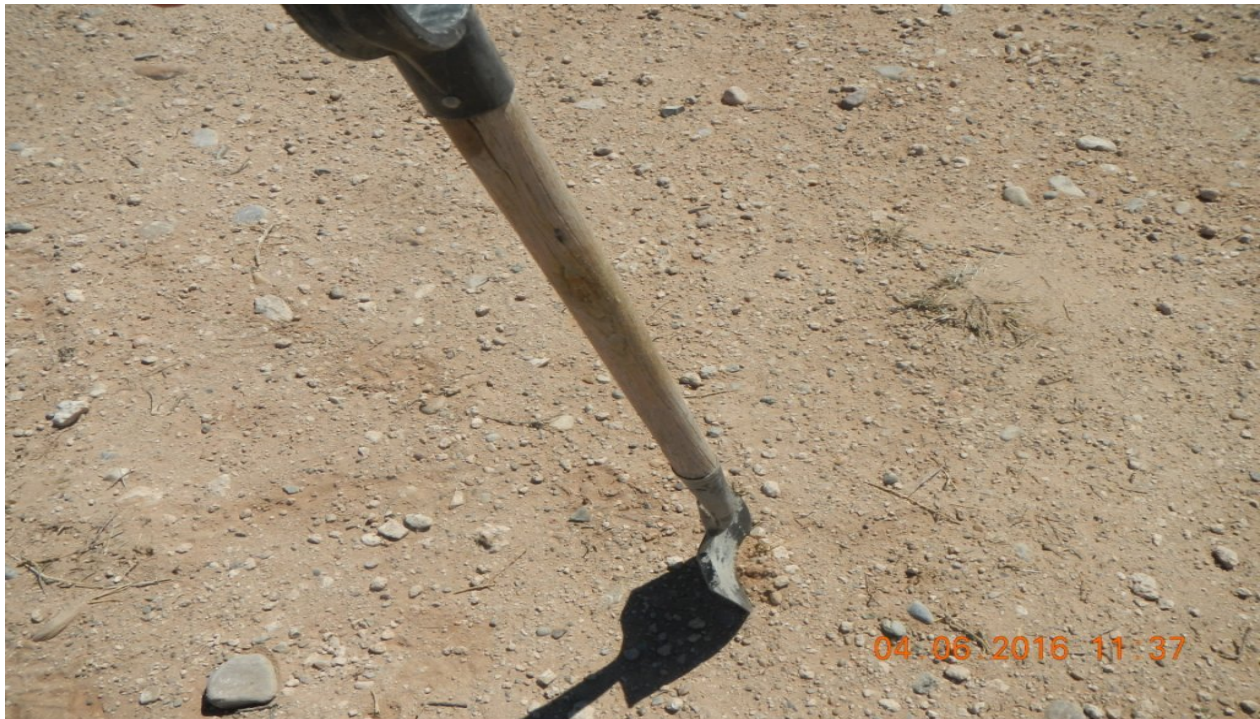
photo 3: Gravel material remains along the access road. The shovel indicates soil compaction issues along the access road.

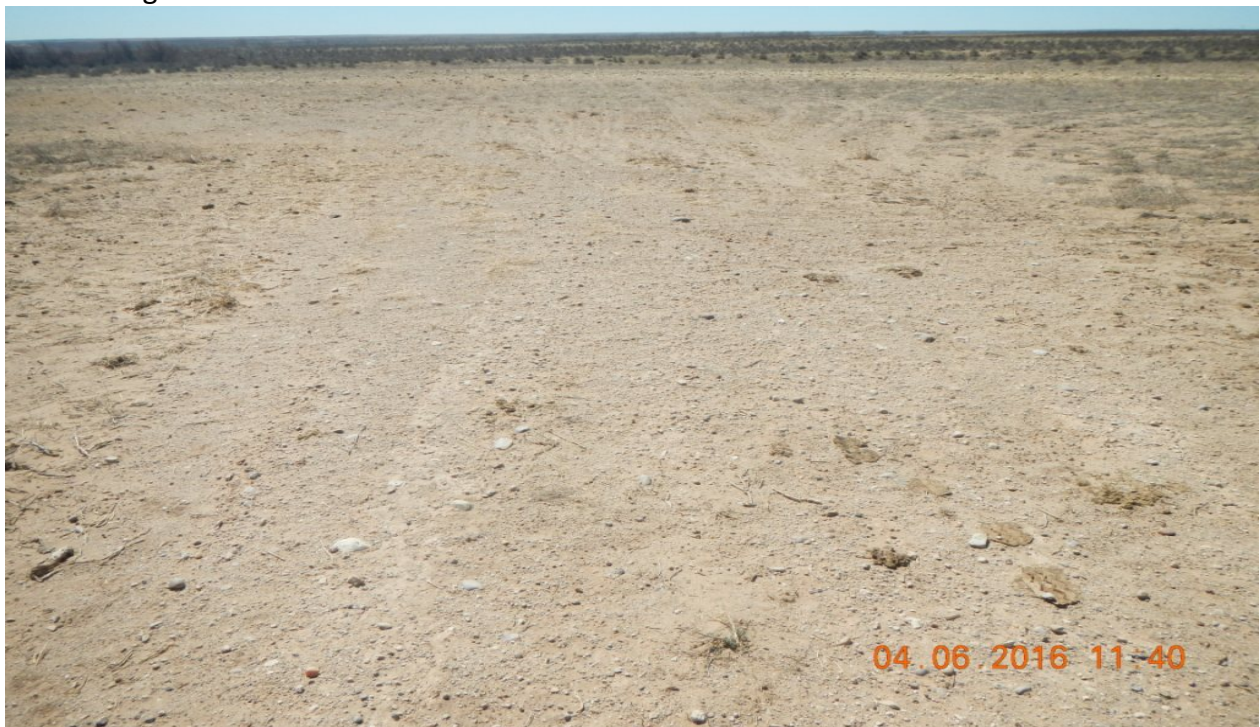
photo 4: North side of the location facing south.

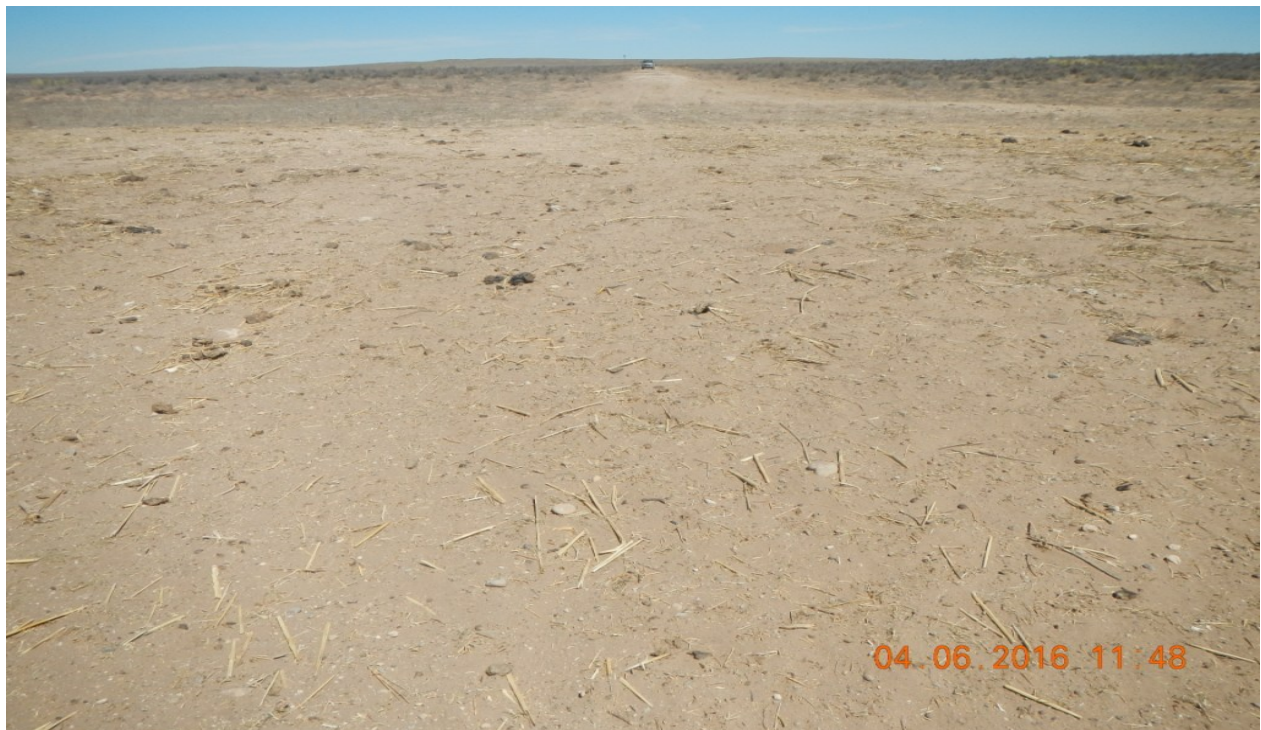
photo 5: Center of the location facing north.

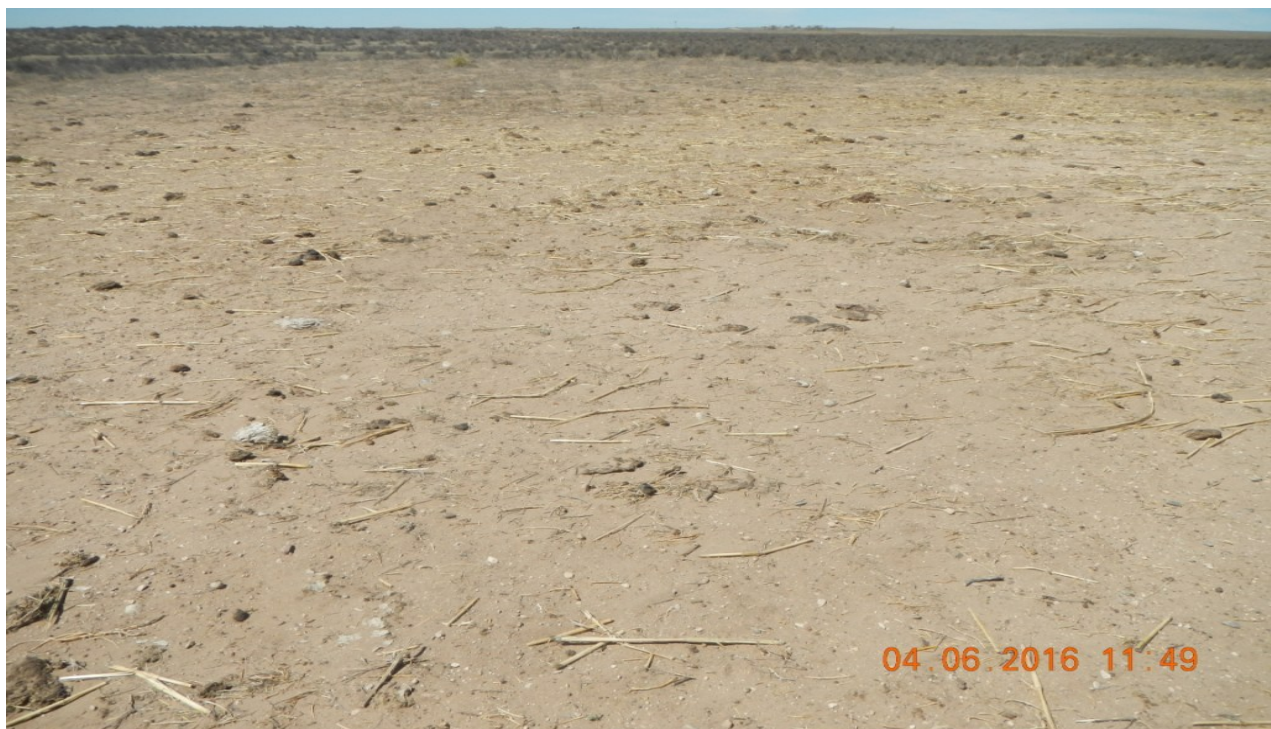
photo 6: Center of the location facing west.

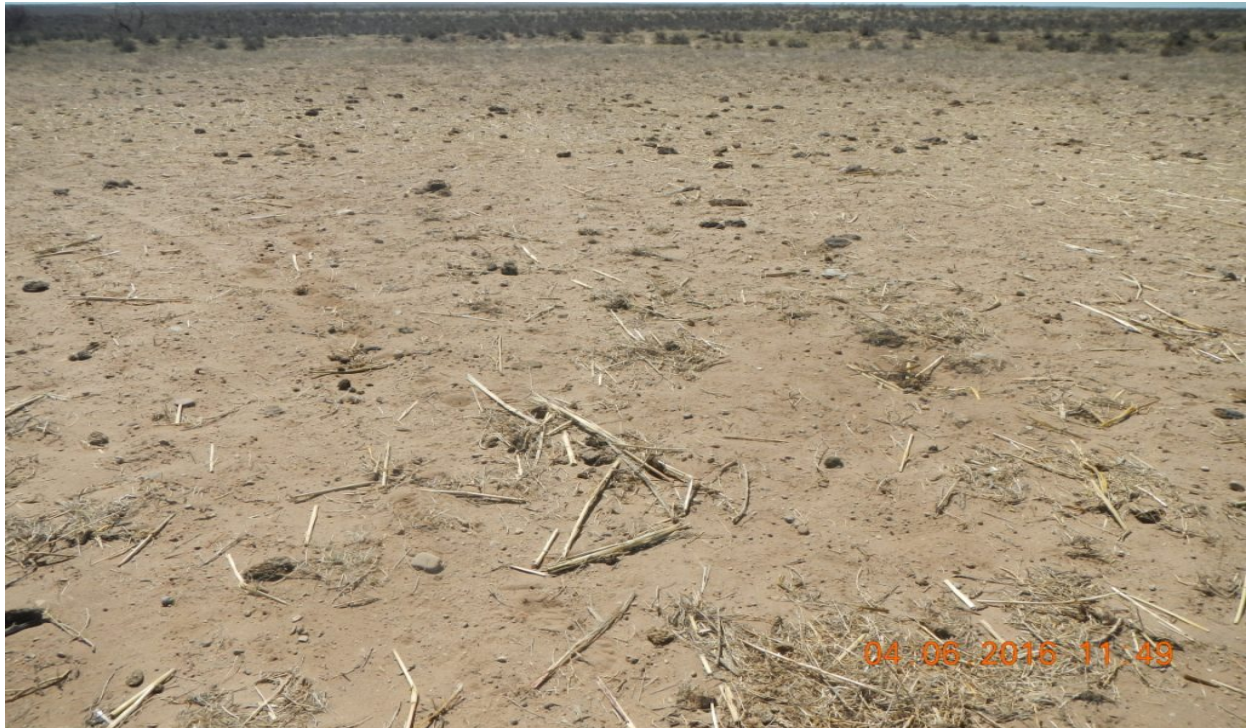
photo 7: Center of the location facing south.

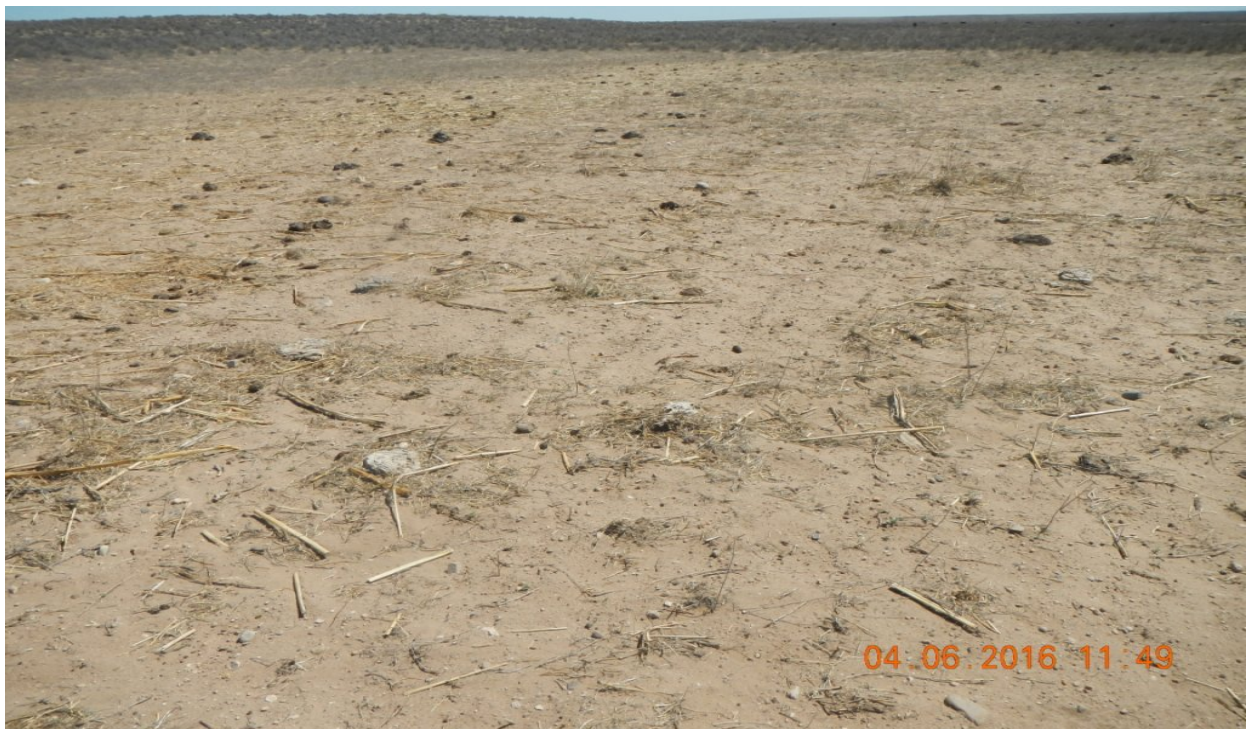
photo 8: Center of the location facing east.

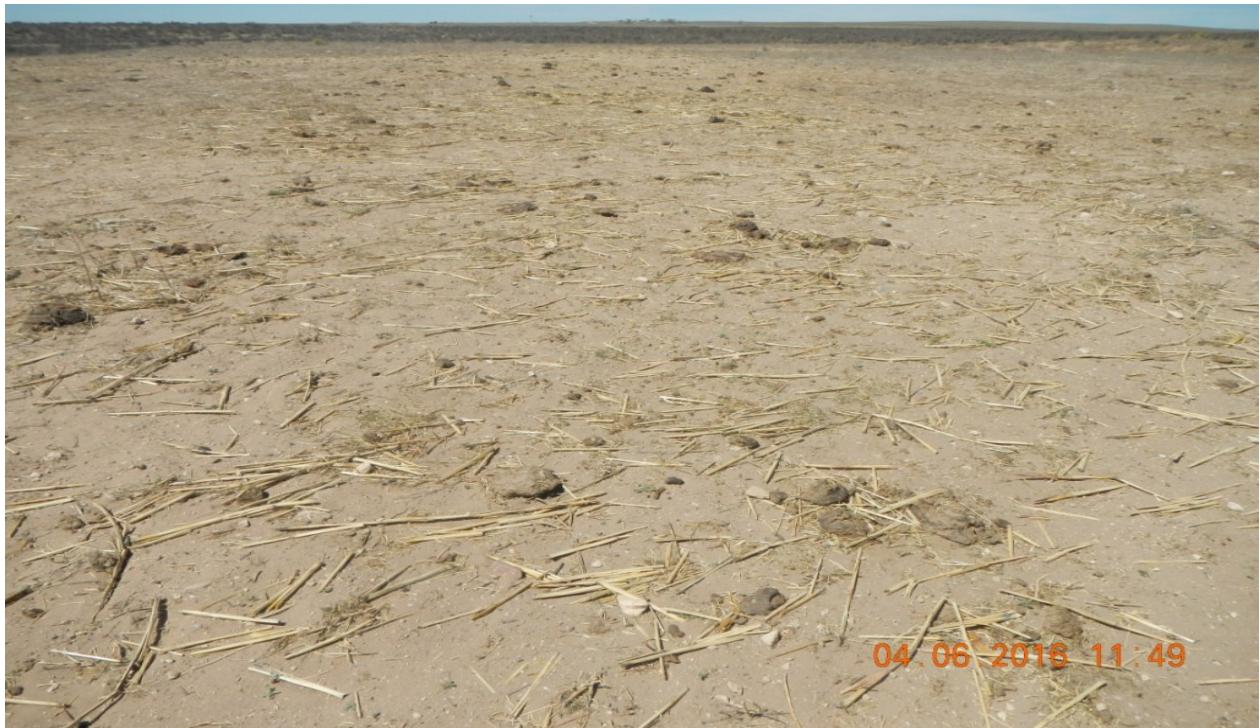
photo 9: East side of the location facing west at the location.

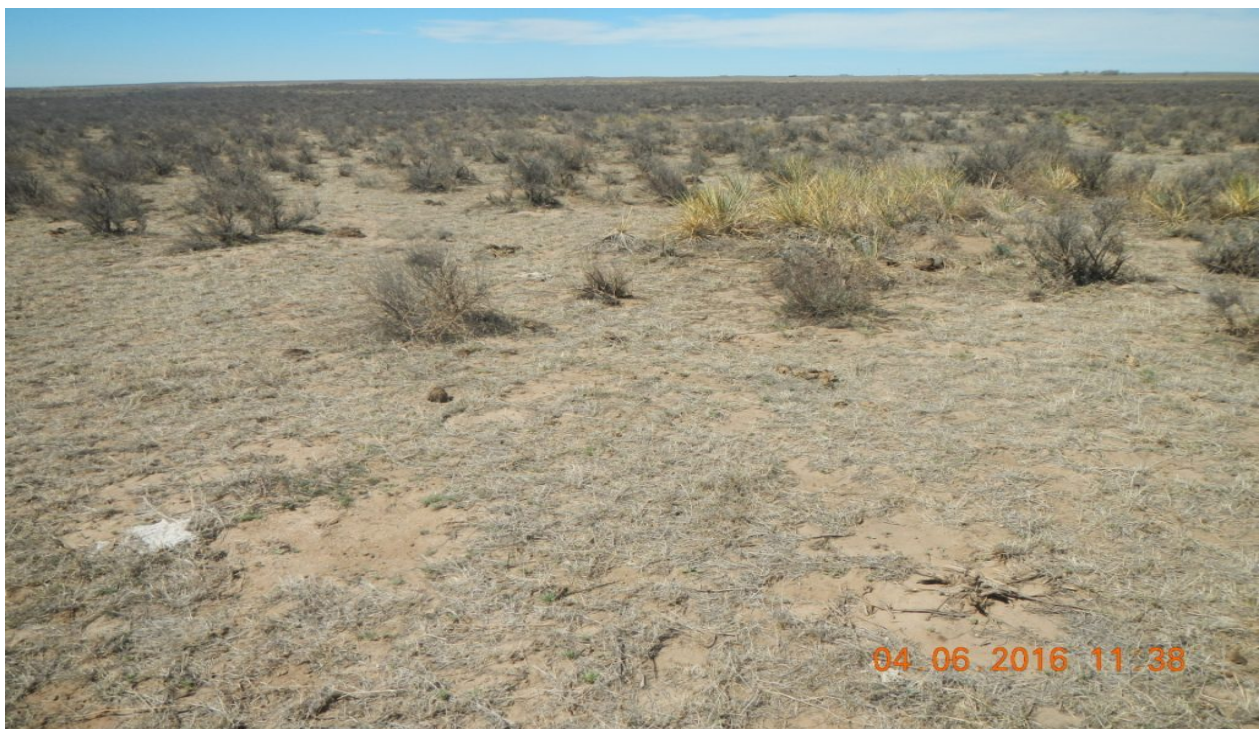
photo 10: Facing west at the surrounding undisturbed vegetation.
