COGCC Environmental Inspection April 7, 2016 – Arauza

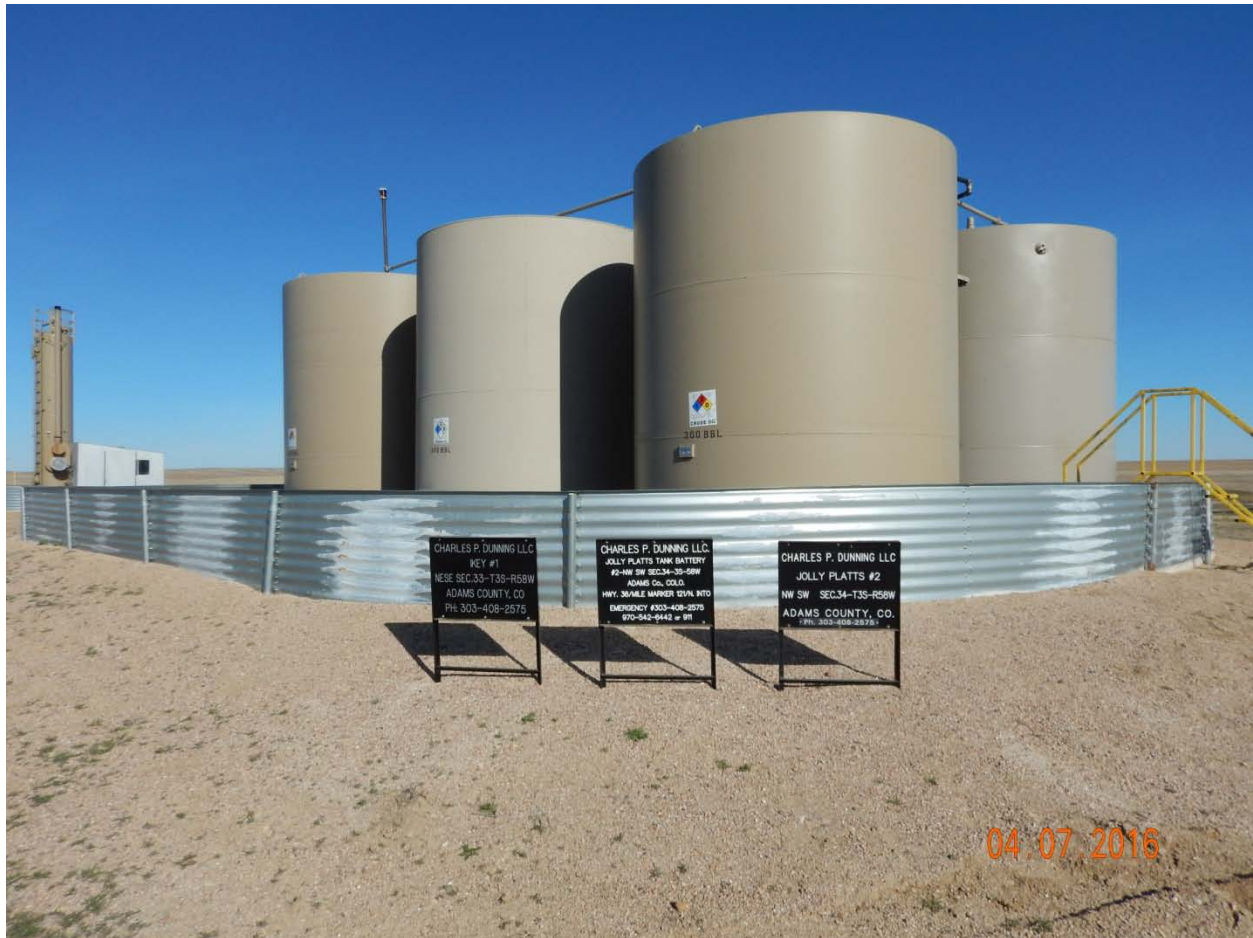
Figure 1 - Tank battery signs.

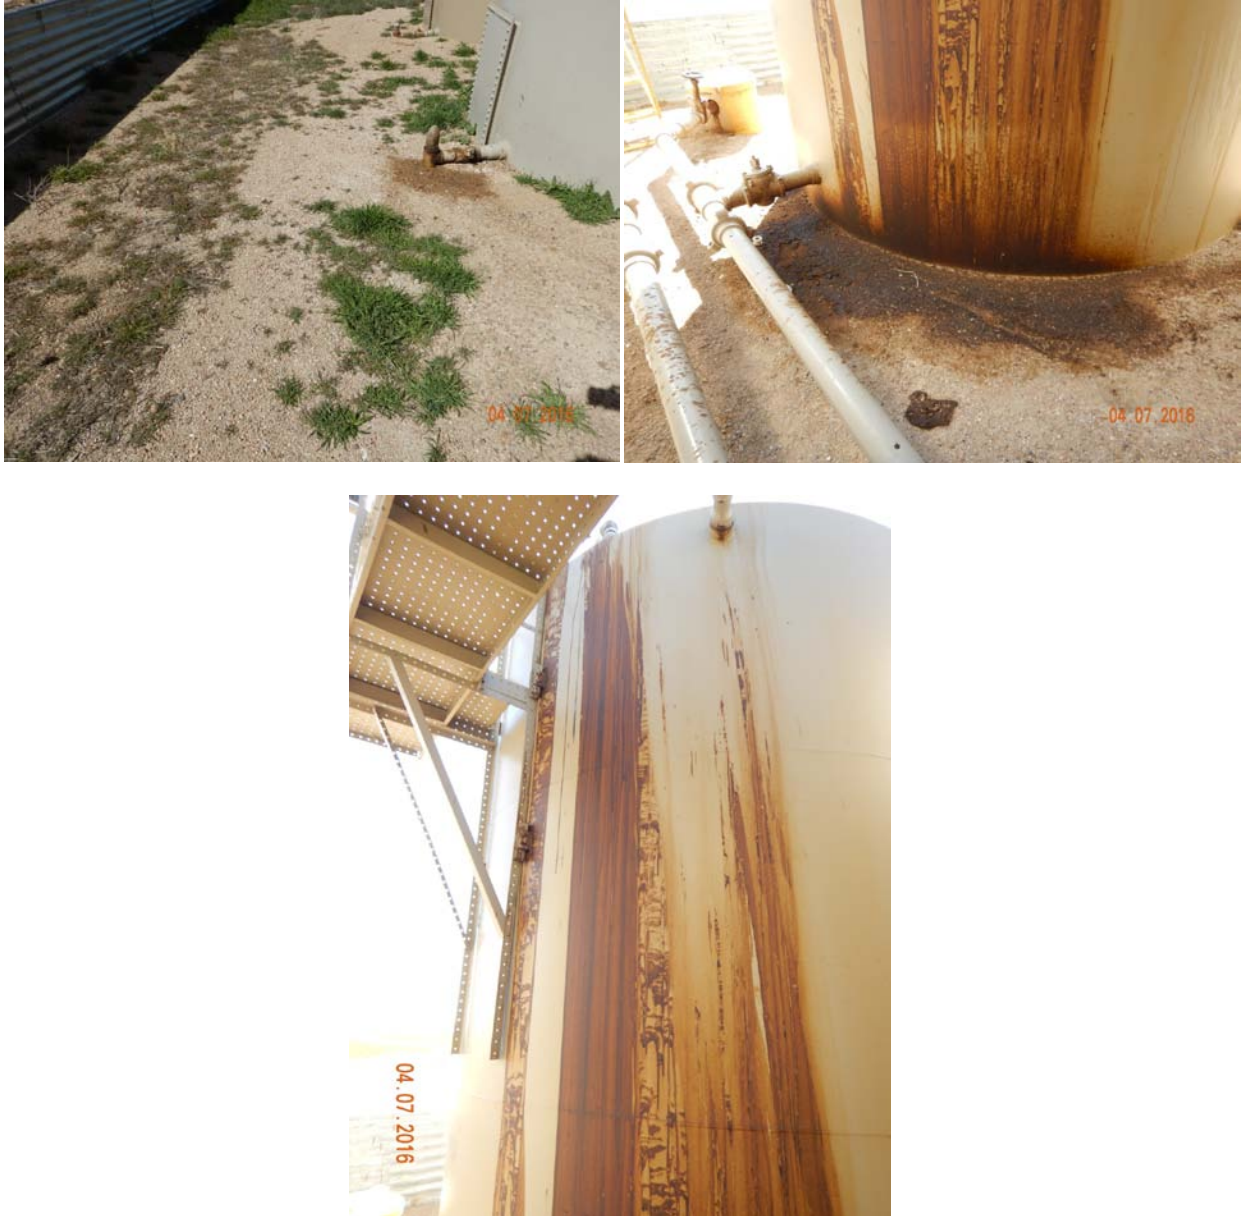
Figure 2 - Localized, oil-stained soil at tank battery and oil staining on north side of SE tank.

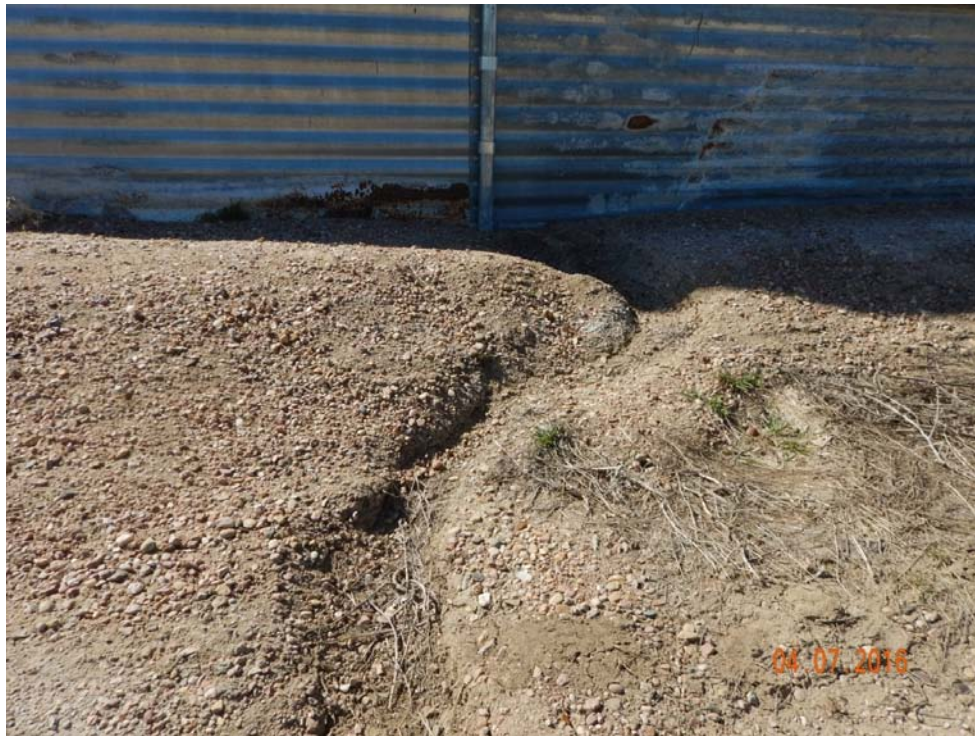
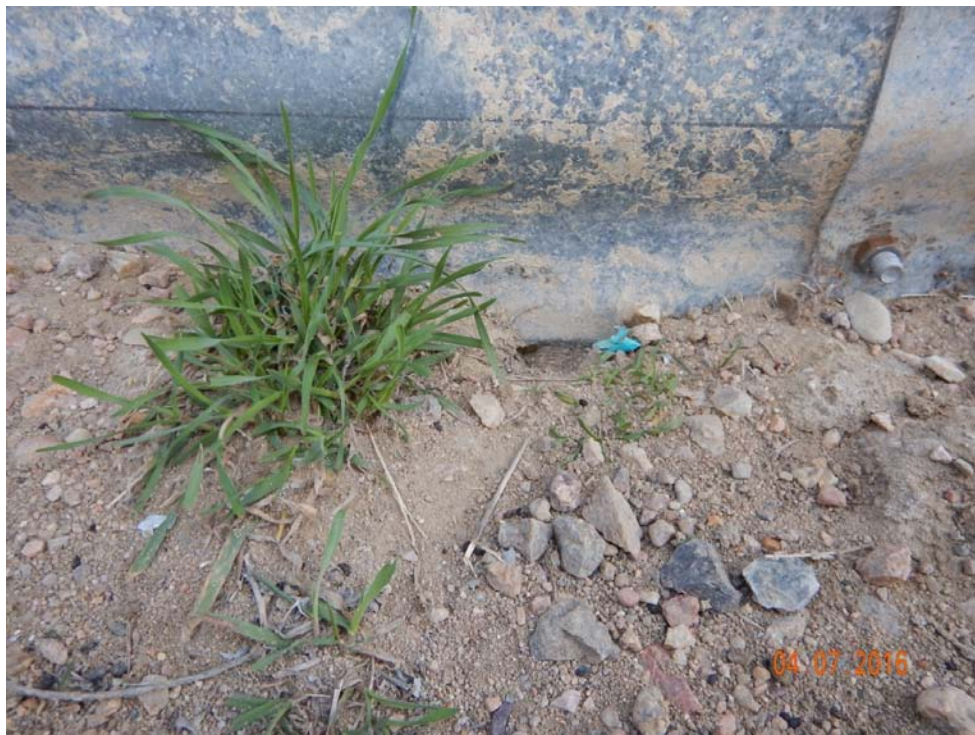
Figure 3 – Erosion rill outside of north berm of tank battery (above) and view of gap beneath berm from the inside (below).

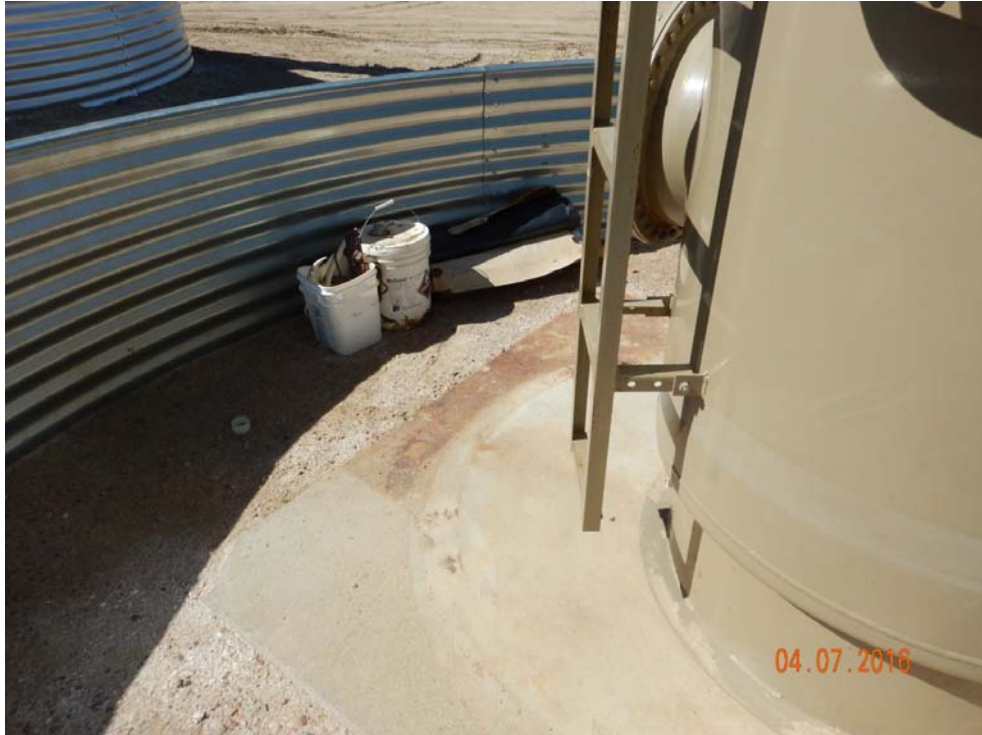
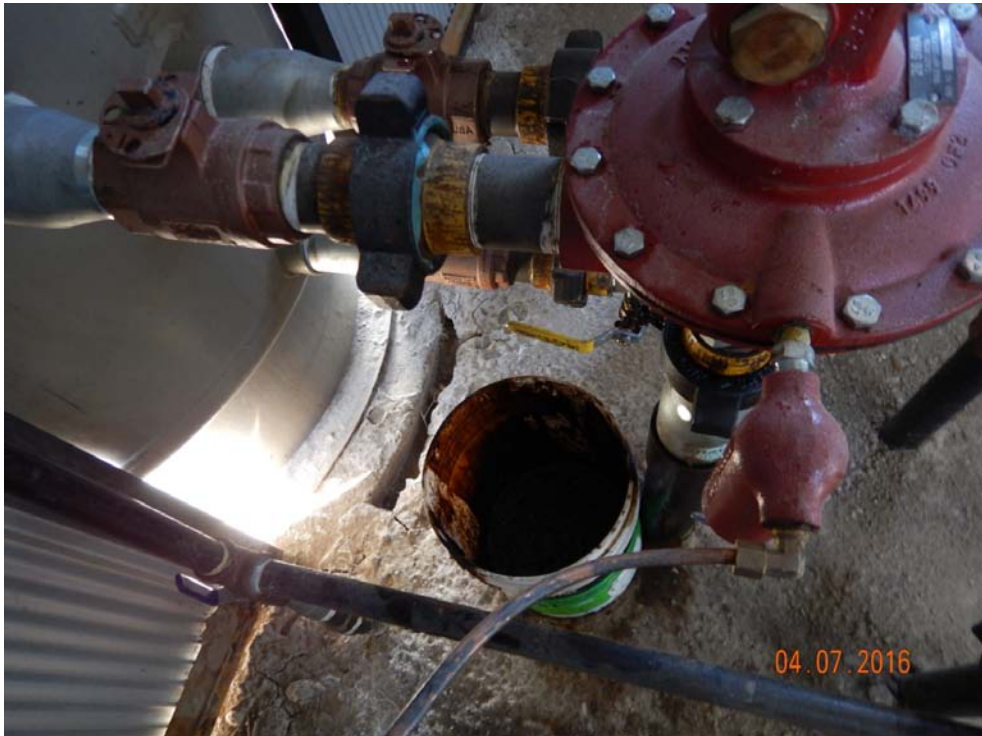
Figure 4 - Various chemical storage containers with localized stained soil inside of heater treater berm and open bucket used to capture oil/grease.

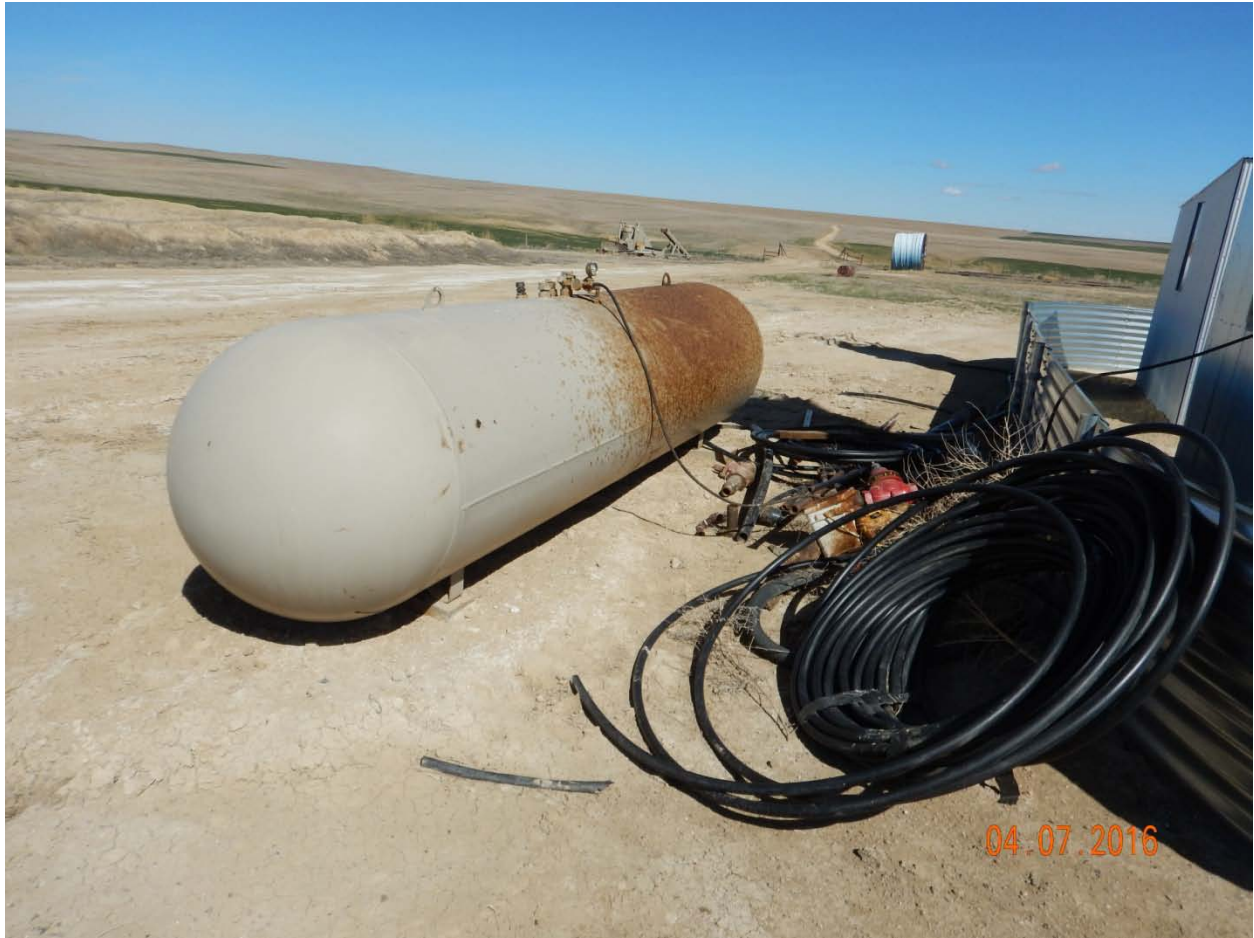
Figure 5 - Propane tank west of heater treater berm with oil stain.

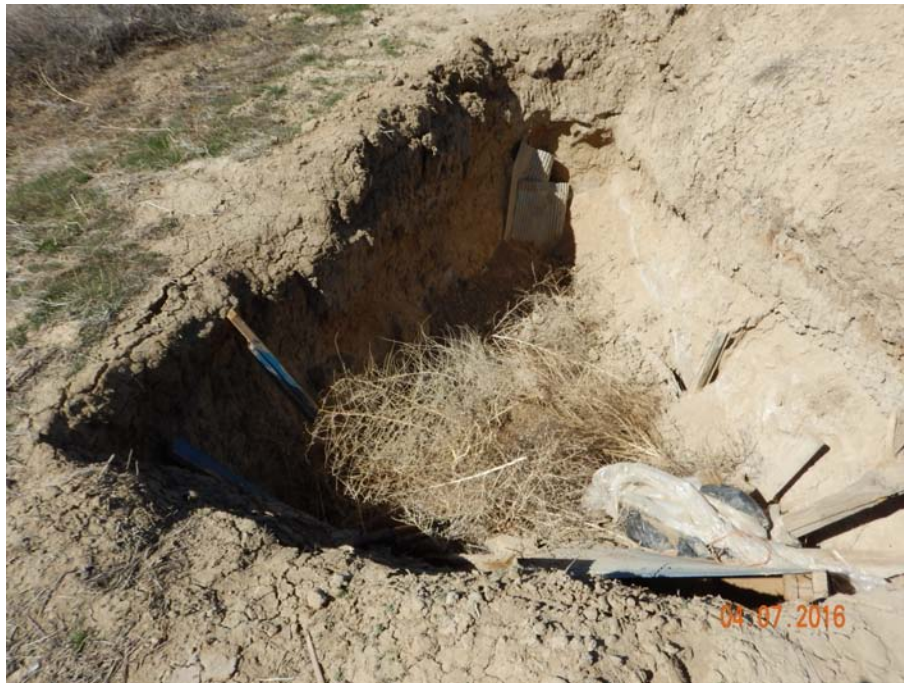
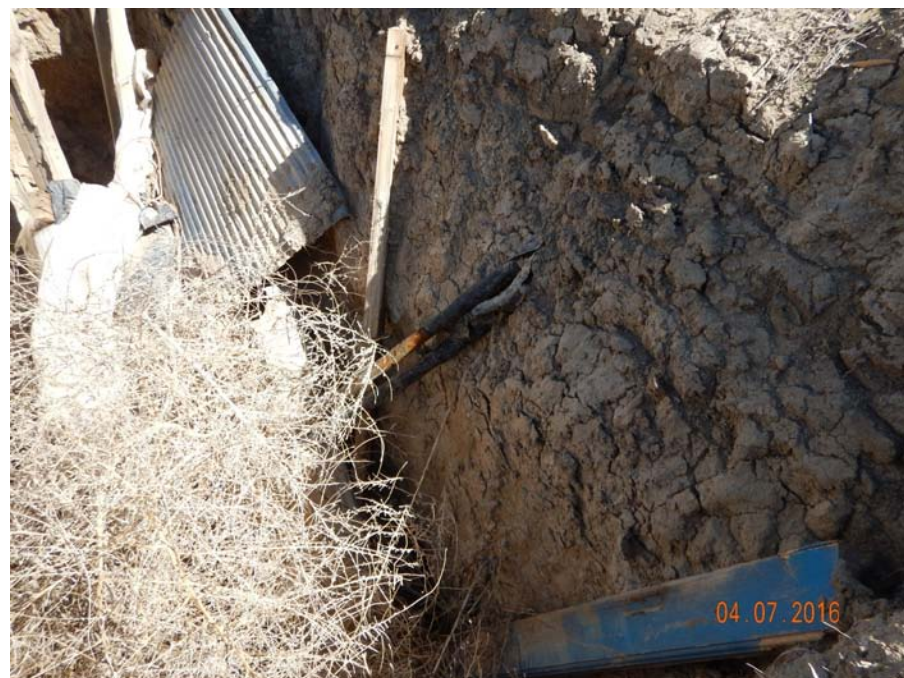
Figure 6 - Excavation observed SE of pit complex. Bottom photo is centered on possible flowlines leading into excavation.

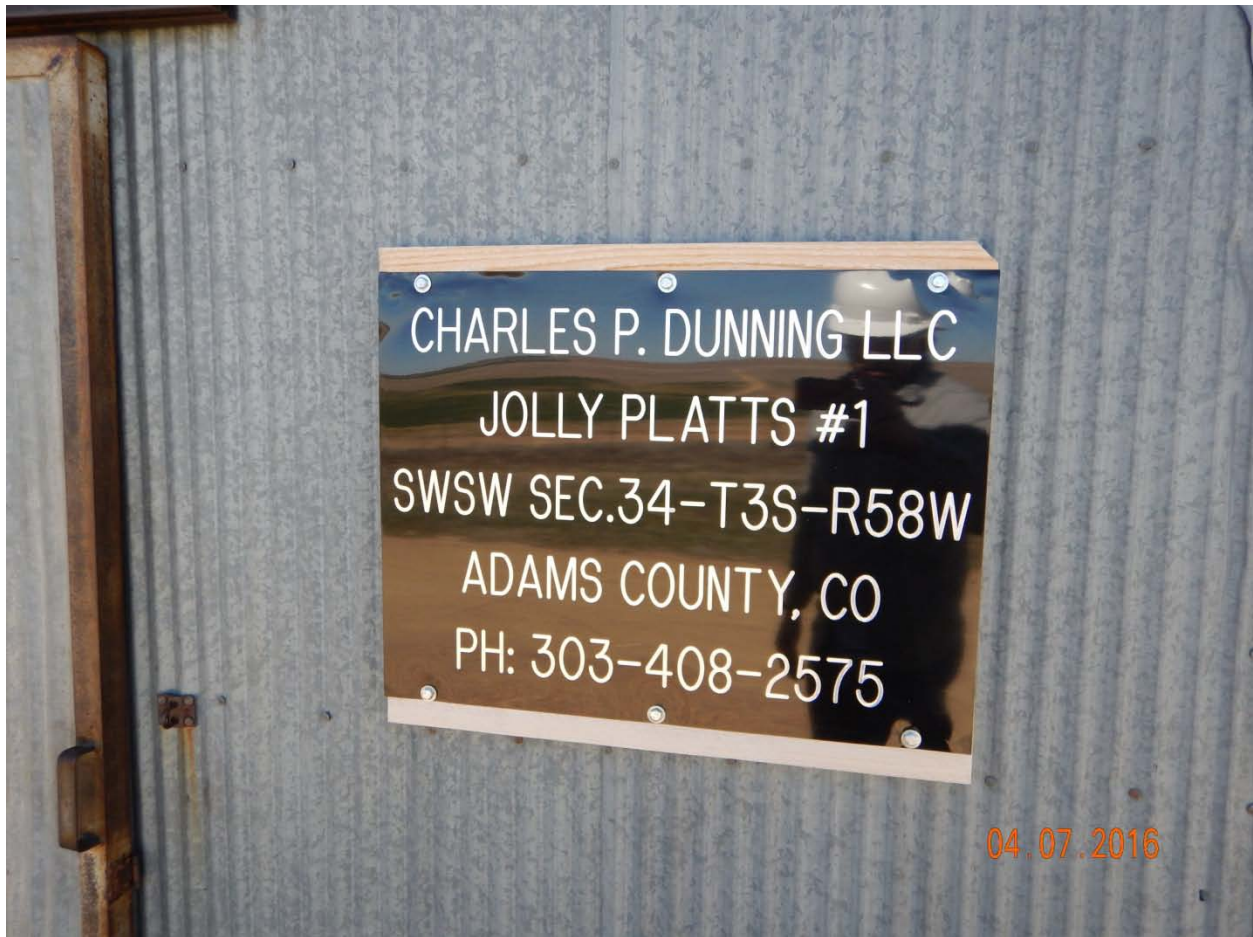
Figure 7 - Well sign.

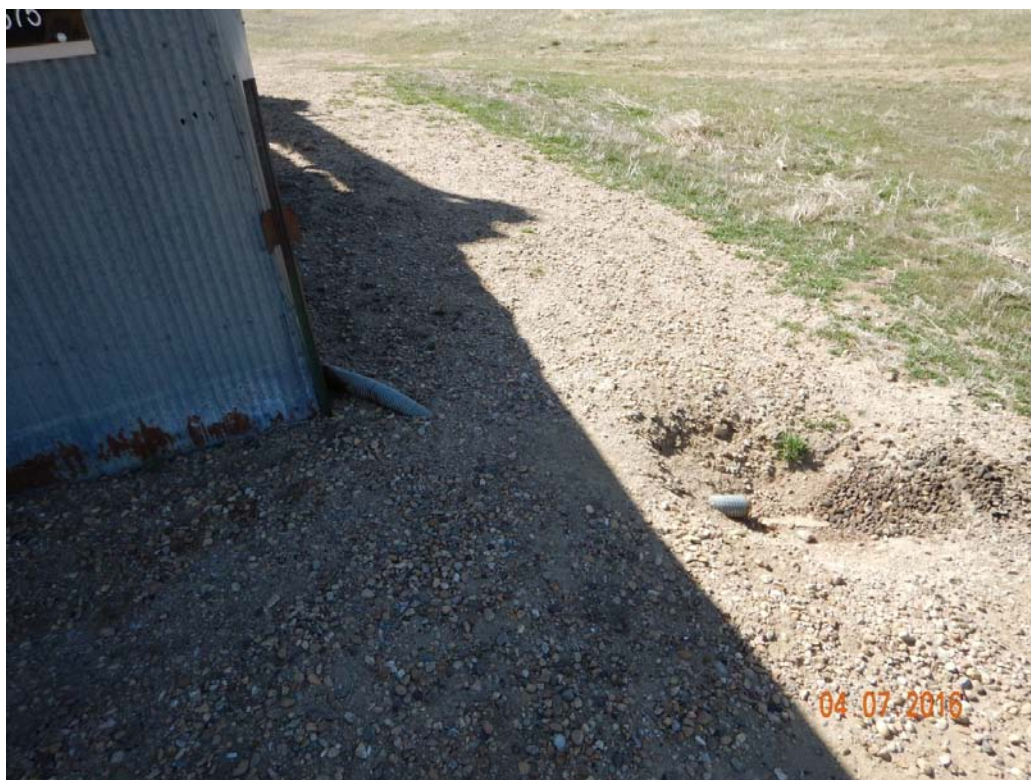
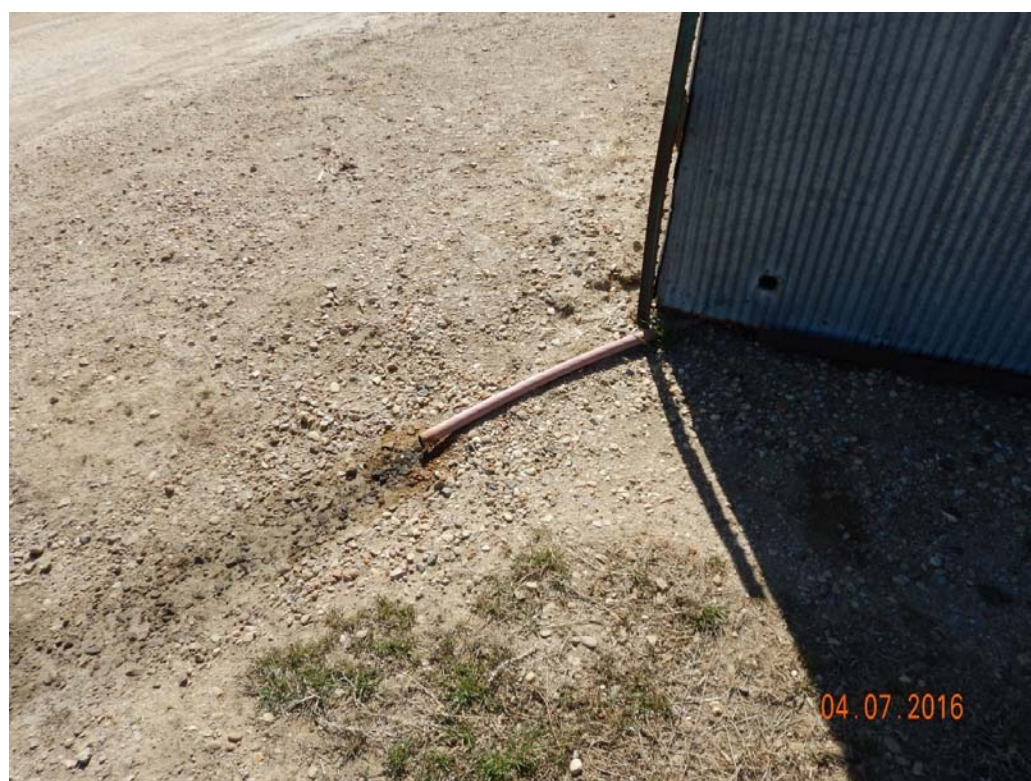
Figure 8 – Localized, oil-stained soil associated with exhaust lines on east side of pump jack shed.

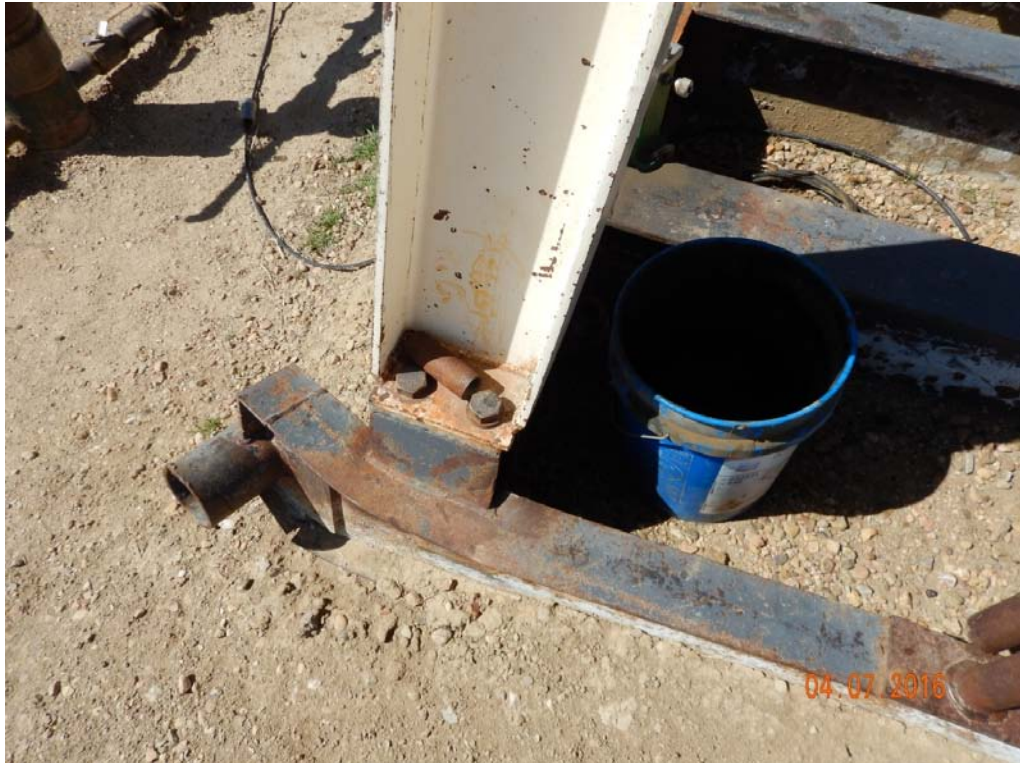
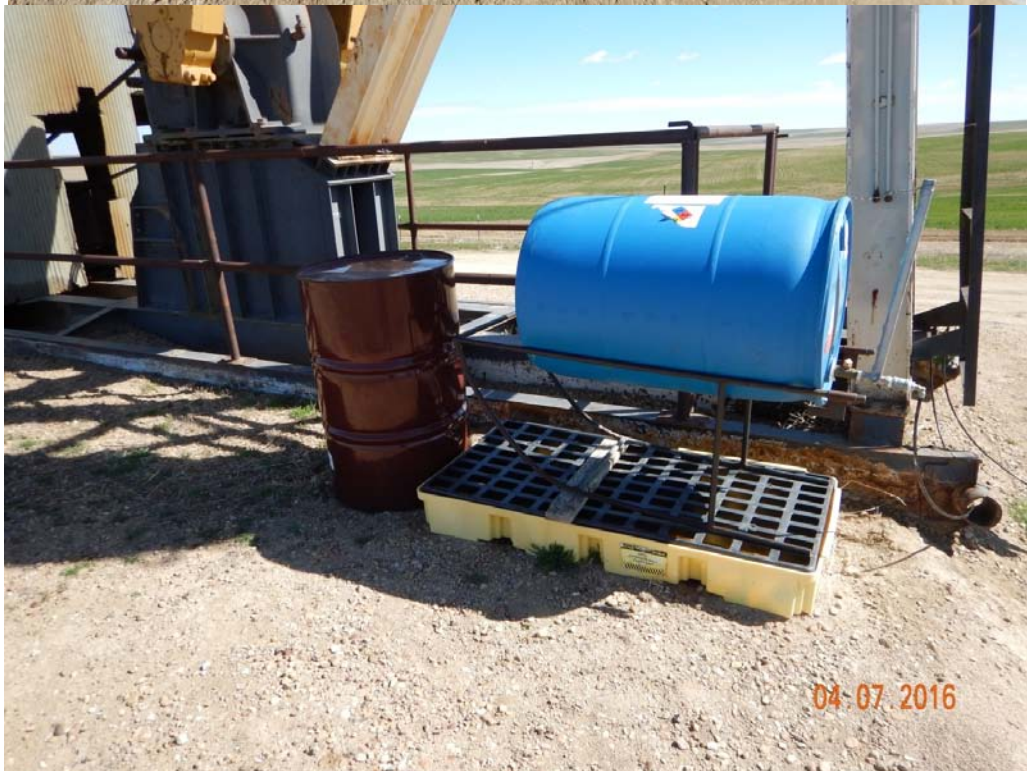
Figure 9 – Chemical storage containers at pumping unit lacking secondary containment.

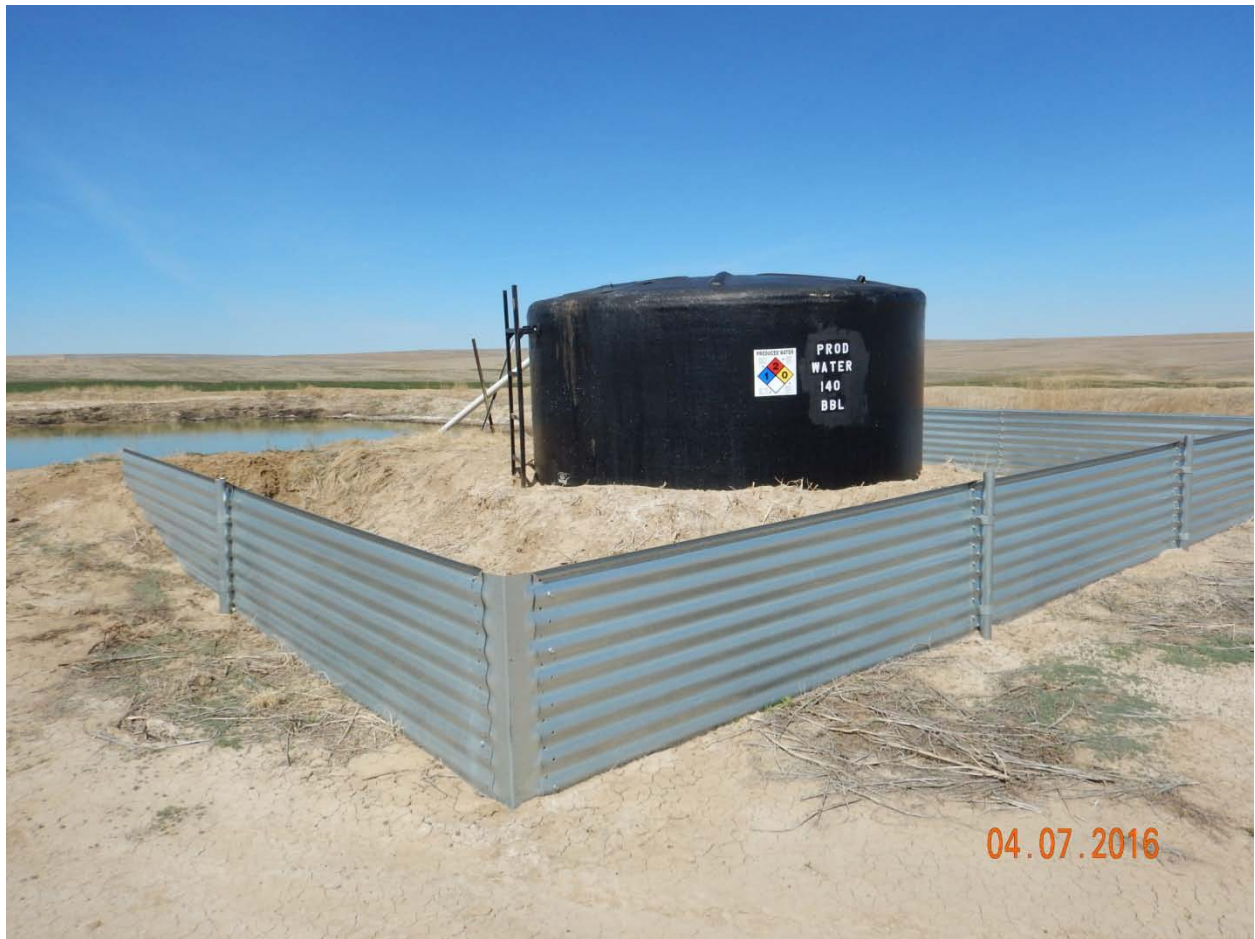
Figure 10 - Produced water vessel.

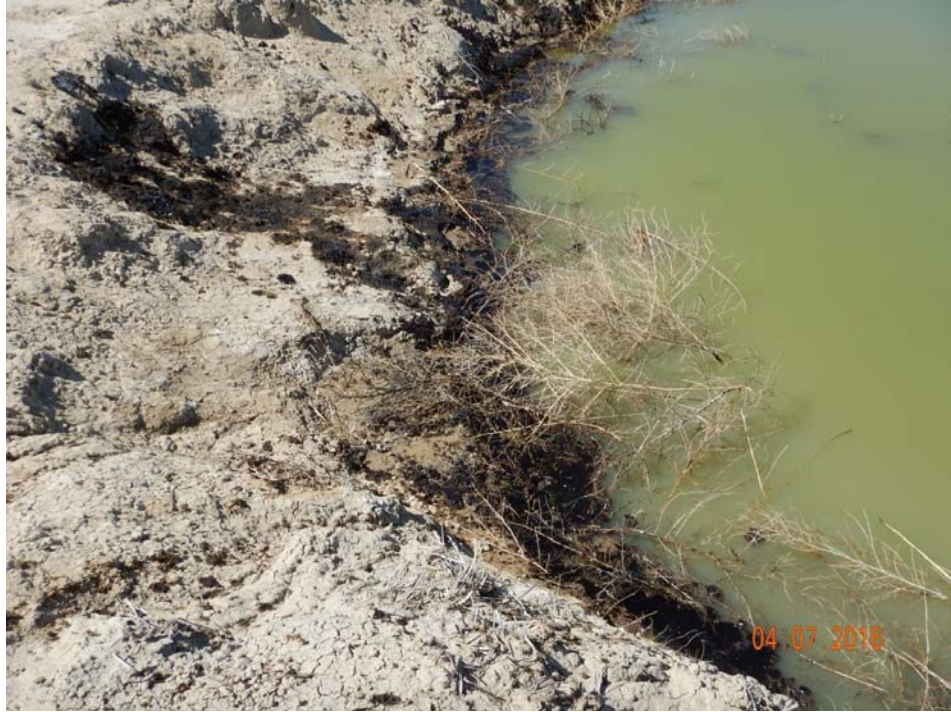
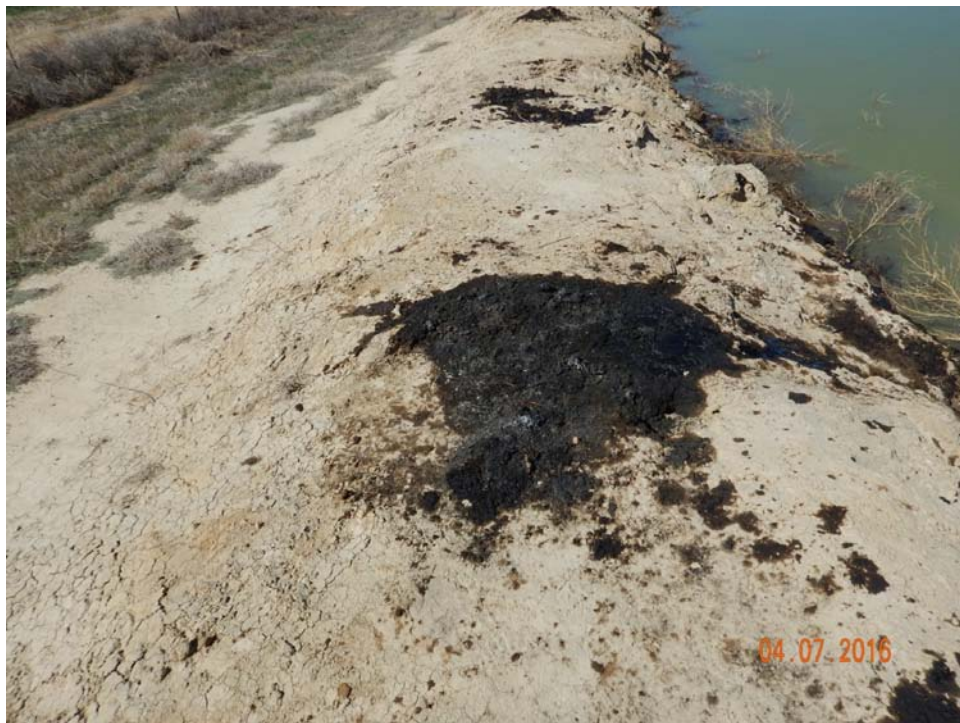
Figure 11 - Oil and stained soil around perimeter of SE produced water pit.

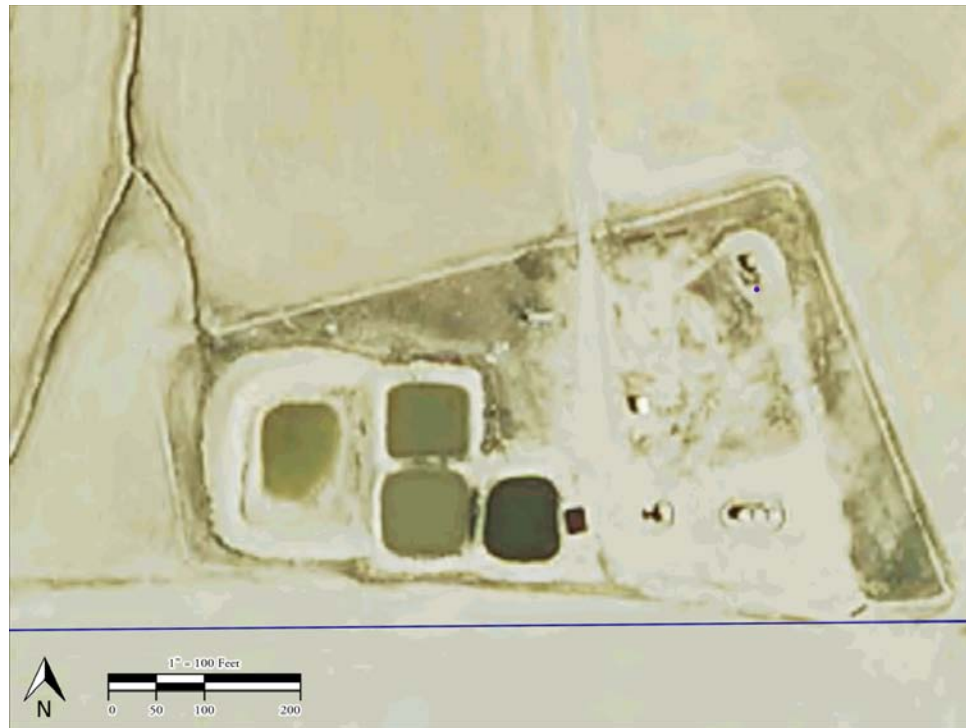
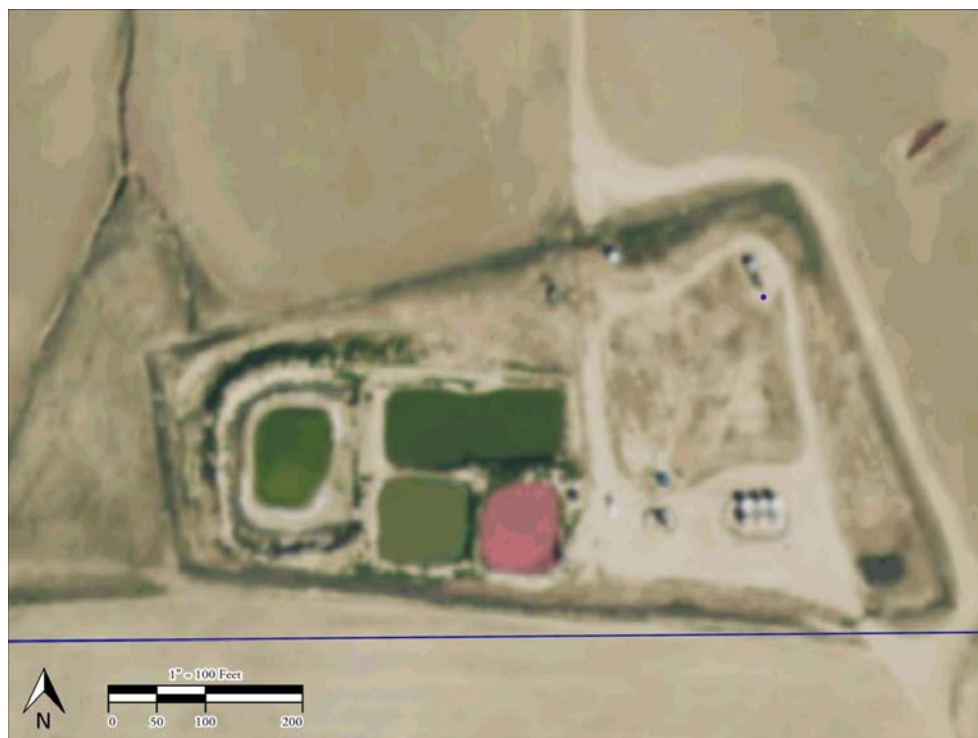
Figure 12 - Aerial photographs from 2013 (above) and 2015 (below) illustrate expansion of northern production pit and addition of three (3) crude oil tanks to tank battery.
