Interim Reclamation Inspection

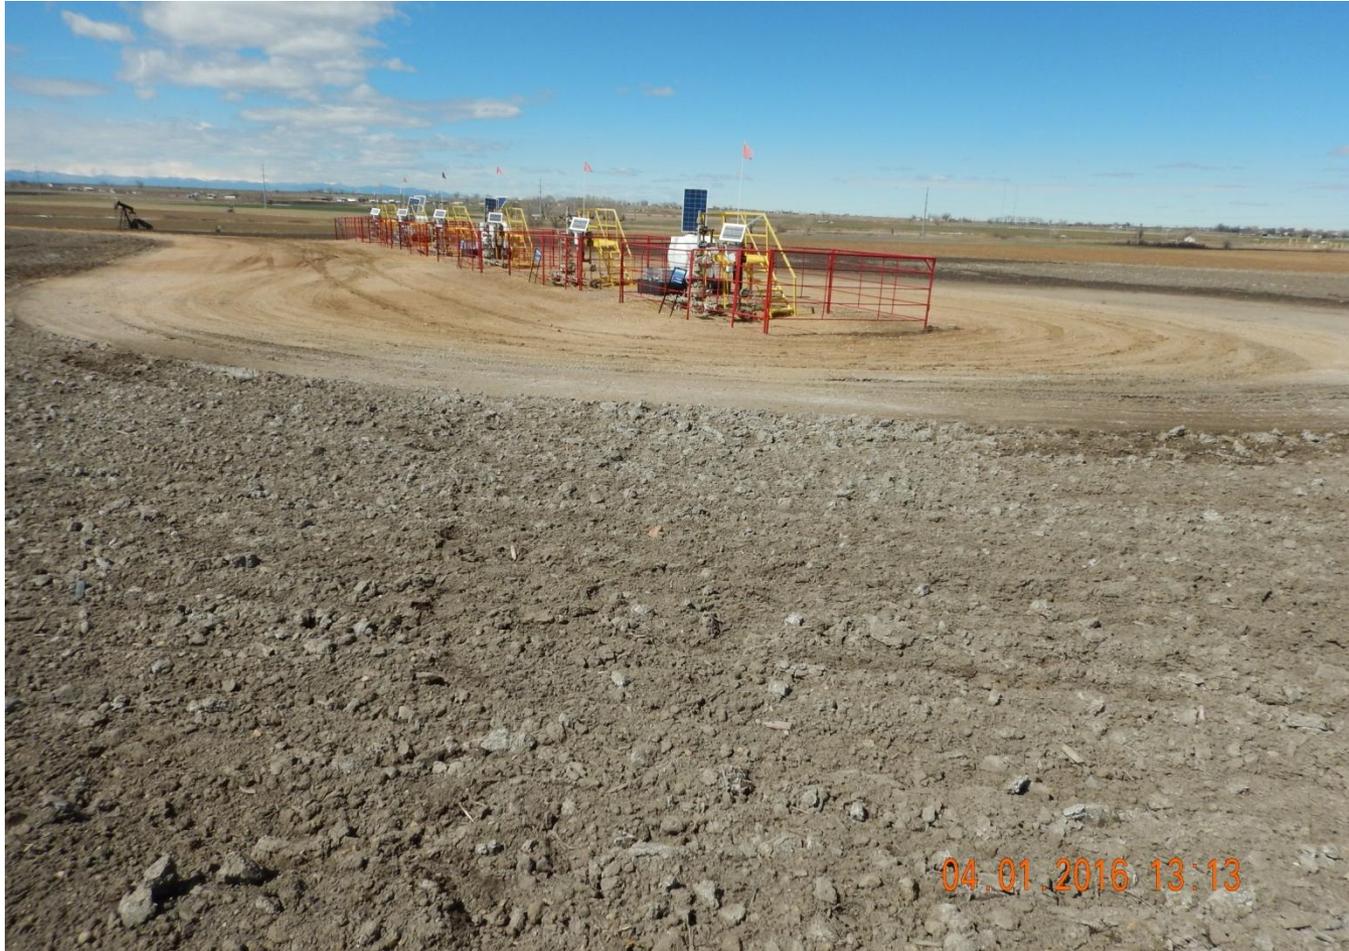
Photo 1. Photo taken east of location, facing West. Interim reclamation areas no longer in use have been reduced.

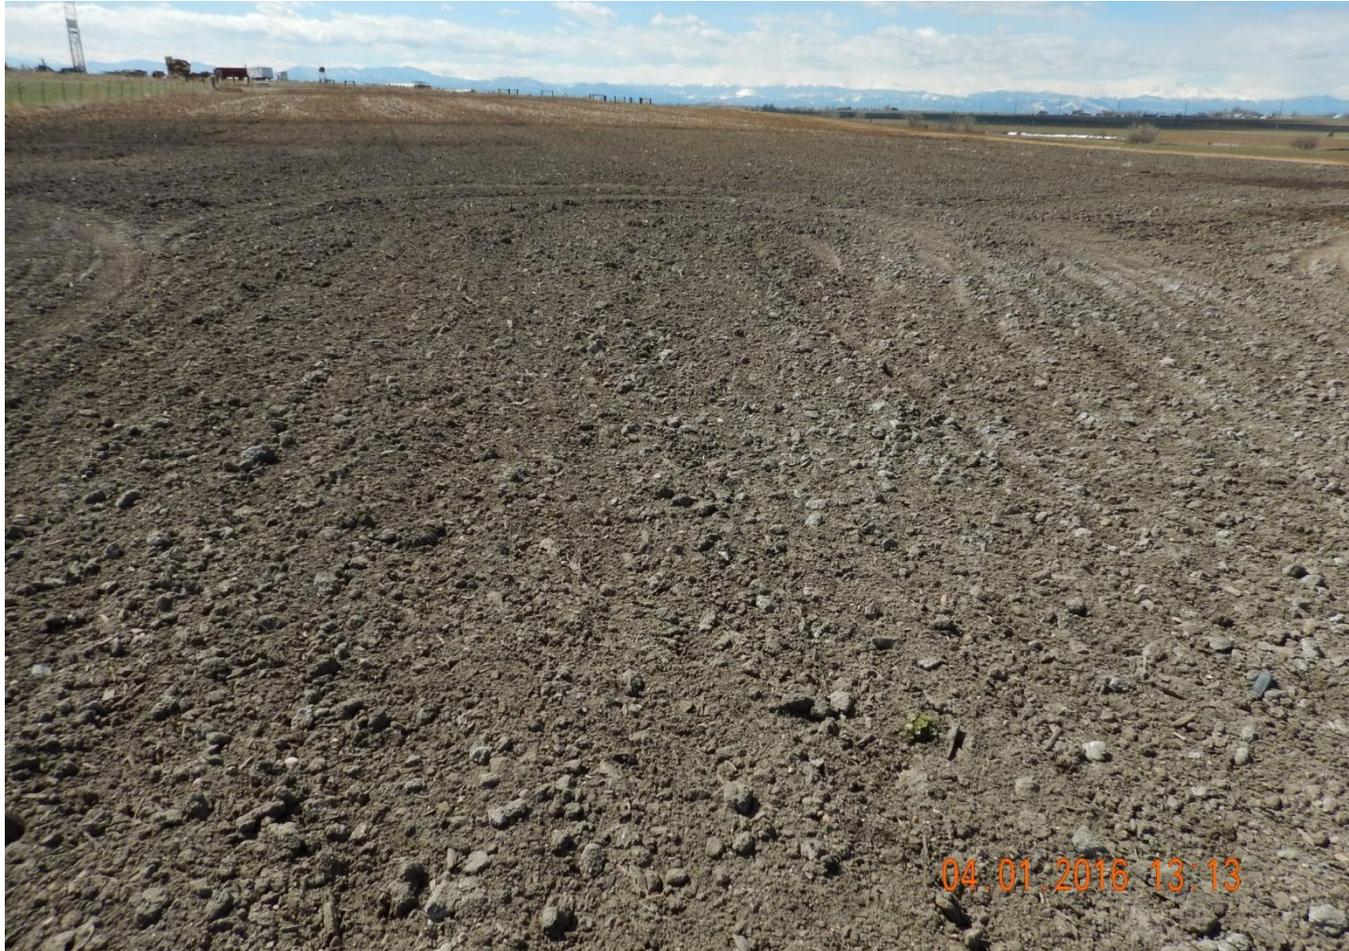
Photo 2. Photo taken east of location, facing Southwest. Cropland has been replaced to relative contour and tilled to re-establish a proper seedbed. Cropland will be evaluated at a future date to ensure compliance with Rule 1003 regarding revegetation.

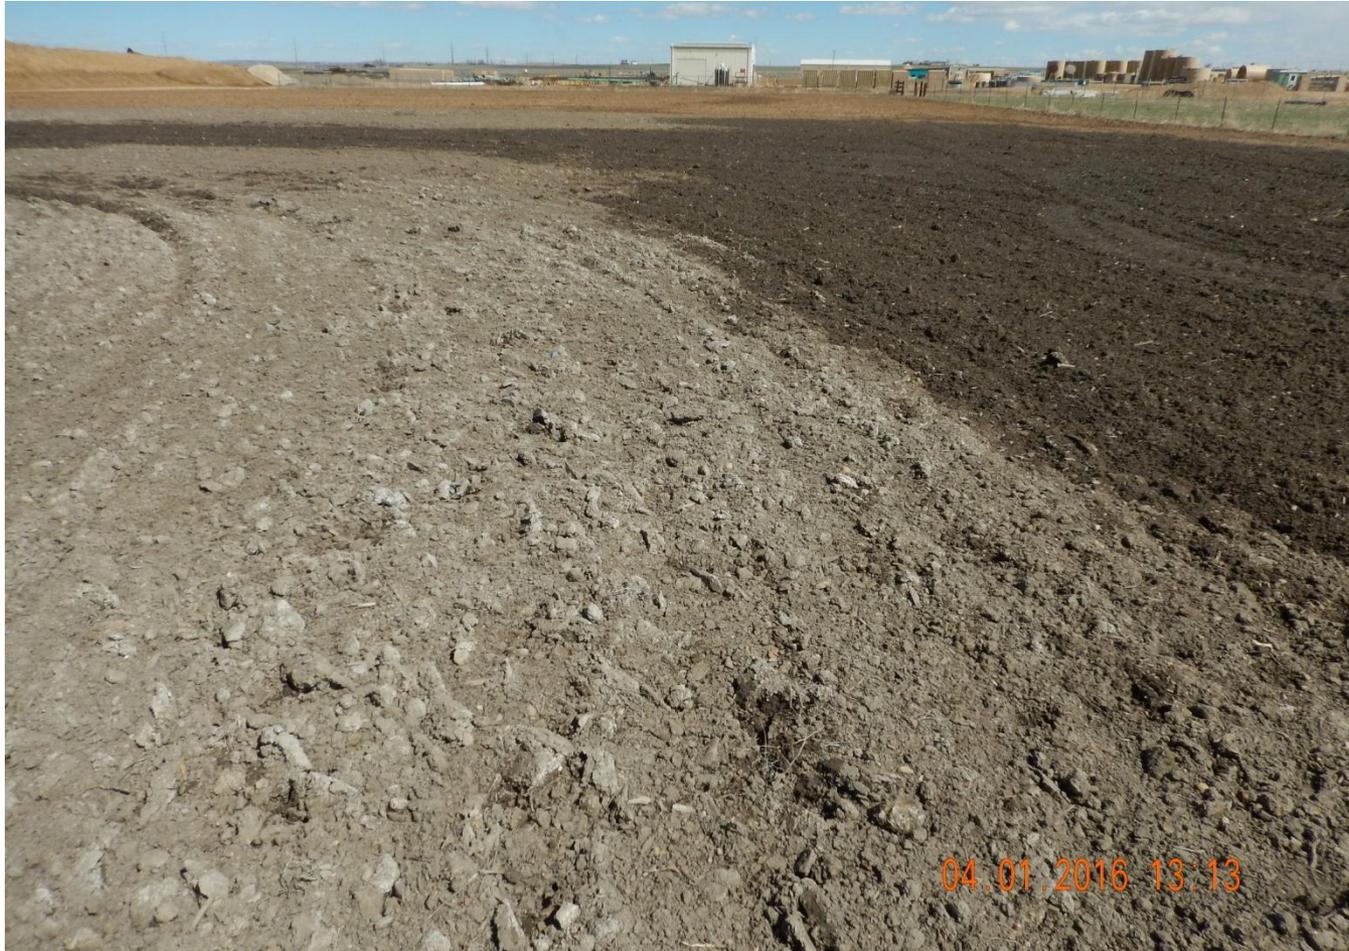
Photo 3. Photo taken east of location, facing East. Cropland has been replaced to relative contour and tilled to re-establish a proper seedbed. Cropland will be evaluated at a future date to ensure compliance with Rule 1003 regarding revegetation.

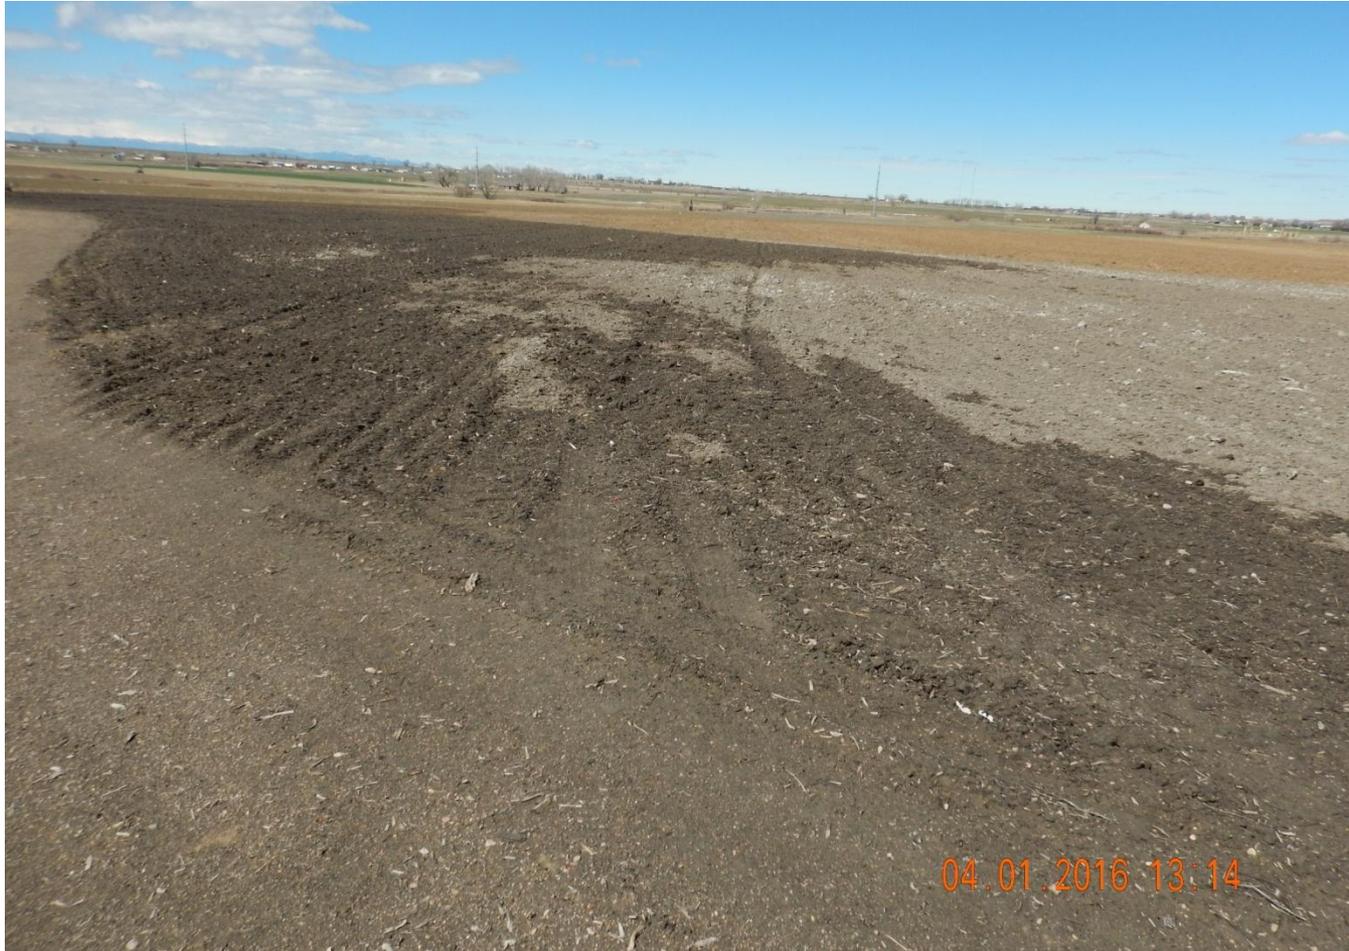
Photo 4. Photo taken east of location, facing North. Cropland has been replaced to relative contour and tilled to re-establish a proper seedbed. Cropland will be evaluated at a future date to ensure compliance with Rule 1003 regarding revegetation.
