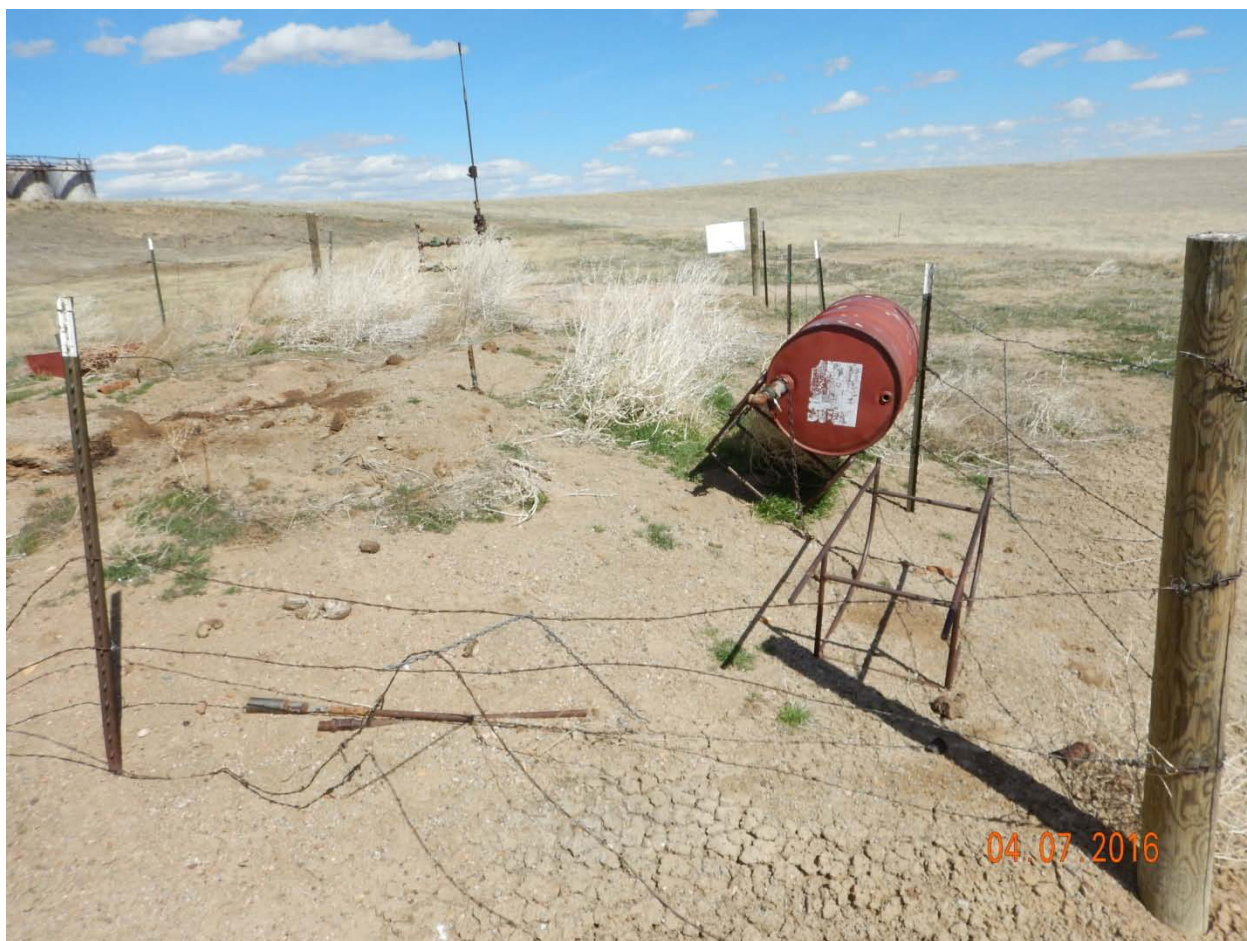
Figure 3 - Damaged fence, stained soil, chemical storage, and unused equipment on west side of well pad.

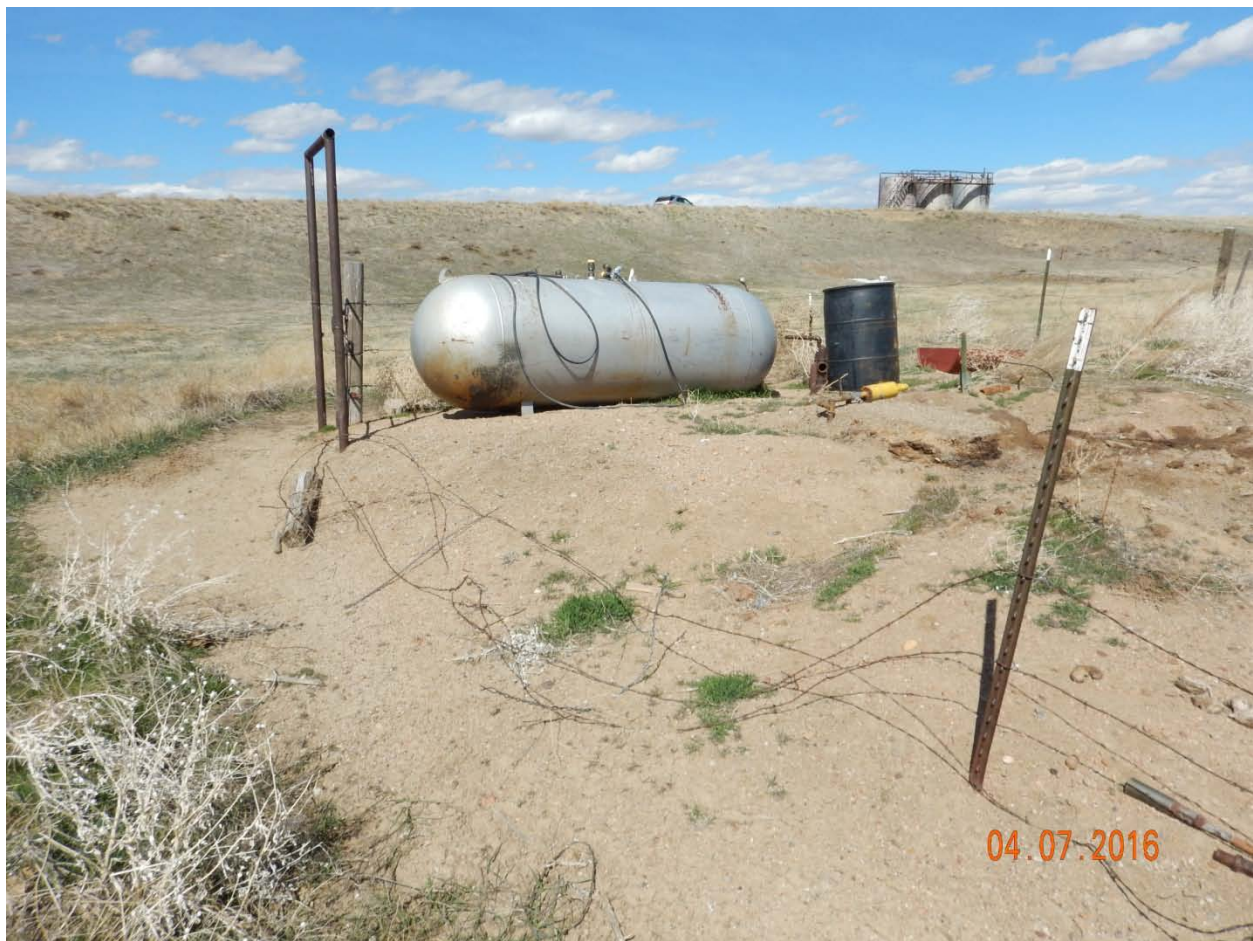
Figure 4 - Damaged fence, chemical storage container, unused propane tank, and additional debris at northwest corner of well pad.

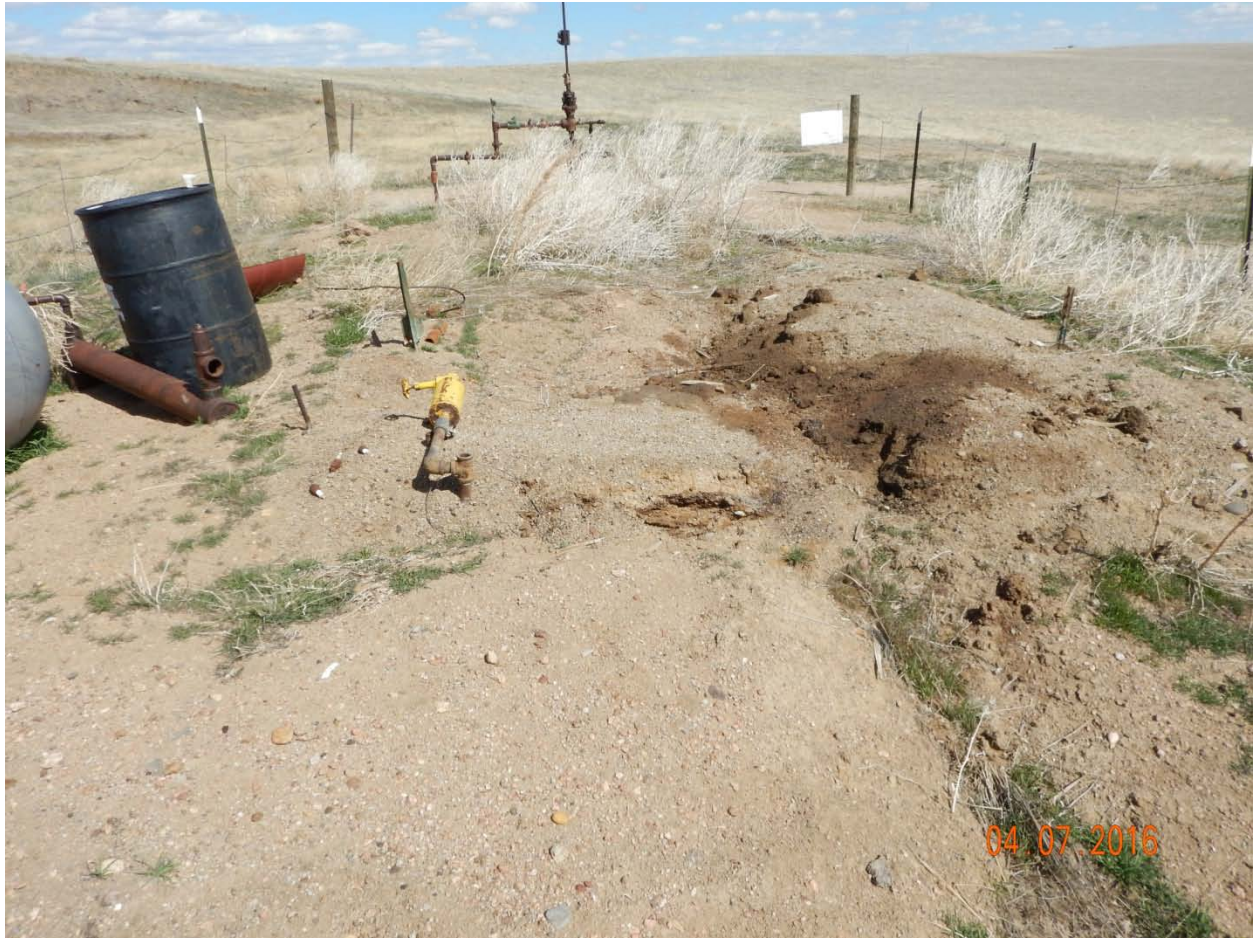
Figure 5 - Oil-stained soil at former pump jack location.

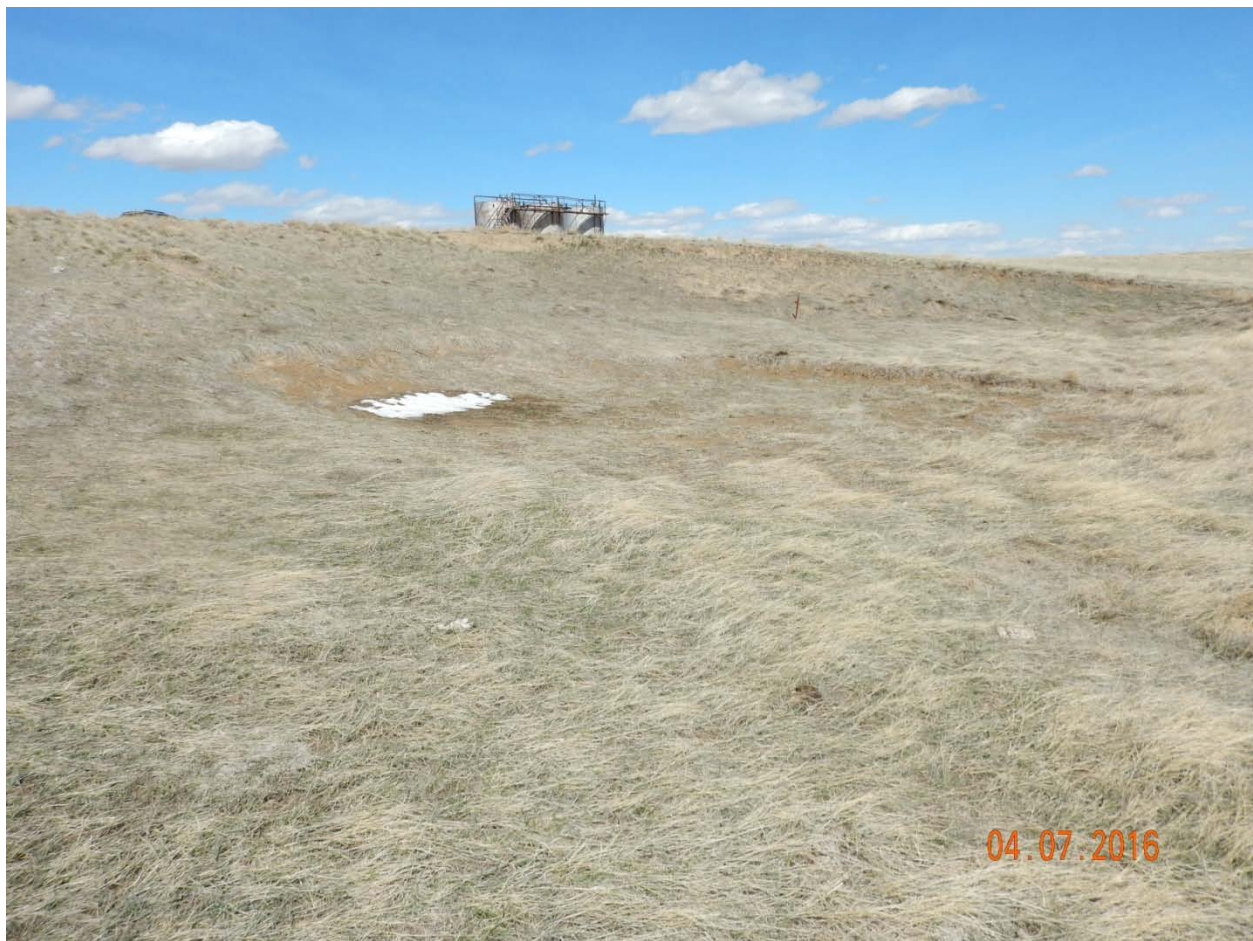
Figure 6 – Low area observed northeast of wellhead (possible former pit location).

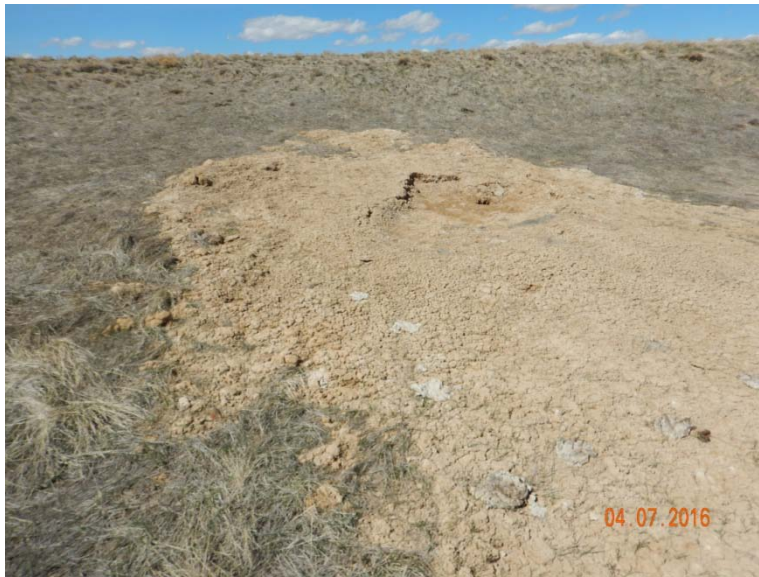
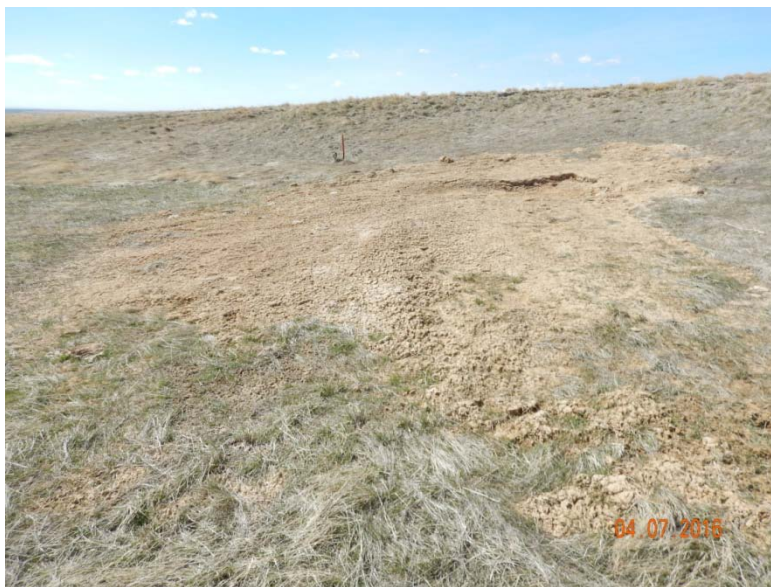
Figure 7 - Excavation and bare soil observed northwest of well pad.

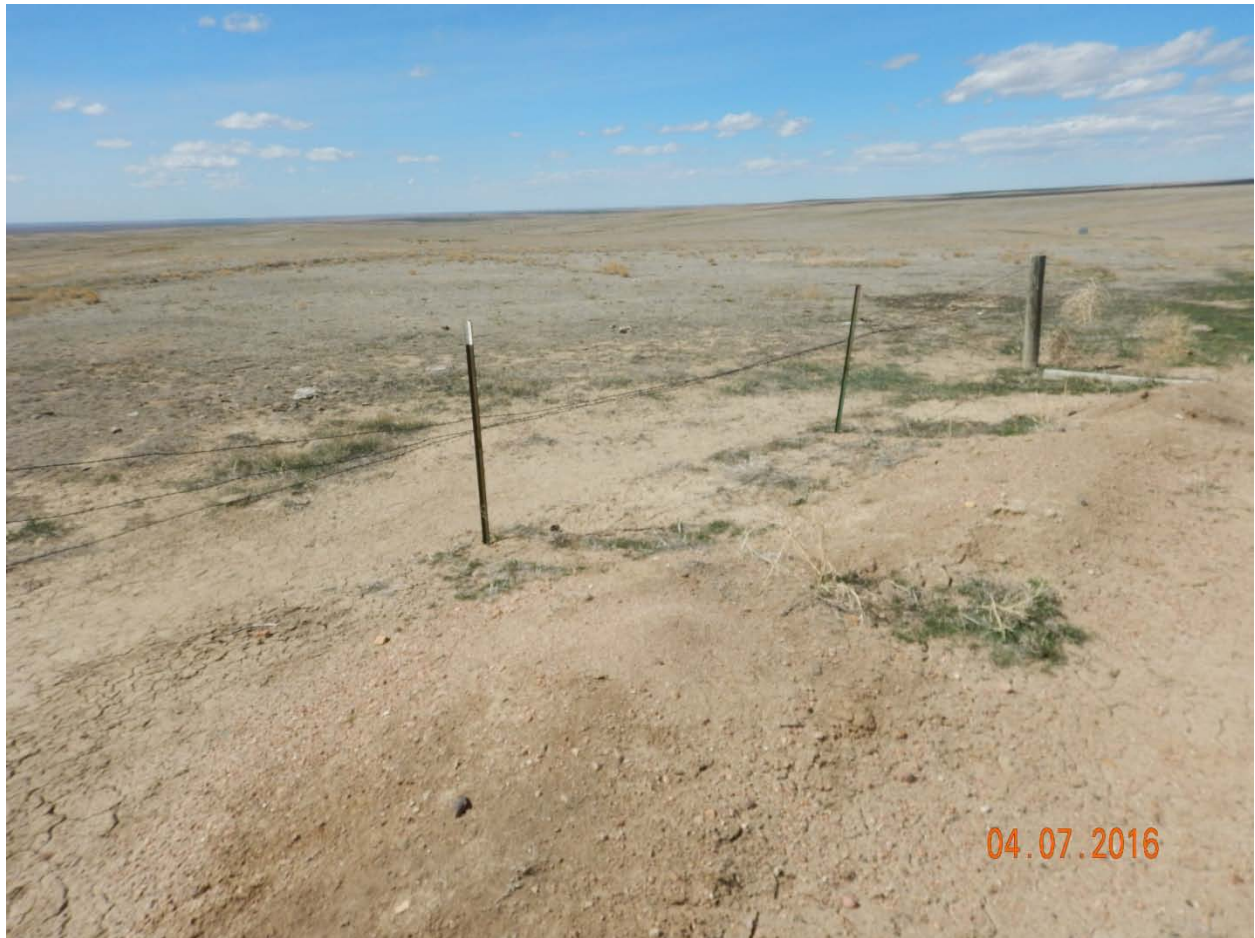
Figure 9 - West side tank battery fence in need of repair.

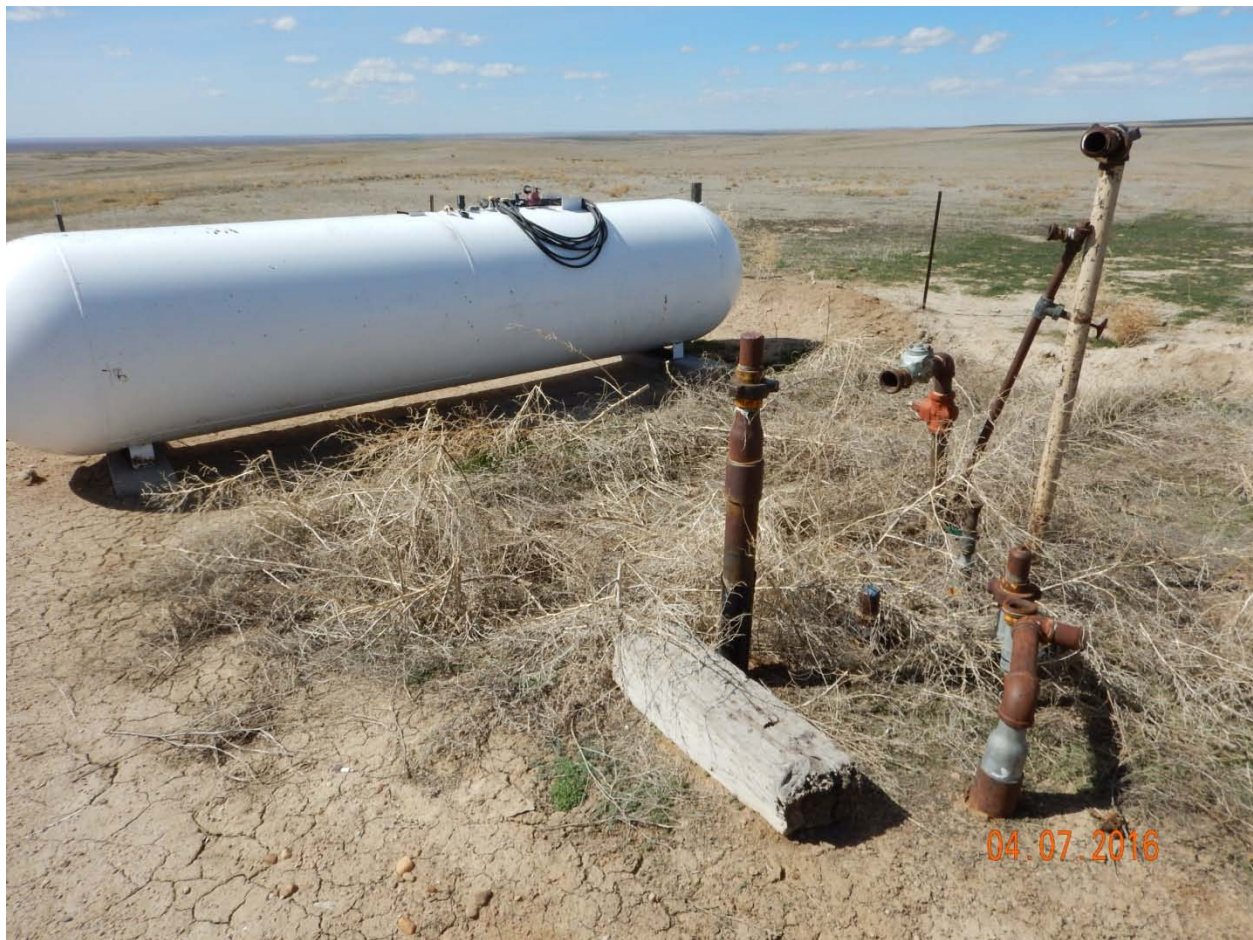
Figure 10 - Unused propane tank, weeds, wooden debris, and exposed flowlines at former heater treater location (west of tank battery).

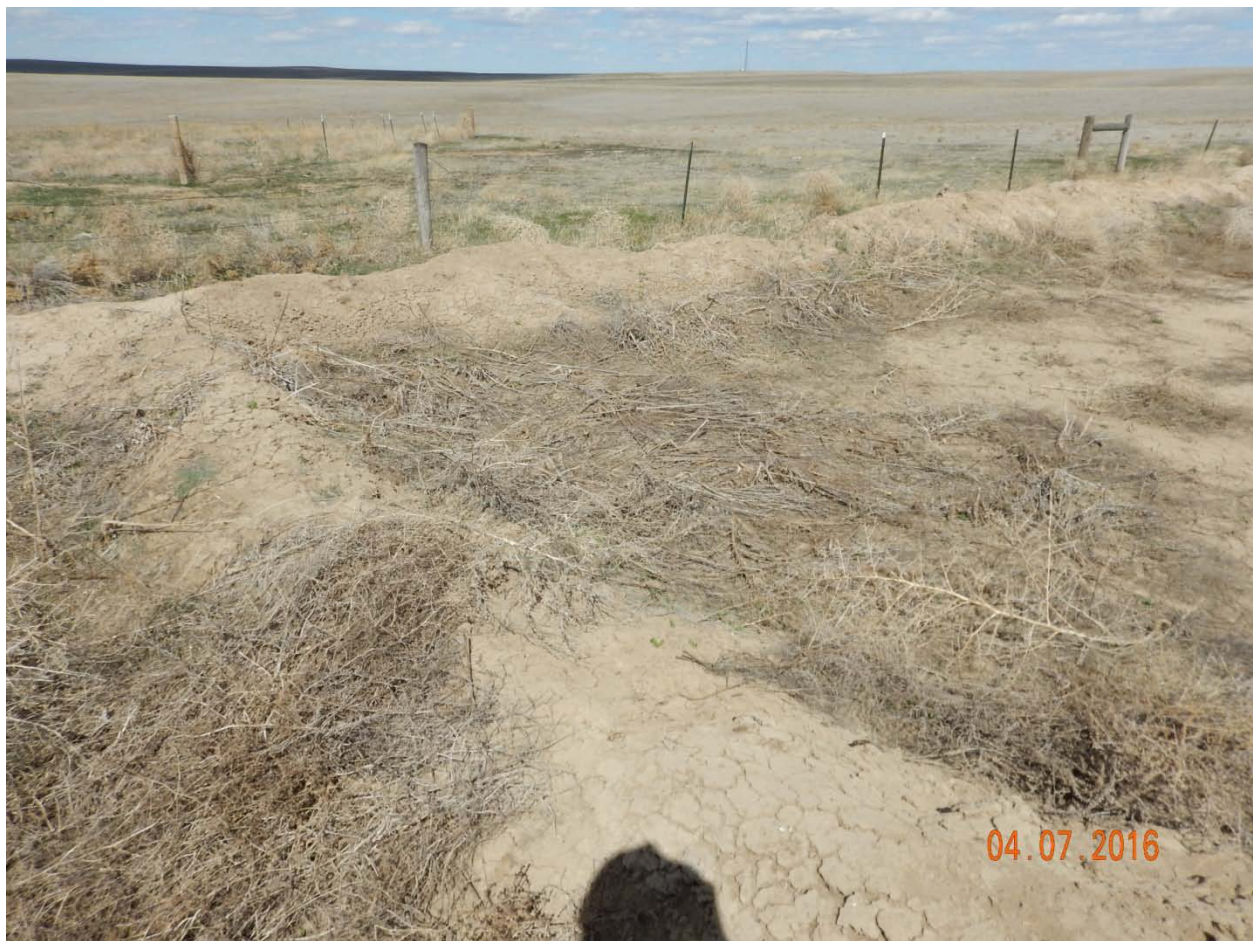
Figure 11 - Low points in tank battery berm (NW corner) and uncontrolled weeds.

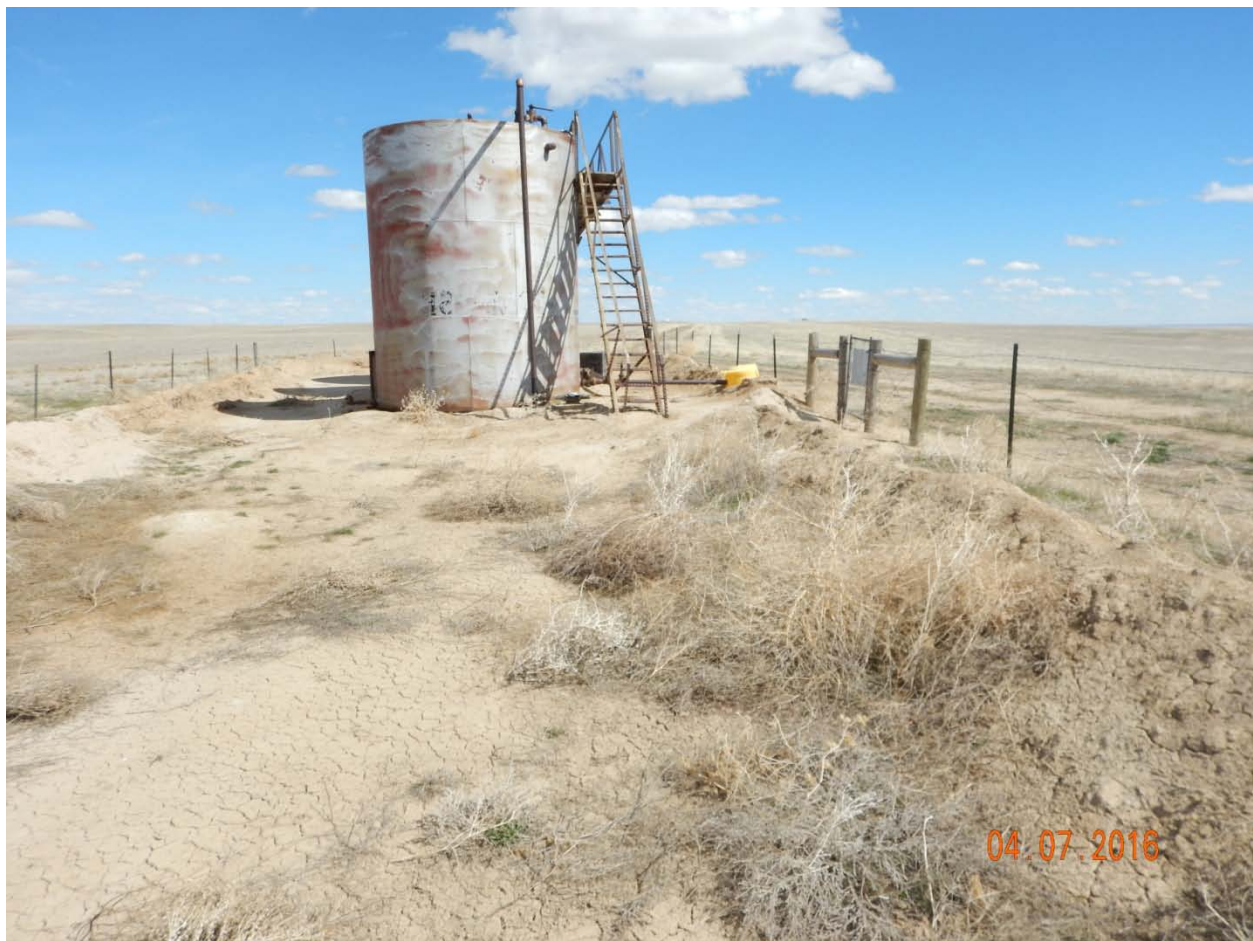
Figure 12 - Western crude oil tank, low berm, and uncontrolled weeds at SW corner of tank battery.

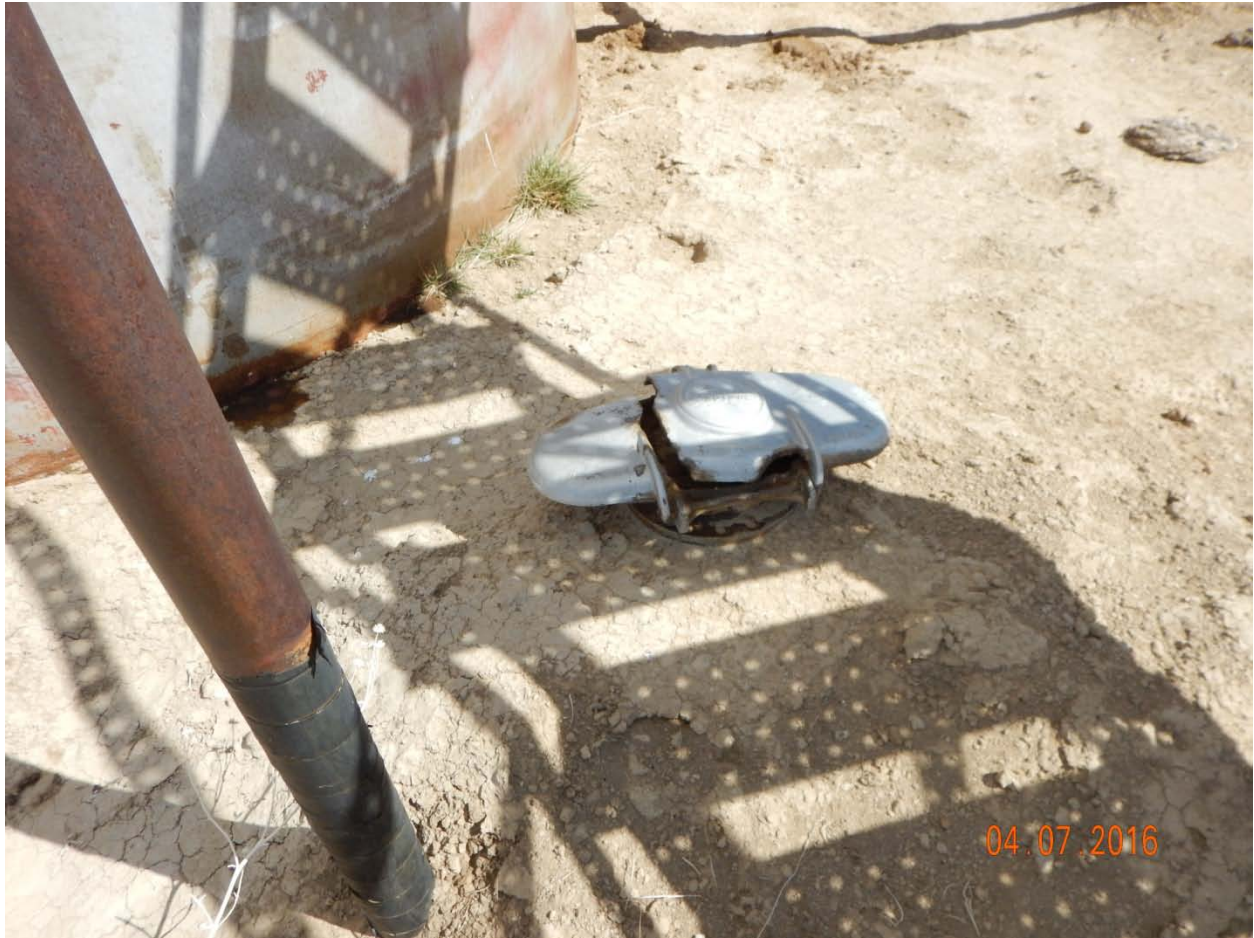
Figure 13 - Unused thief hatch and oil-stained soil west of crude oil tank.

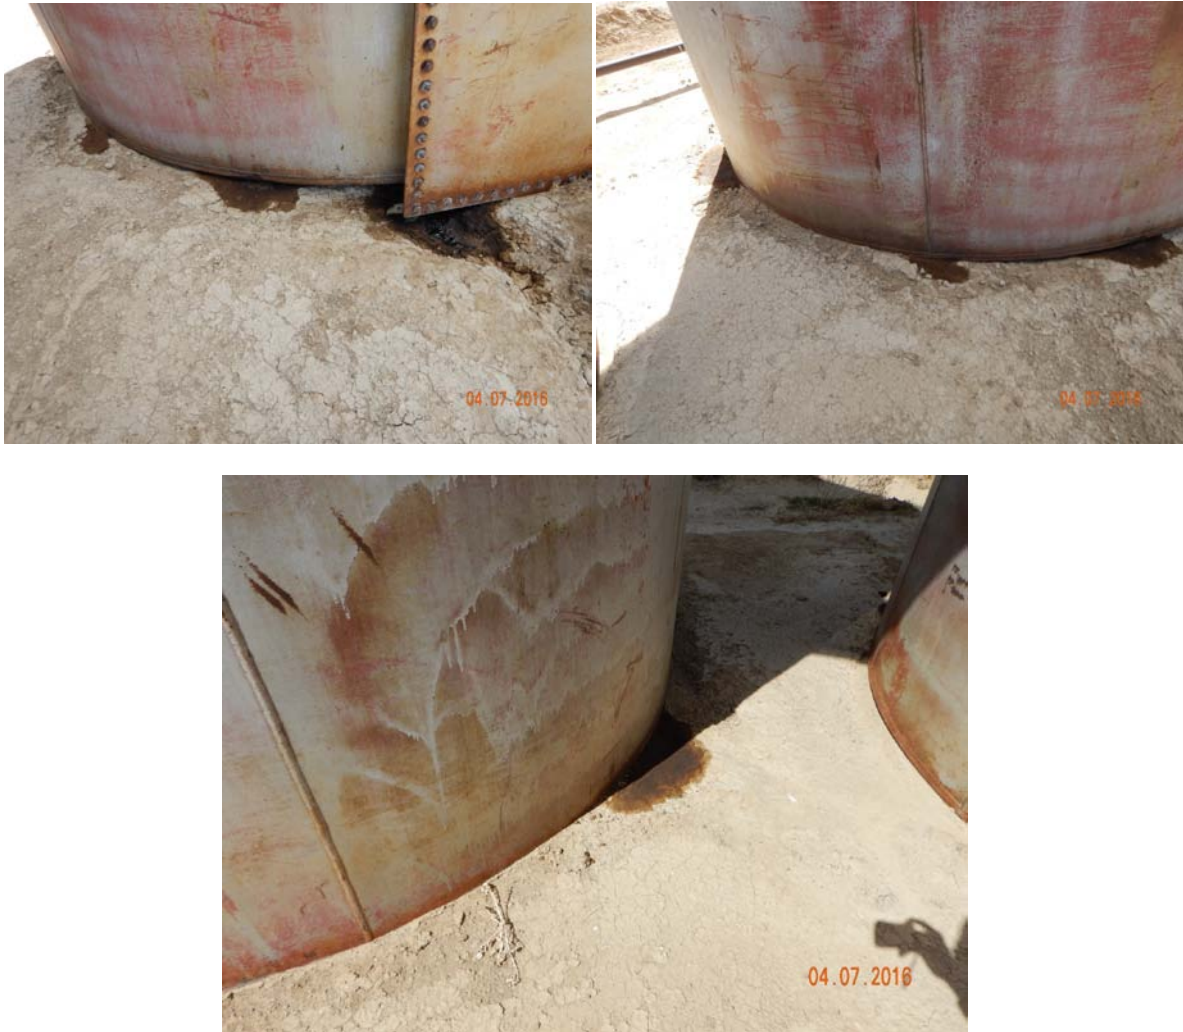
Figure 14 - Oil-stained soil, erosion rills, and seeps from crude oil tanks.

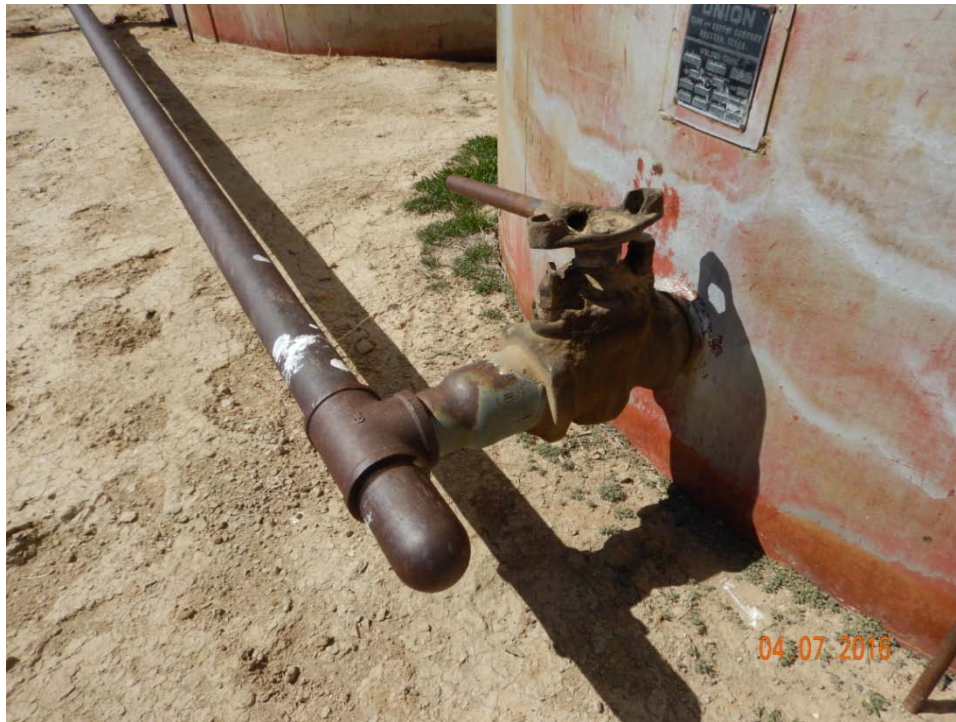
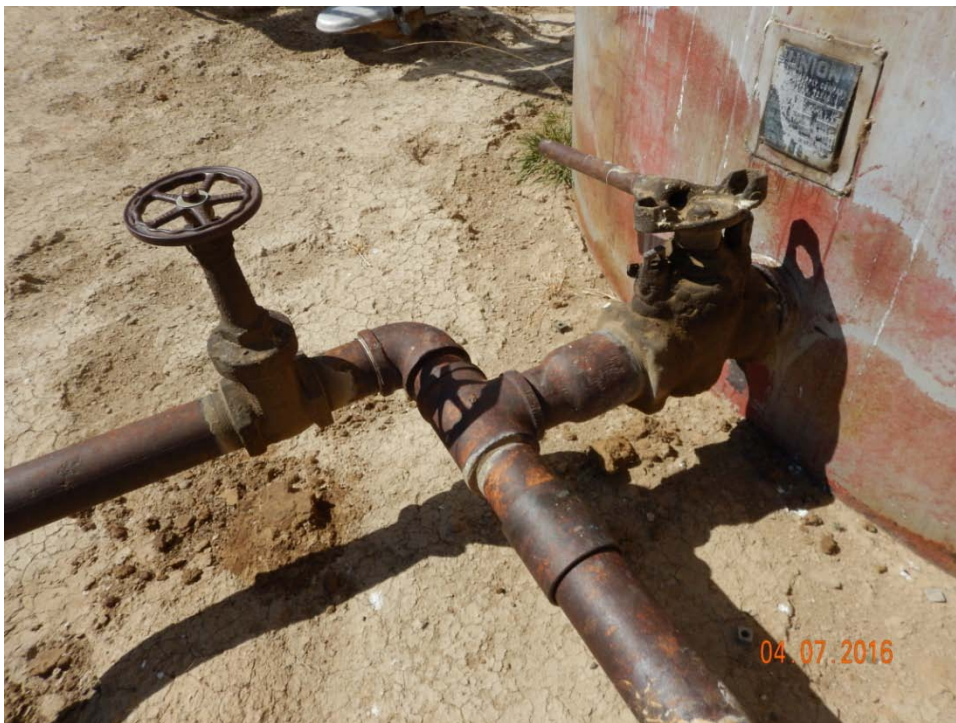
Figure 15 - Oil-stained soil at leaking valves on crude oil tanks.
