Interim Reclamation Inspection

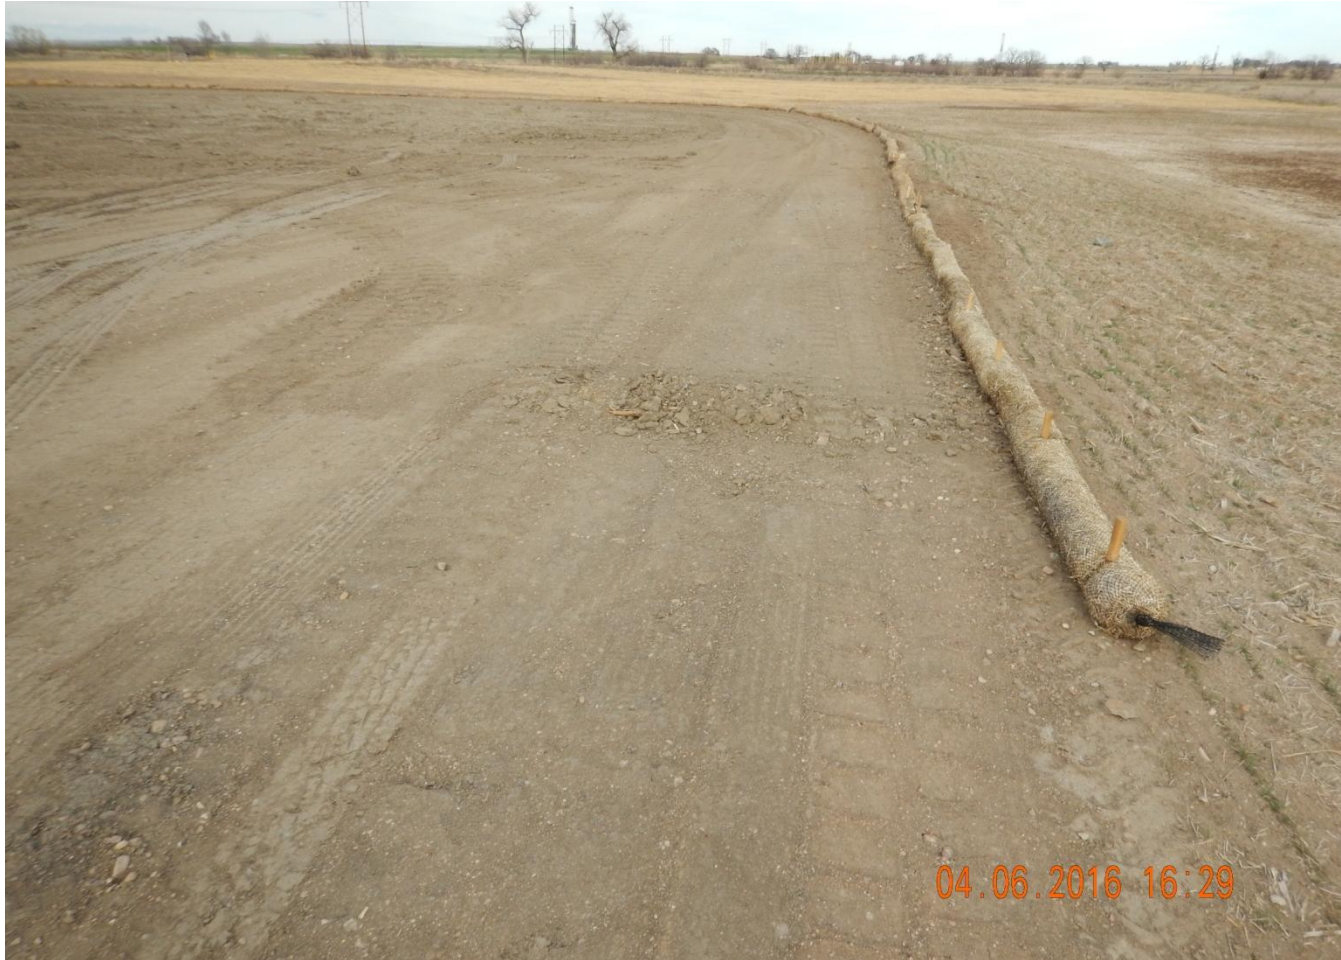
Photo 1. Photo taken from southern location, facing East. Stormwater controls have been installed along southern, eastern and northern location areas.

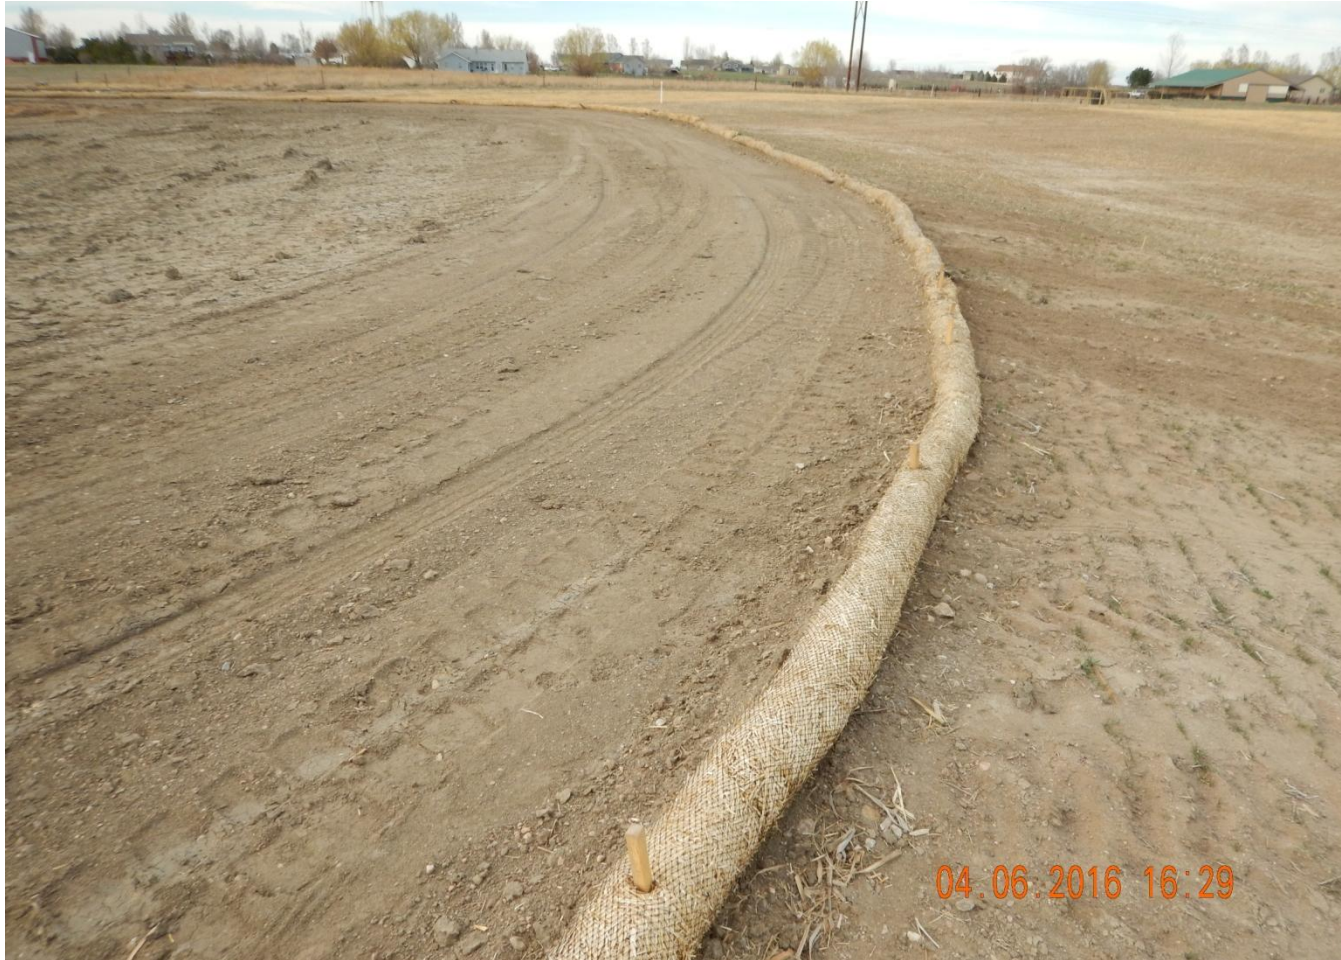
Photo 2. Photo taken from eastern location, facing North. Stormwater controls have been installed along southern, eastern and northern location areas.

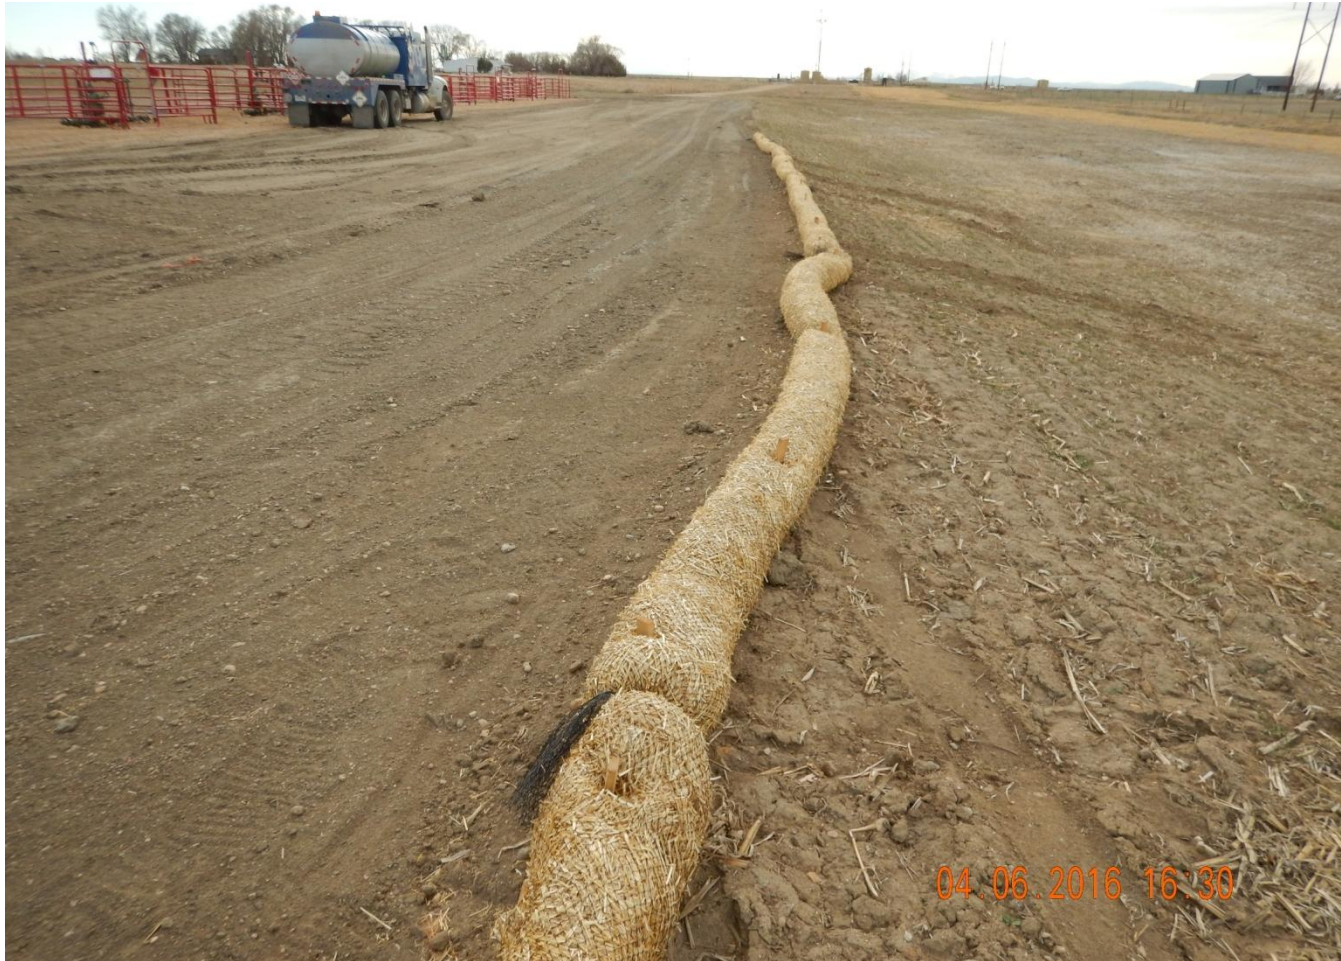
Photo 3. Photo taken from northern location, facing West. Stormwater controls have been installed along southern, eastern and northern location areas.

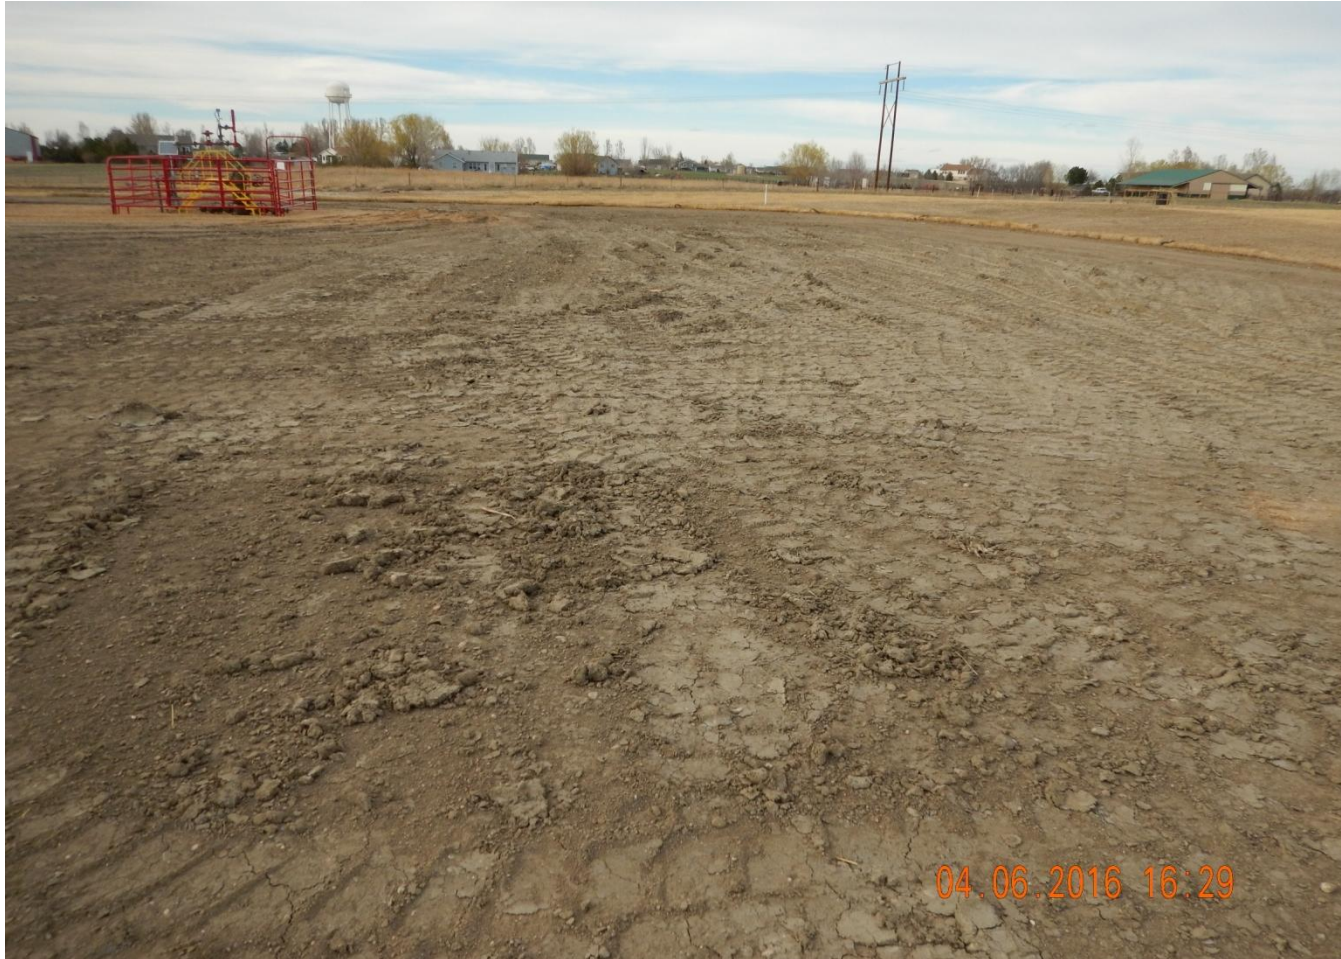
Photo 4. Photo taken from southern location, facing North. Ponding water has been filled in to control additional runoff onto eastern location.
