Interim Reclamation Inspection

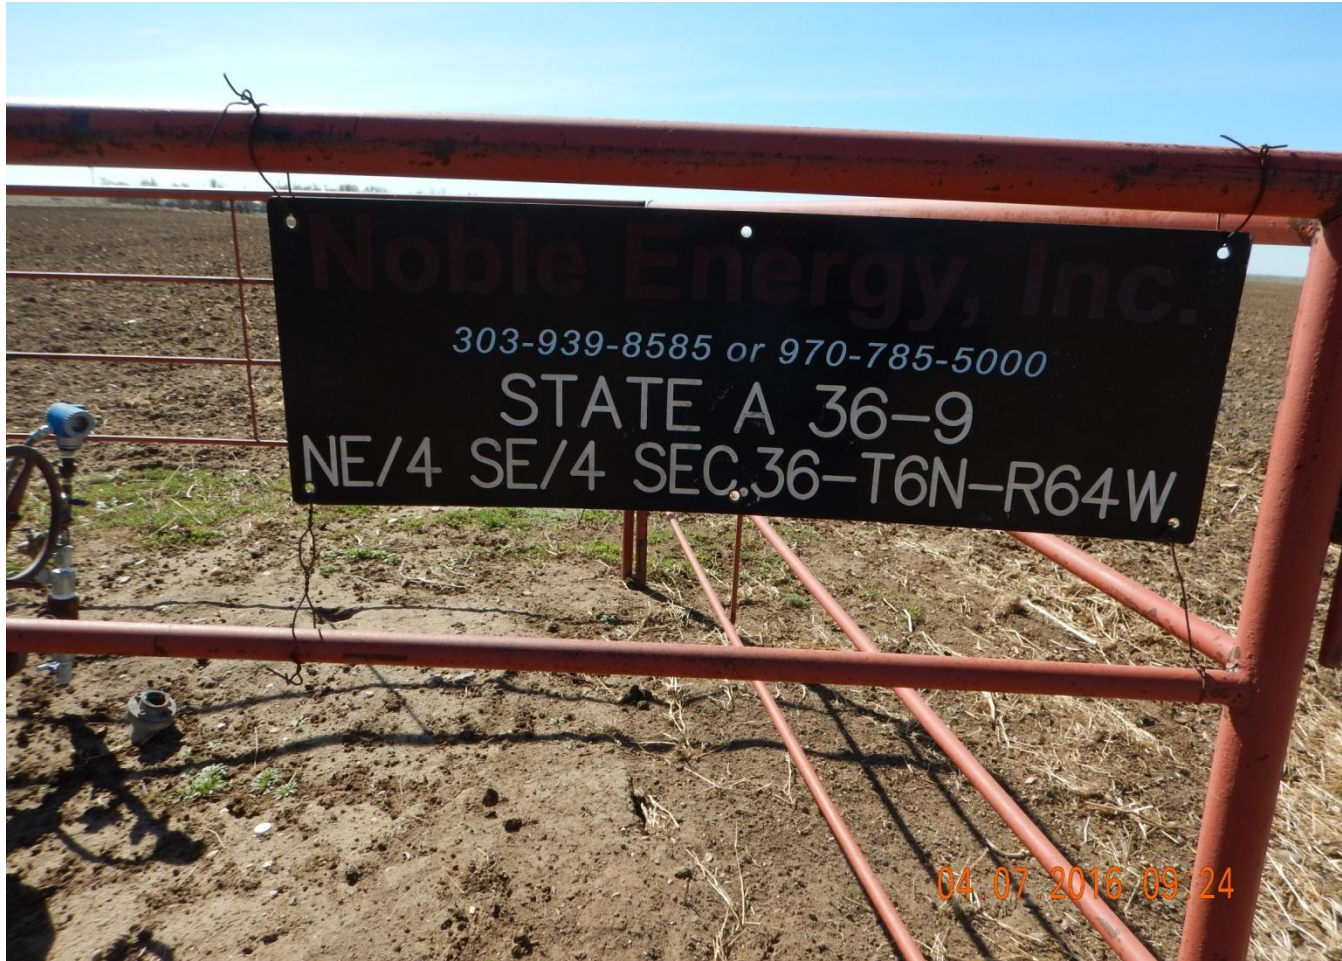
Photo 1. Photo taken of PR well sign for API 123-14790.

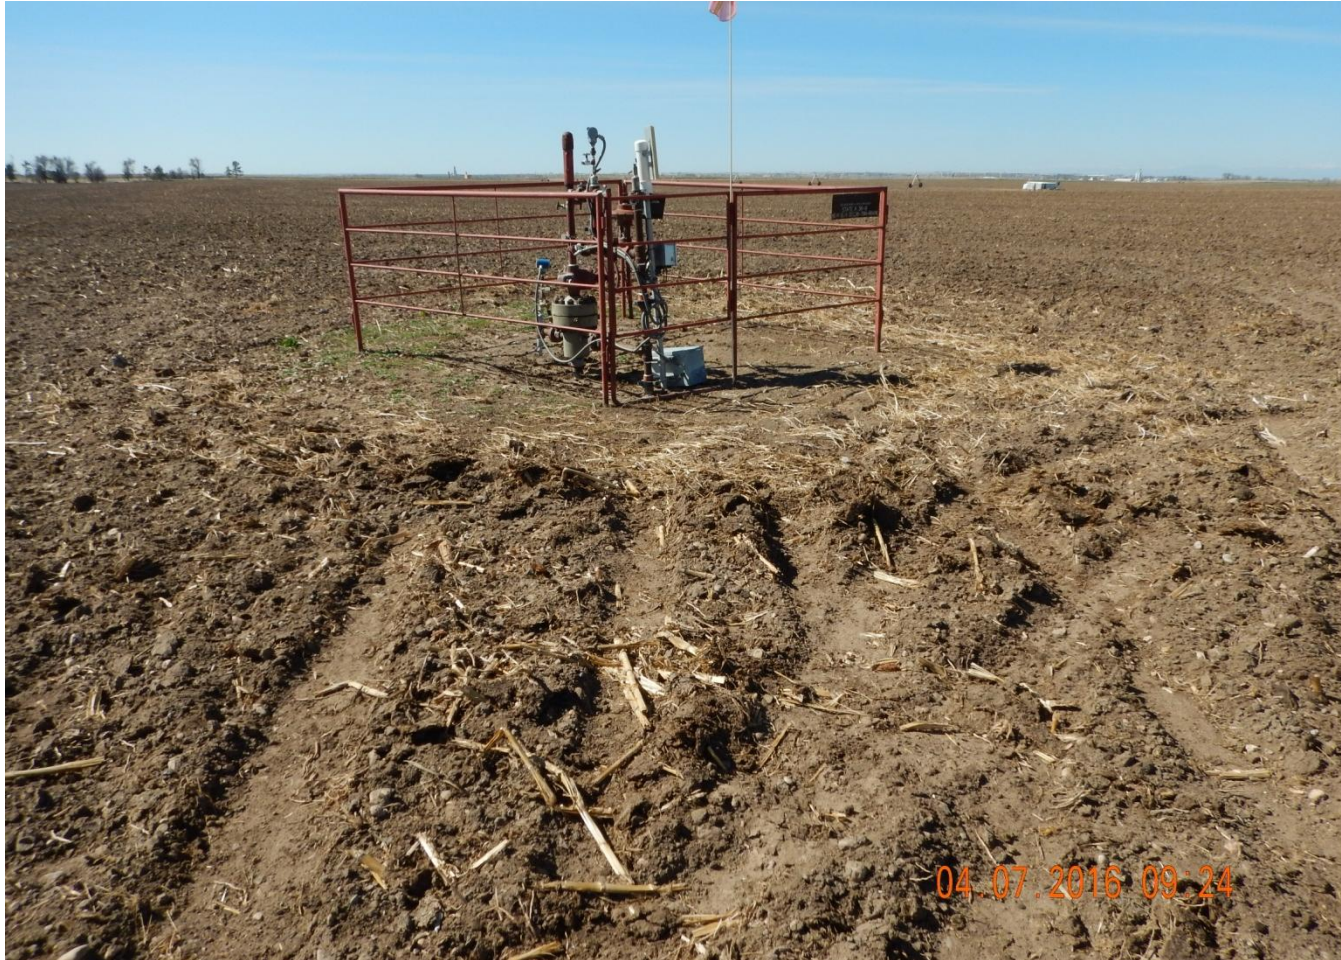
Photo 2. Weeds have been removed around wellhead.
