COGCC staff, Kris Neidel on location with Tammie Crossen, Chevron staff to inspect location. Pit was currently in use; not lined, oil present, netting/fence appears good, freeboard >2'. Pit is west, north-west of a stormwater impoundment (see aerial image attached). There is a gate on the stormwater impoundment that is kept closed. This impoundment is used as part of the SPCC for the collection station. Chevron told COGCC when stormwater accumulates in the impoundment, after it is determined that the water is all stormwater, the gate is opened and water allowed to flow to ditches.

Collection Station 3

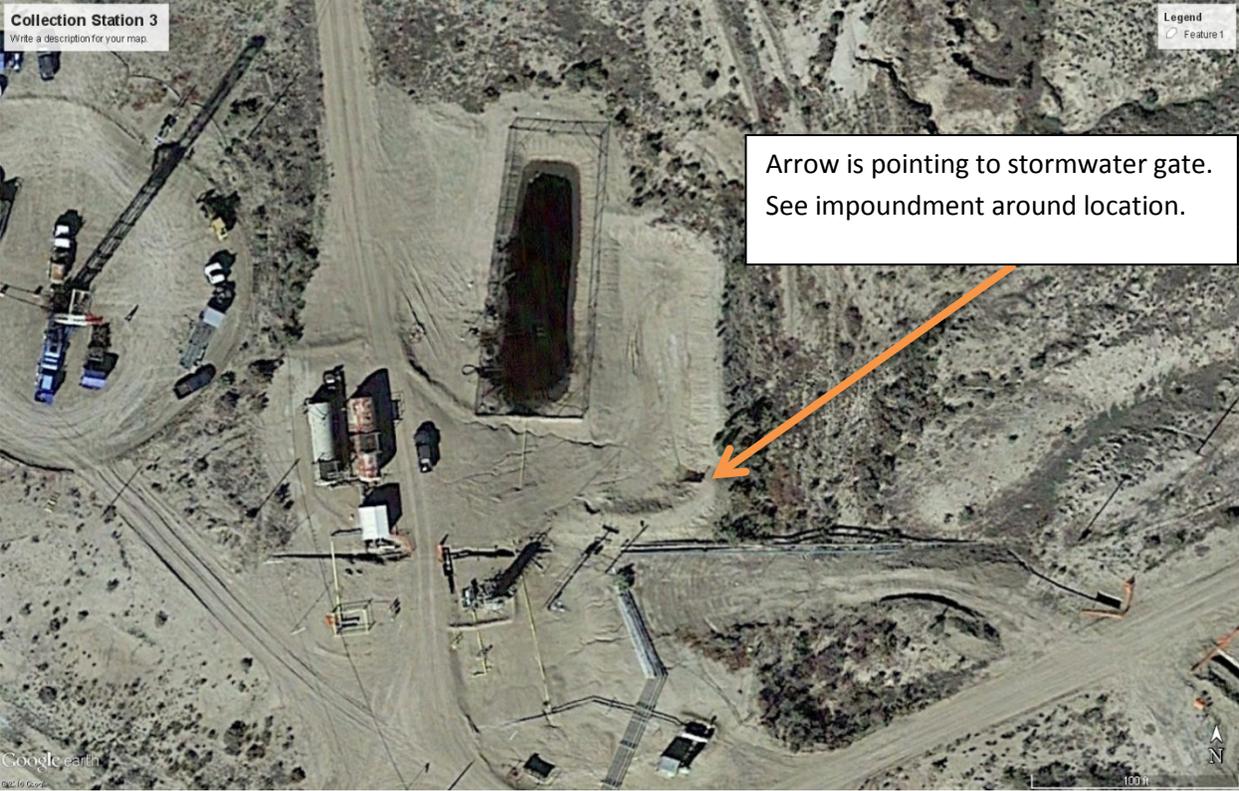
Arrow is pointing to stormwater gate.
See impoundment around location.
