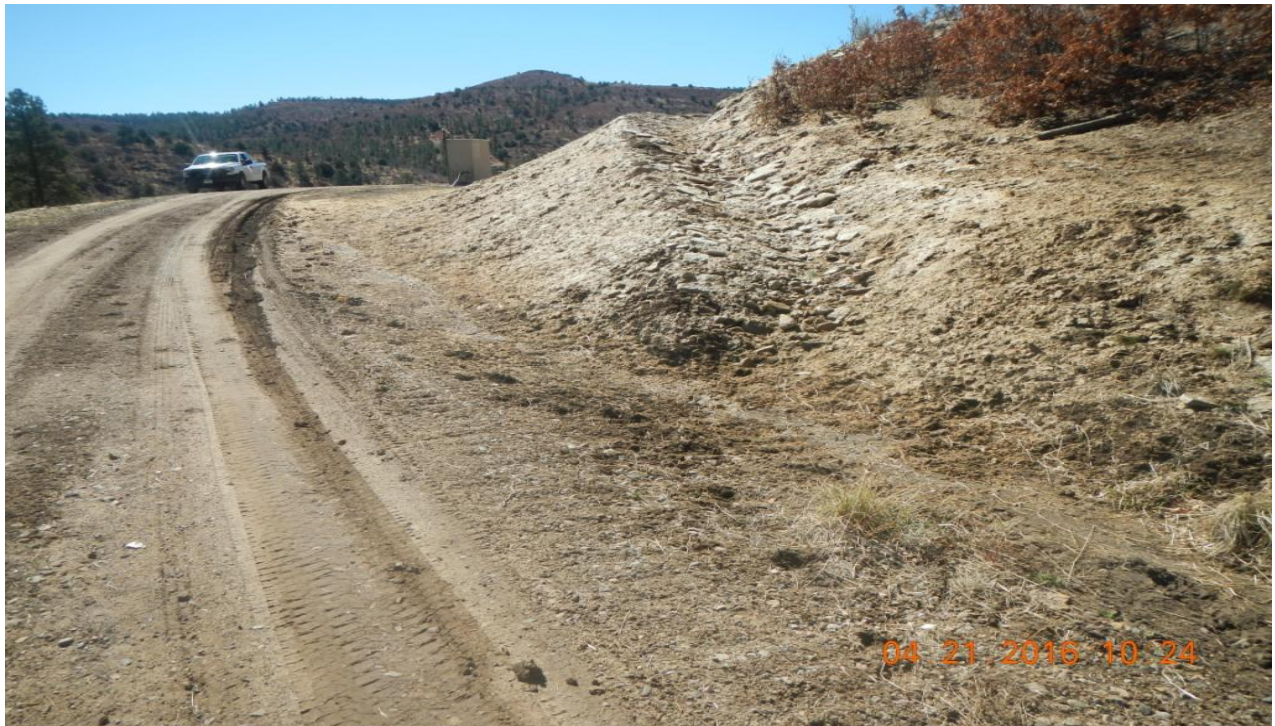
**photo 1:** Facing southeast toward the location along the access road.

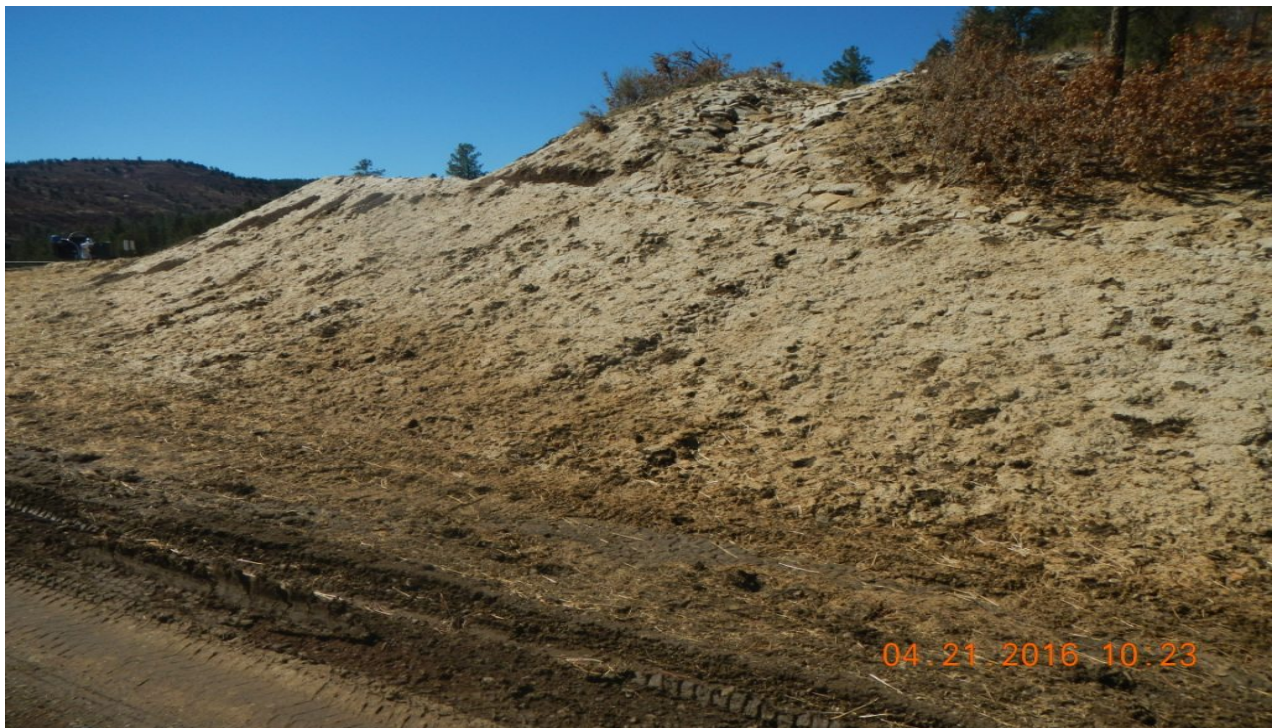
**photo 2:** Facing south toward the cut face of the location where reclamation and stormwater controls have recently been installed.

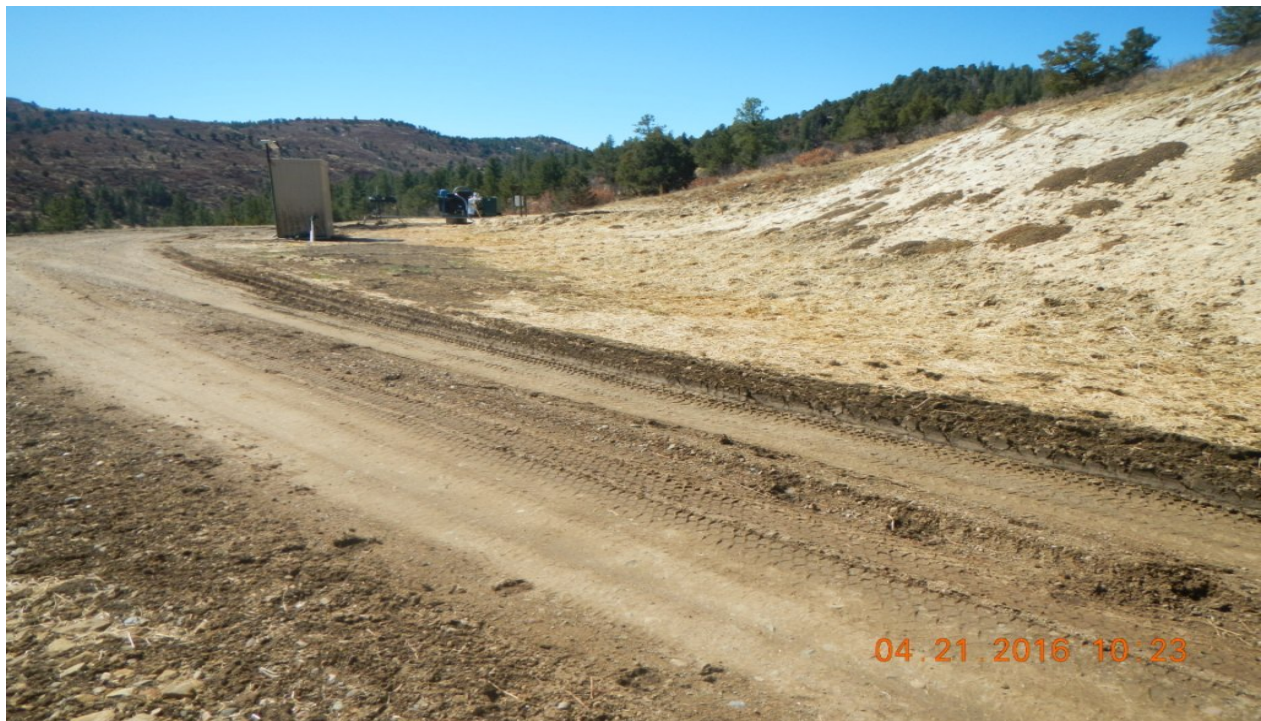
**photo 3:** Facing south toward the location.

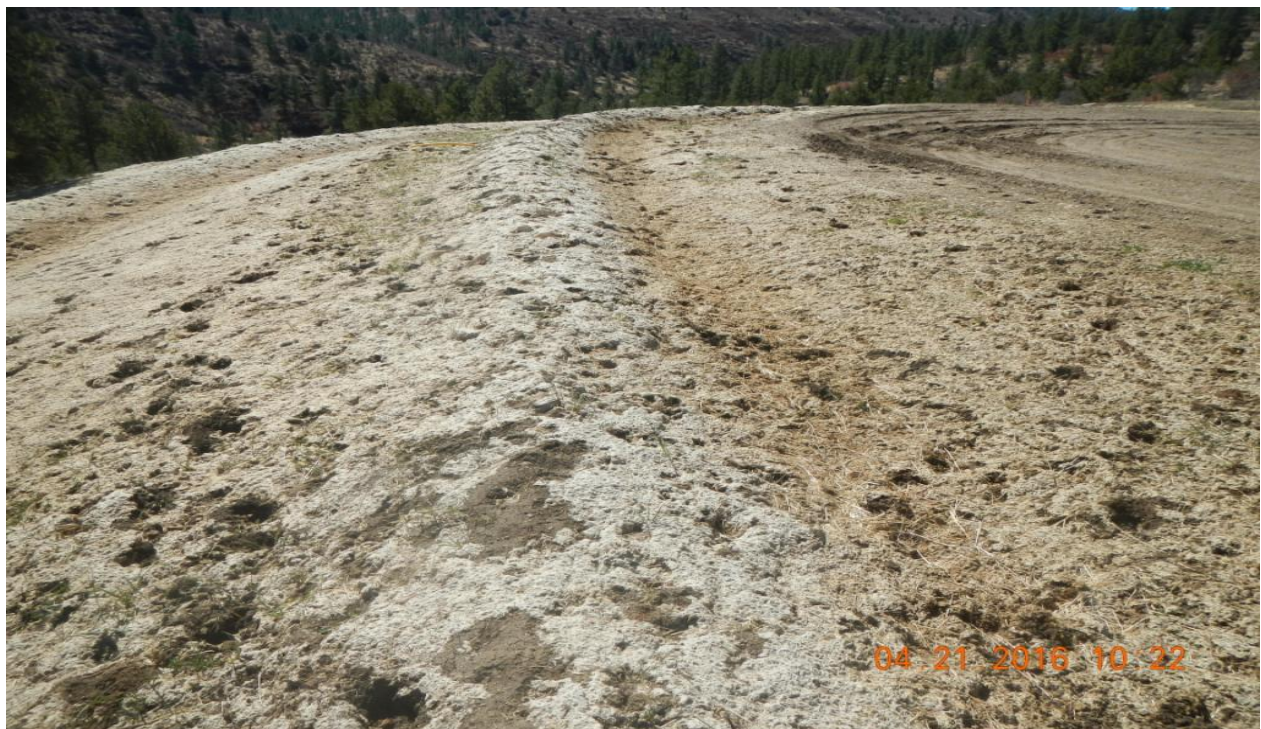
**photo 4:** East side of the location facing south.

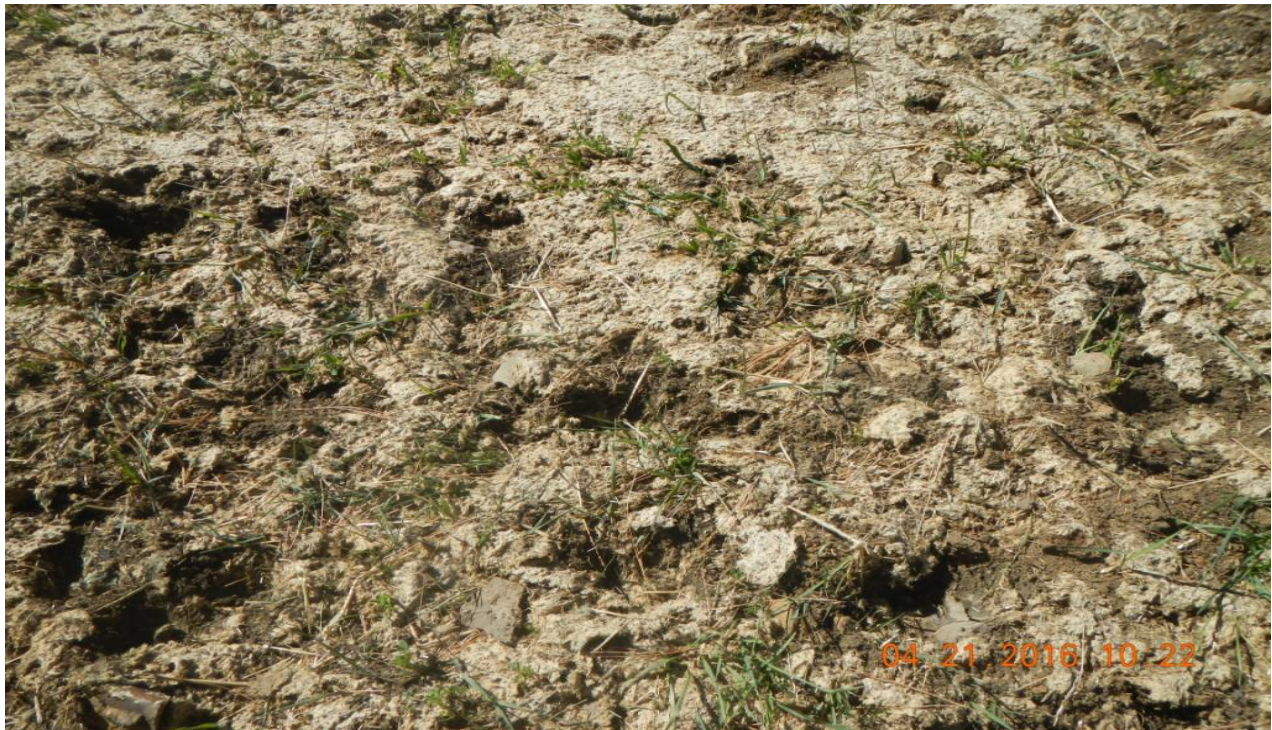
**photo 5:** Noticed vegetation beginning to germinate in the reclamation area.

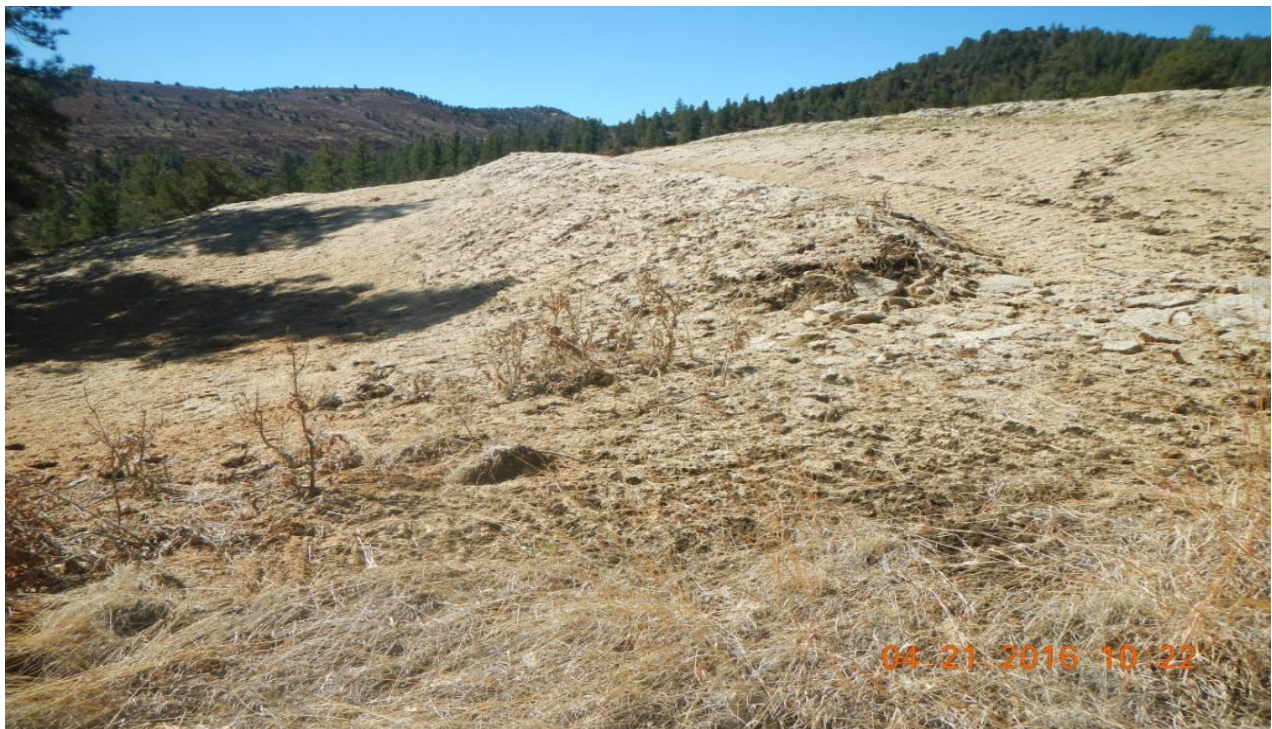
**photo 6:** Northeast side of the location facing south.

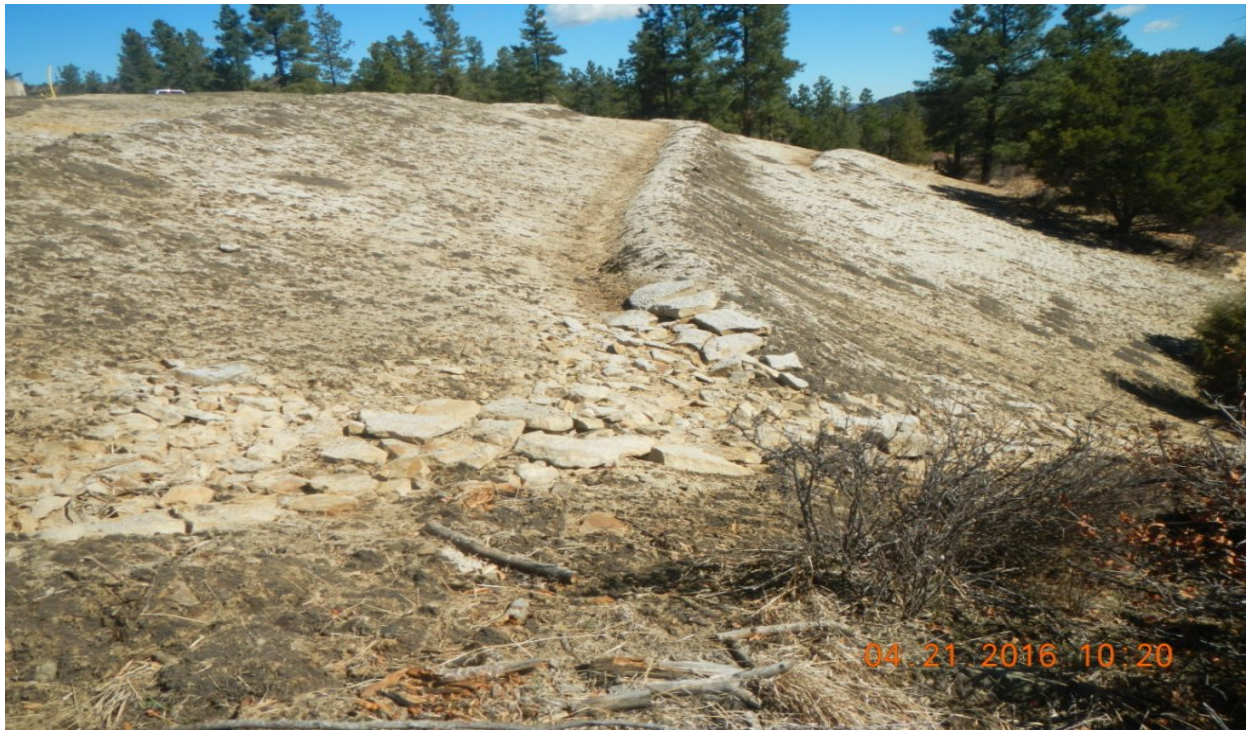
**photo 7:** Southeast side of the location facing north.

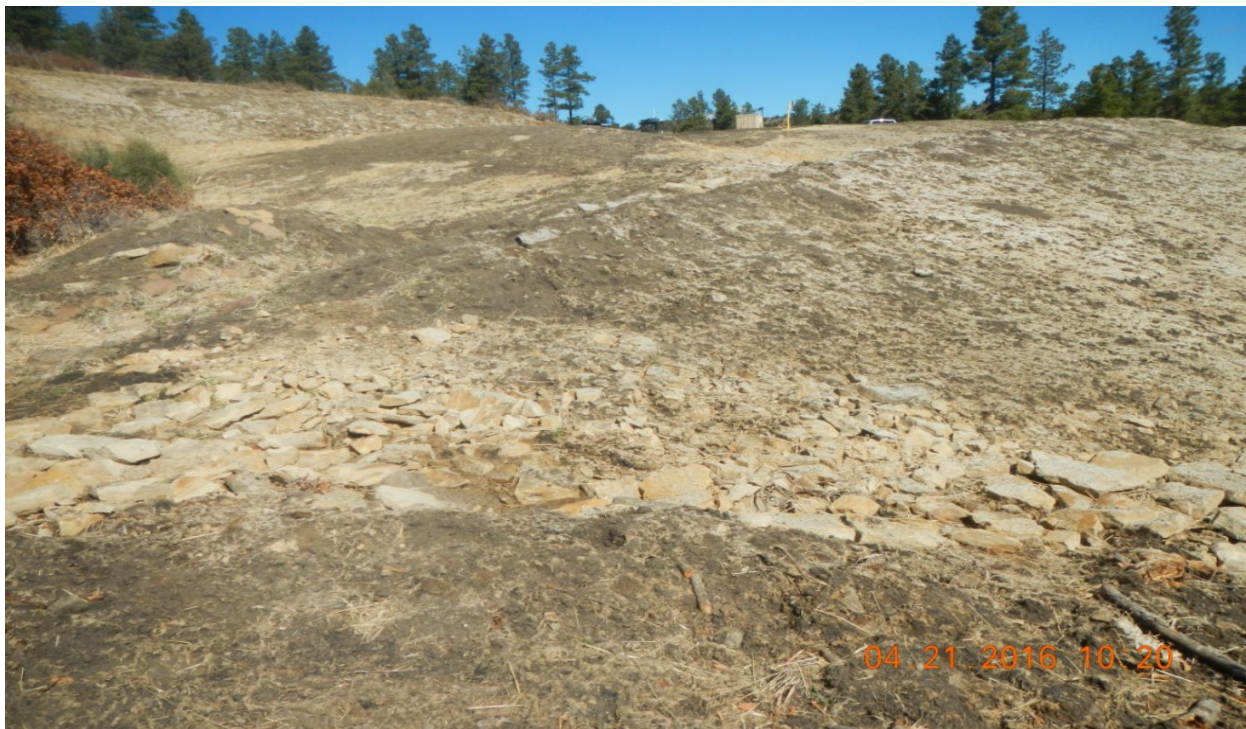
**photo 8:** Southeast side of the location facing northwest.
