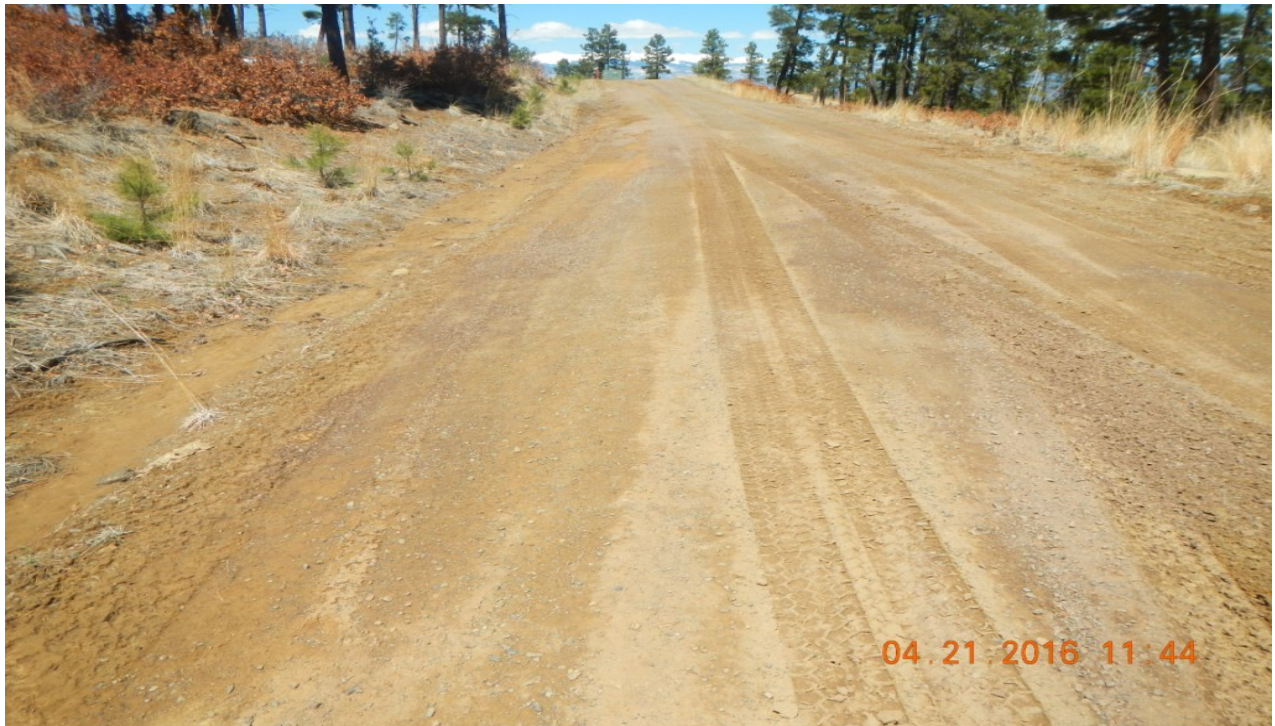
photo 1: Facing northwest toward the access road.

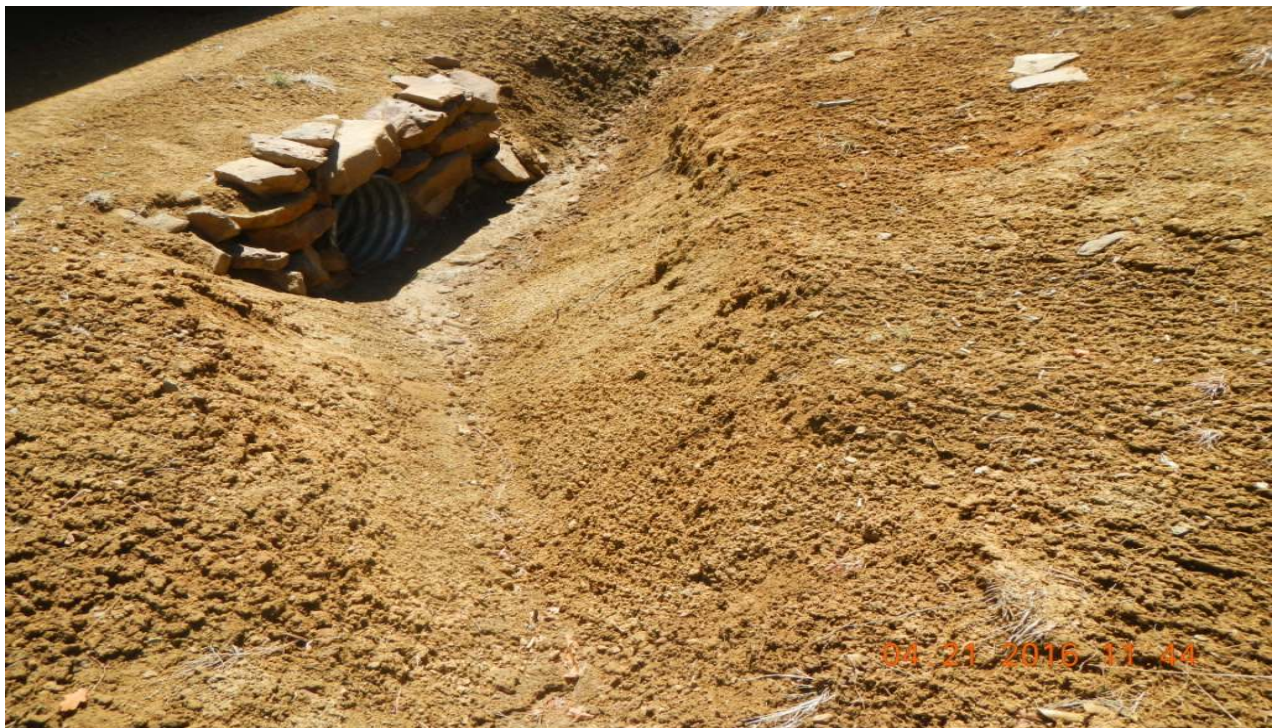
photo 2: Culvert is maintained at beginning of the access road.

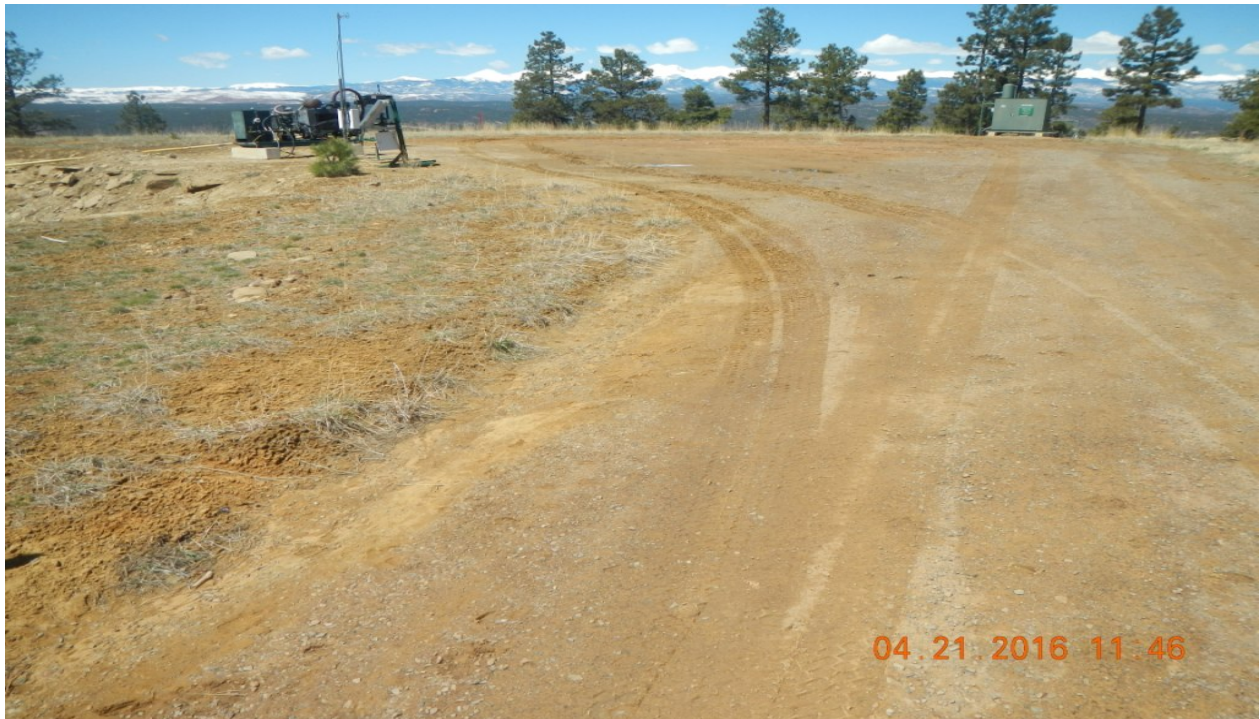
photo 3: Facing west toward the location.

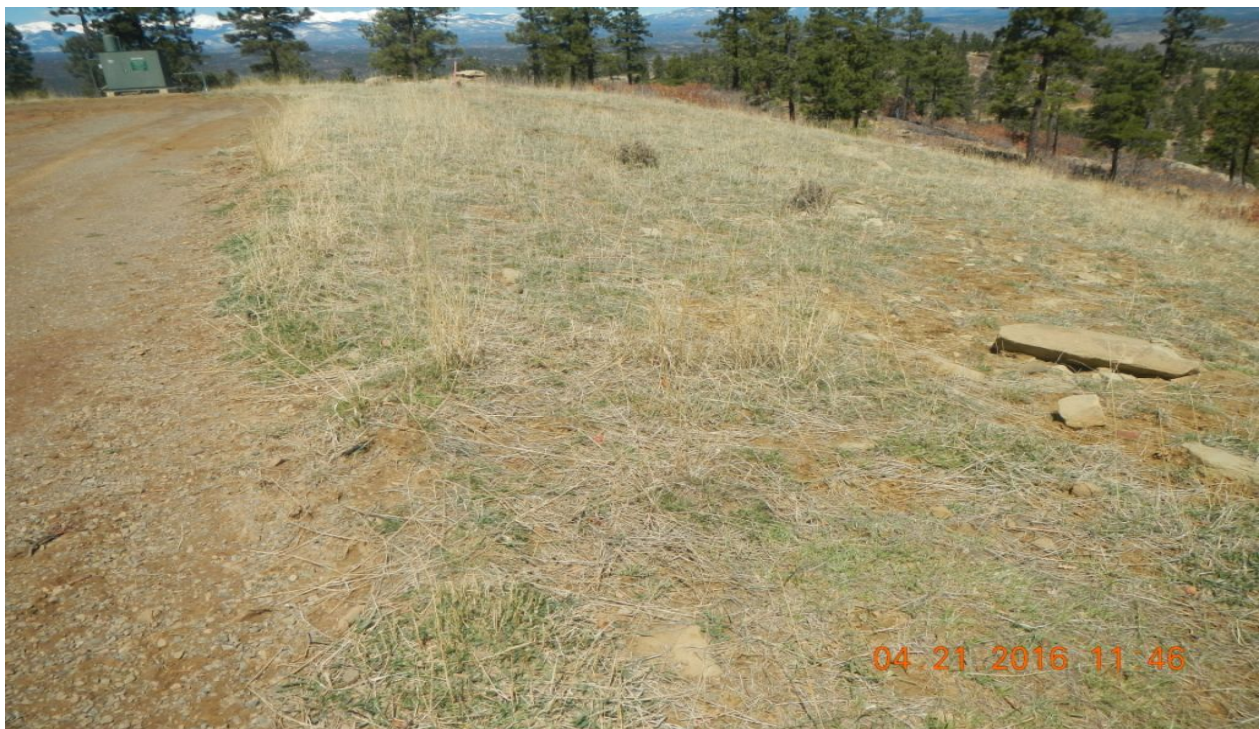
photo 4: Facing west toward the north side of the location.

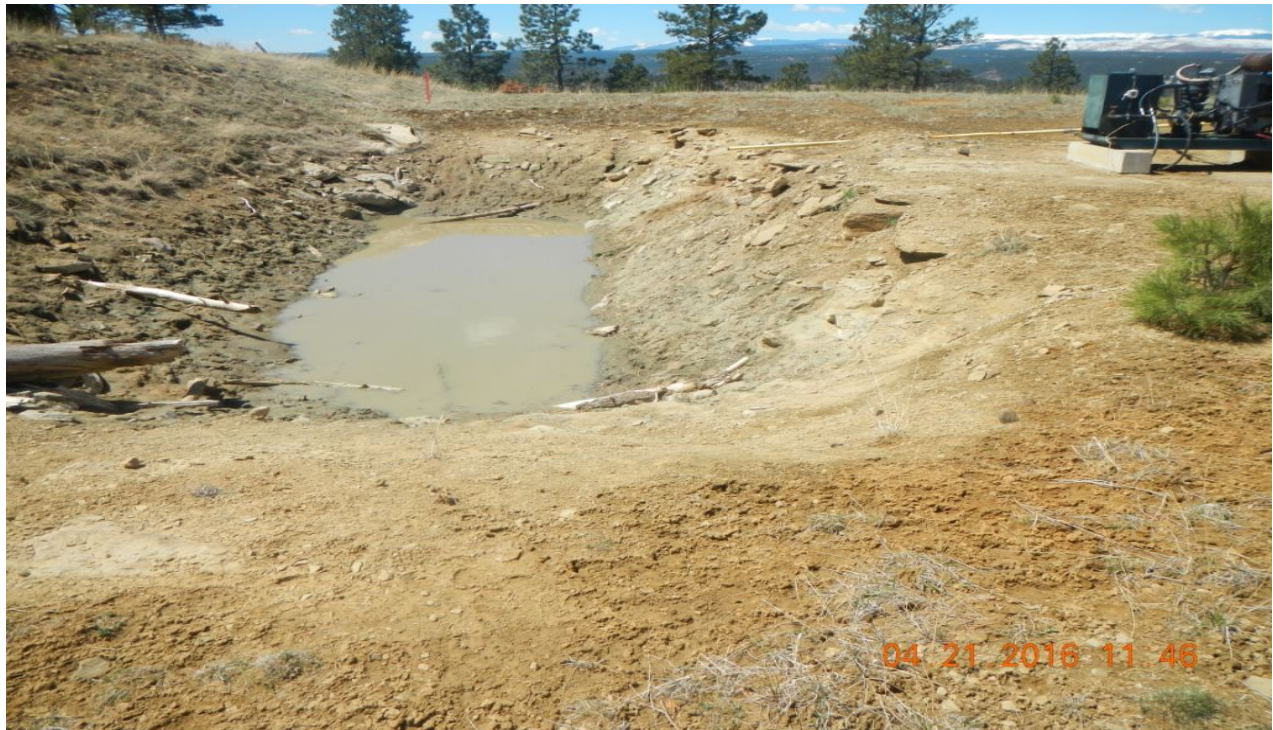
photo 5: Facing southwest toward onsite pit.

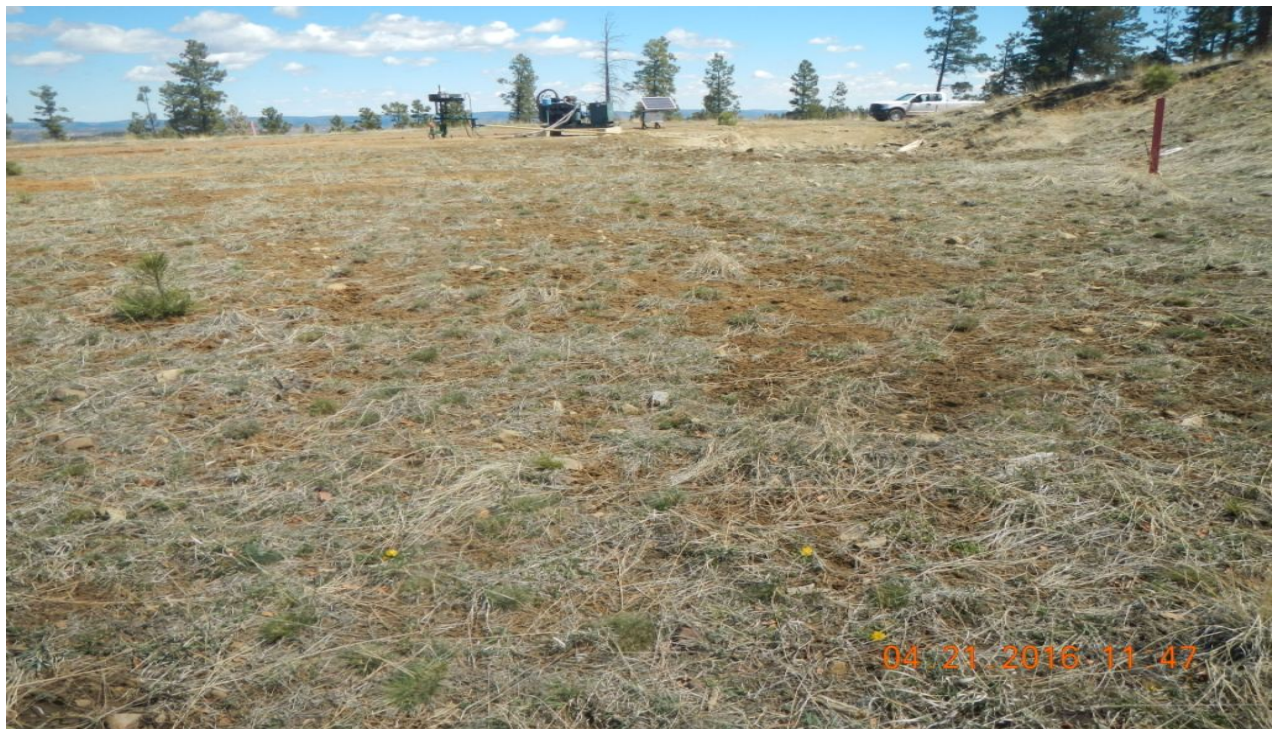
photo 6: Southeast side of the location facing north.

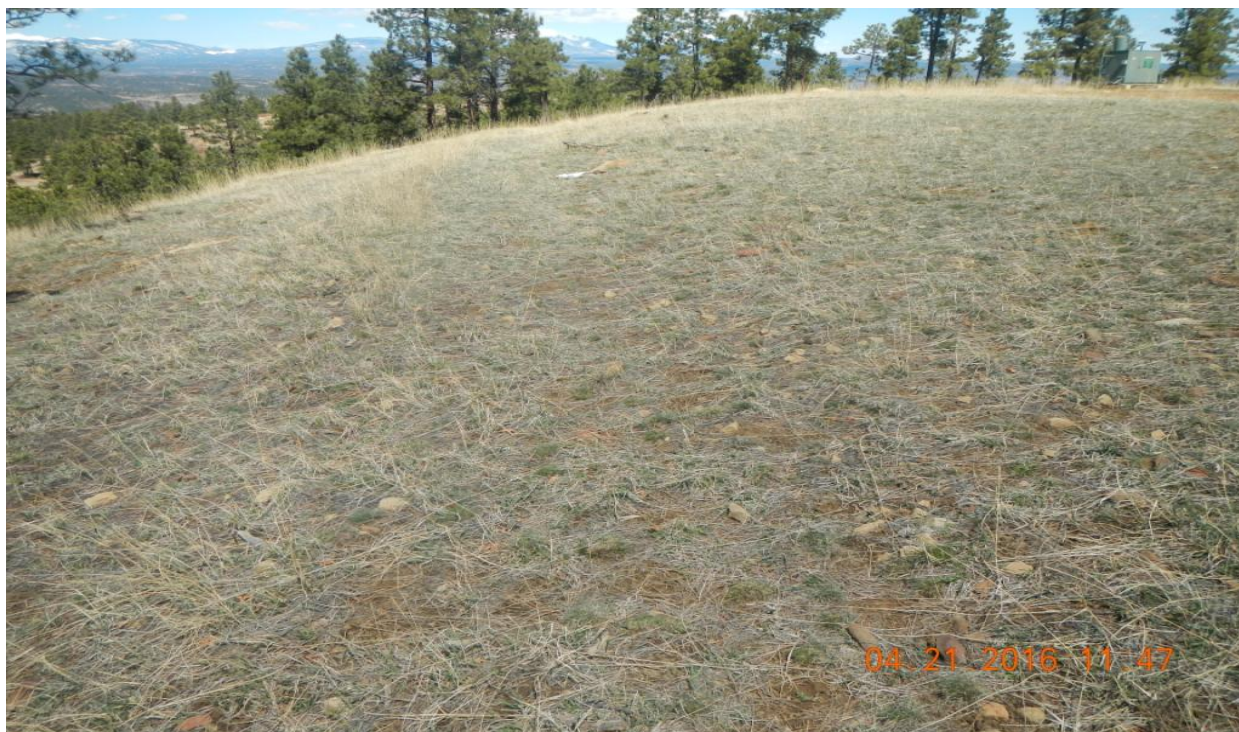
photo 7: Southeast side of the location facing northwest.

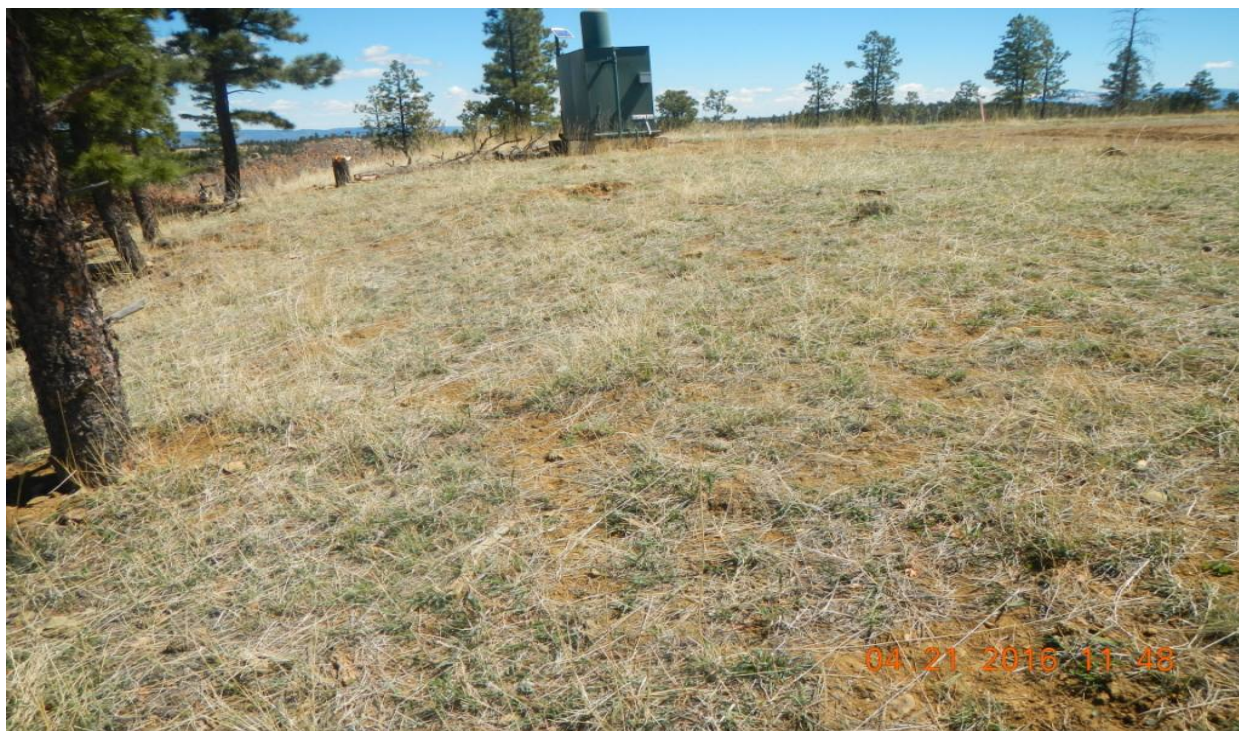
photo 8: West side of the location facing north.
