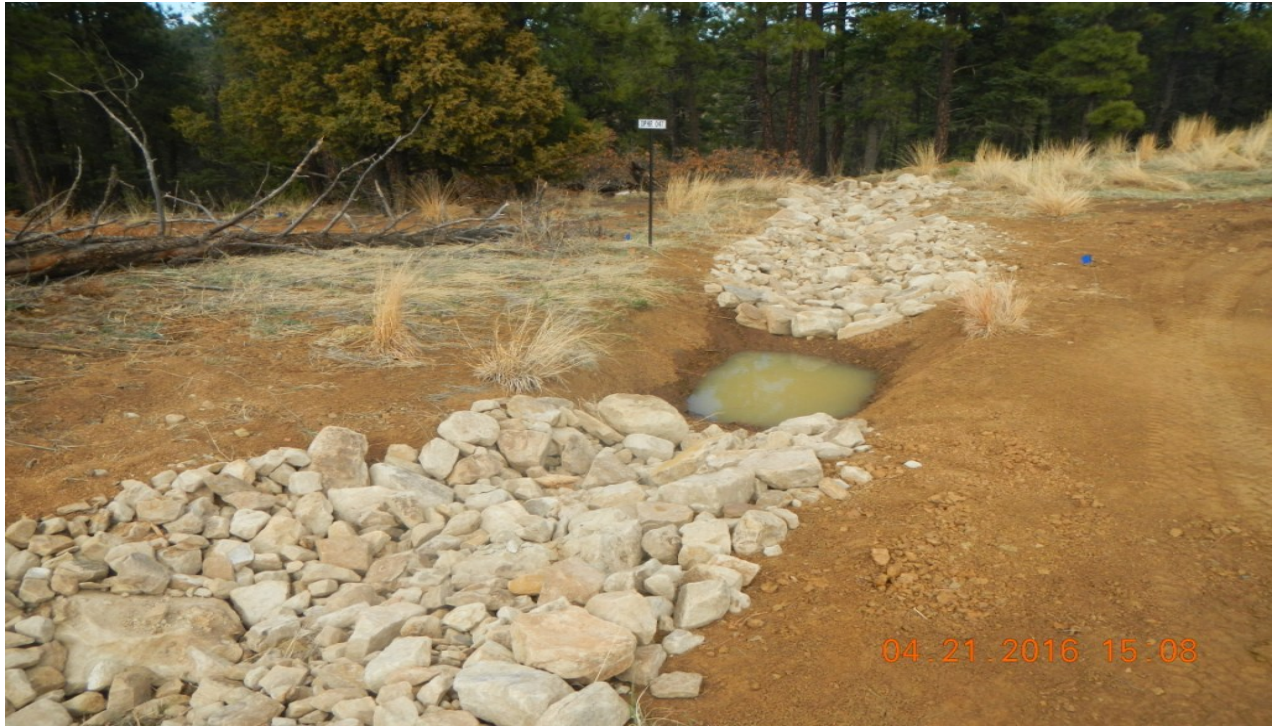
photo 3: Rip/rap rock and sediment trap has been installed at the northwest corner of the location.

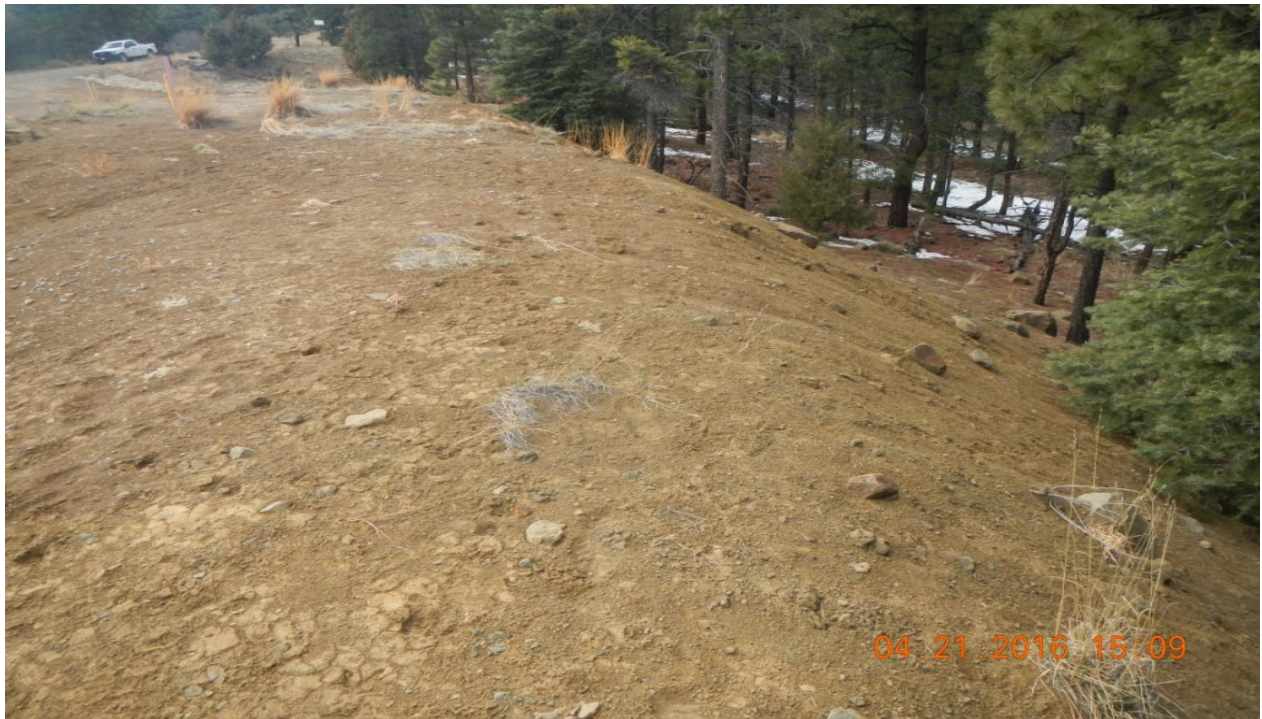
photo 4: North side of the location facing west. Vegetation is not well established in this area.

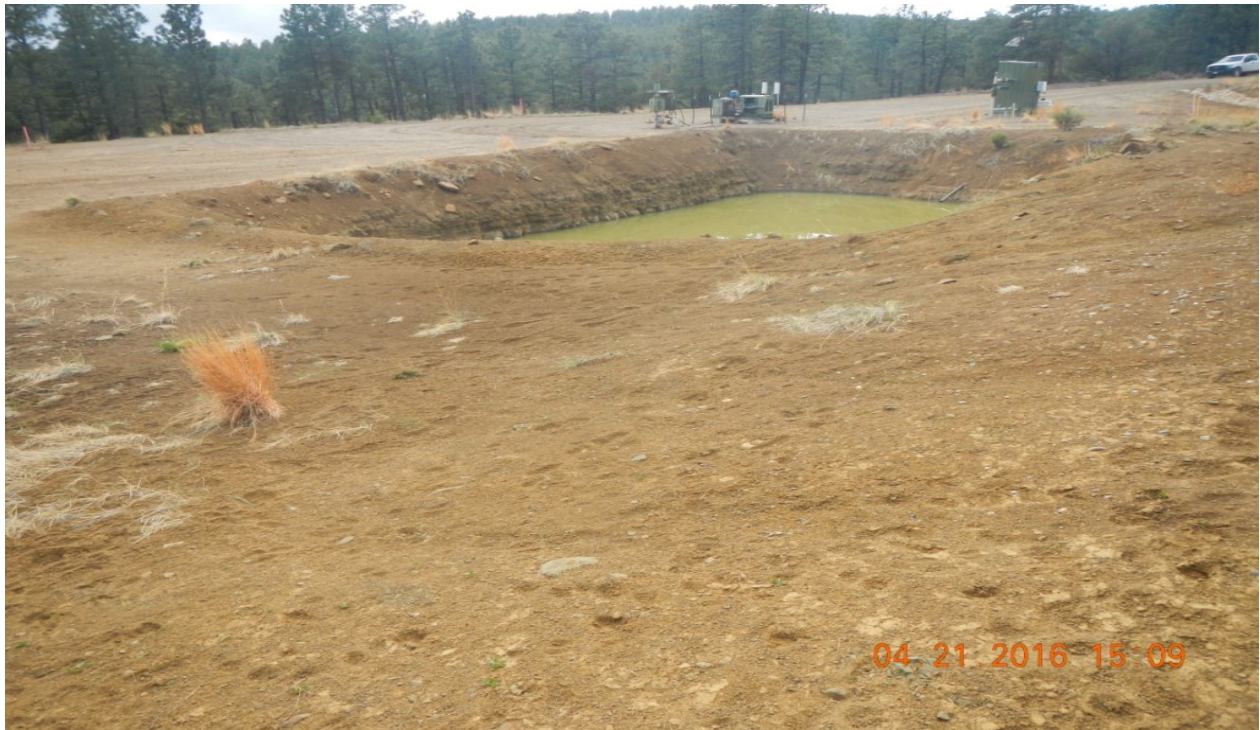
photo 5: Northeast side of the location facing southwest. Vegetation is not well established in this area.

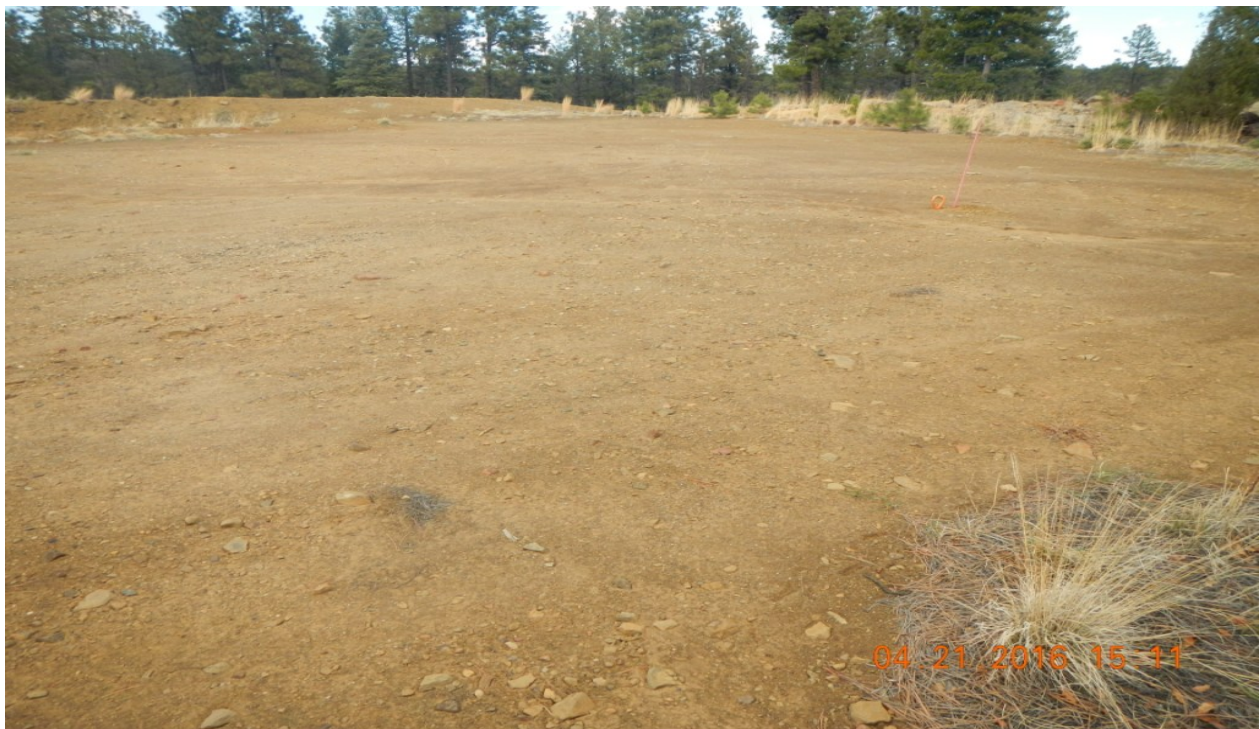
photo 6: Southeast side of the location facing north. Vegetation is not well established in this area.
