April 24, 2016

Inspection Photos: Lloyd & Lowell 1 API# 077-40017

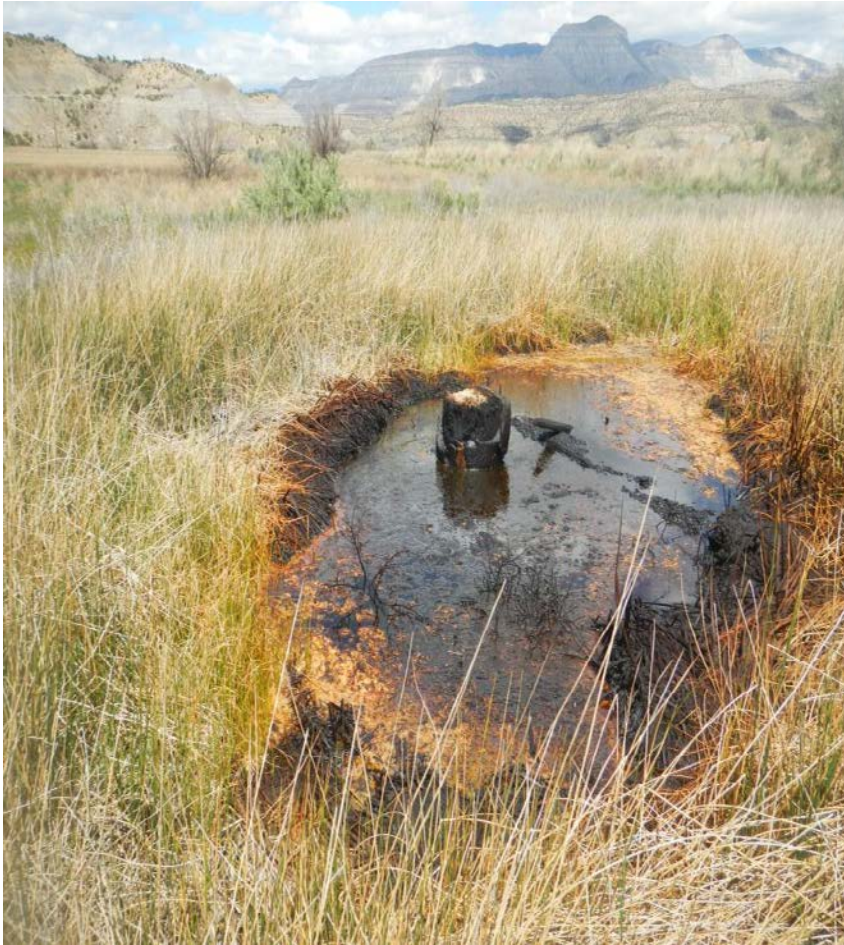
Photo#1:

View North over Well

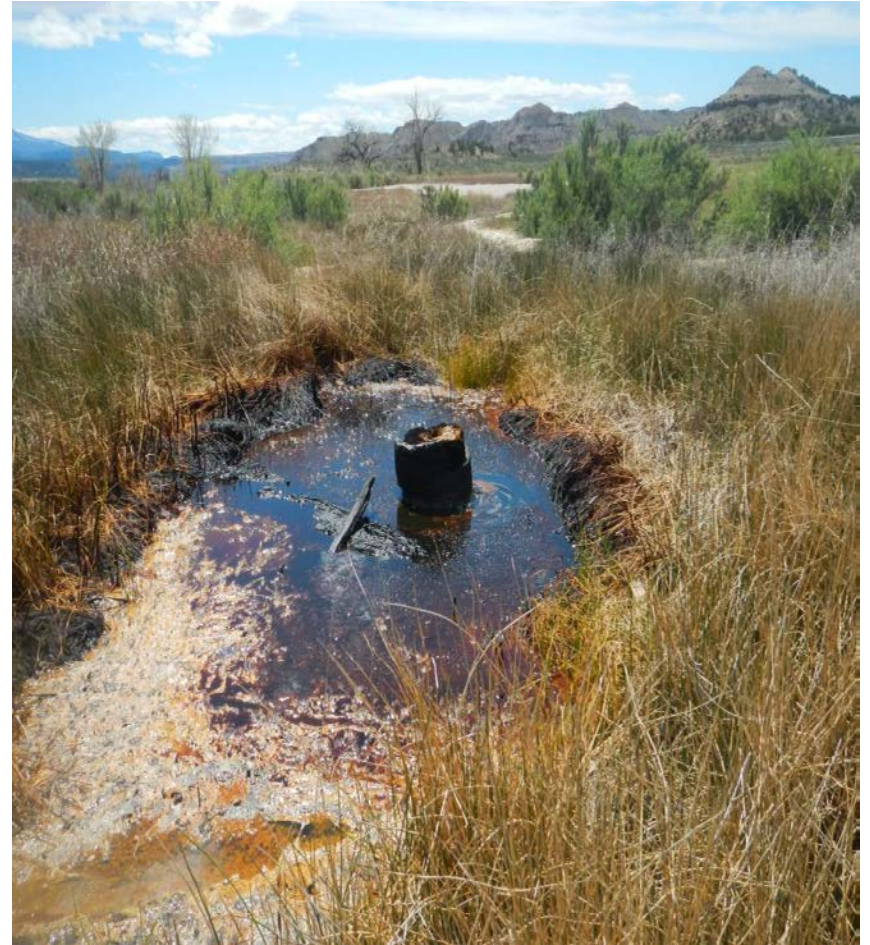
Photo#2:

View South over Well

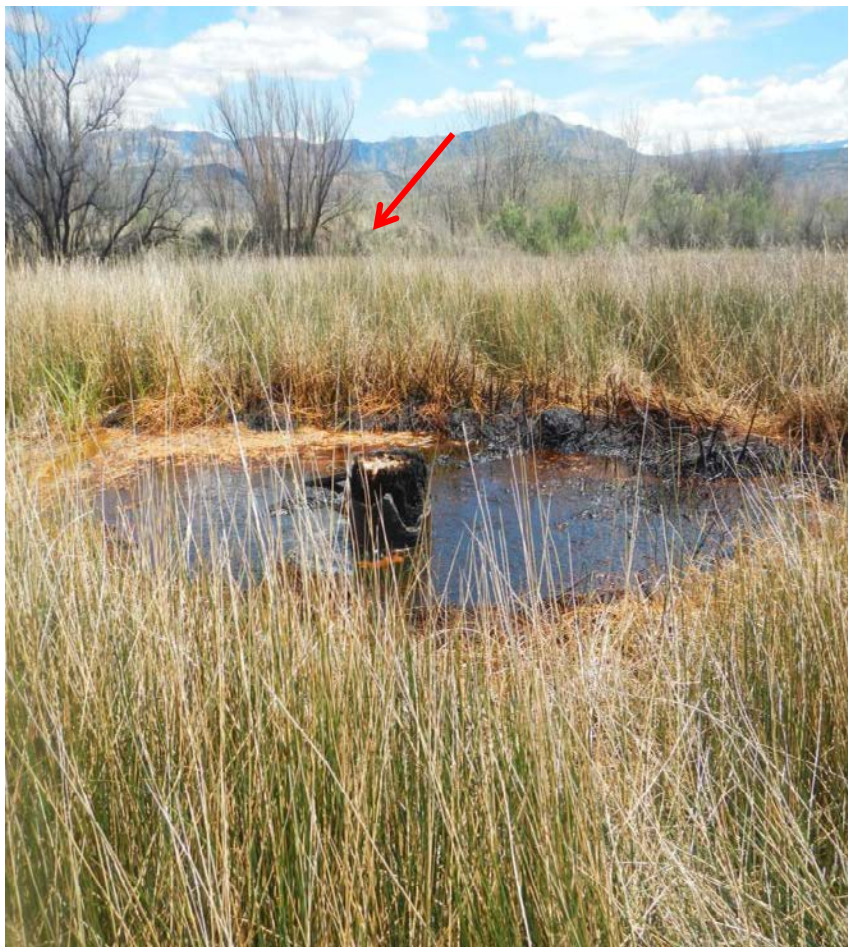
Photo#3:

View East over well

Arrow shows position of Irrigation ditch

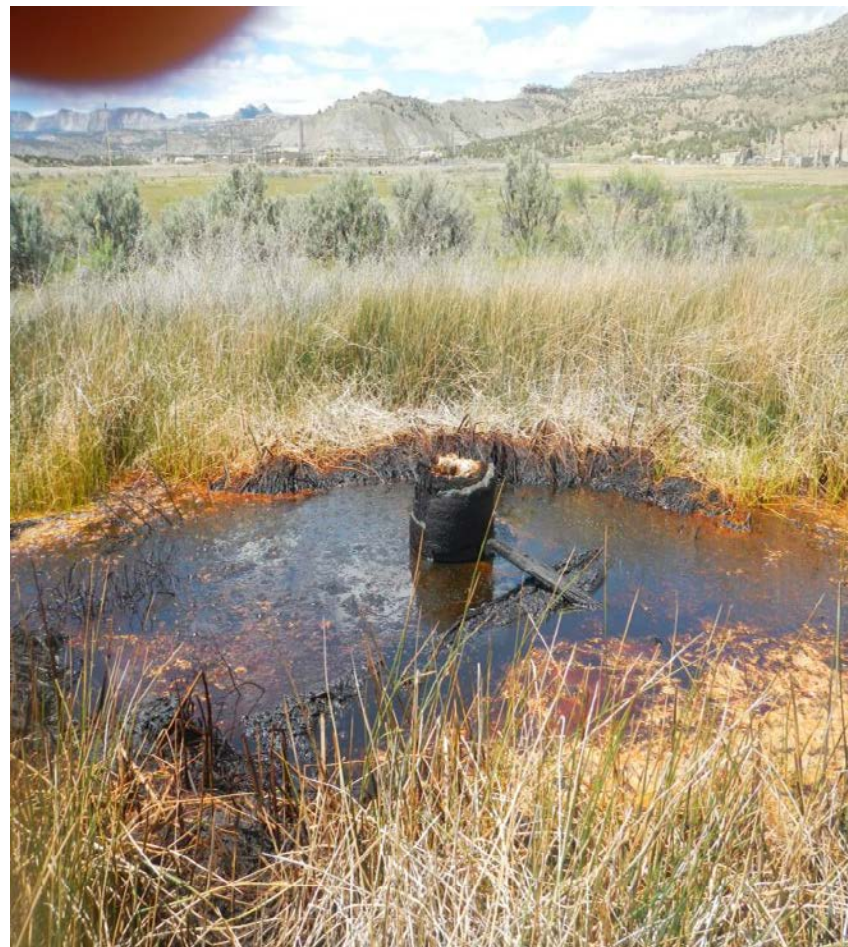
Photo#4:

View West over Well

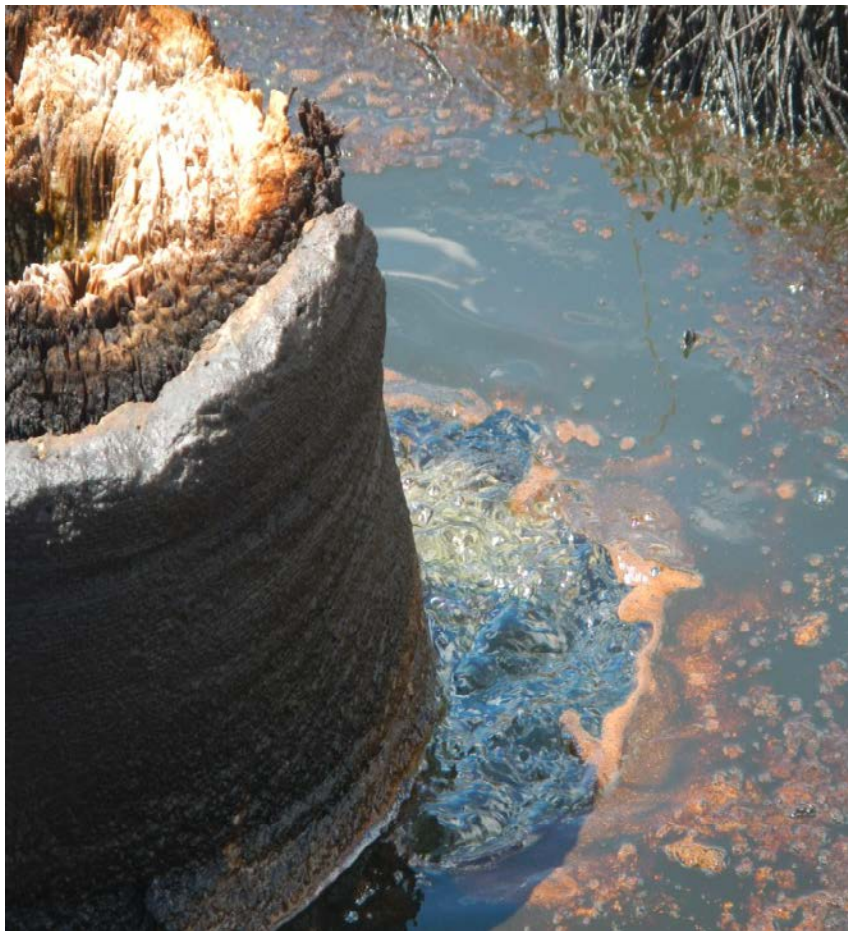
Photo#5:

Burbling Liquids at base of and in center of Plug

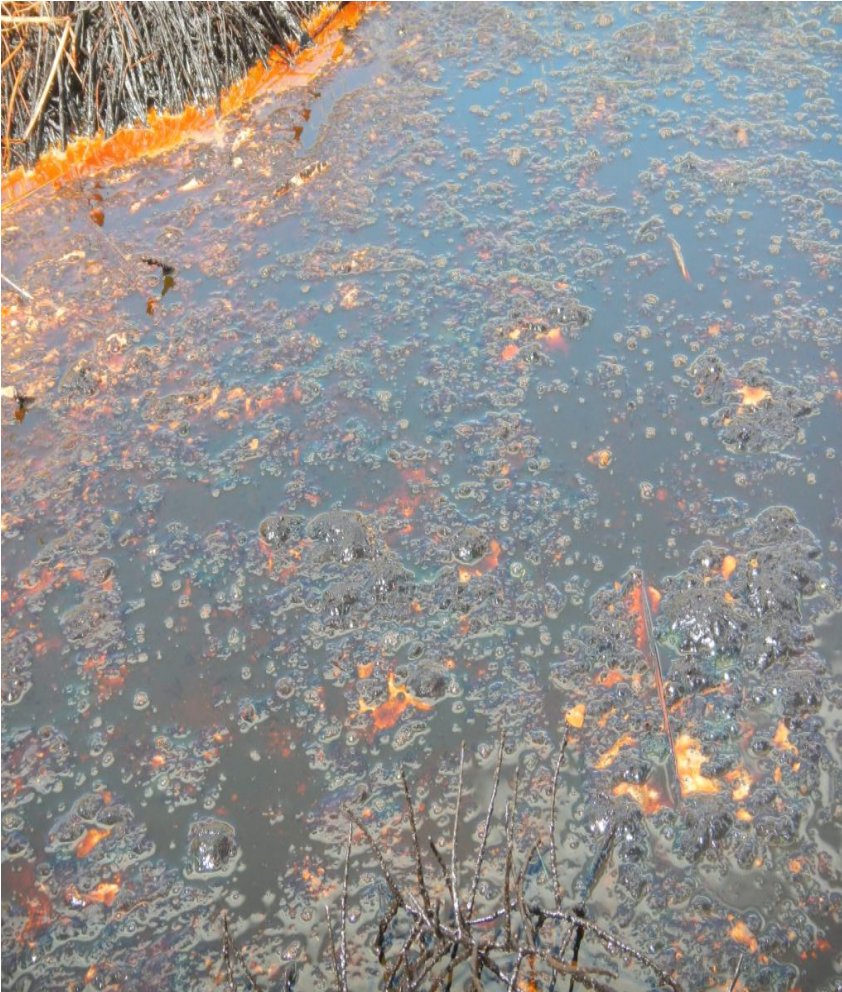
Photo#7:

Oily / tarry Scum on surface around Well Head; Mouse was seen to run over area without submerging

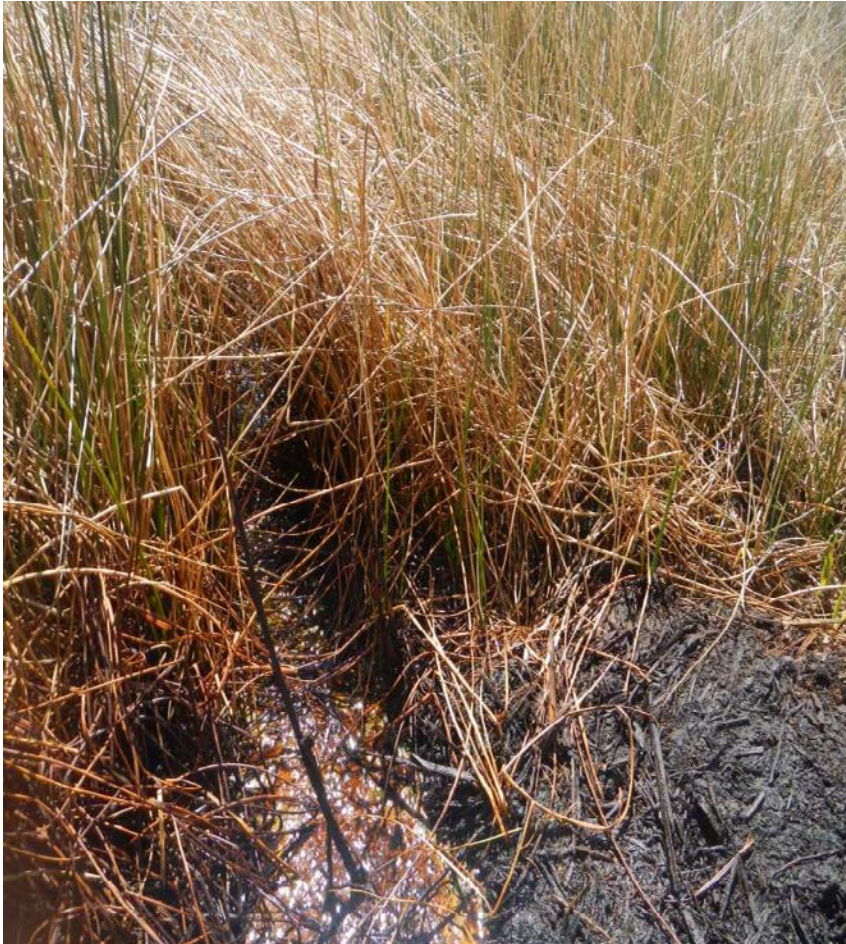
Photo#9:

Oil saturated Vegetation at Pool edge.

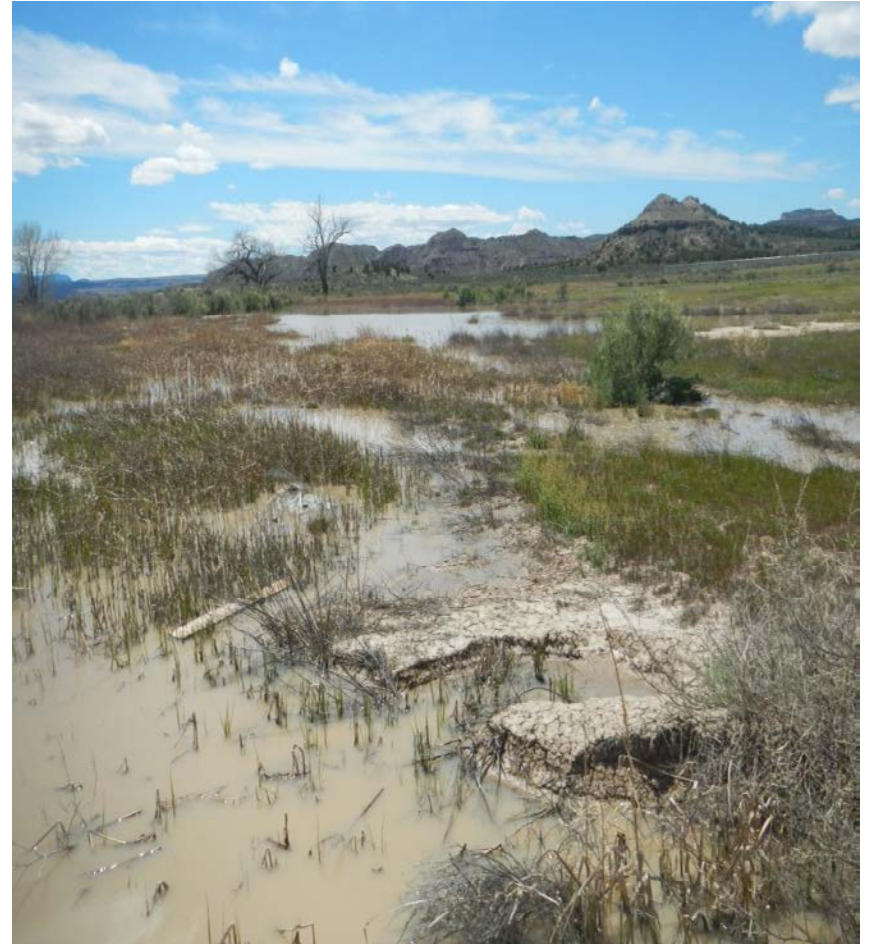
Photo#10:

Slew area formed by Well discharge to SW
