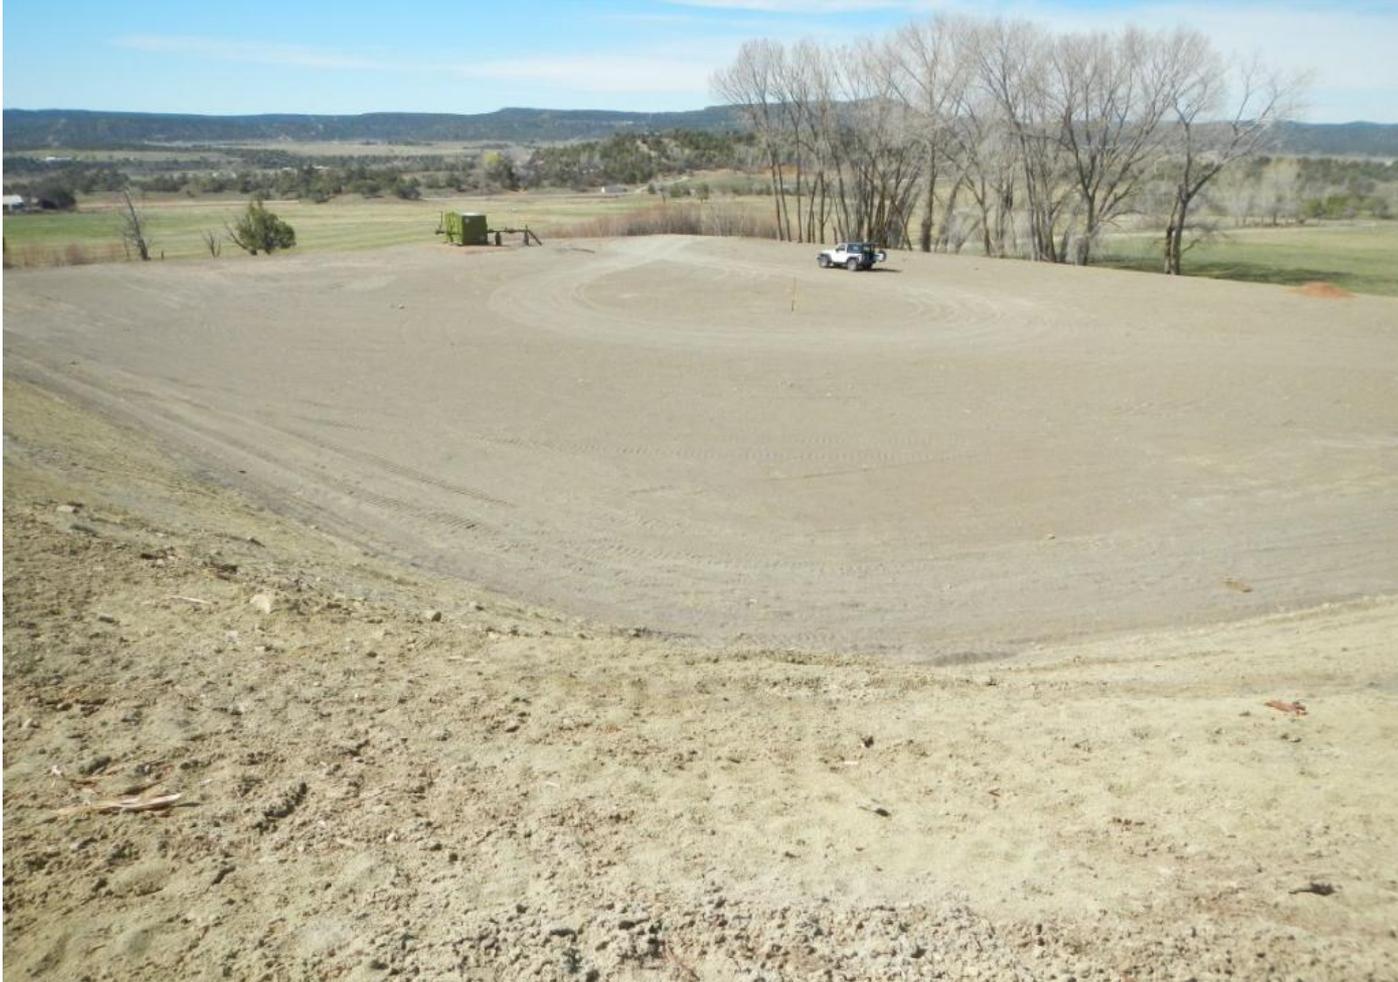
Photo 1. View of the project area from the northeastern corner facing center.

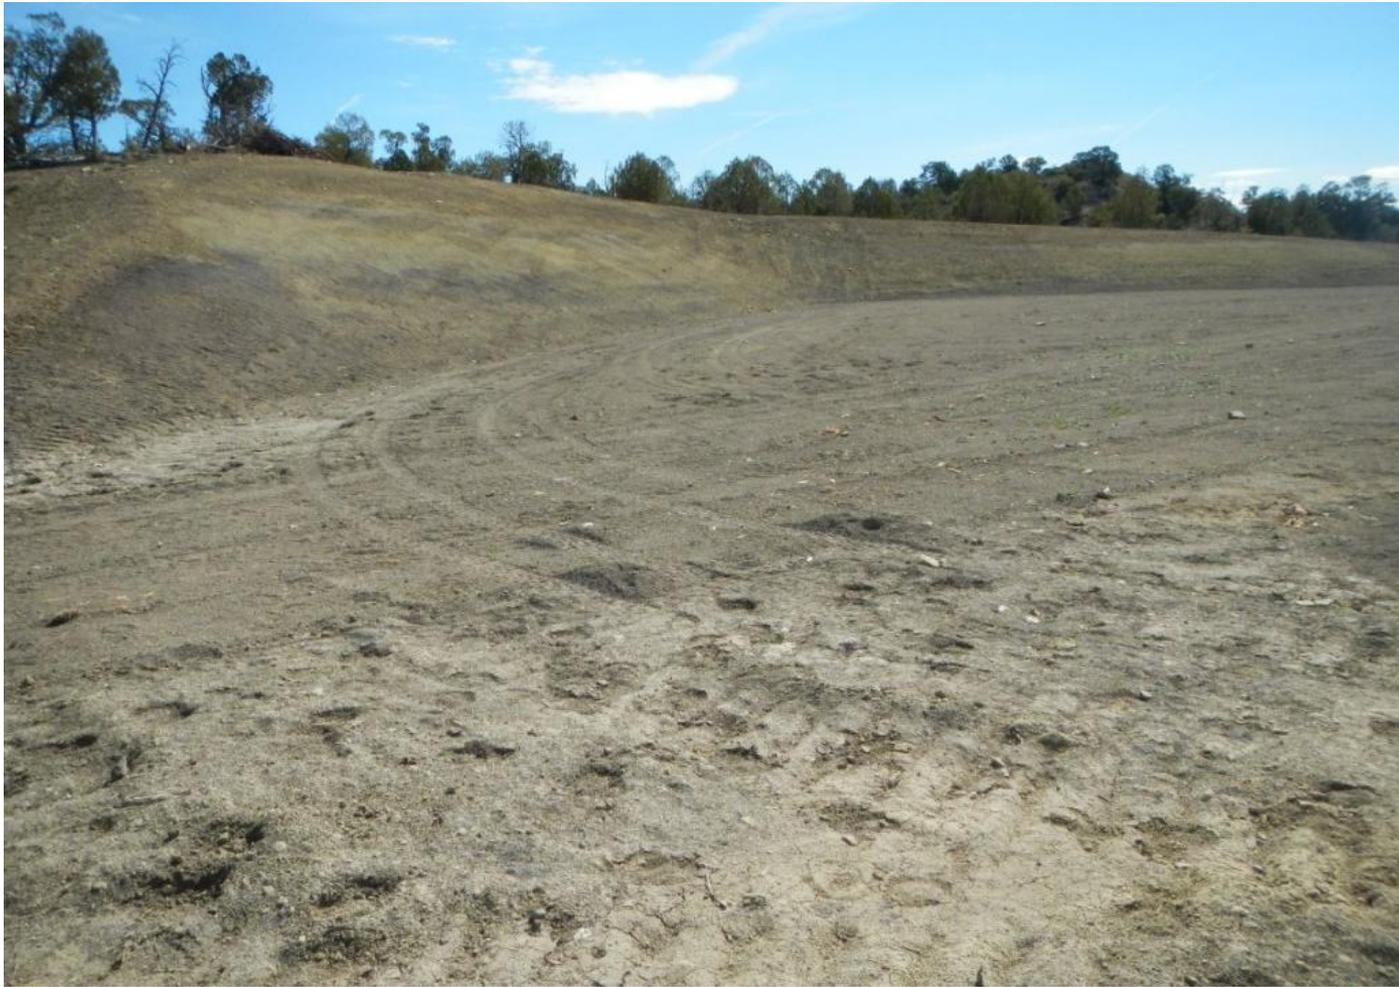
Photo 2. View of the northern portion of the project area from the northwestern corner facing eastward. Cut slope is approximately 50 feet tall.

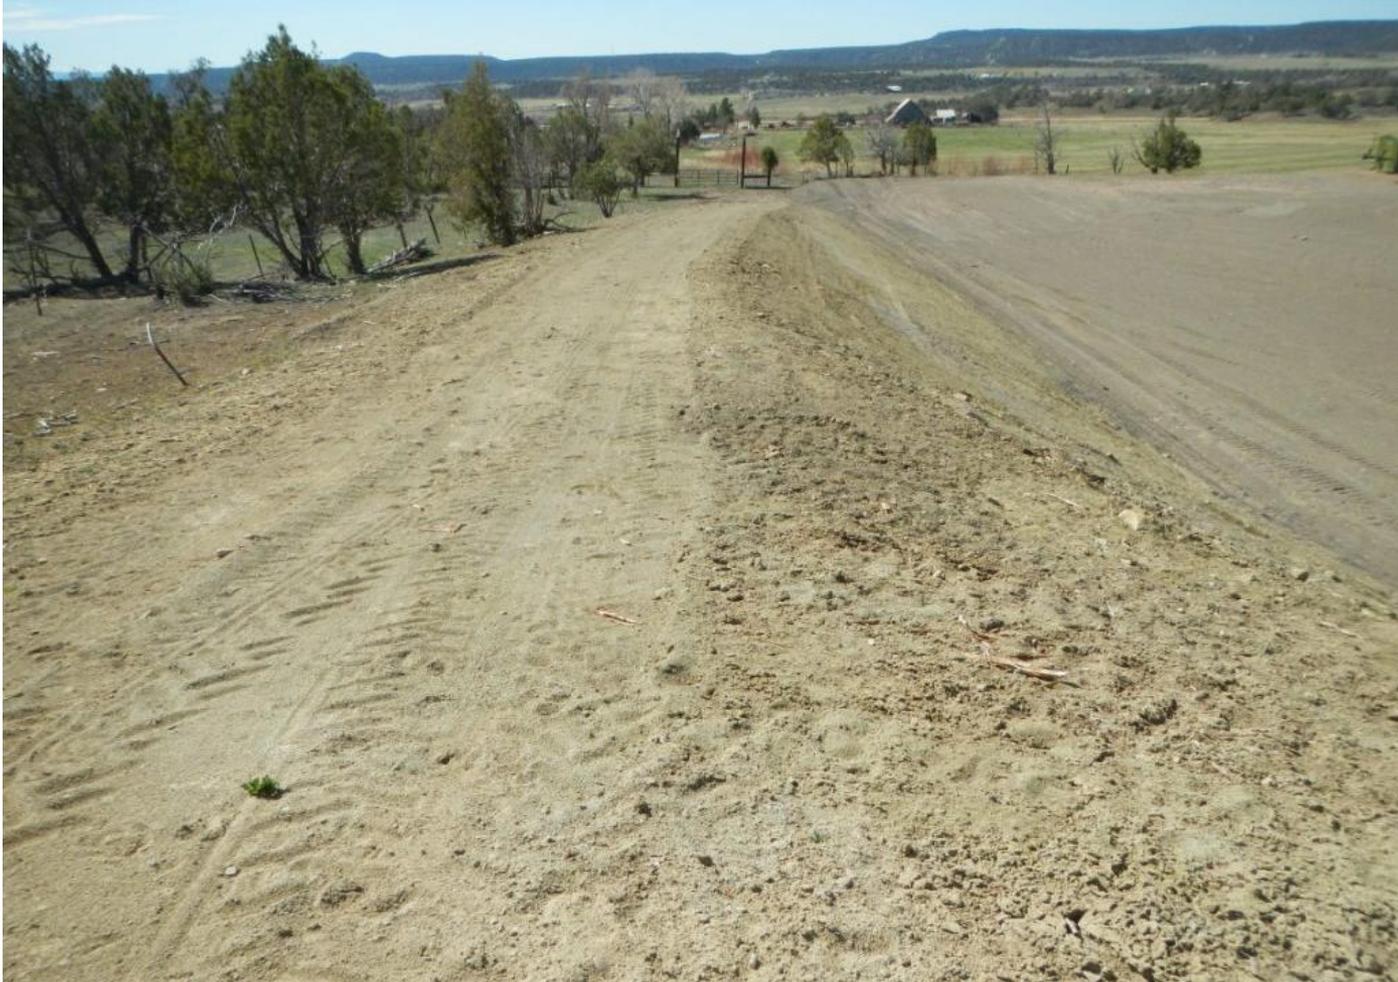
Photo 3. View of the eastern portion of the project area from the northeastern corner facing southward.

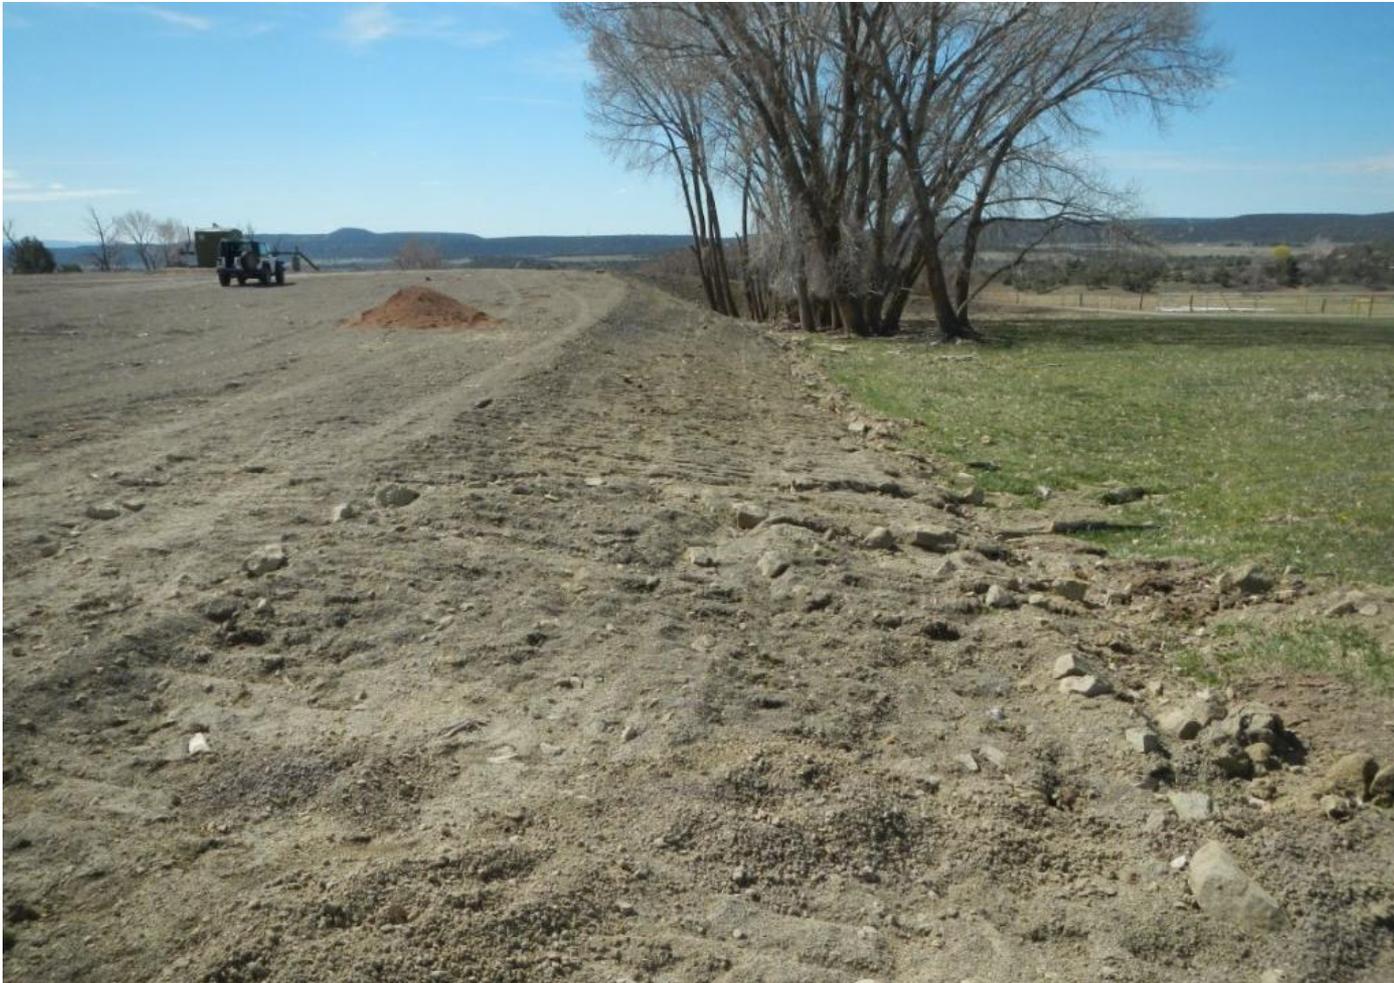
Photo 4. View of the western portion of the project area from the northwestern corner facing southward. Rill erosion is occurring in the fill slopes. No erosion or sediment controls were observed.

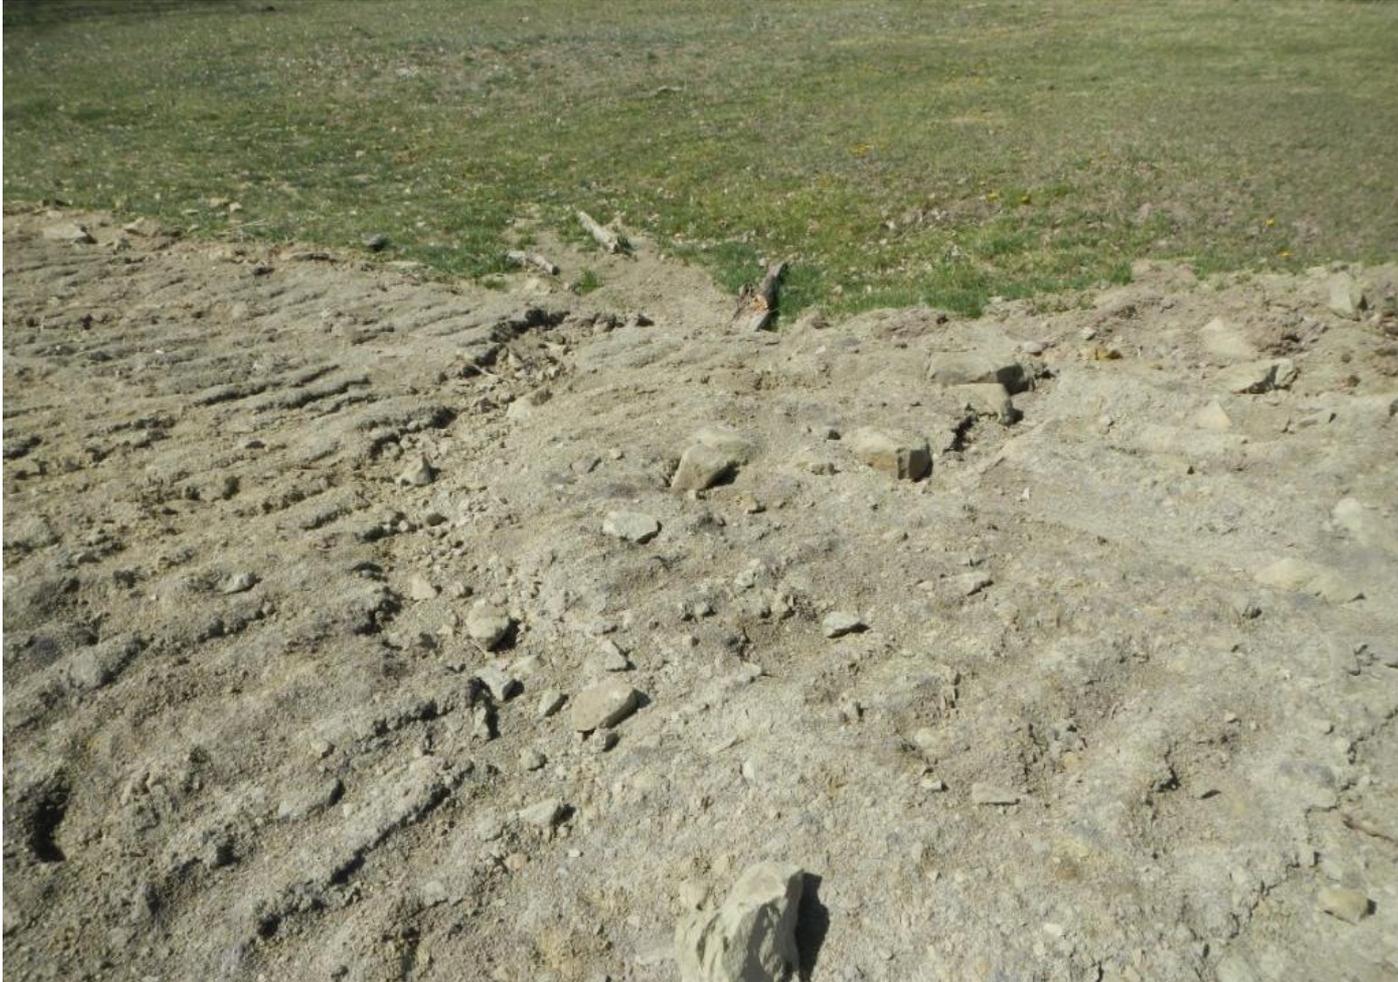
Photo 5. Close-up view of rill erosion observed in the western portion of the project area.

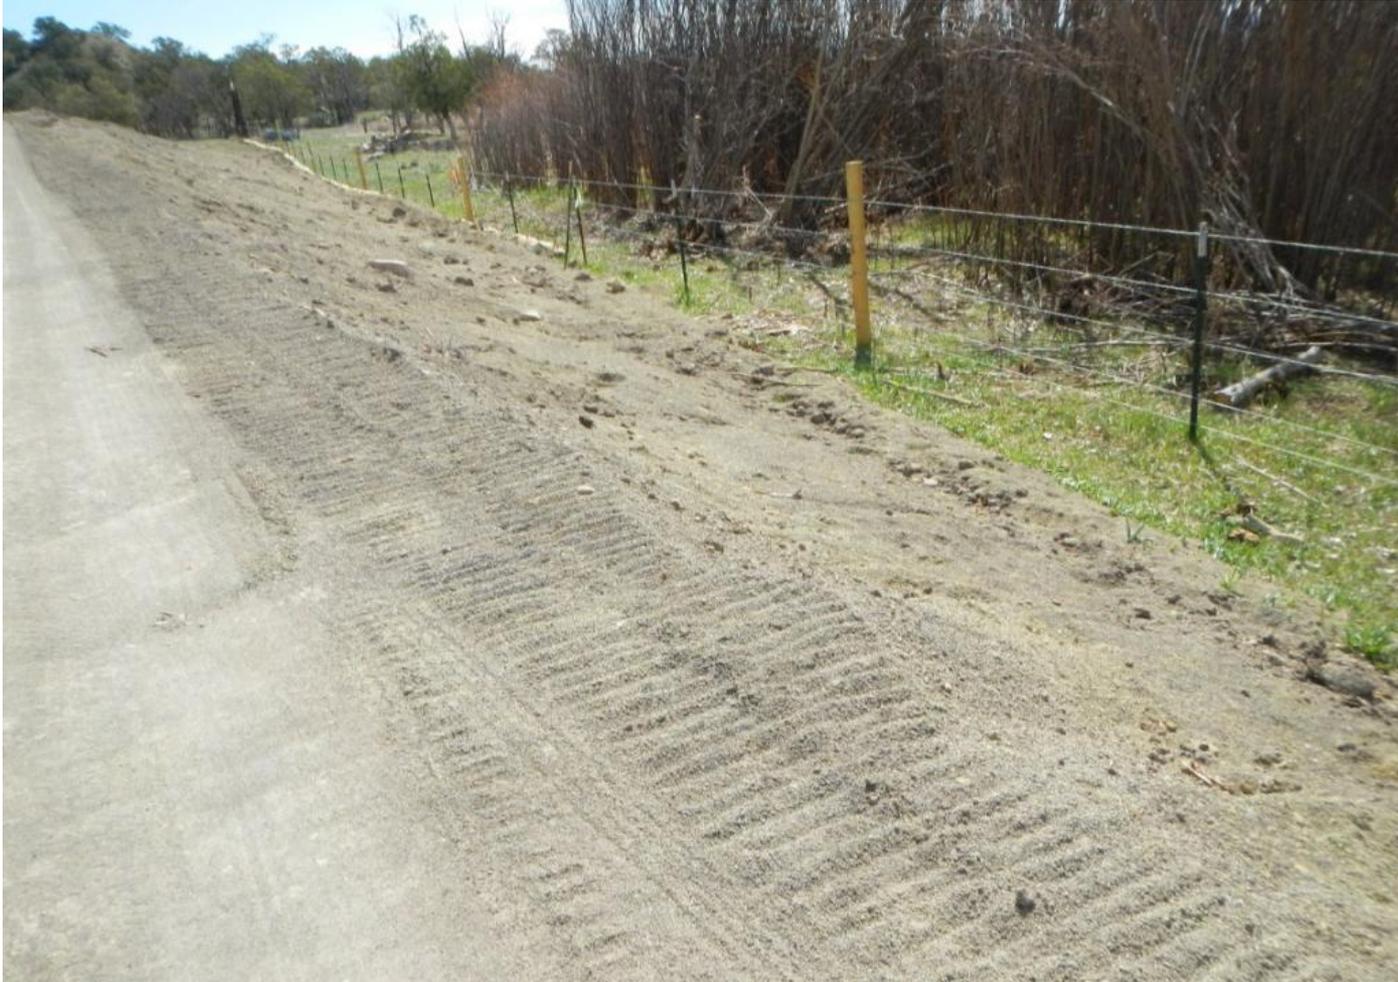
Photo 6. View of the southern portion of the project area from the southwestern corner facing eastward. Sediment is overtopping the perimeter wattles along this edge.

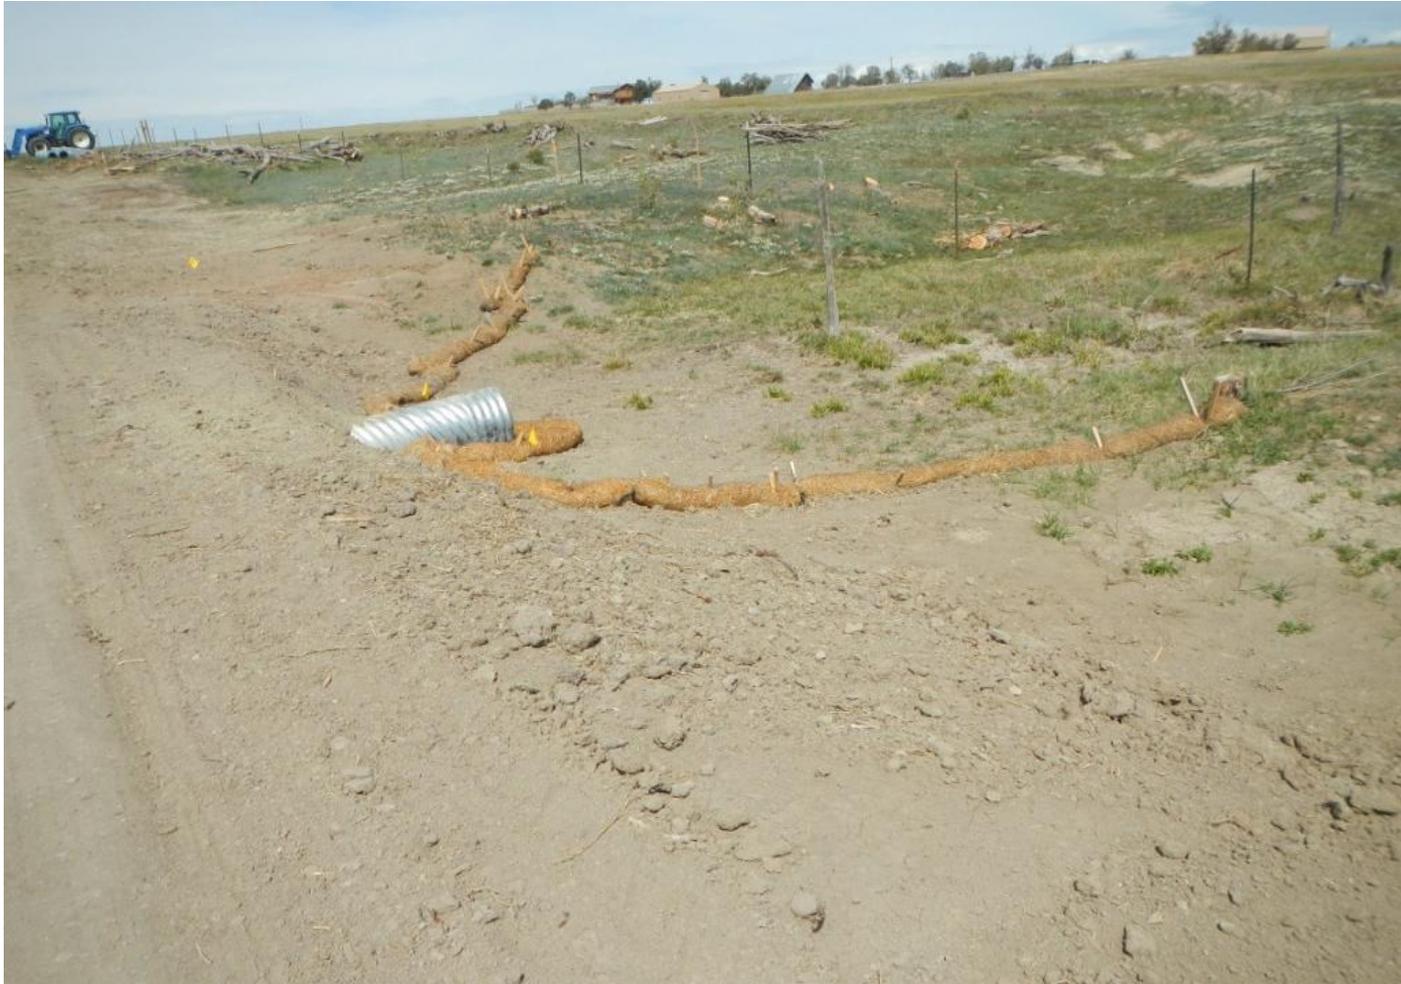
Photo 7. View of culvert inlet along the access road.

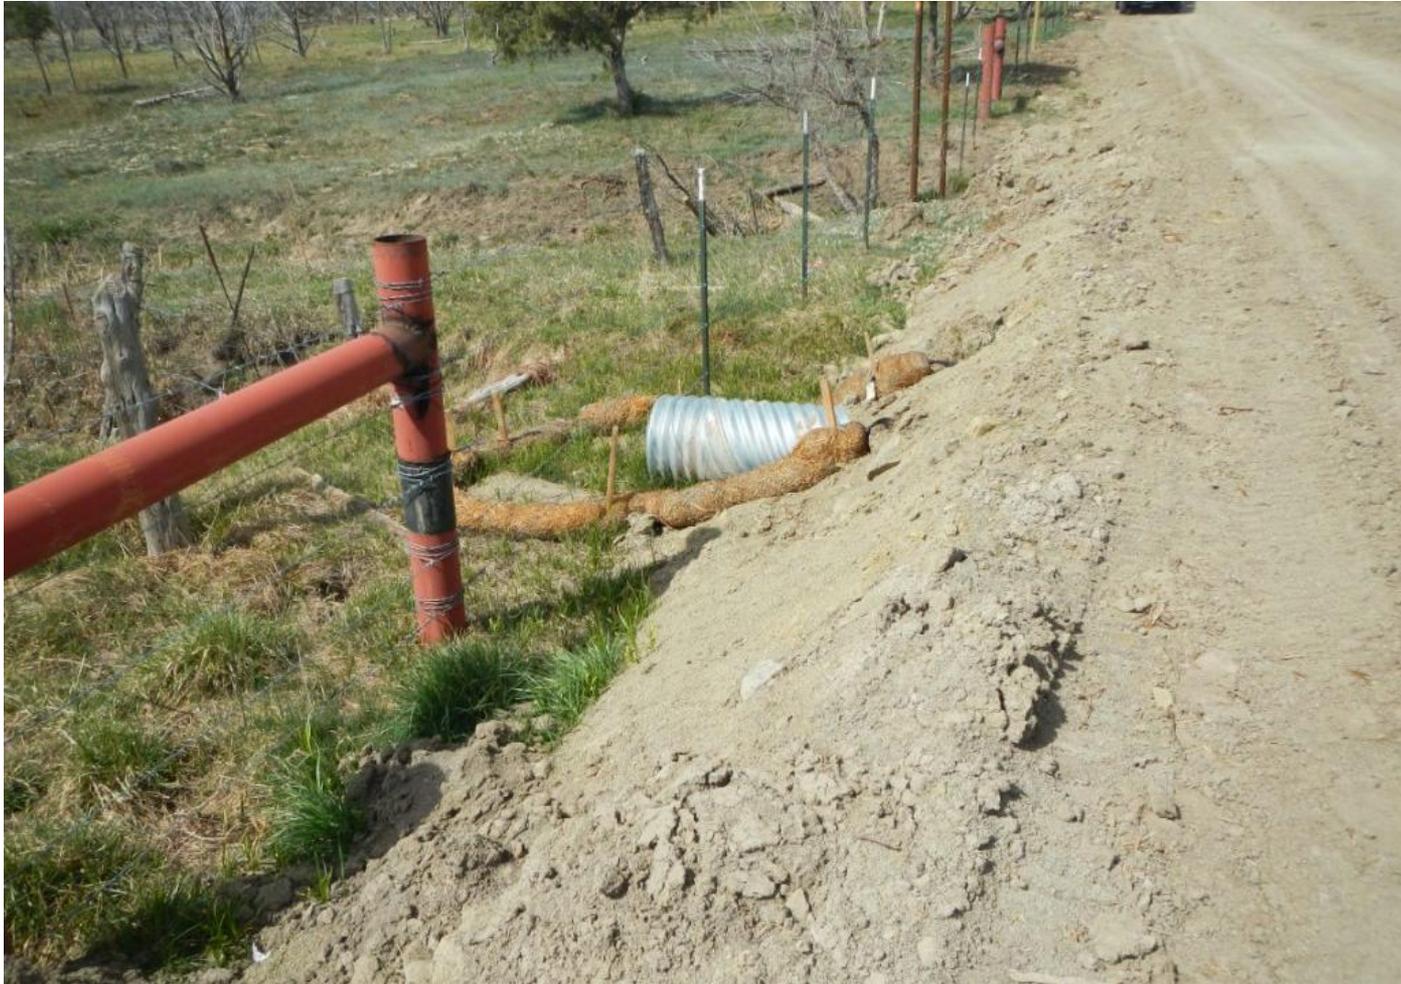
Photo 8. View of culvert outlet along access road, downstream from Photo 7.

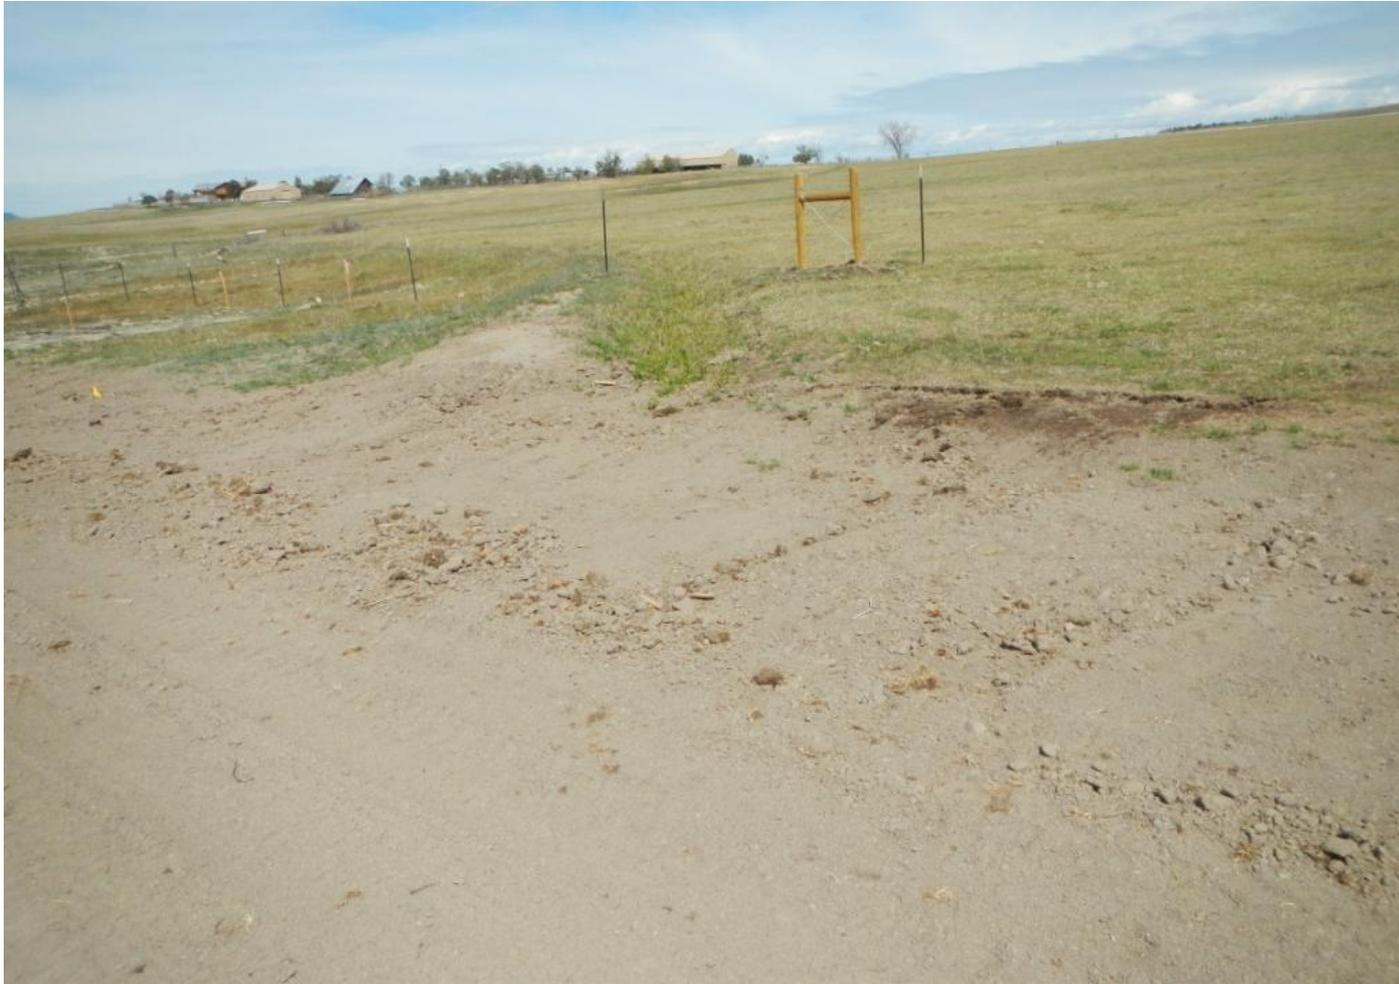
Photo 9. View of irrigation ditch that flows toward access road. It is unclear how erosion will be controlled as water flows through here toward the road.

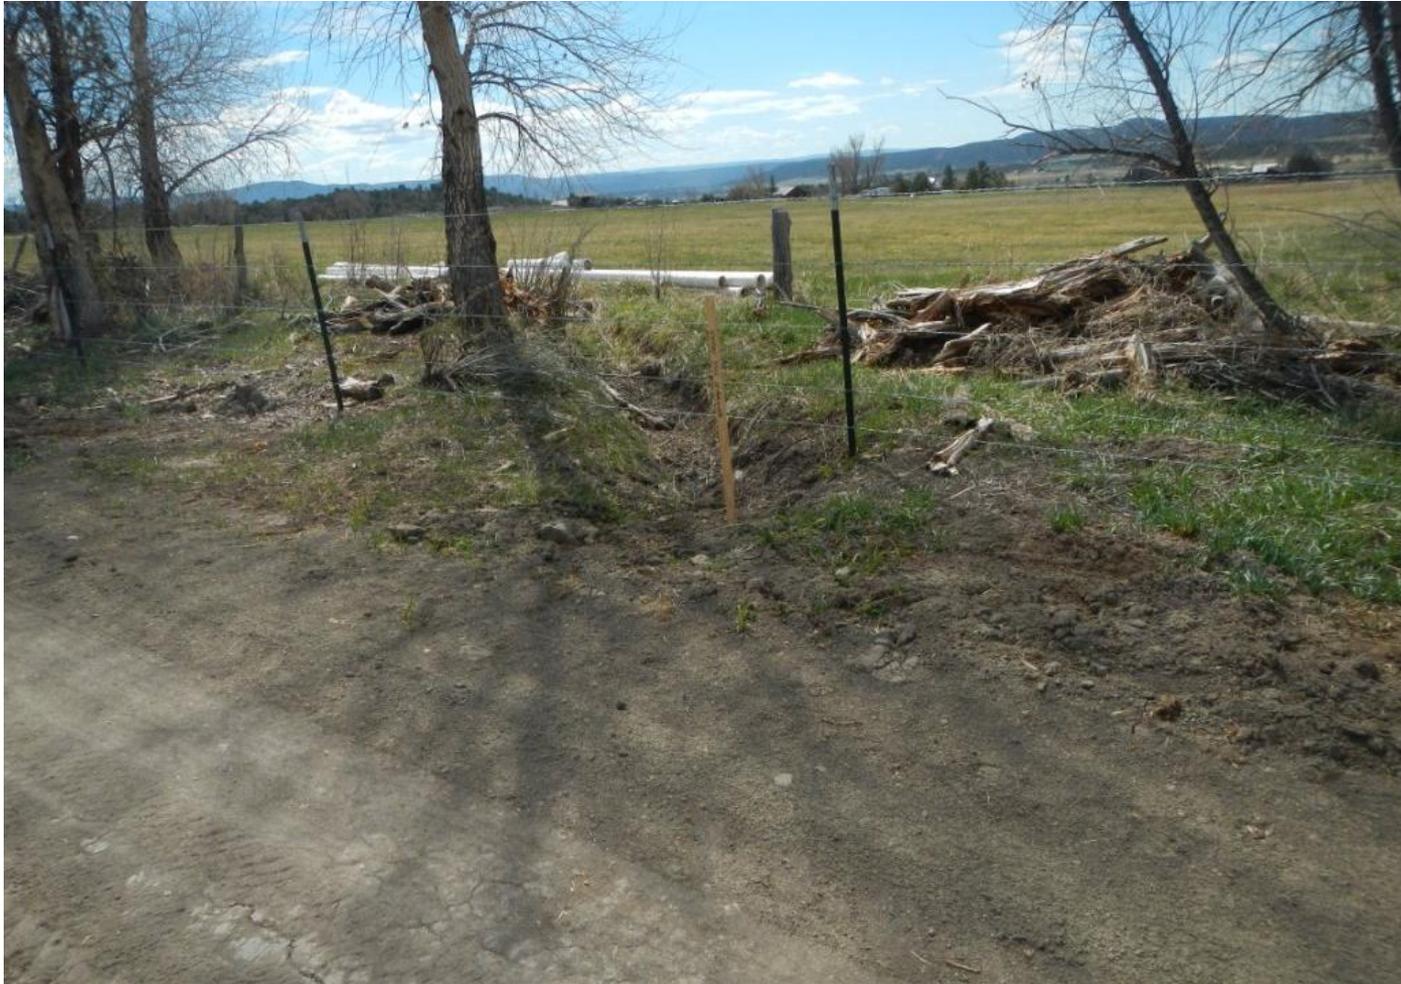
Photo 10. Downstream view of irrigation ditch that flows across access road. No controls are present to control flows that bisect the access road.

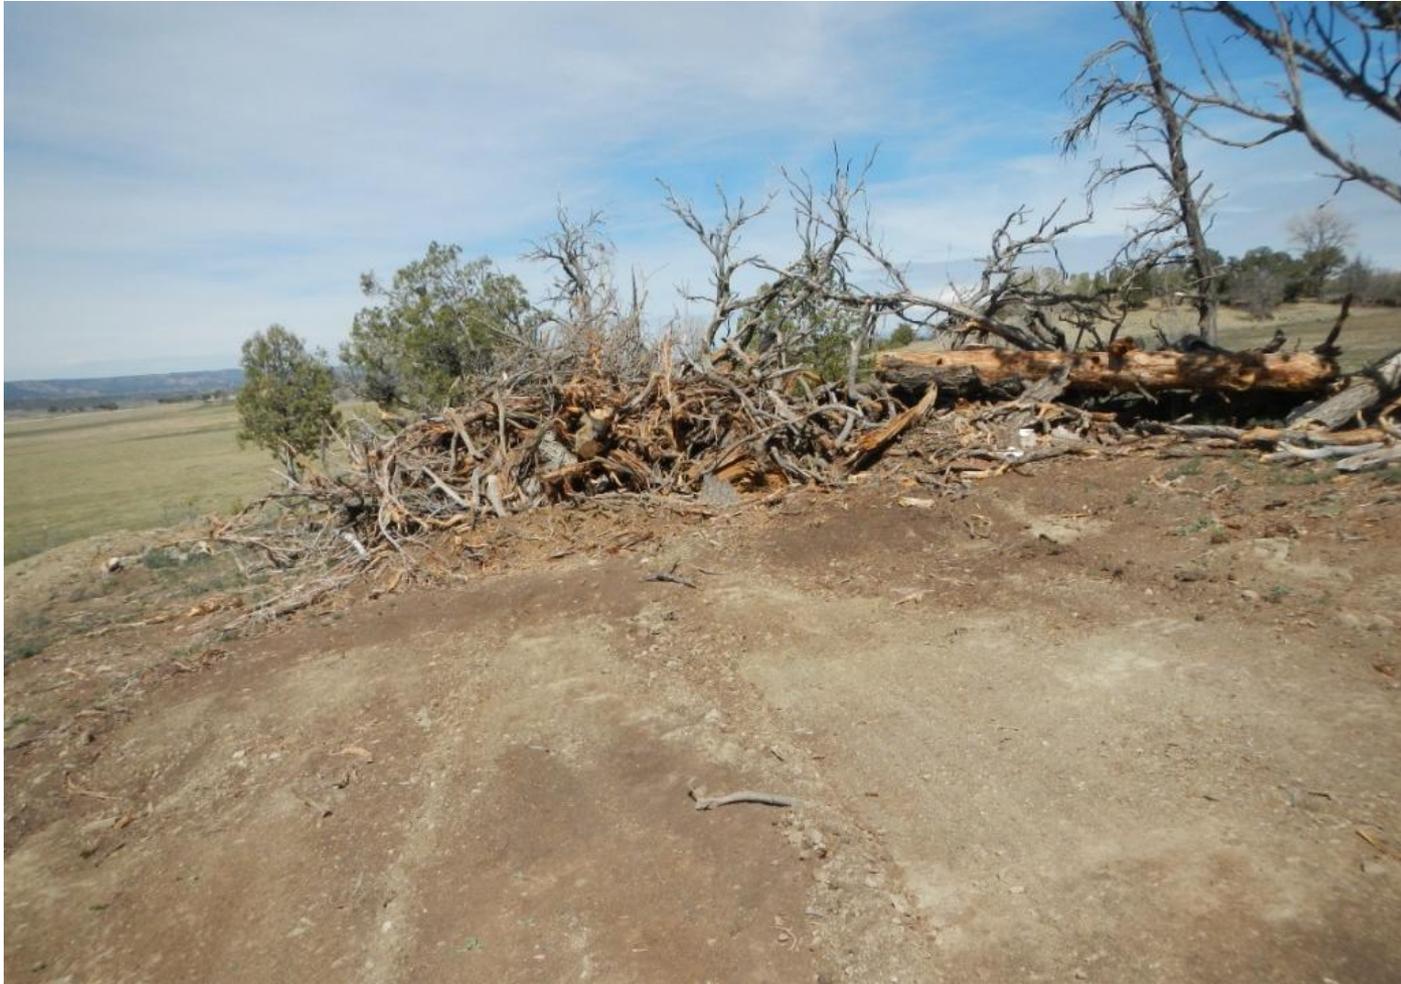
Photo 11. View of woody debris in the northern portion of the project area that needs to be removed.

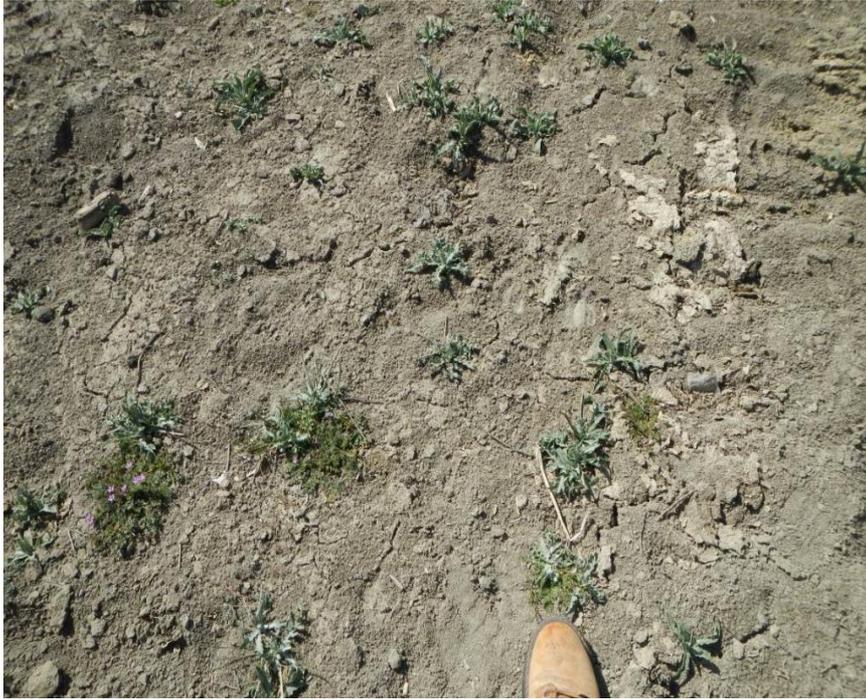
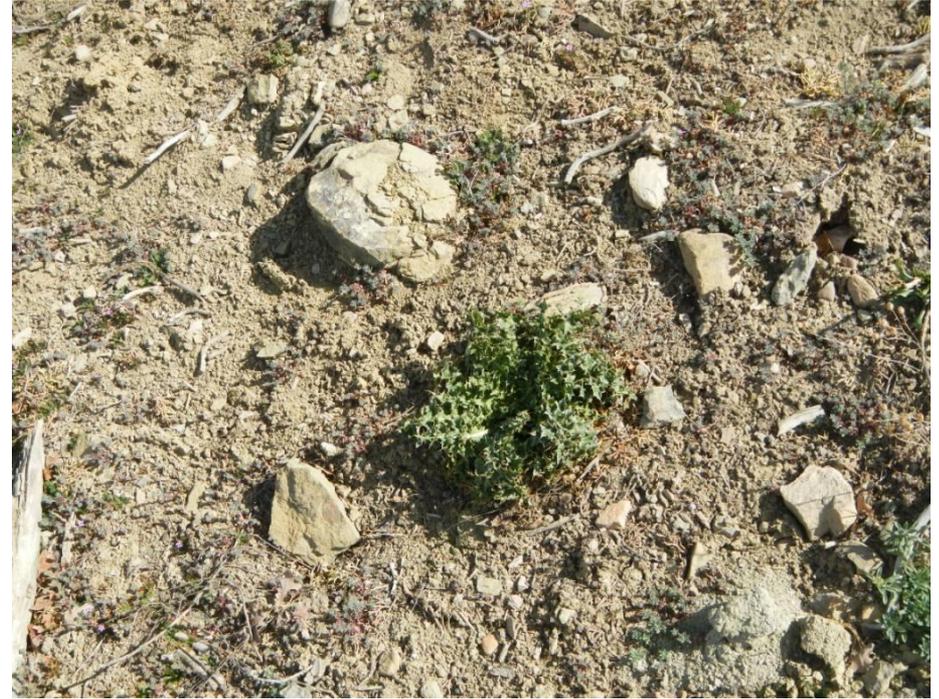
Photos 12 and 13. View of Russian knapweed (*Acroptilon repens*; left) and musk thistle (*Carduus nutans*; right) observed along the edges of the project area. These are both State and County-listed noxious weeds that will need to be carefully controlled to prevent infestation within the newly disturbed project area.
