Reclamation Inspection

4/15/2016

Operator: HRM

Location ID: 313925

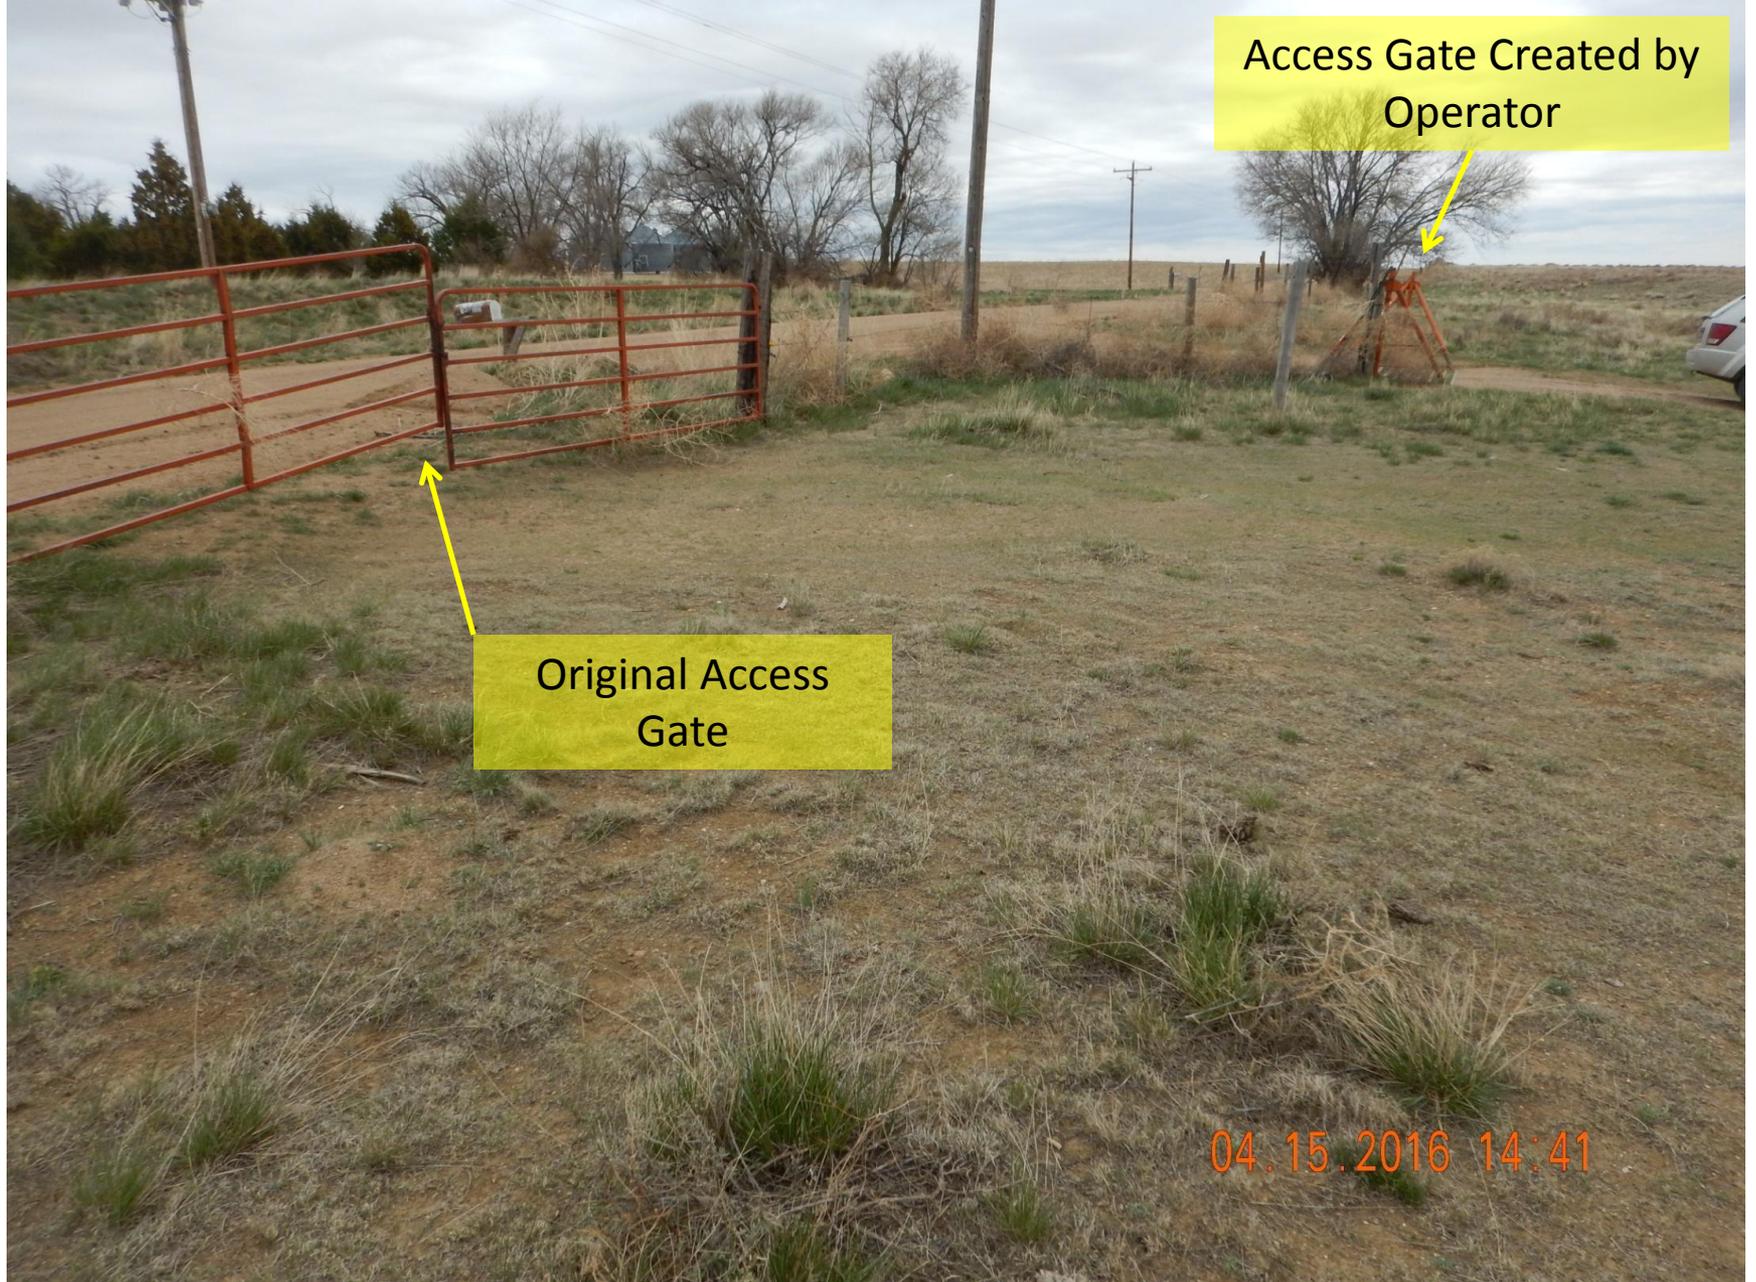
Figure 2: Photo taken at access road entrance and Morgan CR-2. Photo shows original access gate to the property on left side of image, and operator entrance on top right of image.

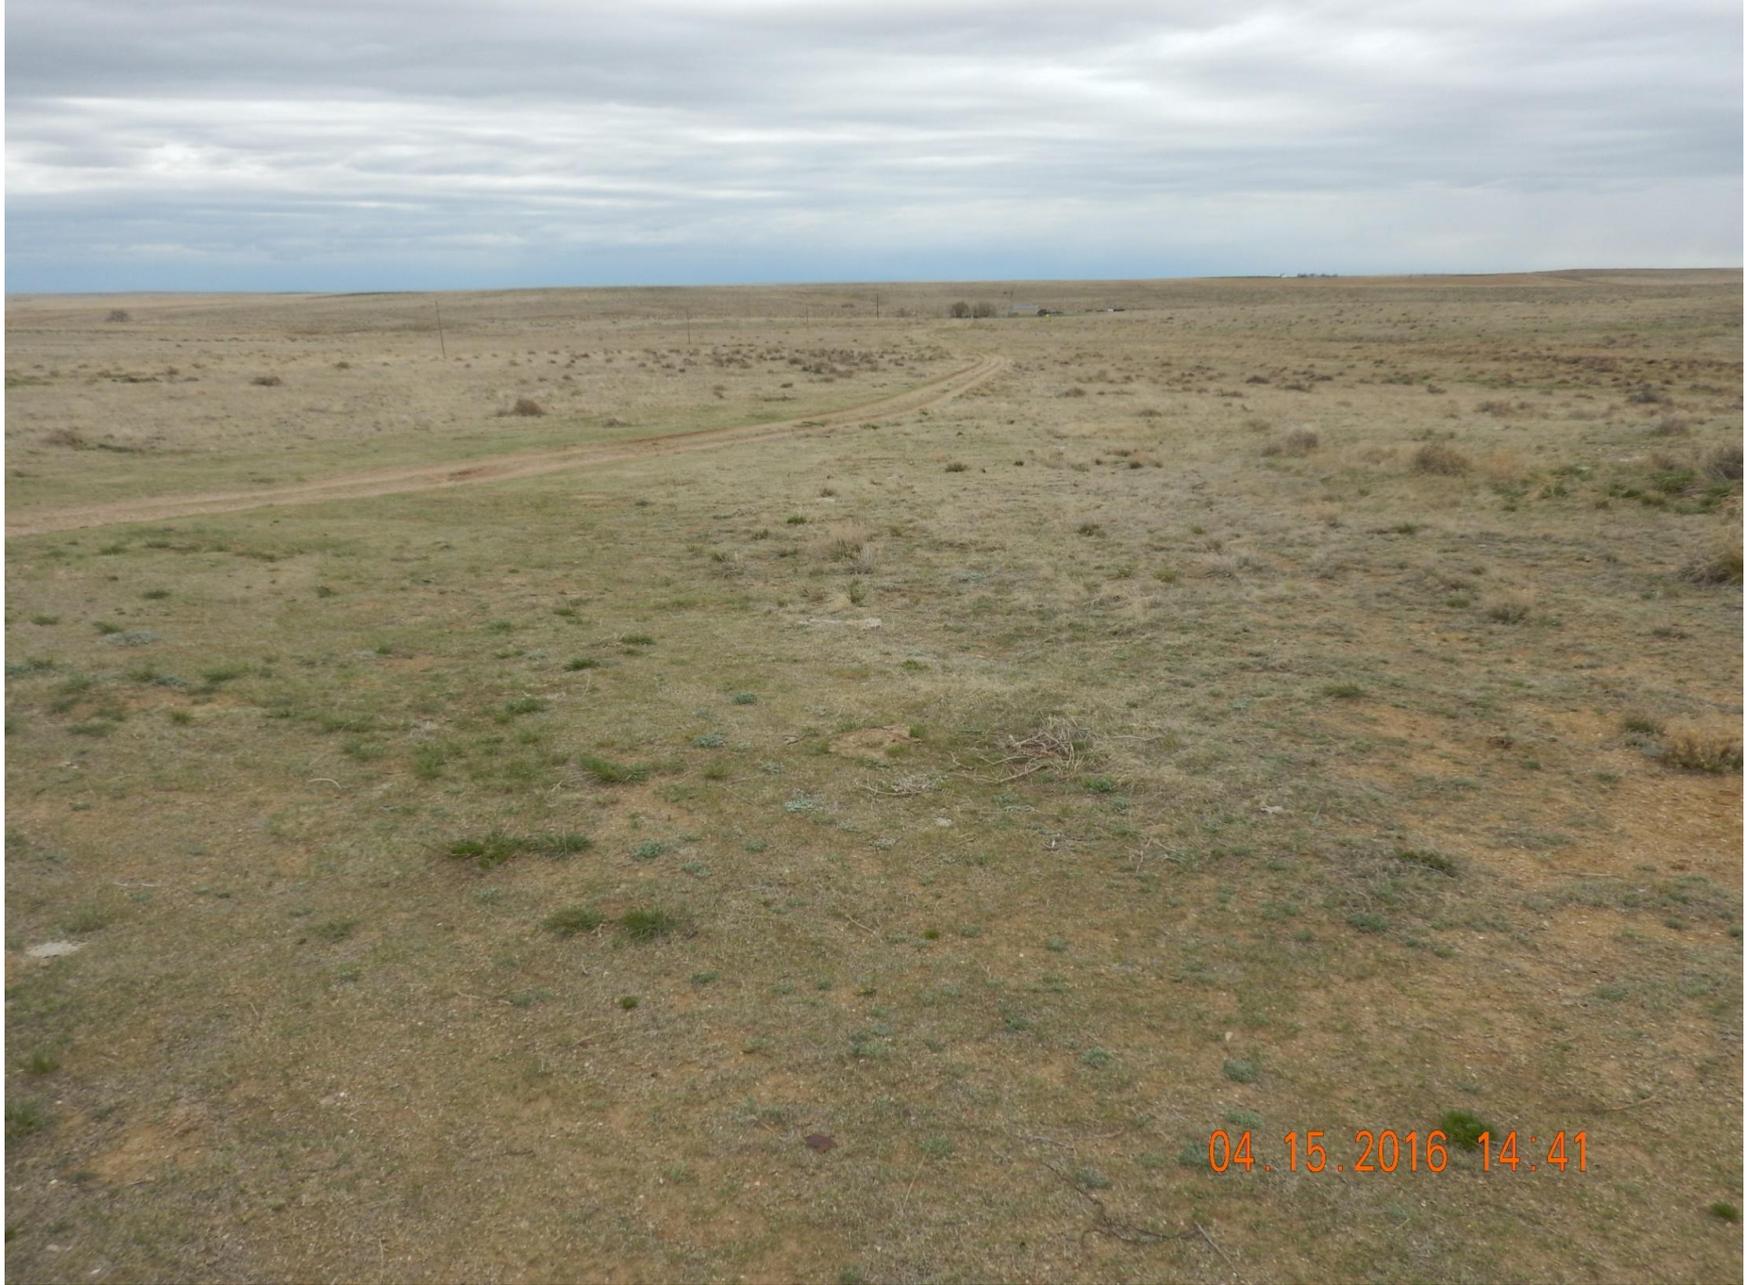
Figure 3: Photo taken at access road entrance, facing west. Photo shows access road leading to location.

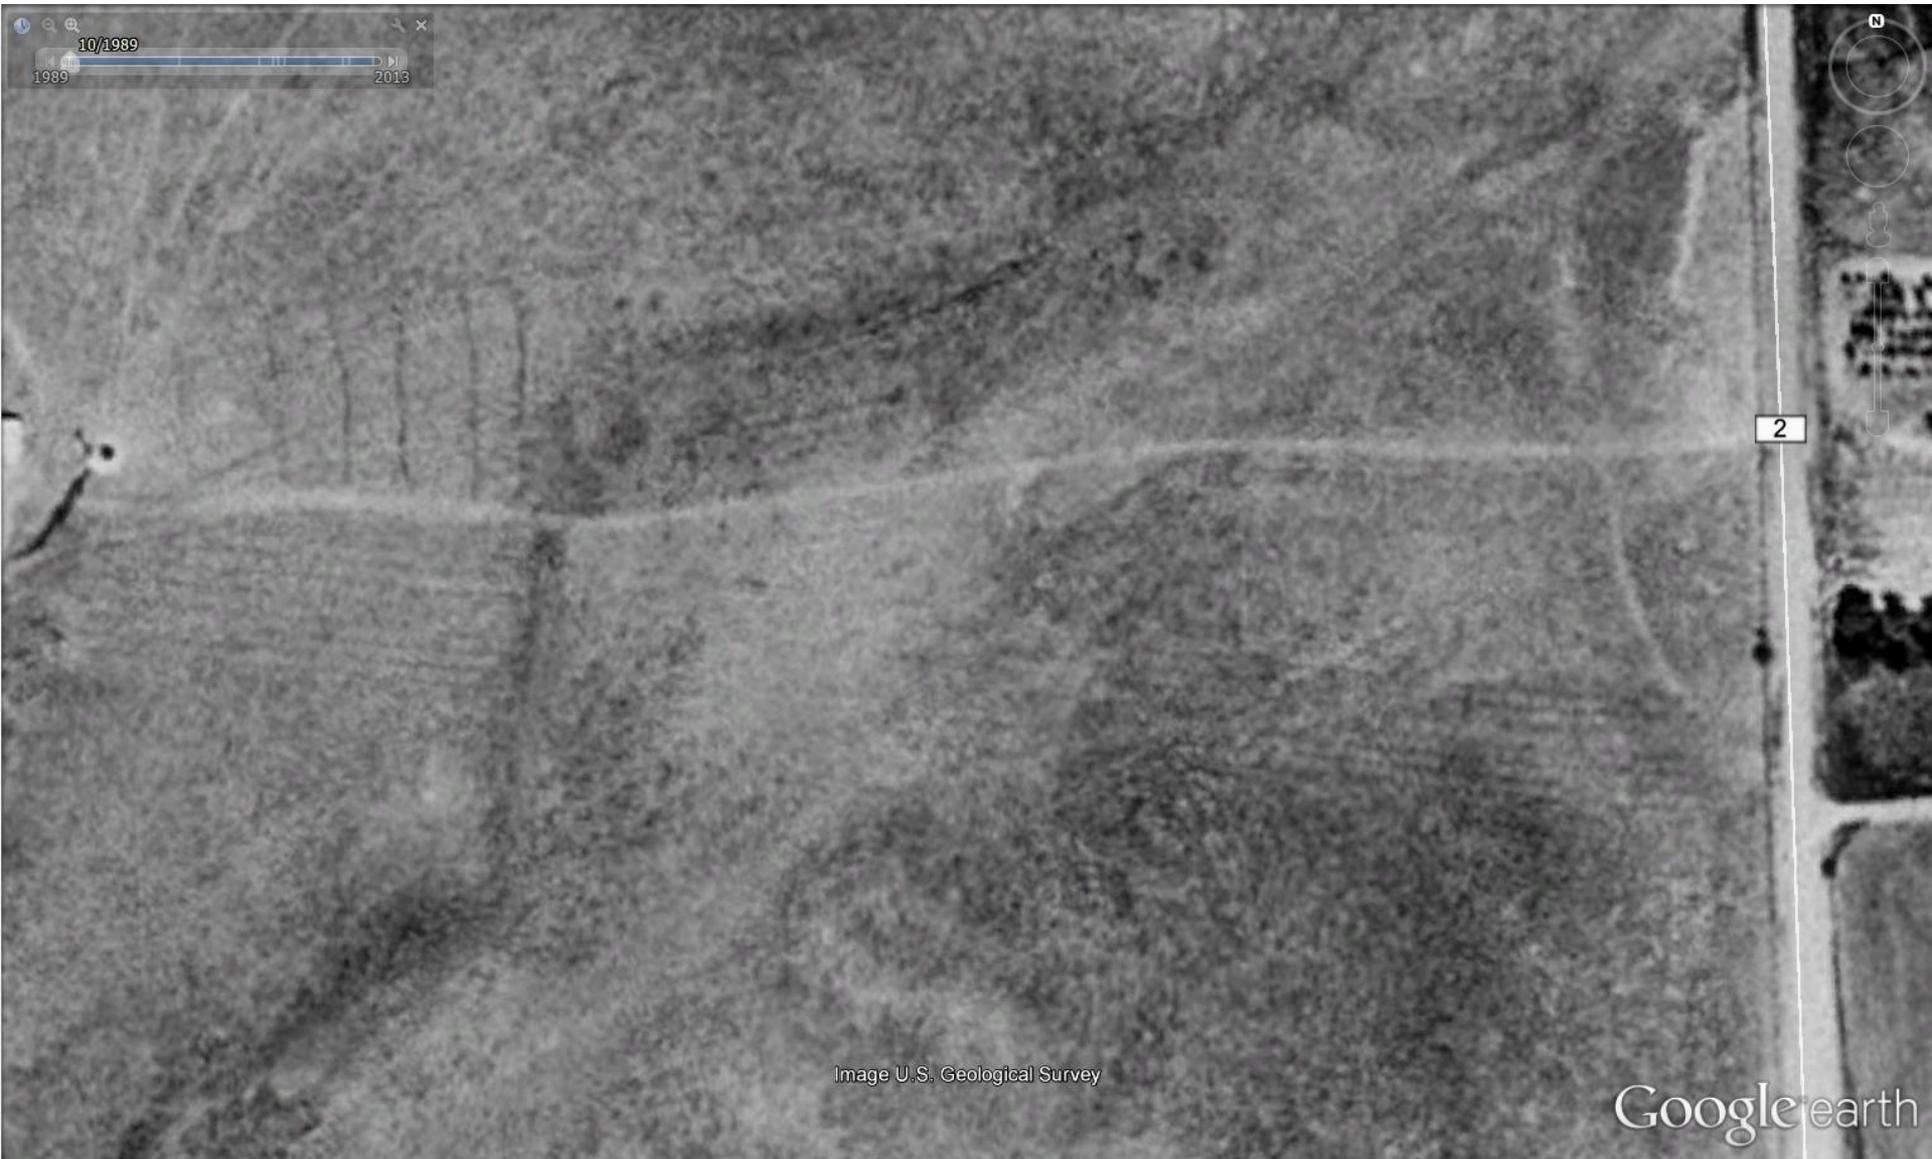
Figure 4: 1989 Aerial imagery of original two-track road pre-oil and gas disturbance on location 313925.

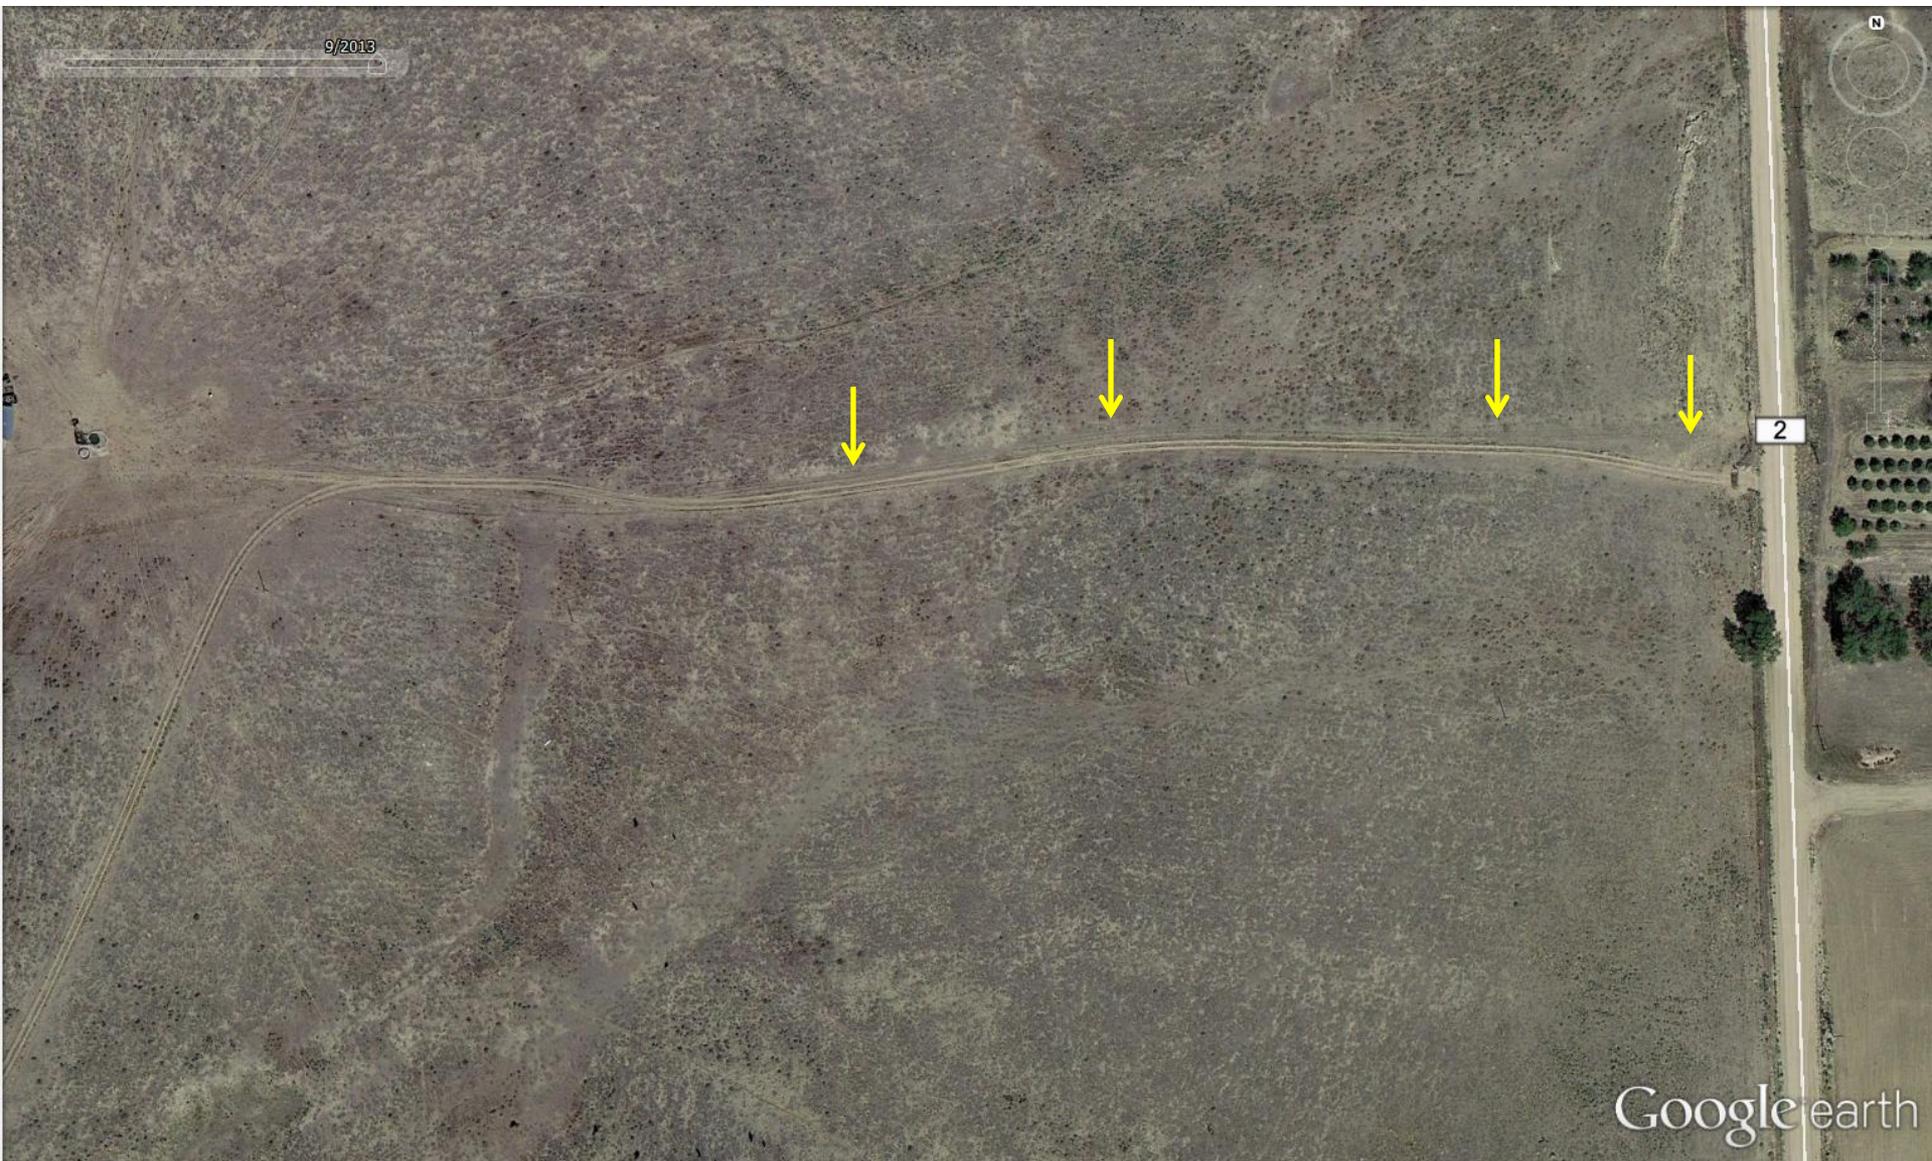
Figure 5: Most current aerial imagery (2013) of access road. Image shows lease road to location 313925 was constructed adjacent to the original two-track road (indicated by arrows). This is also evident in Figures 6 and 7.

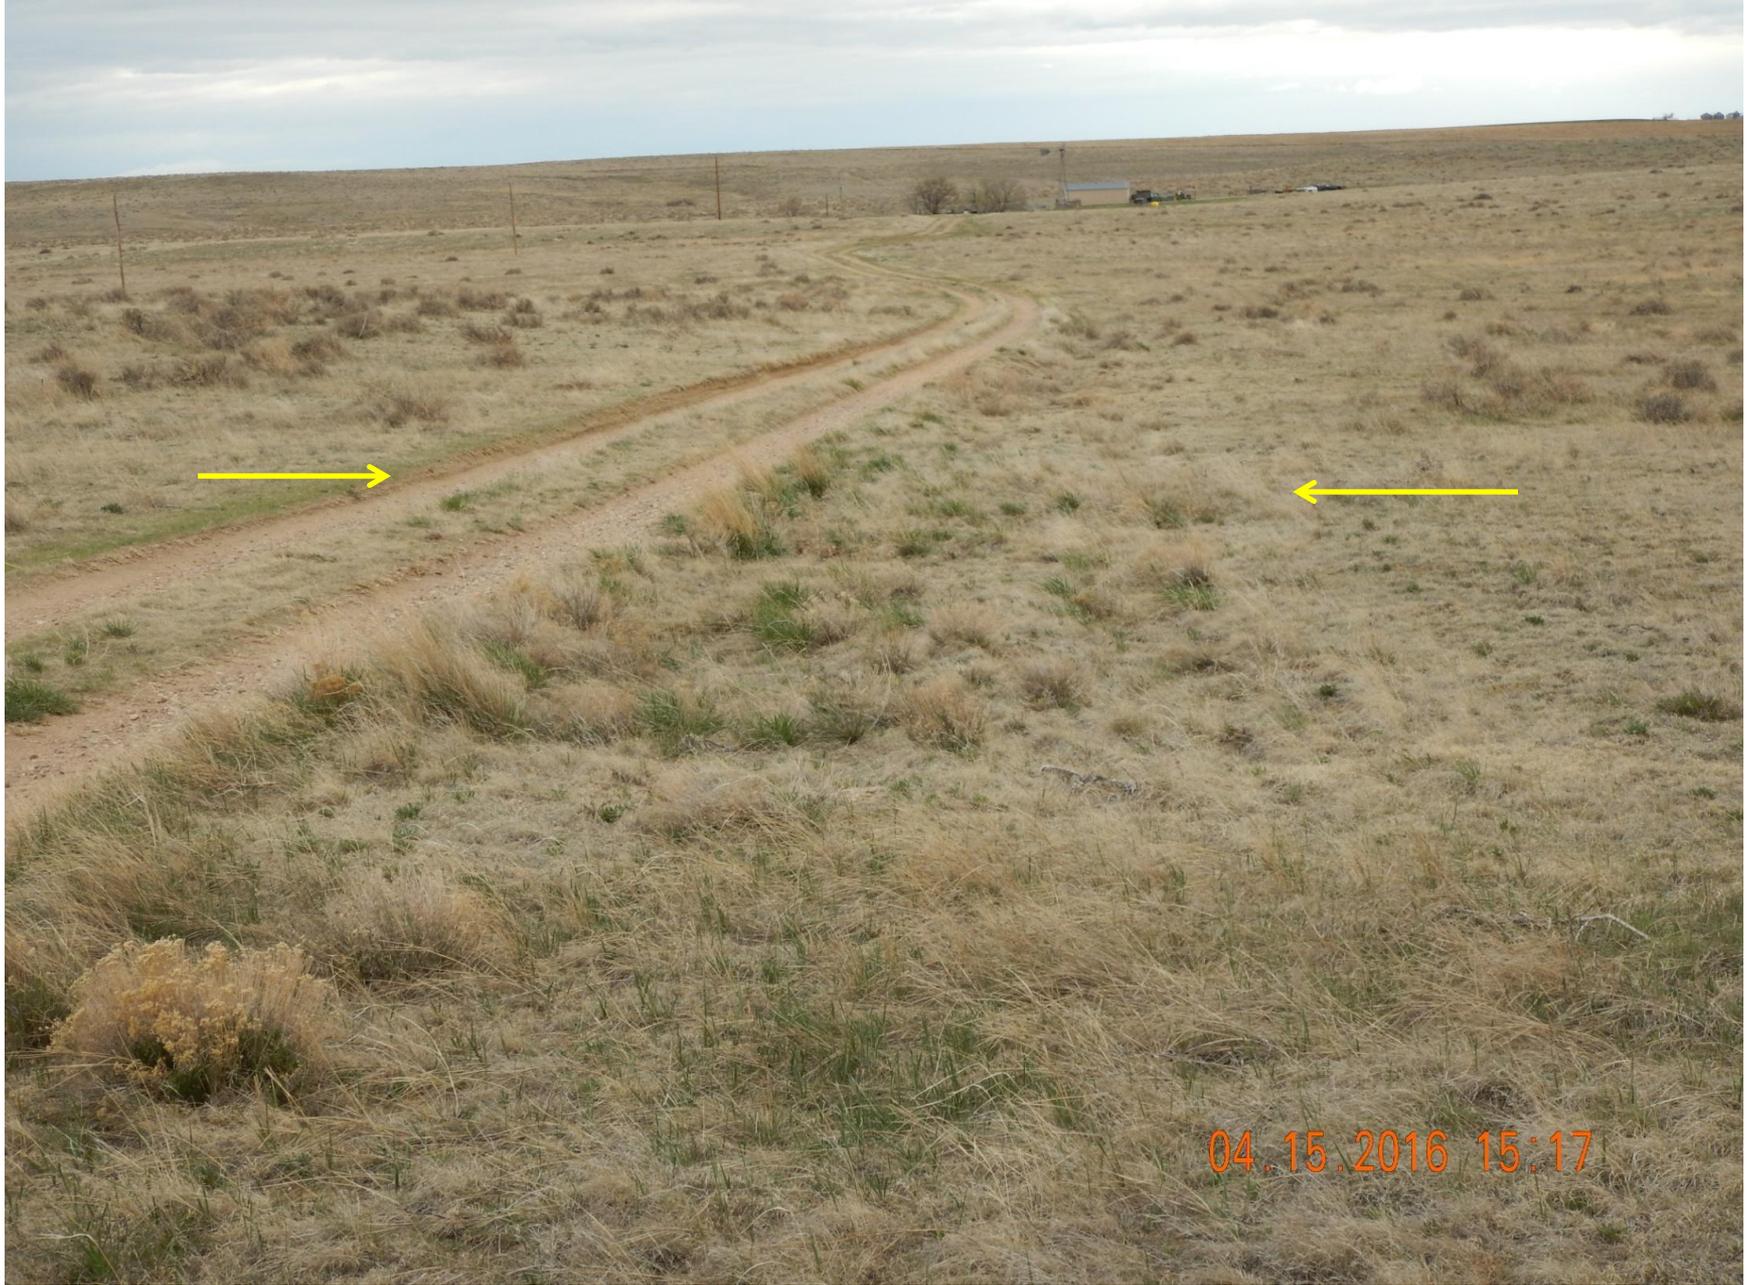
Figure 6: Photo taken from access road, facing west. Photo shows current access road (left), and pre-existing two-track (right)

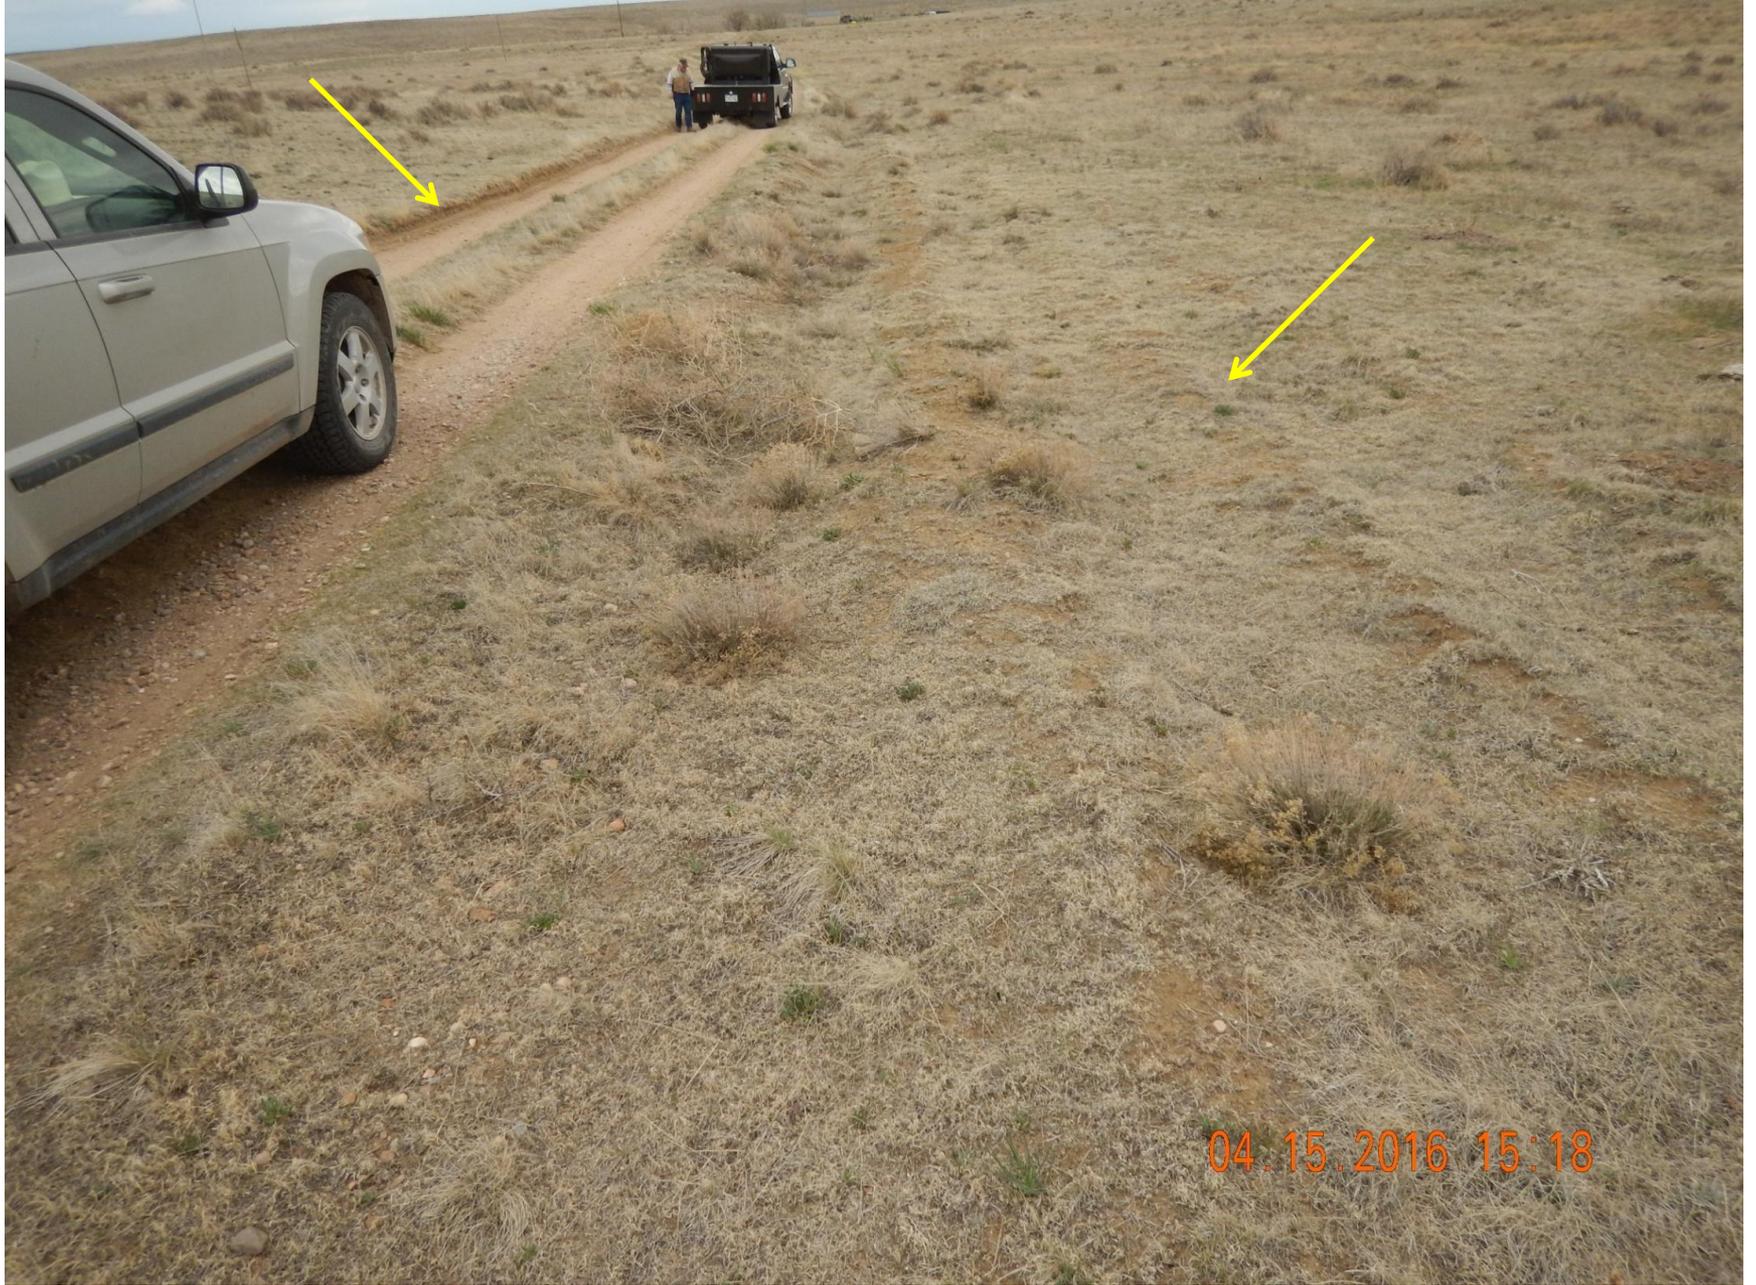
Figure 7: Photo taken from access road, facing west. Photo shows access road (left), and pre-existing two-track (right).

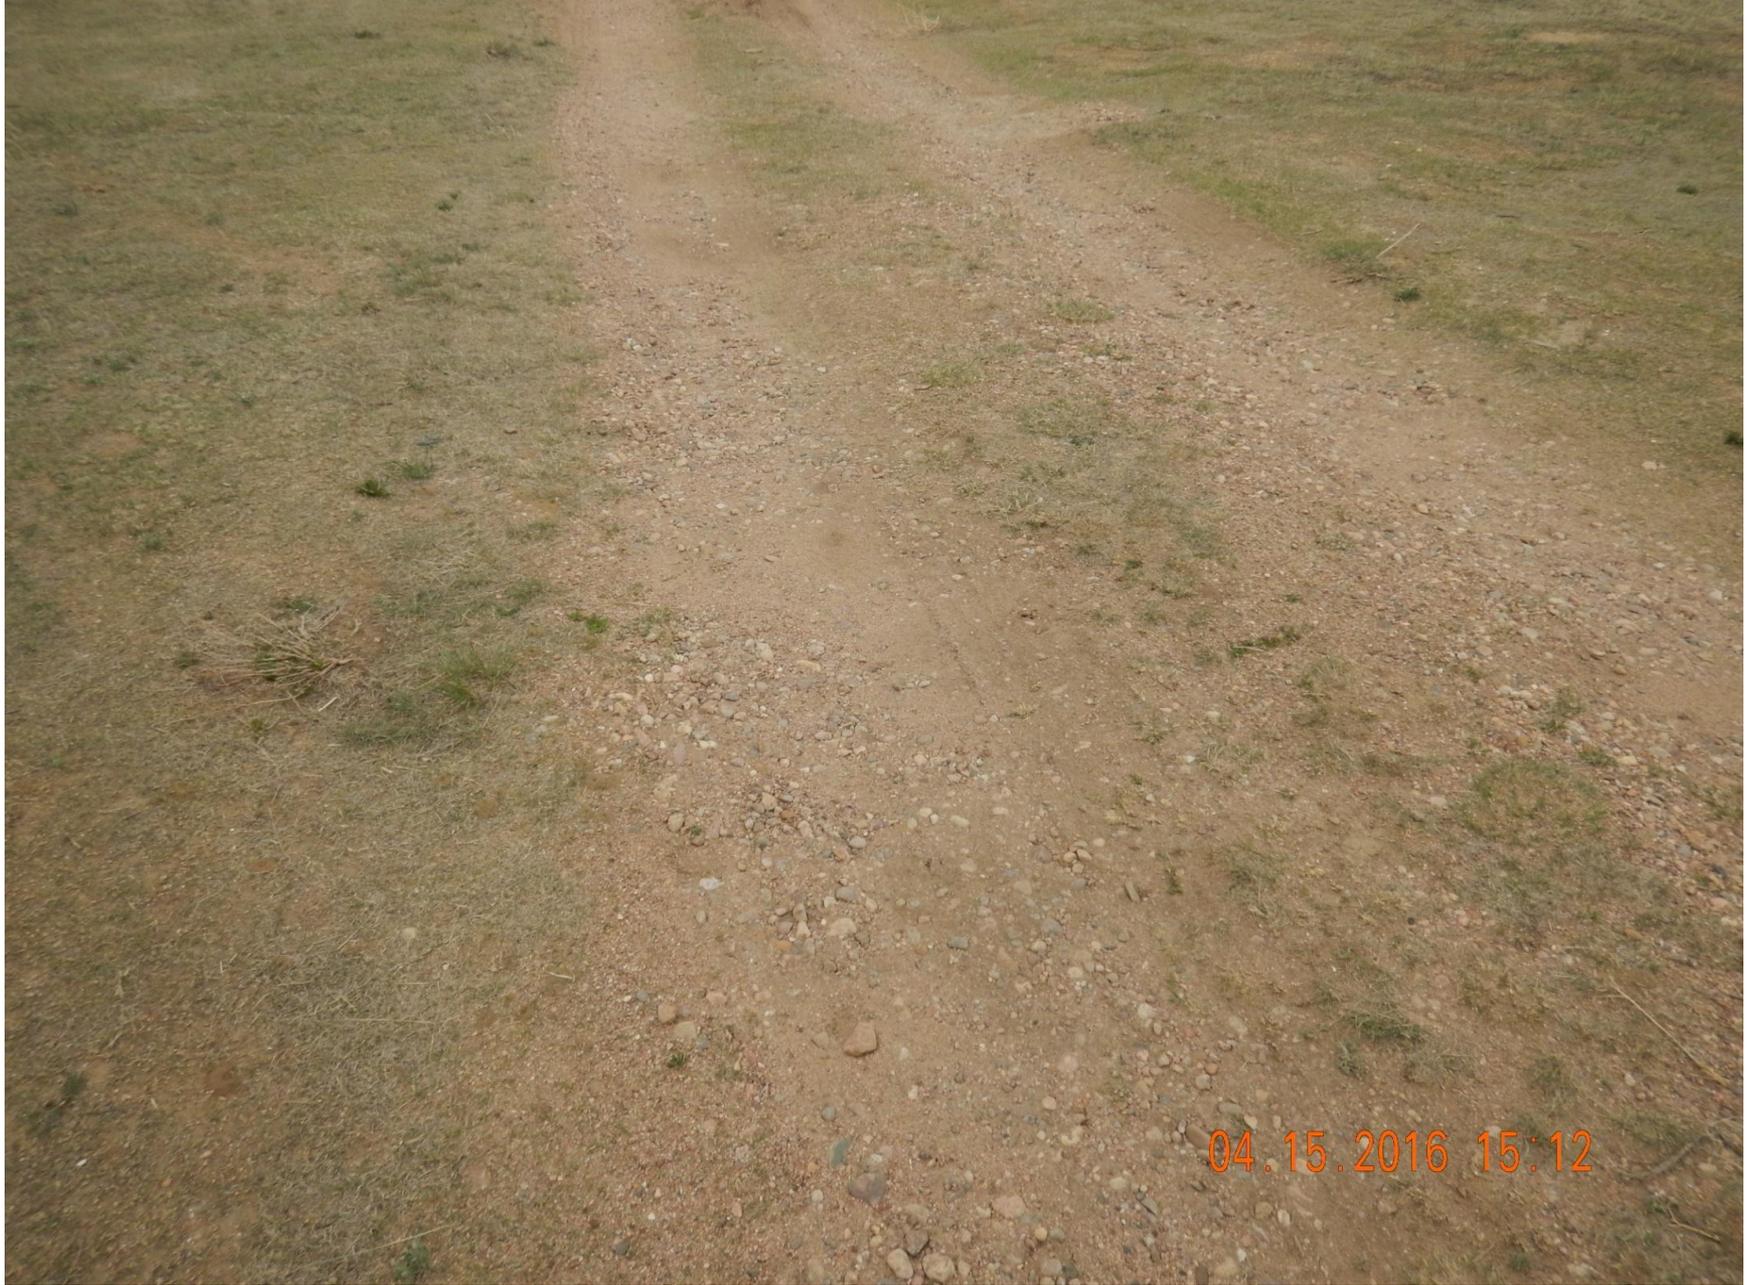
Figure 8: Photo taken from access road. Photo shows gravel on road.

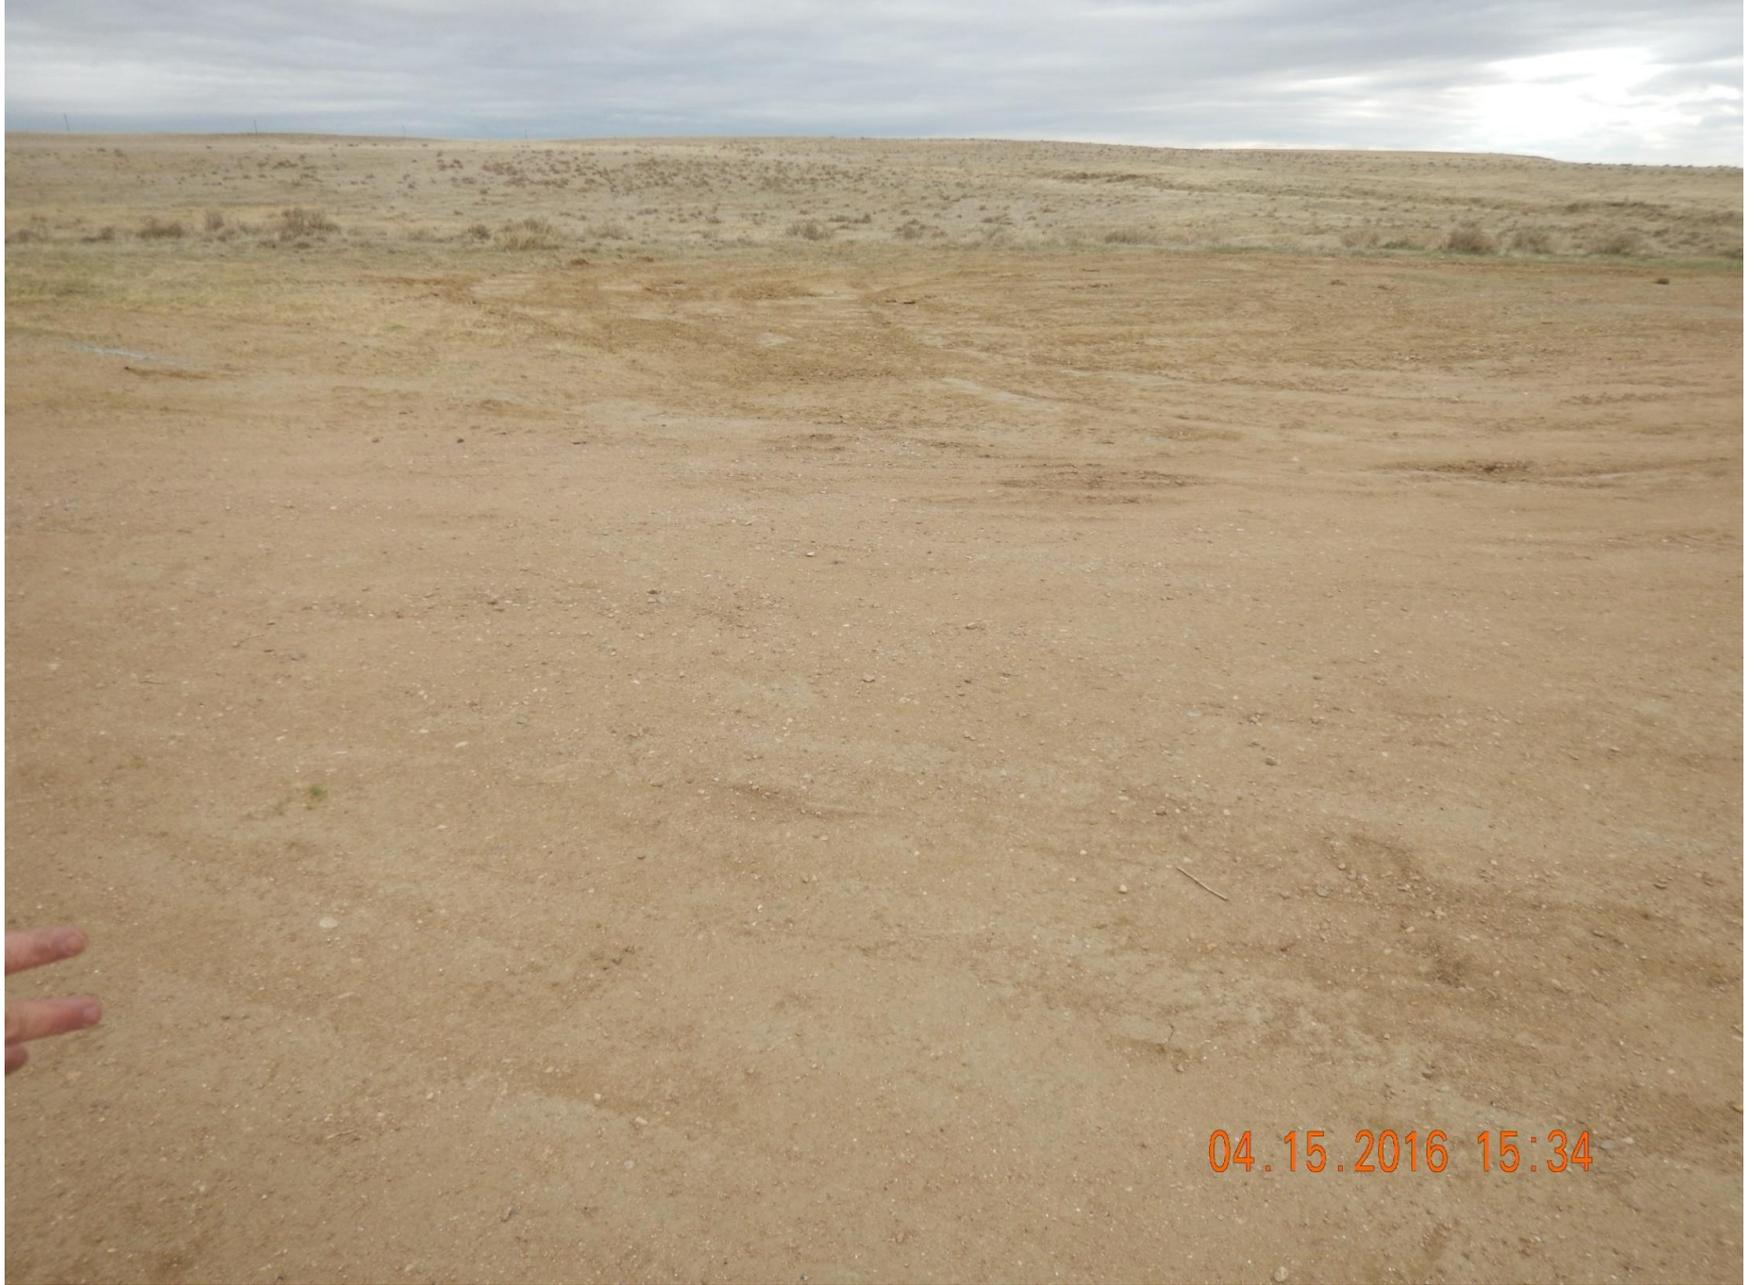
Figure 9: Photo taken from the north end of the location, facing southeast. Photo shows equipment and facilities have been removed.

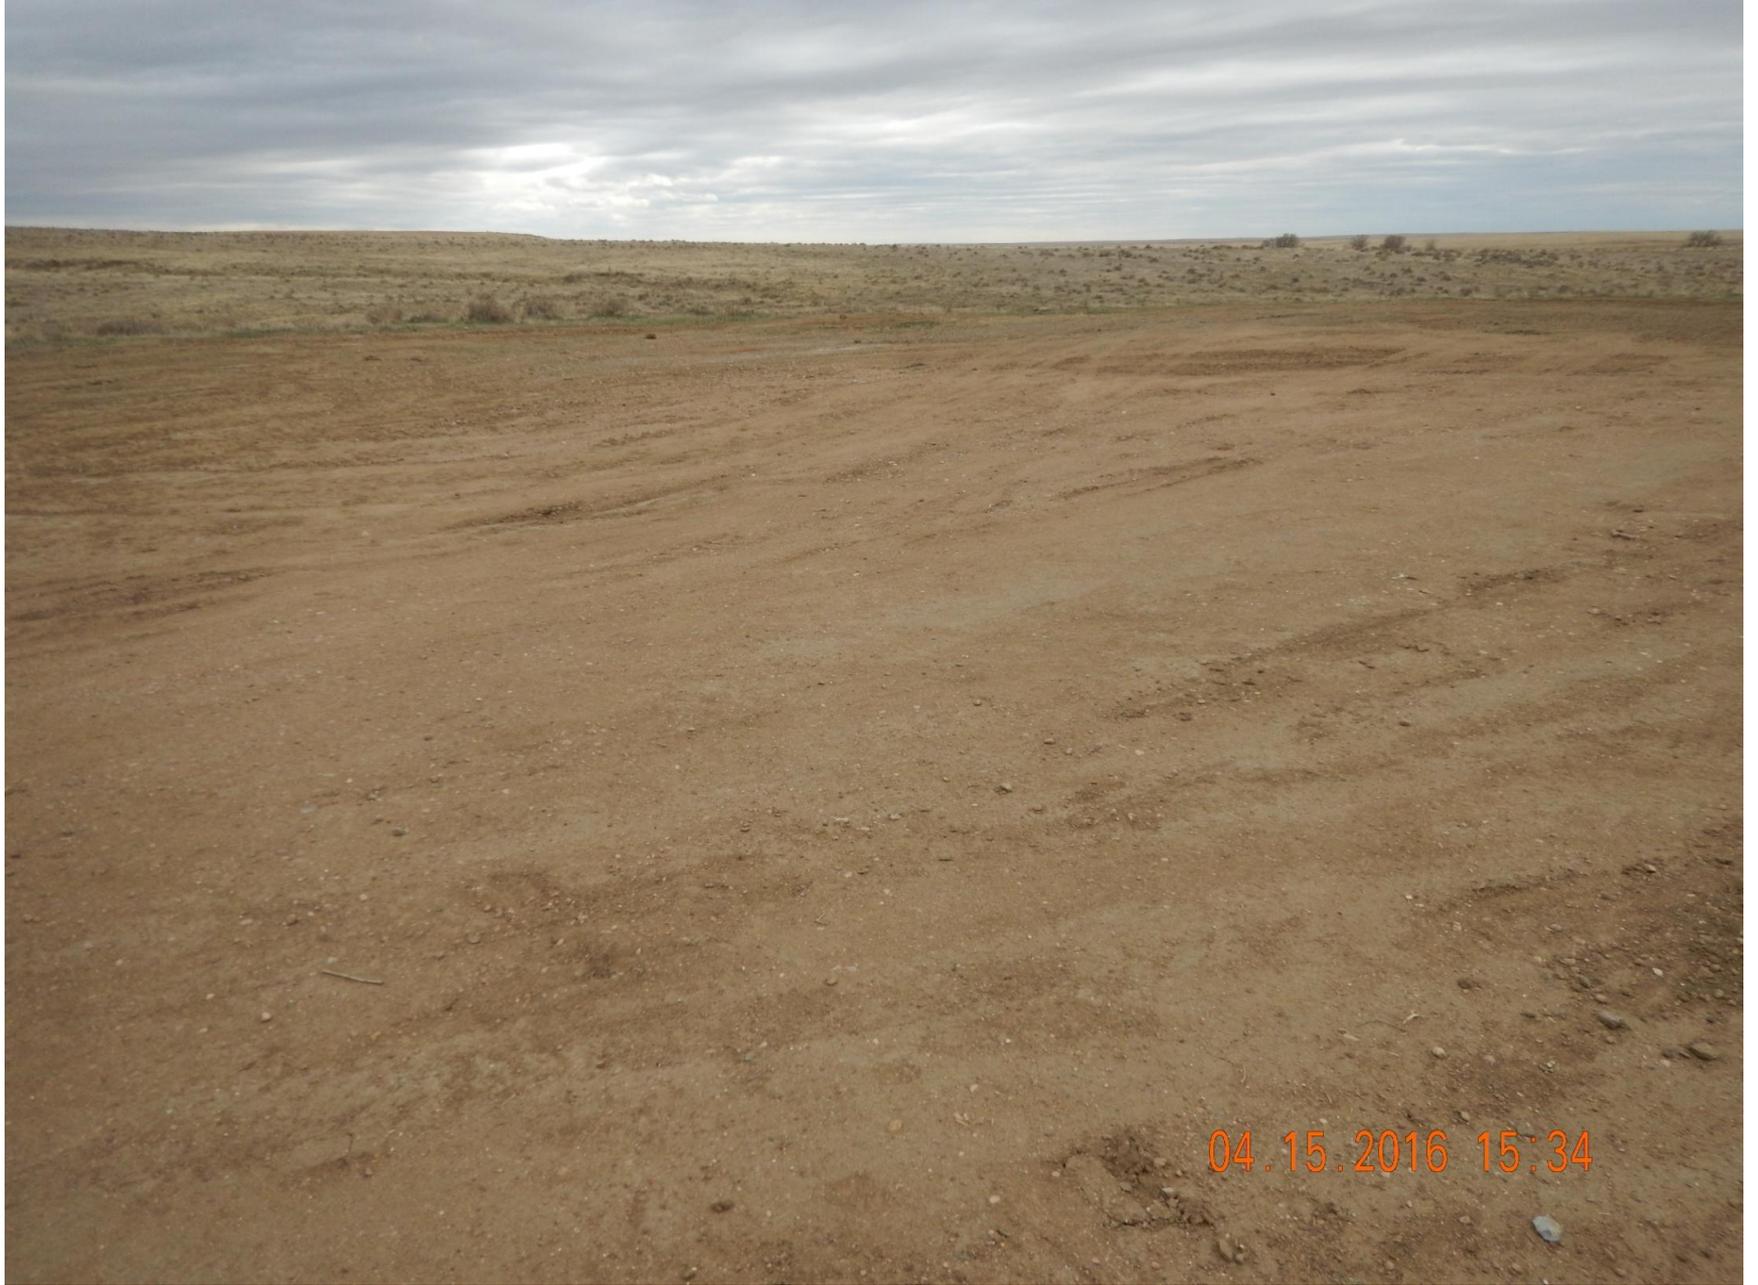
Figure 10: Photo taken from the north end of the location, facing south. Photo shows equipment and facilities have been removed.

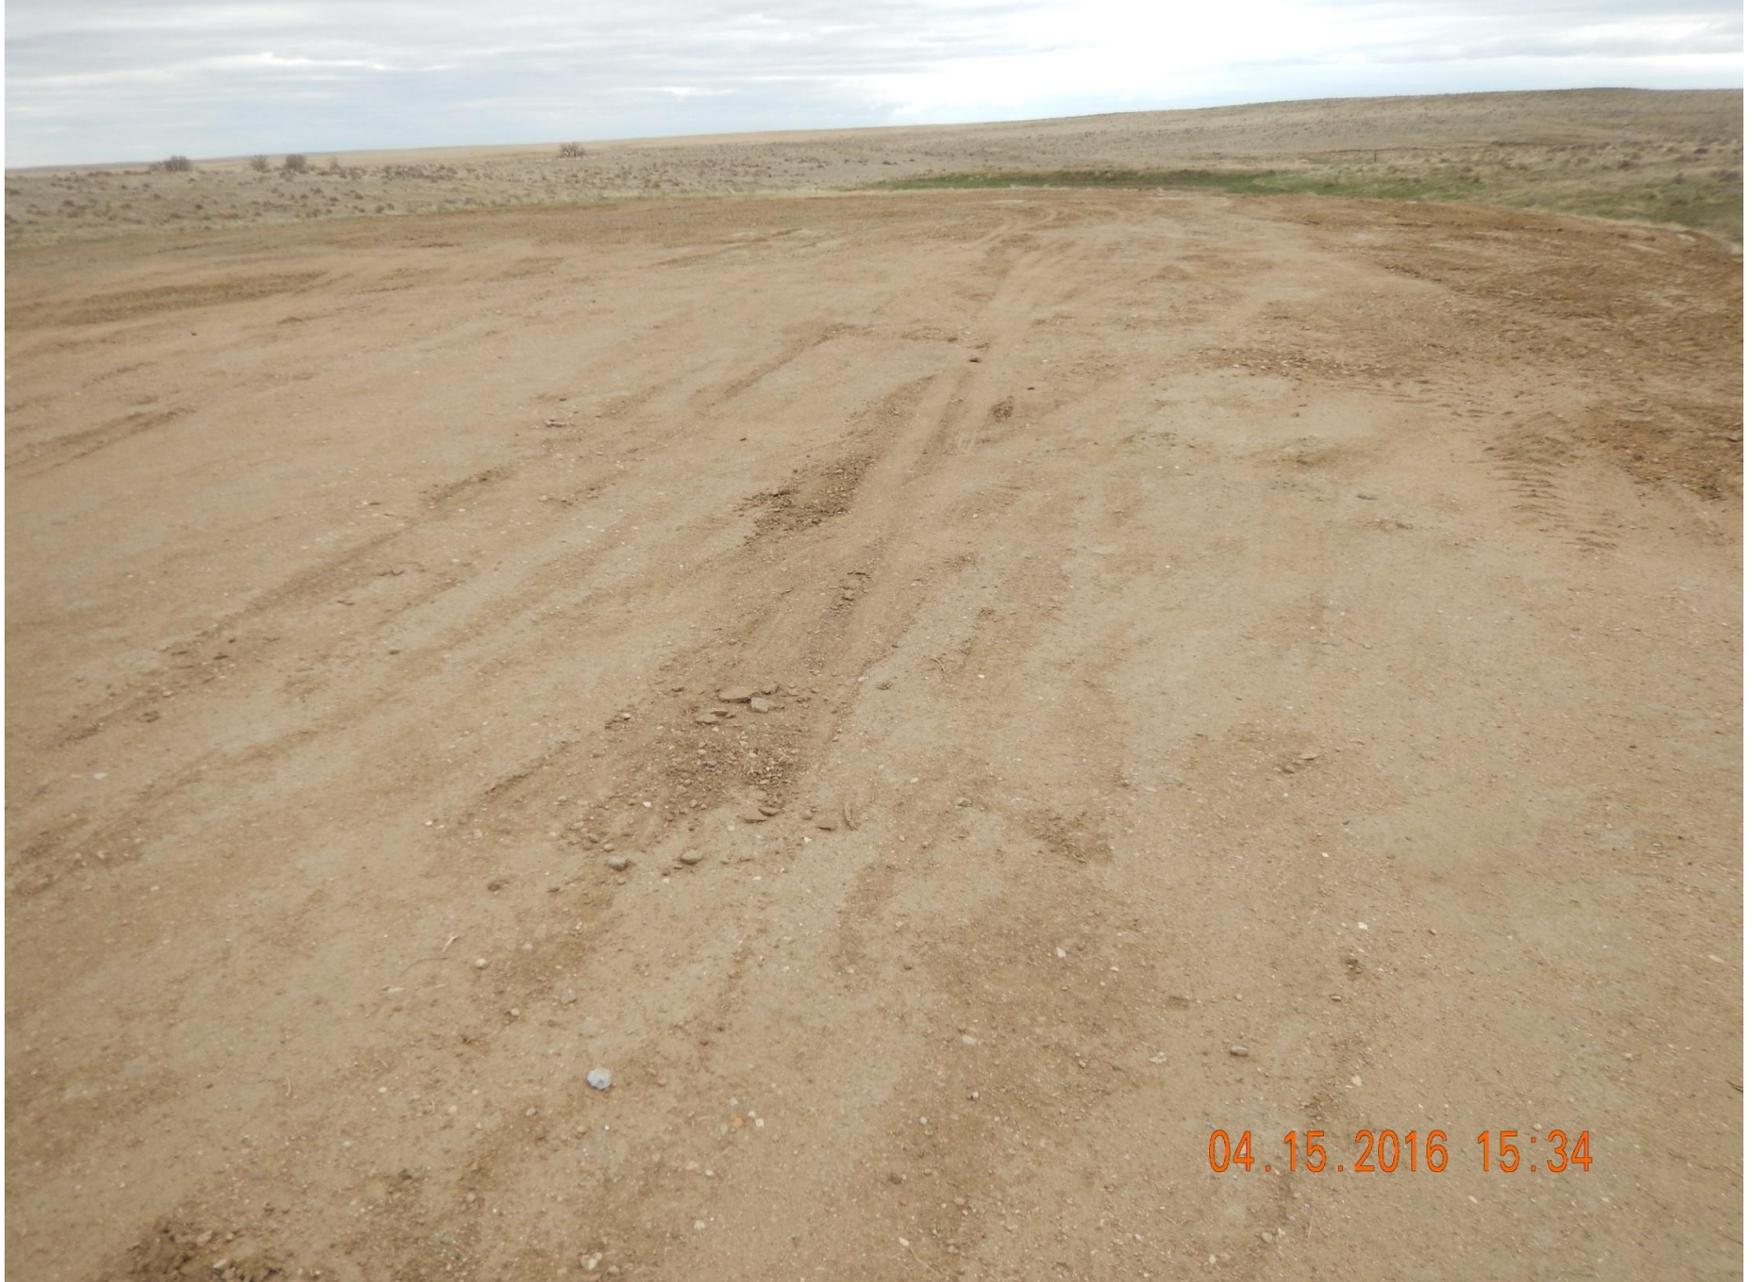
Figure 11: Photo taken from the north end of the location, facing southwest. Photo shows equipment and facilities have been removed.
