Reclamation Inspection

4/15/2016

Operator: HRM

Location ID: 313925

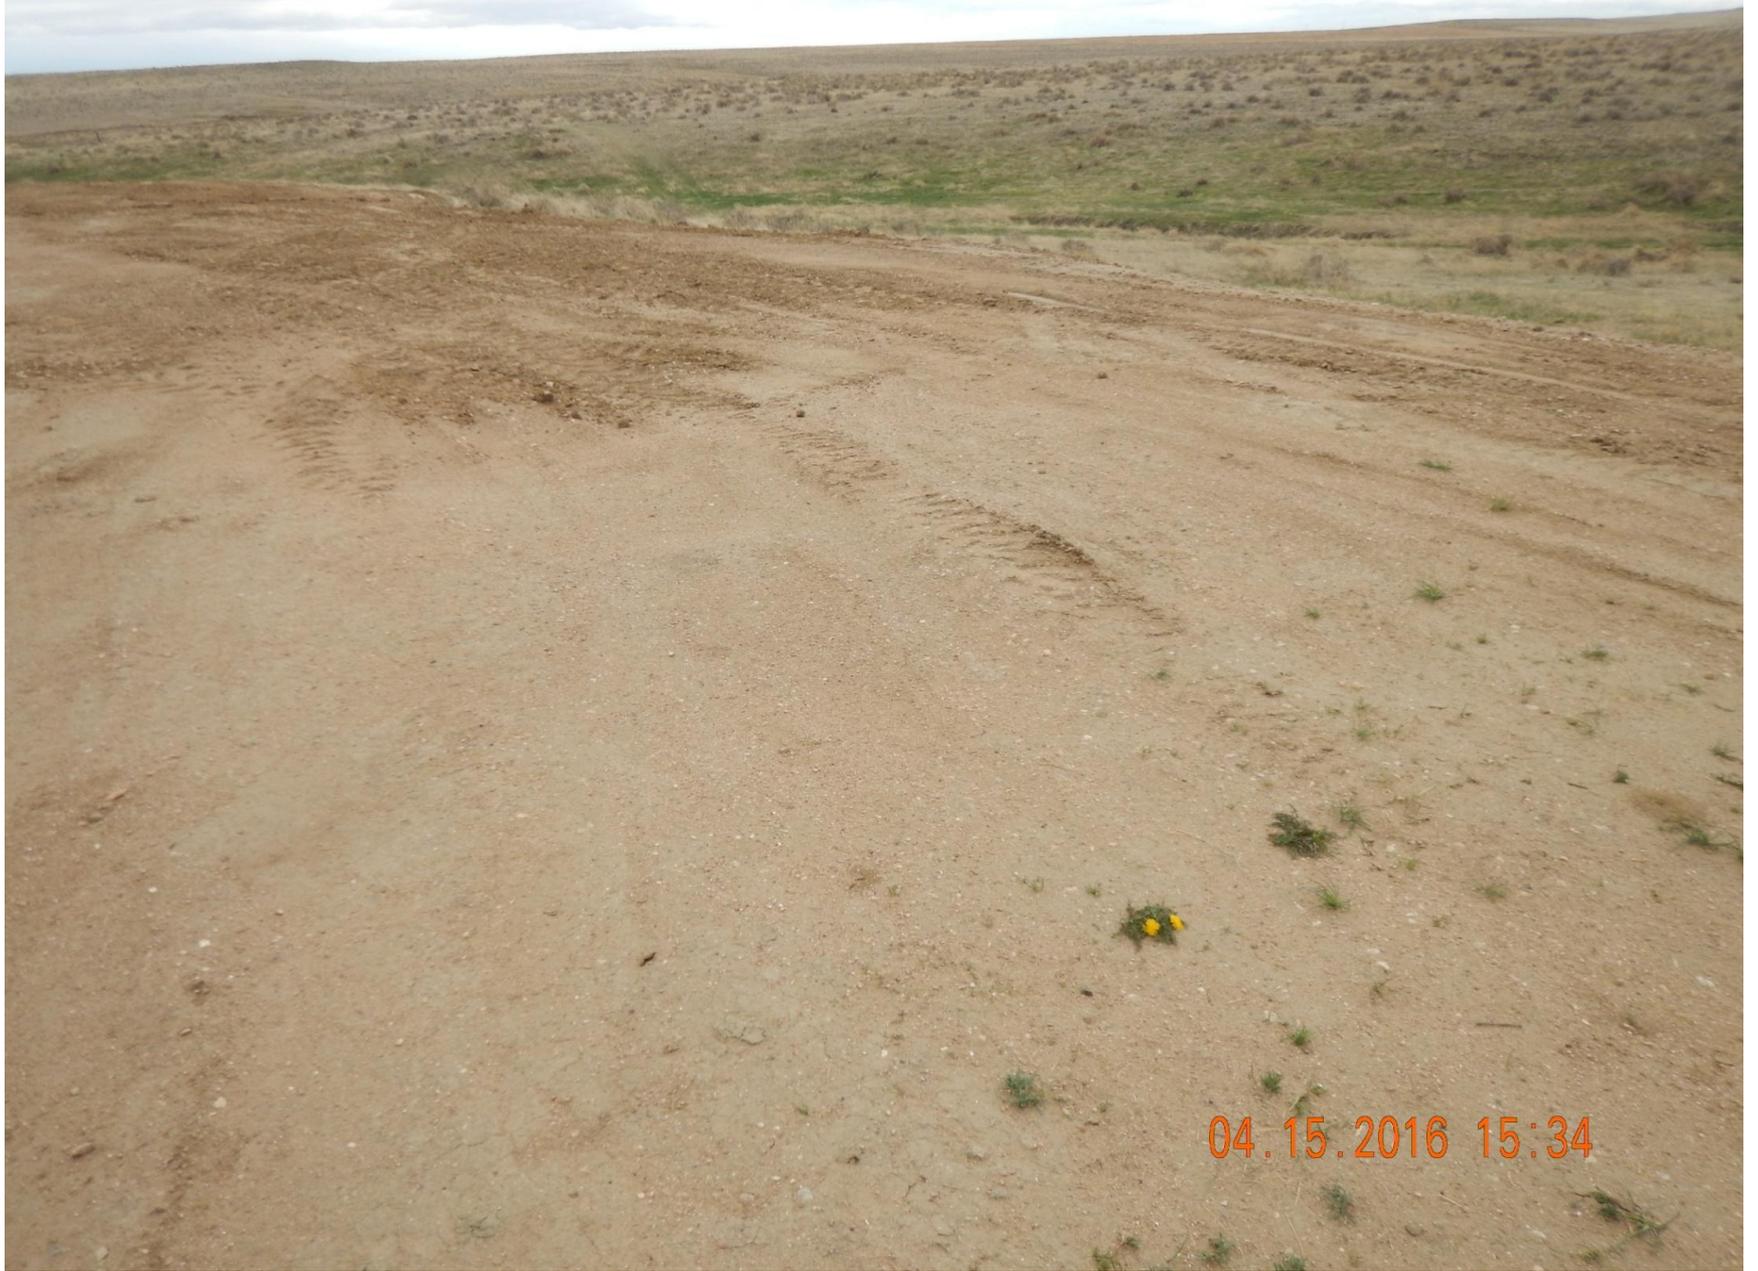
Figure 12: Photo taken from the north end of the location, facing west. Photo shows equipment and facilities have been removed.

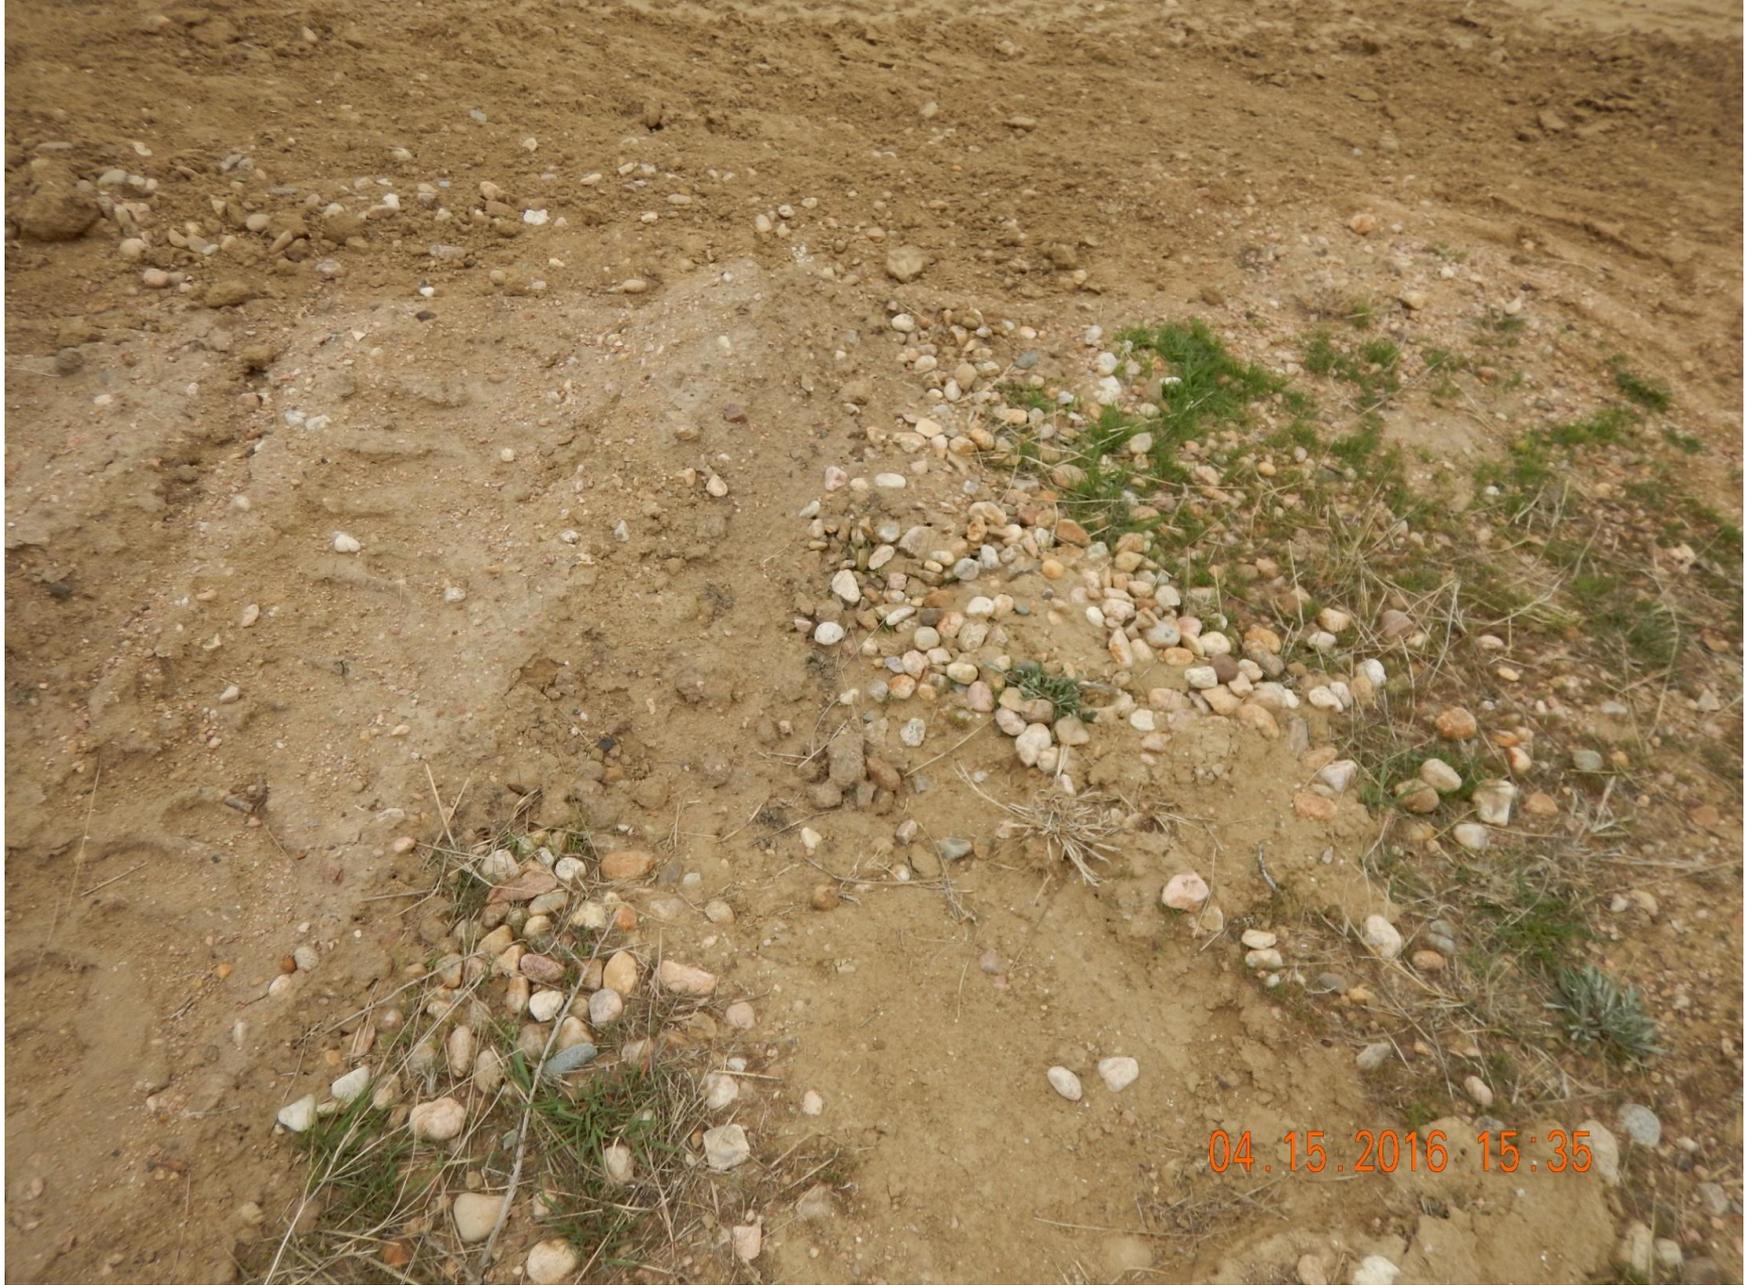
Figure 13: Photo taken from the west end of the location. Photo shows gravel remaining on location.

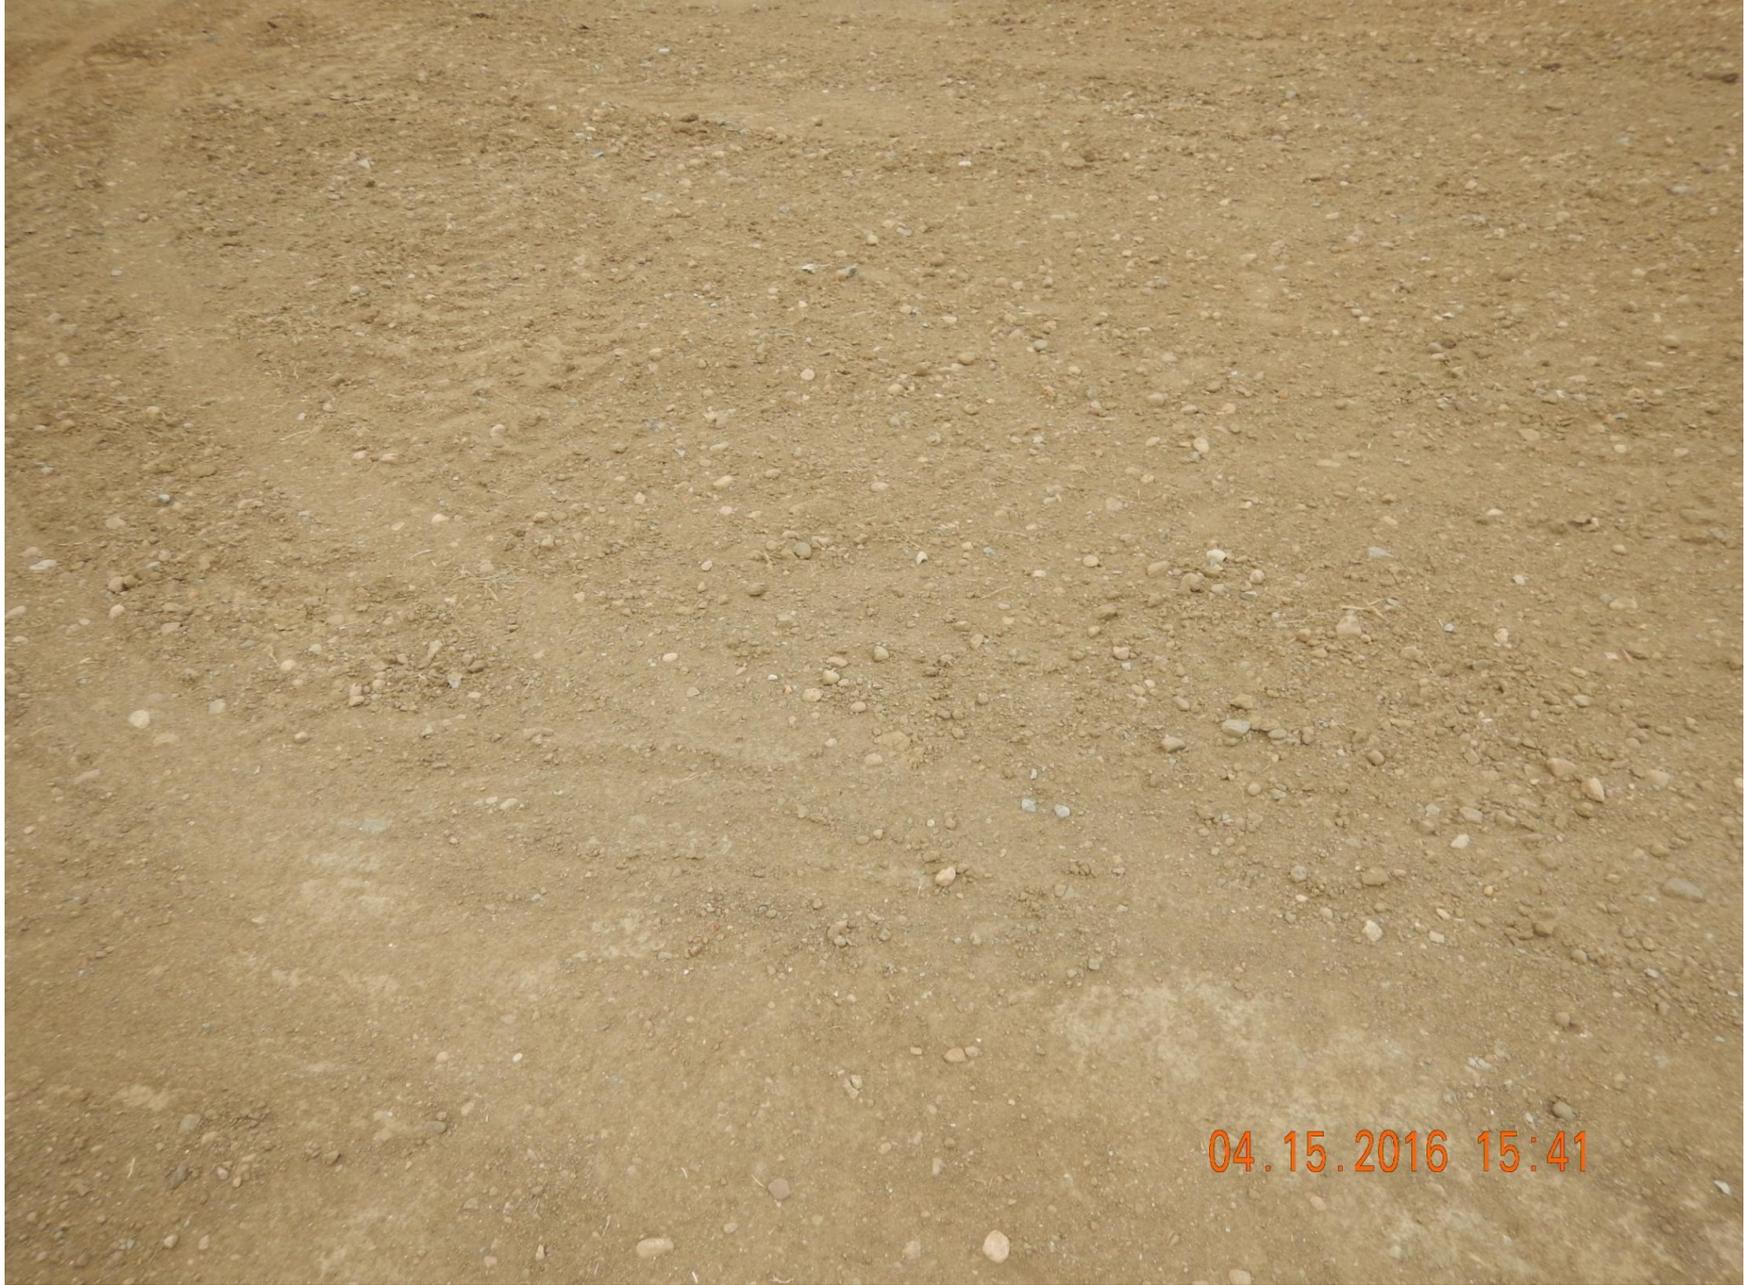
Figure 14: Photo taken from location. Location requires decompaction.

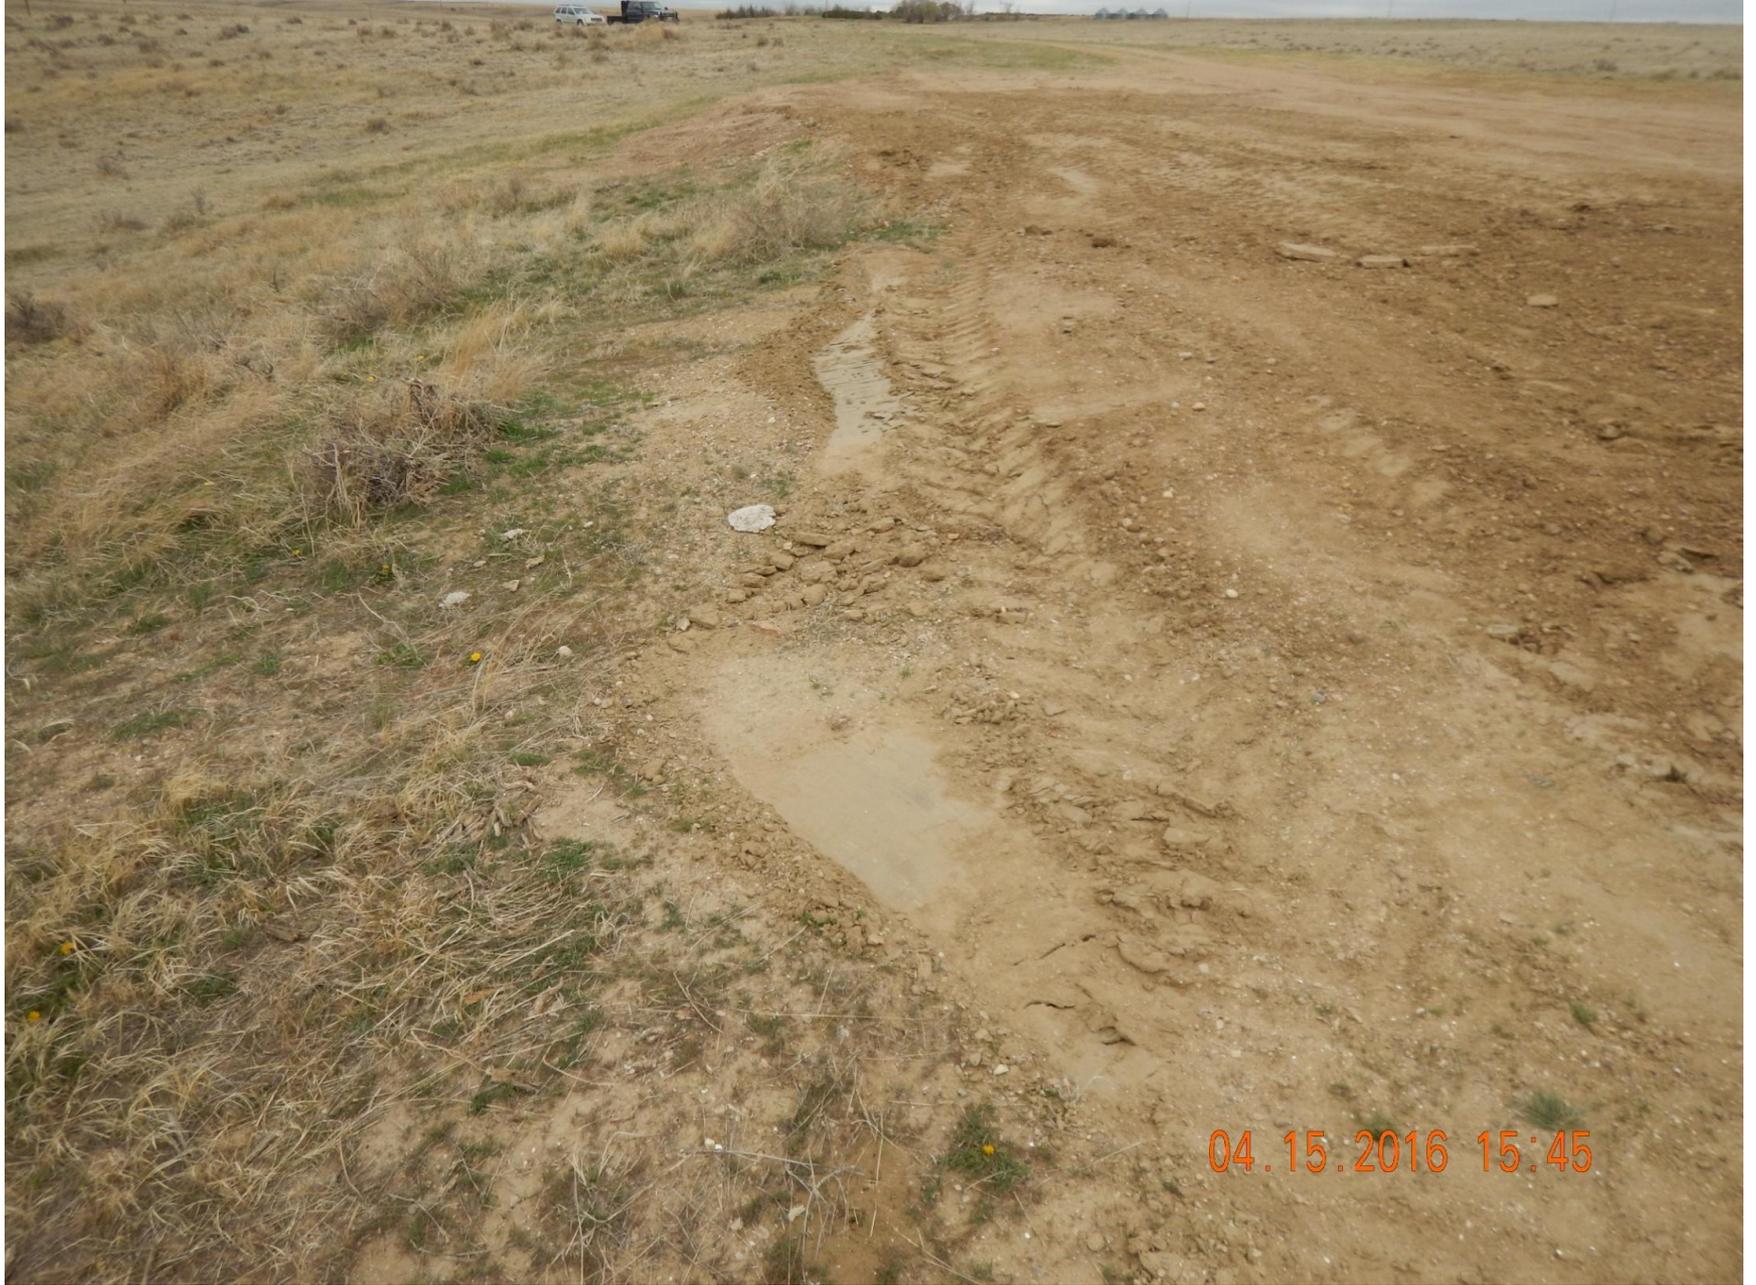
Figure 15: Photo taken from the southwest corner of the location, facing north. Photo show areas the location at higher risk for erosion.

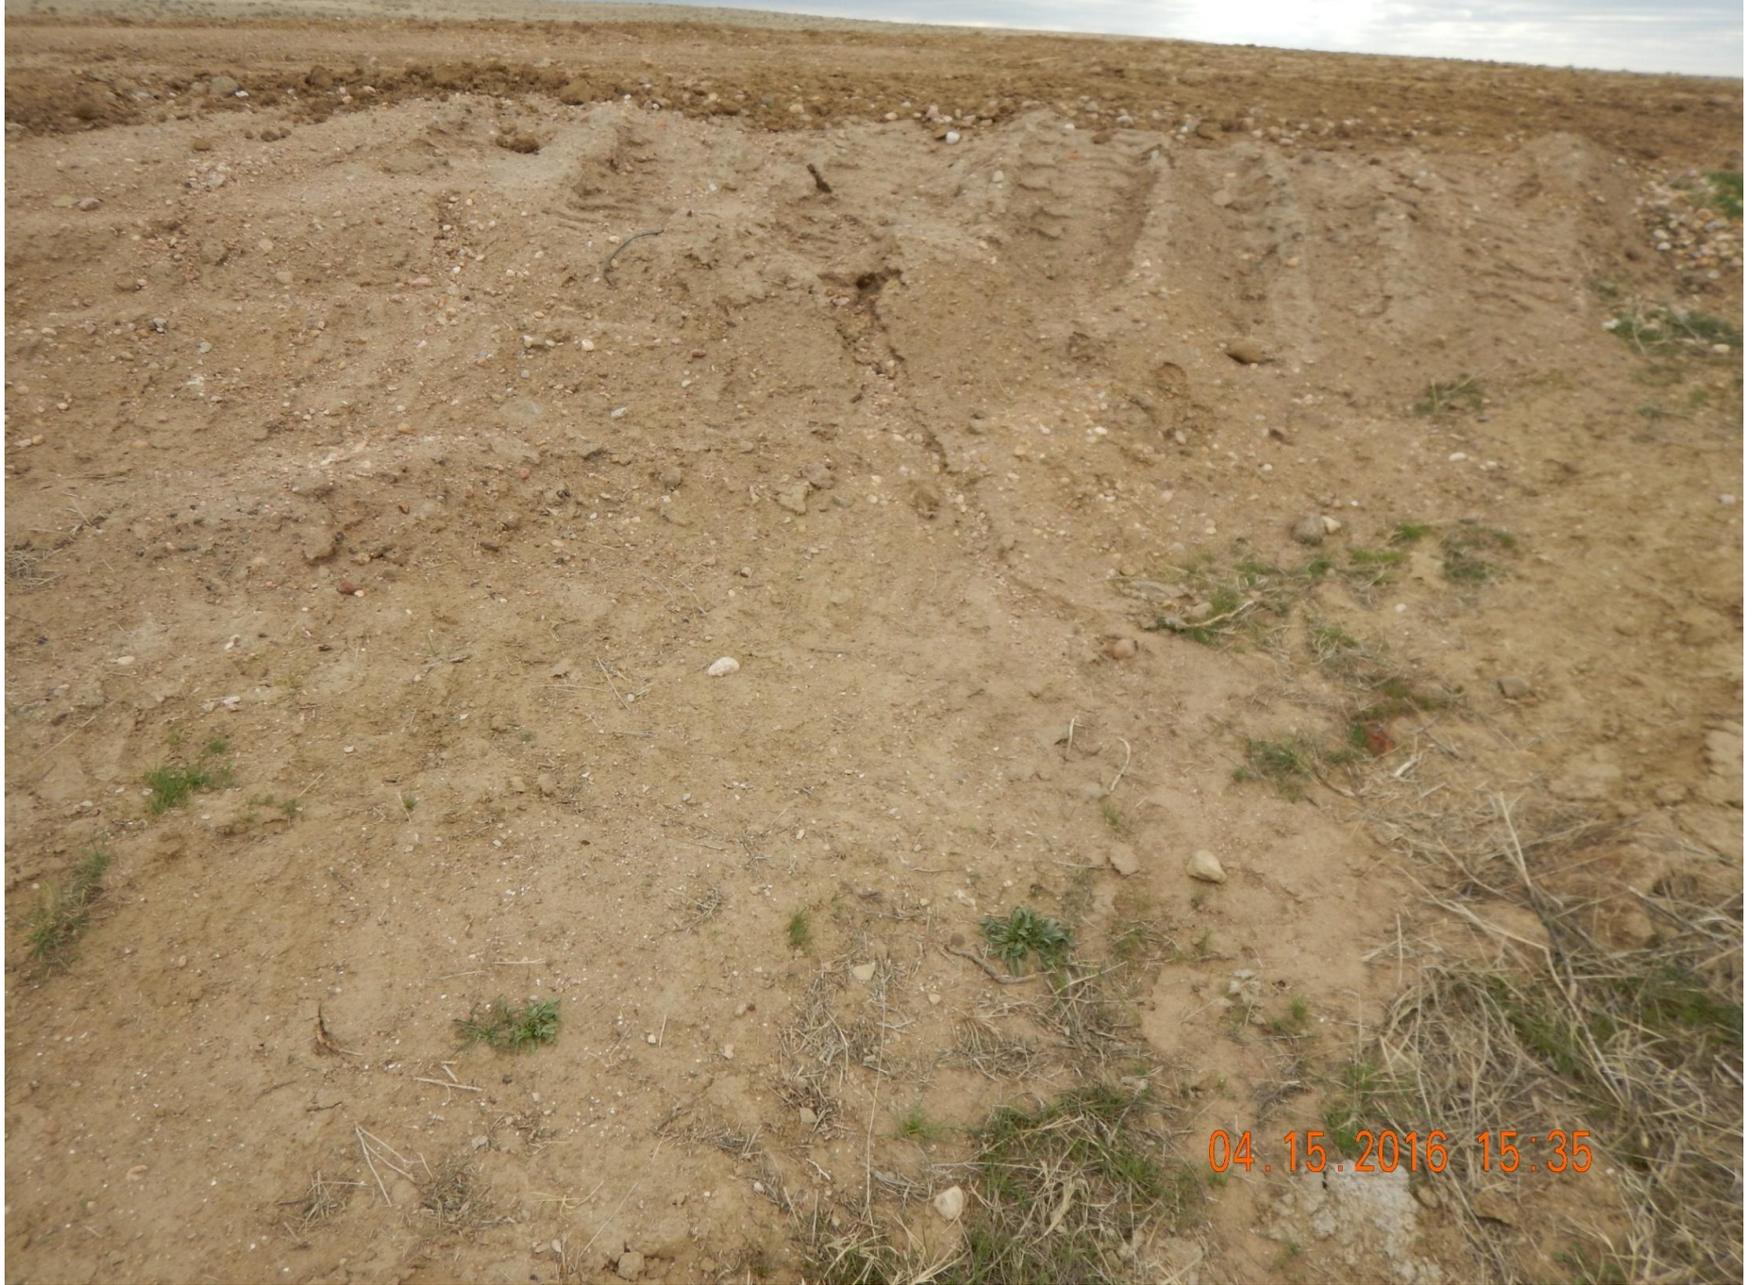
Figure 16: Photo taken from the west end of the location, facing east. Multiple rills forming on slope.

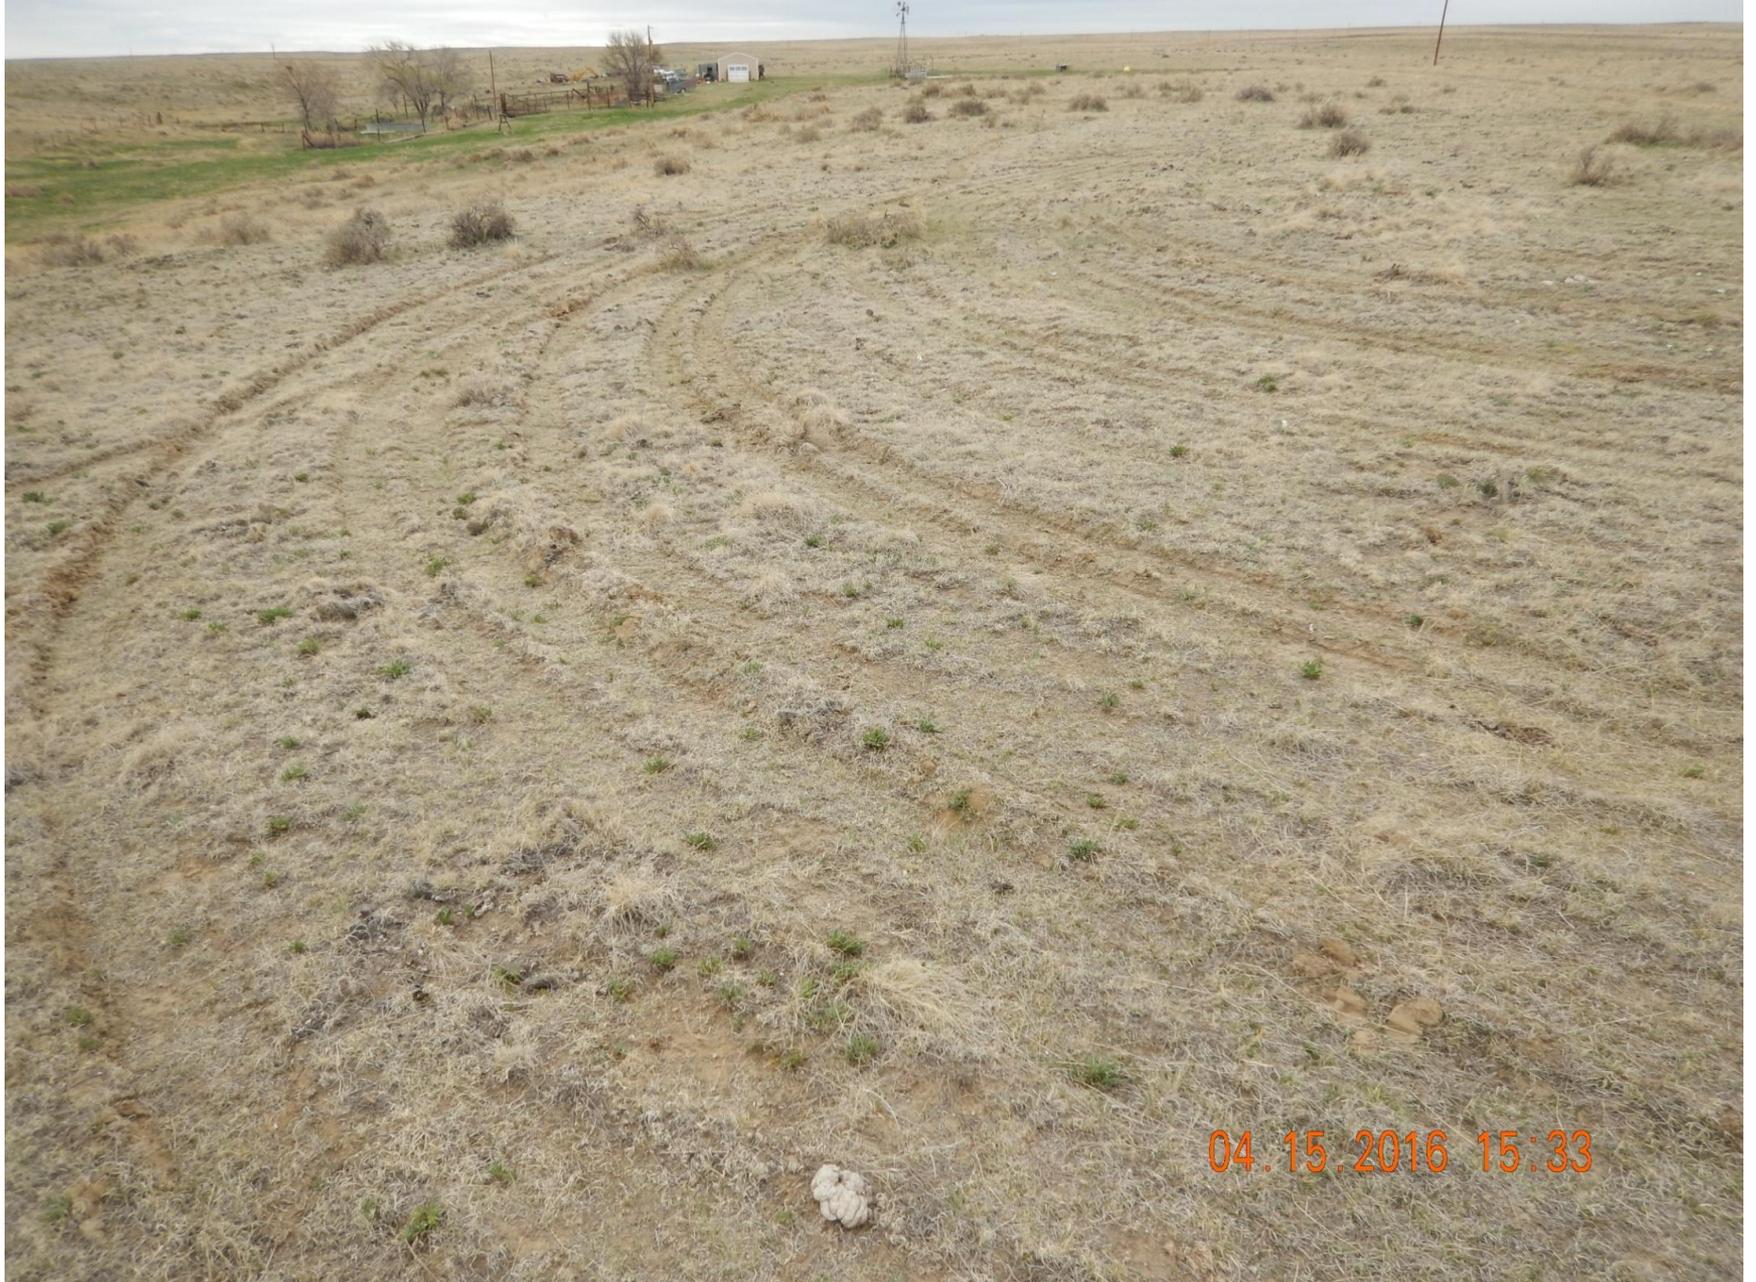
Figure 17: Photo taken from the north end of the location, facing north. Photo shows additional disturbance created during the removal of equipment/facilities outside of the location. Rule 1002.e(4) requires all vehicles used by the operator, contractors, and other parties associate with the well shall not travel outside of the original access road boundary.
