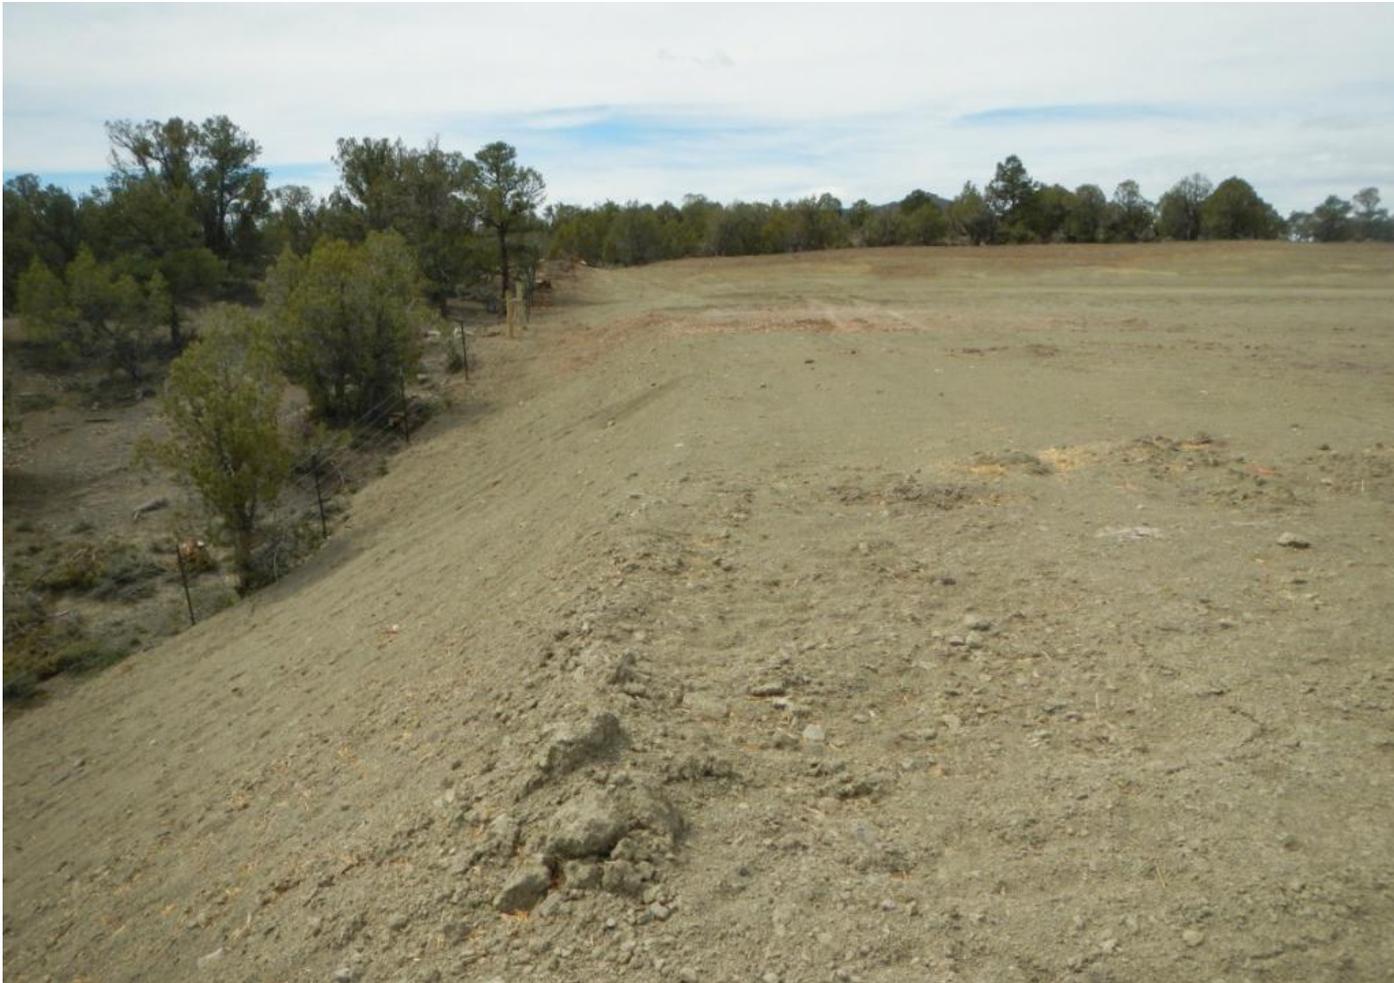
Photo 2. View of the eastern portion of the project area from the northeastern corner facing southward. No erosion controls are present on the fill slopes and temporary erosion control of tracking is employed on the cut-slope. Erosion controls are needed in these areas.

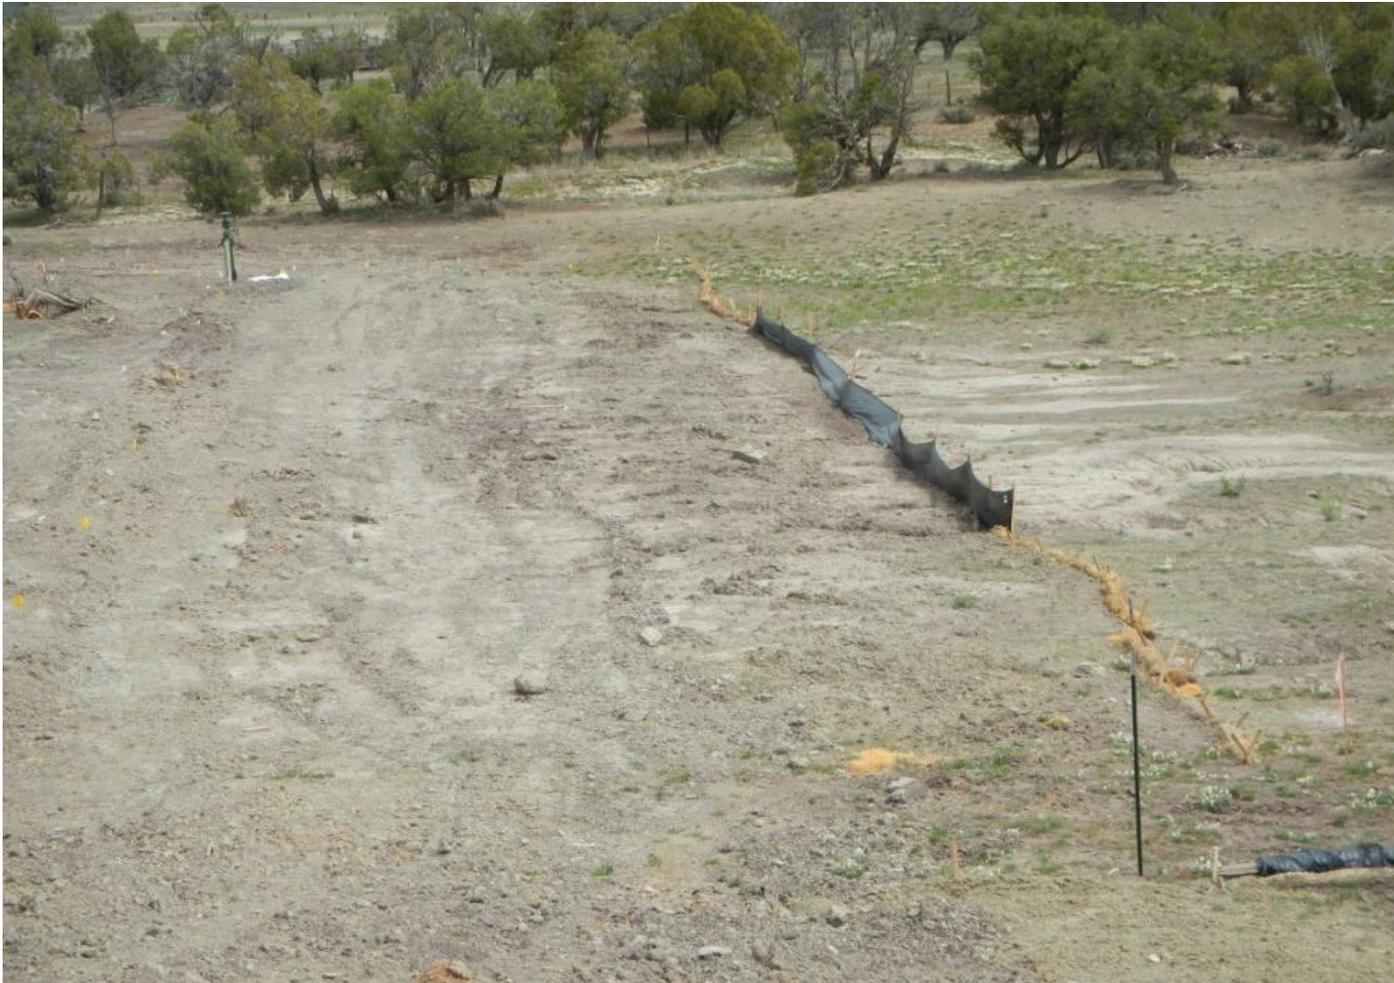
Photo 4. View of sediment controls downstream of what appear to be the pipeline alignment. Pipeline alignment needs revegetation to stabilize wetland area.

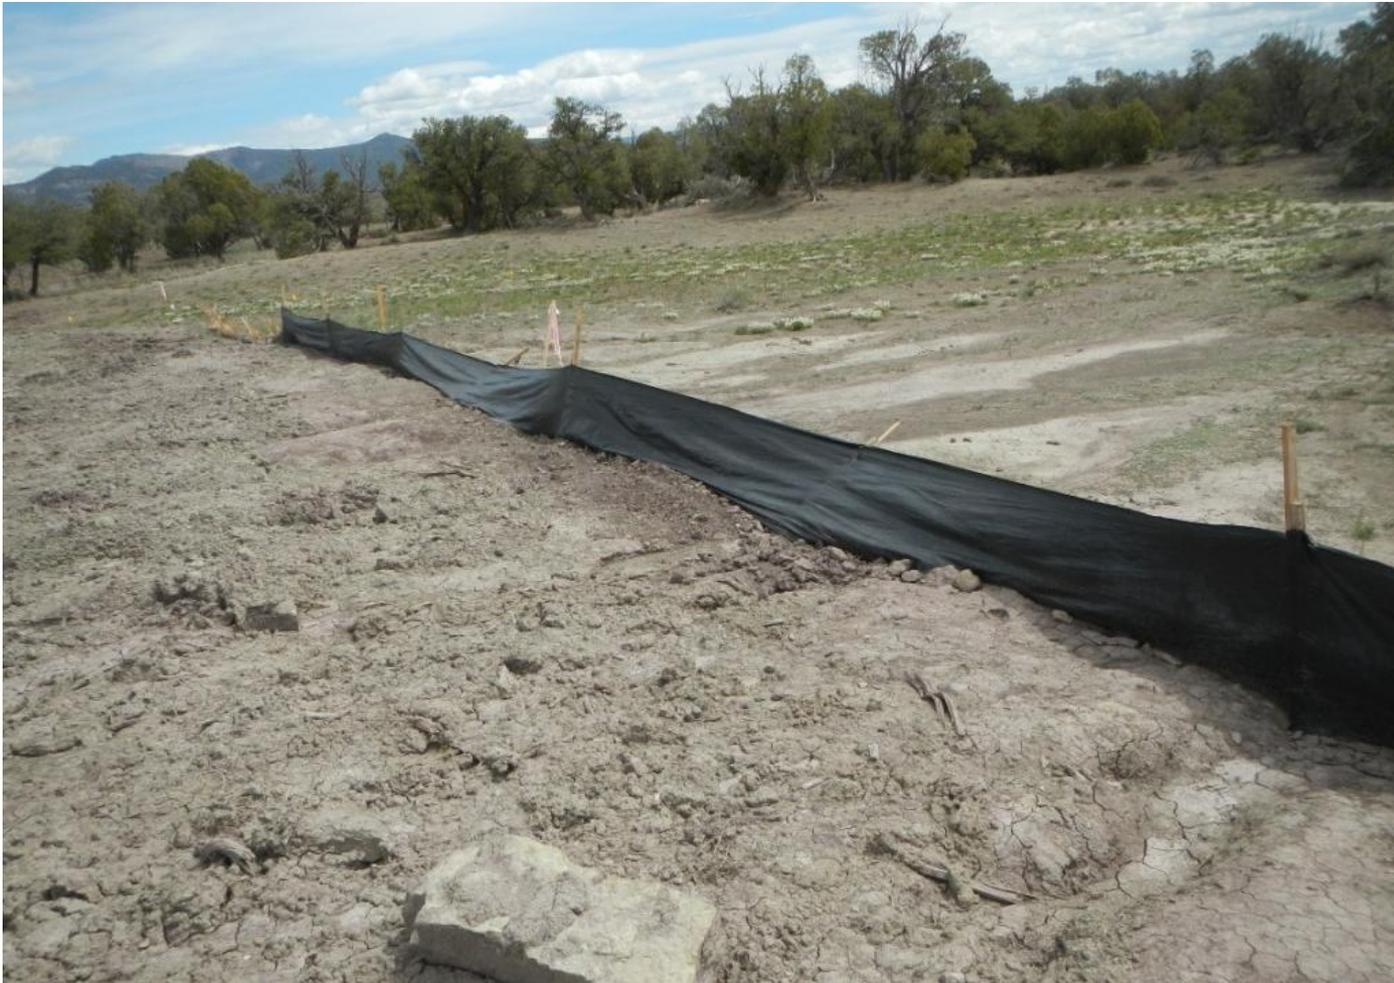
Photo 5. View of the western portion of the interim reclamation area from the northwestern corner facing southward. Silt fence and wattles need maintenance. Revegetation of upstream areas will be the best way to stabilize this area.

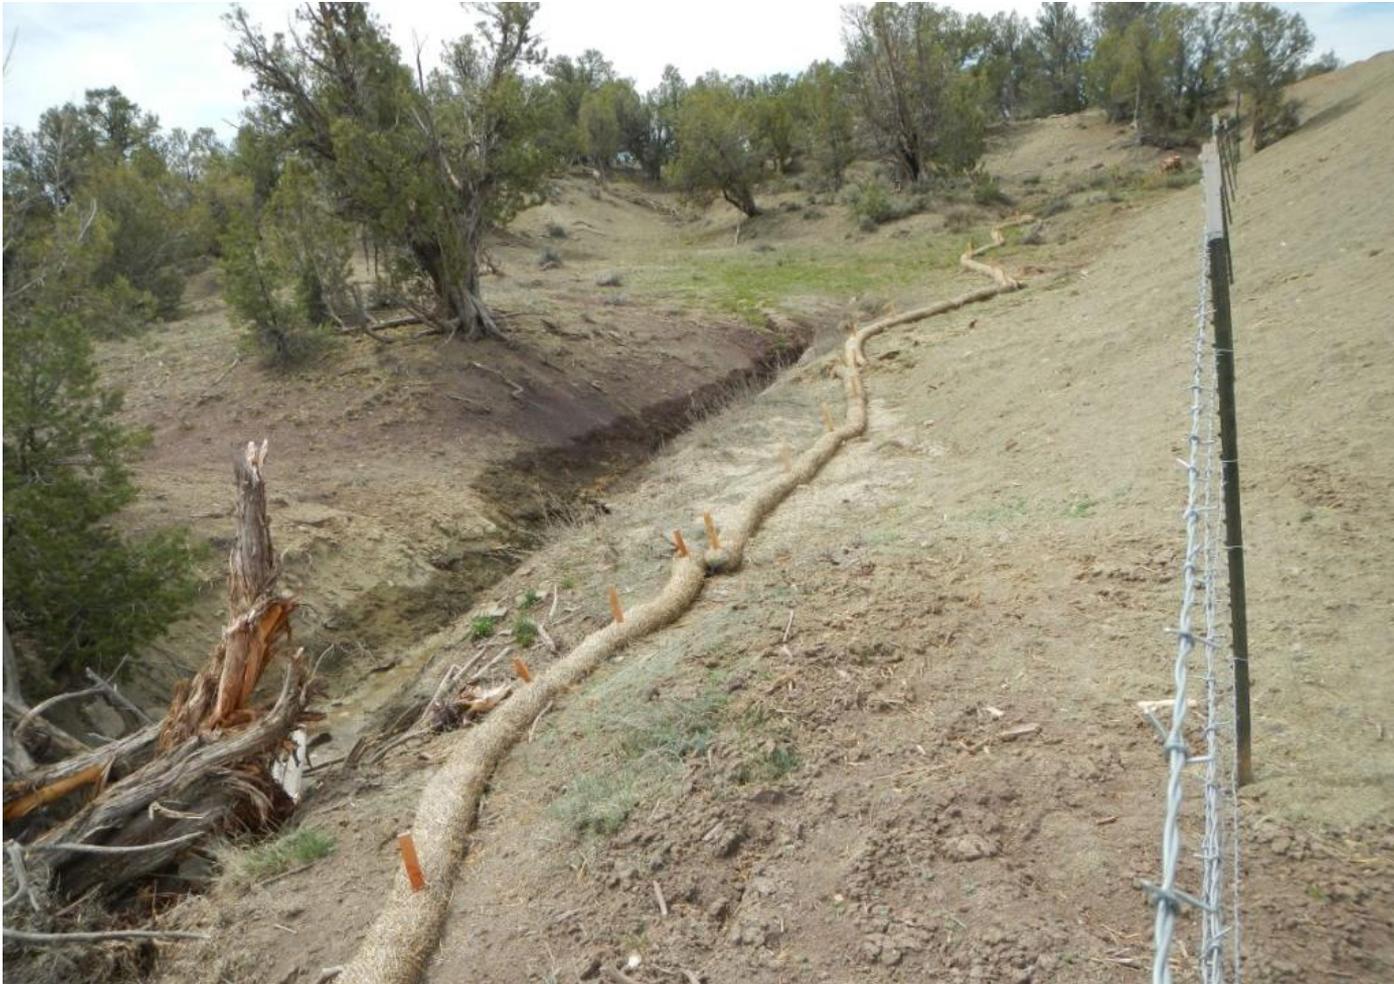
Photo 6. View of wattles lining the outer edge of the eastern project area. These will require careful monitoring as downslope discharge is directly into an ephemeral stream. No erosion controls are on the fill slopes above the wattles.

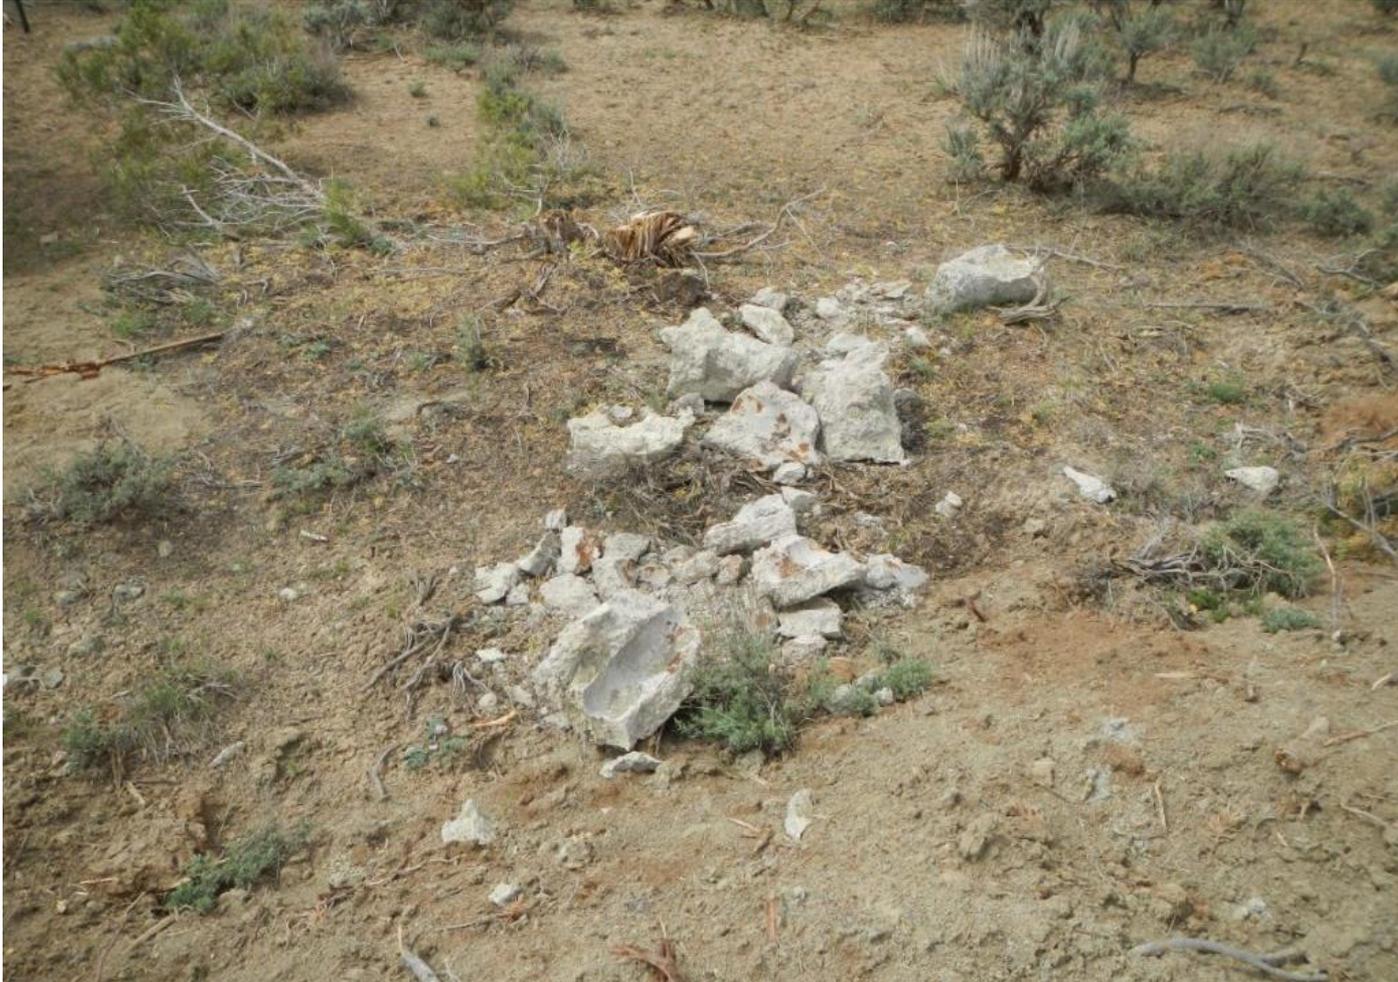
Photo 7. View of cement debris in the southeastern portion of the project area. Additional cement debris is on the southwestern edge of the project area. These need to be removed.

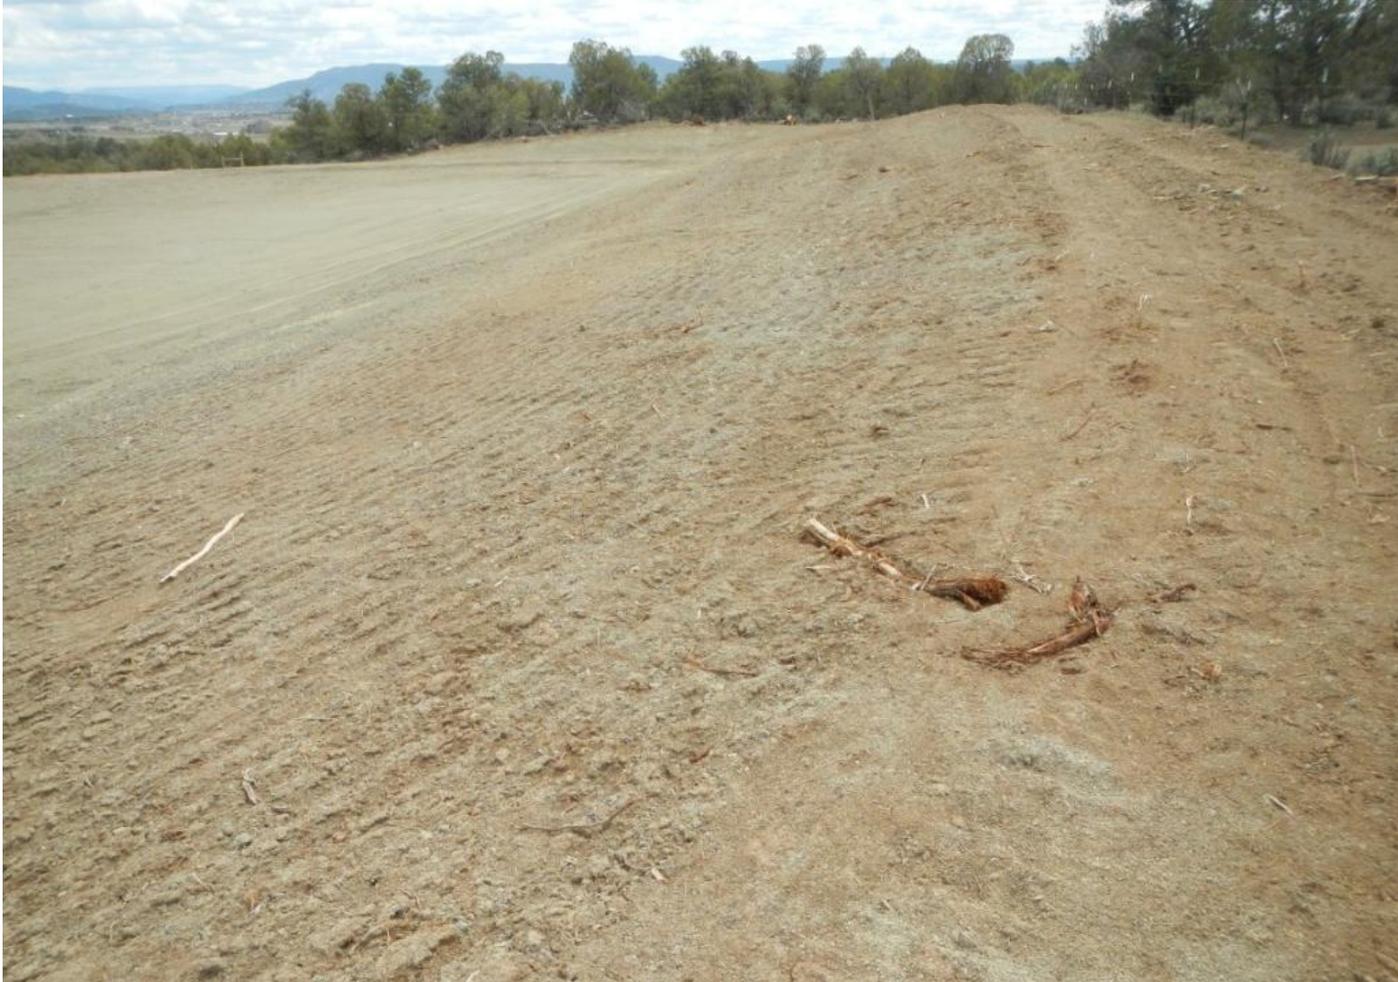
Photo 9. View of the southern portion of the project area from the southwestern corner facing eastward. Tracking on cut-slopes is a temporary erosion control measure and longer term erosion controls should be employed on the cut and fill slopes.
