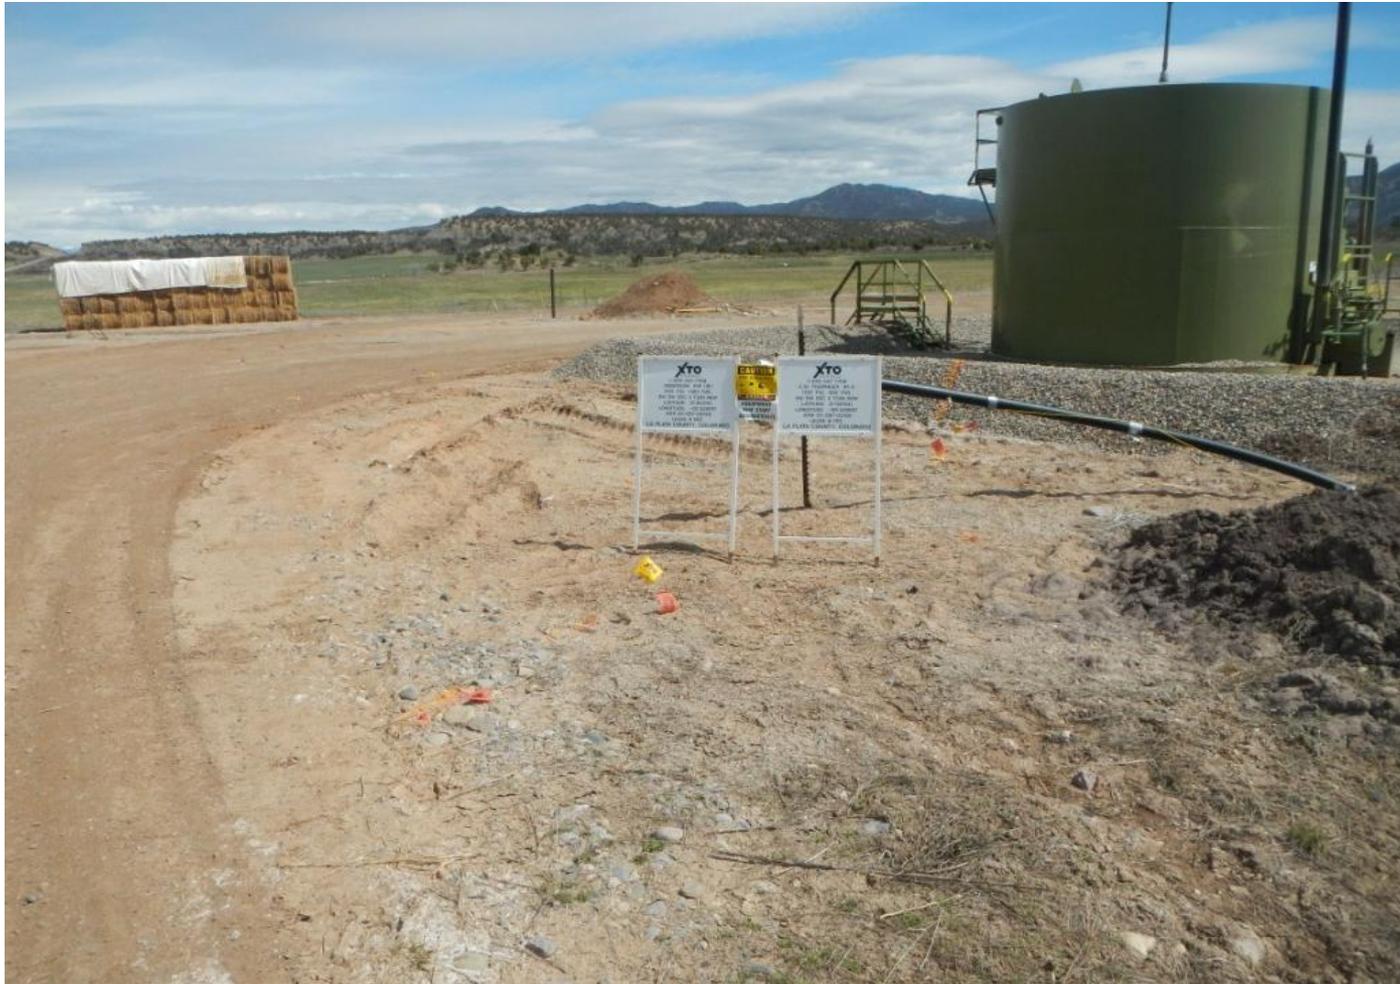
Photo 1. View of the project area from the well pad entrance facing center.

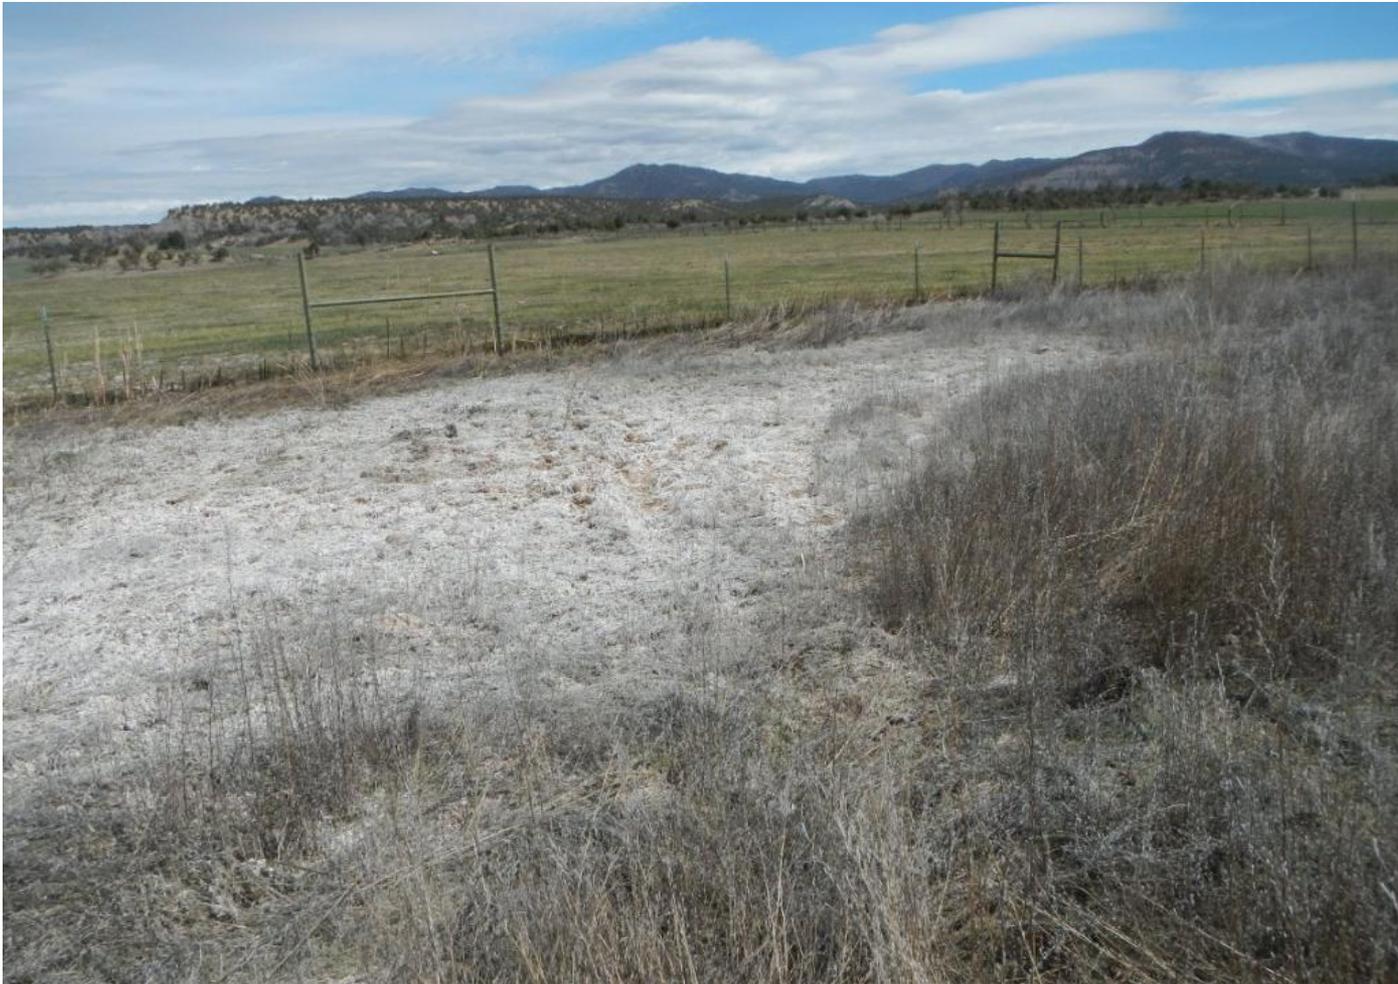
Photo 2. View of area in the northeastern portion of the project area with salt crust that is likely the result of water ponding and evaporating. The only vegetation observed here is dense kochia (*Kochia scoparia*).

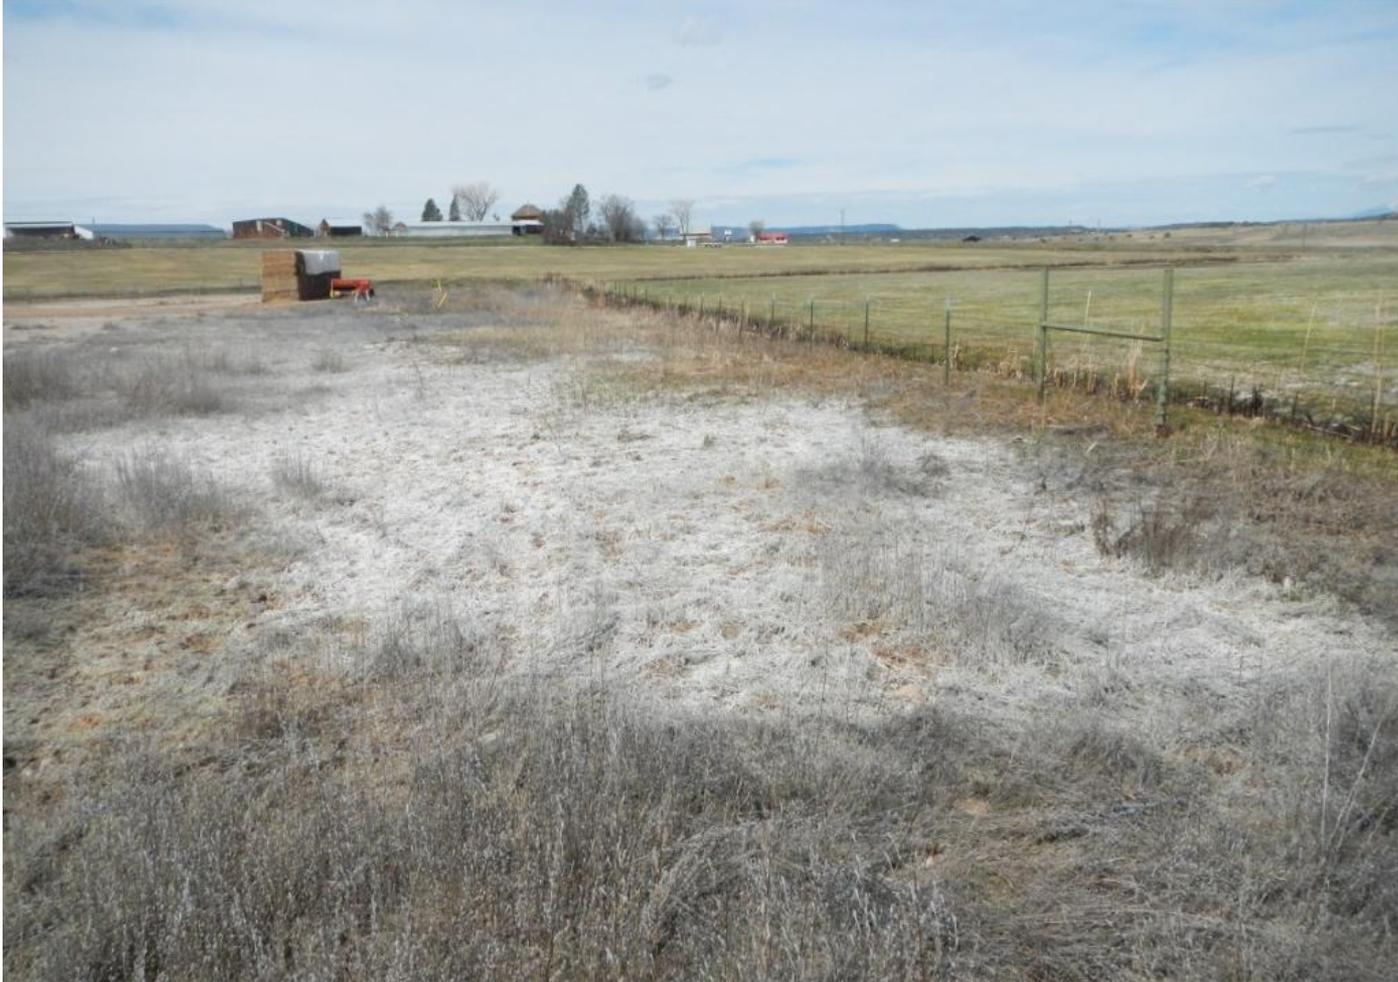
Photo 3. View of the northern portion of the project area from the northeastern corner facing westward. This area is largely weedy and needs revegetation. Adjacent pasture is comprised of healthy irrigated grasses.

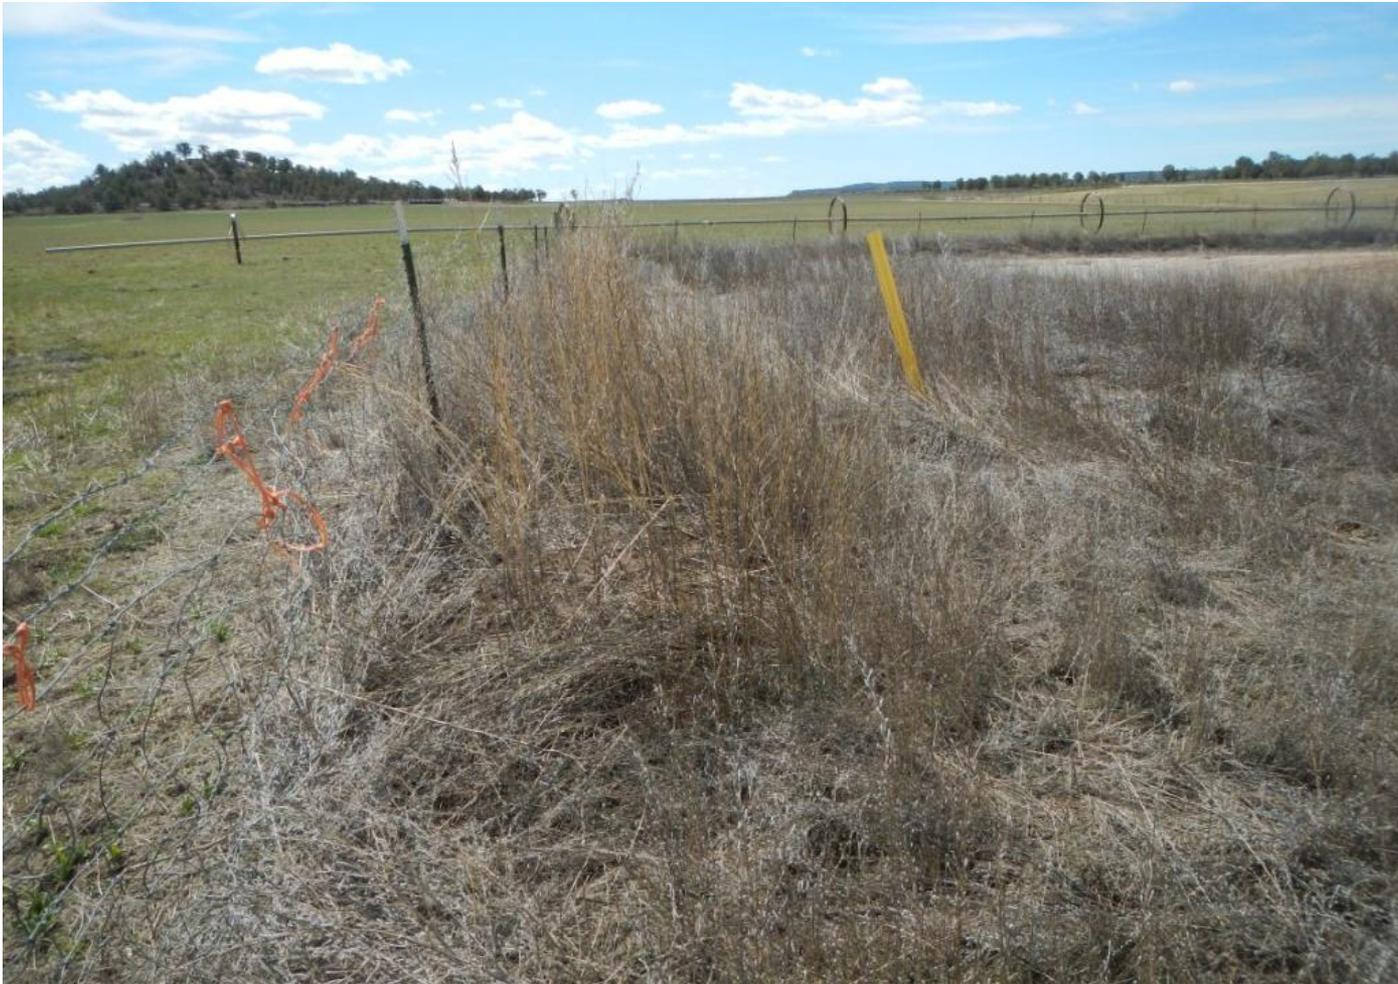
Photo 4. View of the eastern portion of the project area from the northeastern corner facing southward. Vegetation is nearly 100 percent kochia in this area.

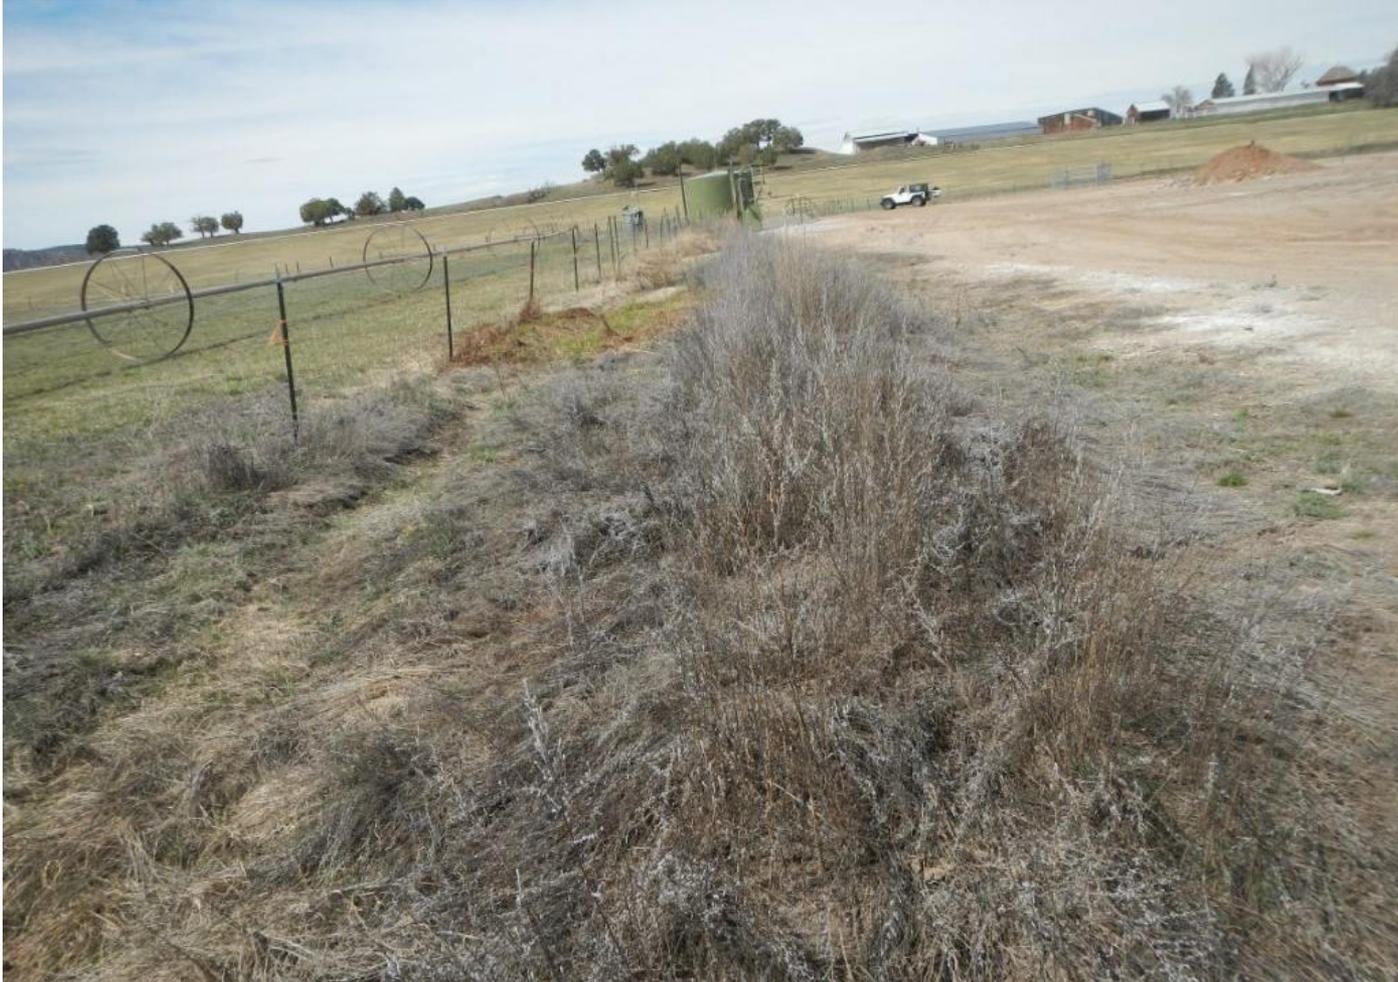
Photo 5. View of the southern portion of the project area from the southeastern corner facing westward.

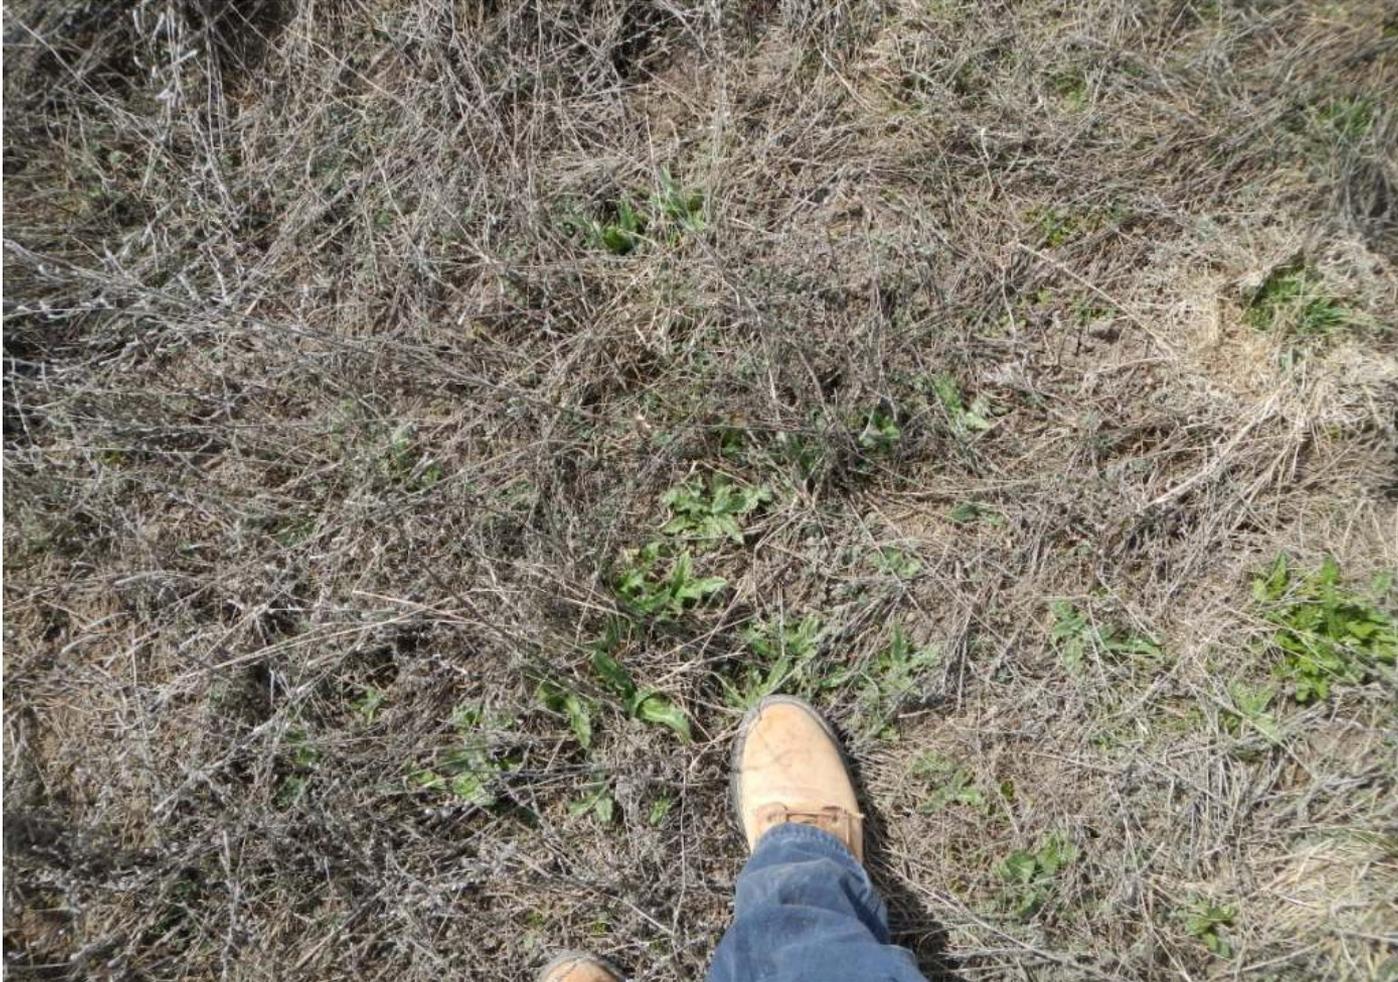
Photo 6. View Canada thistle (*Cirsium arvense*) growing amongst kochia debris near the well pad entrance.
