HRM- Stormwater and Erosion Overview Map

**#3-Mandy
Lease Road
API 123-10604**

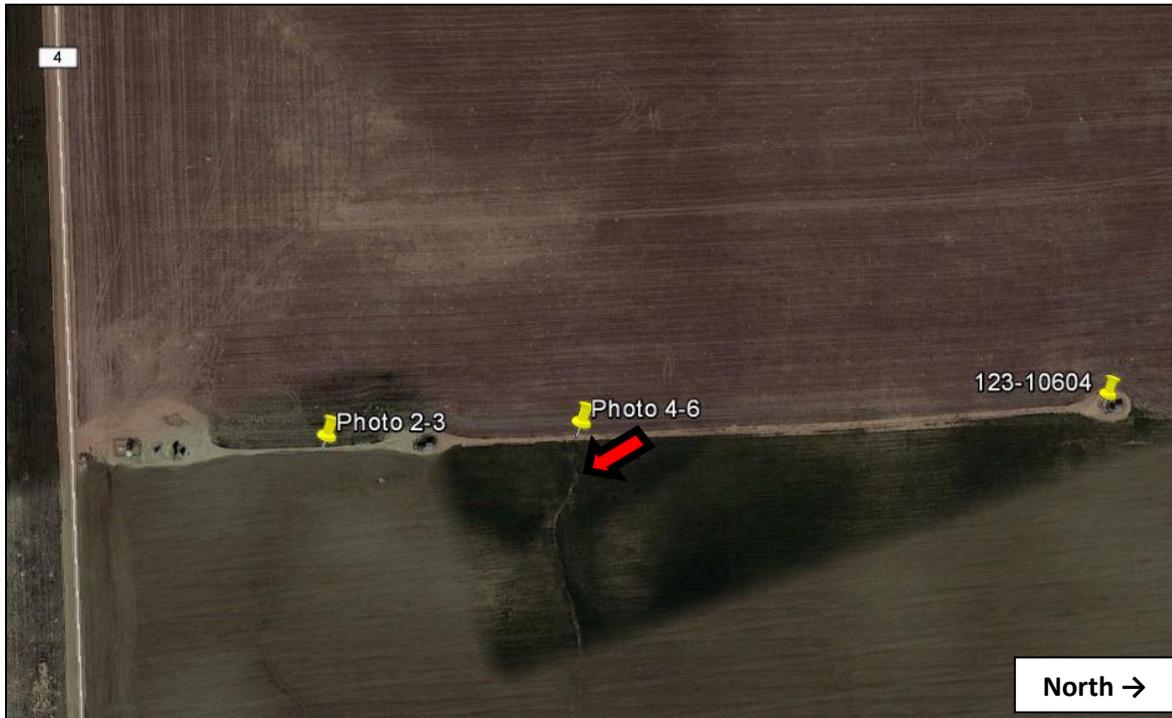
Photo 1: Aerial photo referencing locations of field photos taken on 4/19/16. Refer to Document# 682400496 for complete field photos from the 3/8/16 inspection.

Google Earth aerial photo illustrating that erosion and transport of sediment initiates on the lease road used for API# 123-10604, then travels east onto cropland.

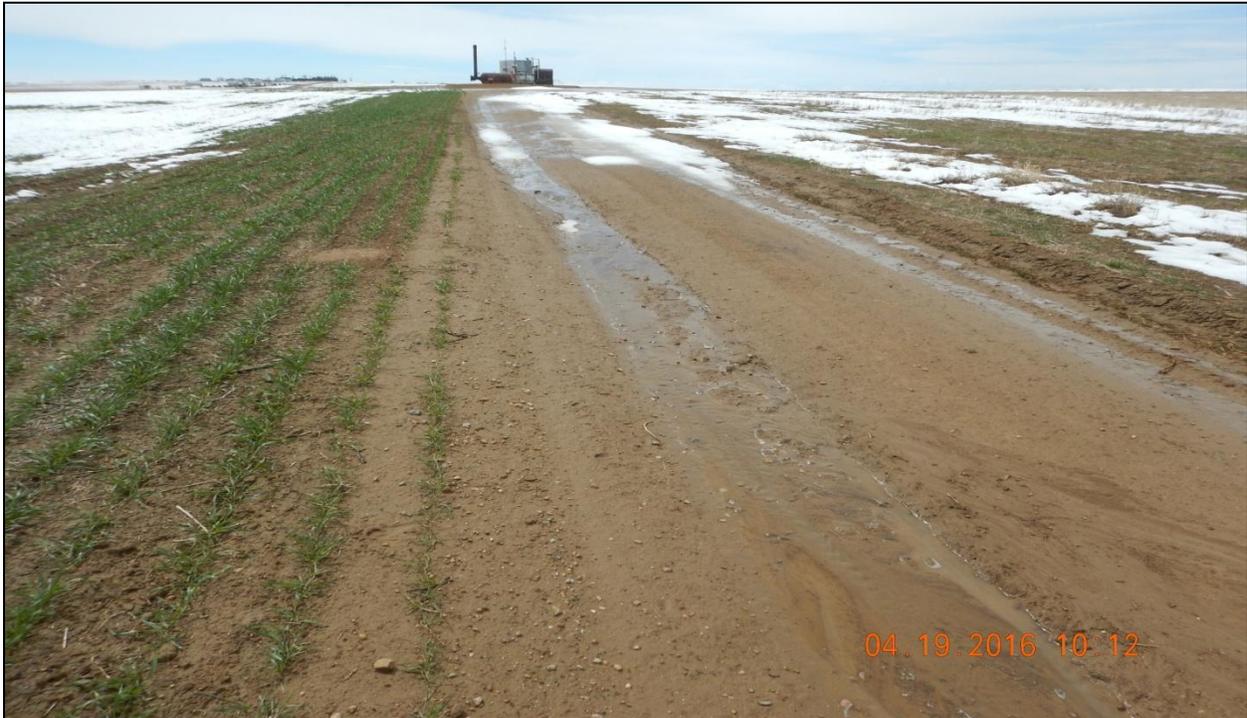
Photo 2: Photo taken 4/19/16 south of well, facing South. This photo illustrates stormwater traveling along the path of the lease road.

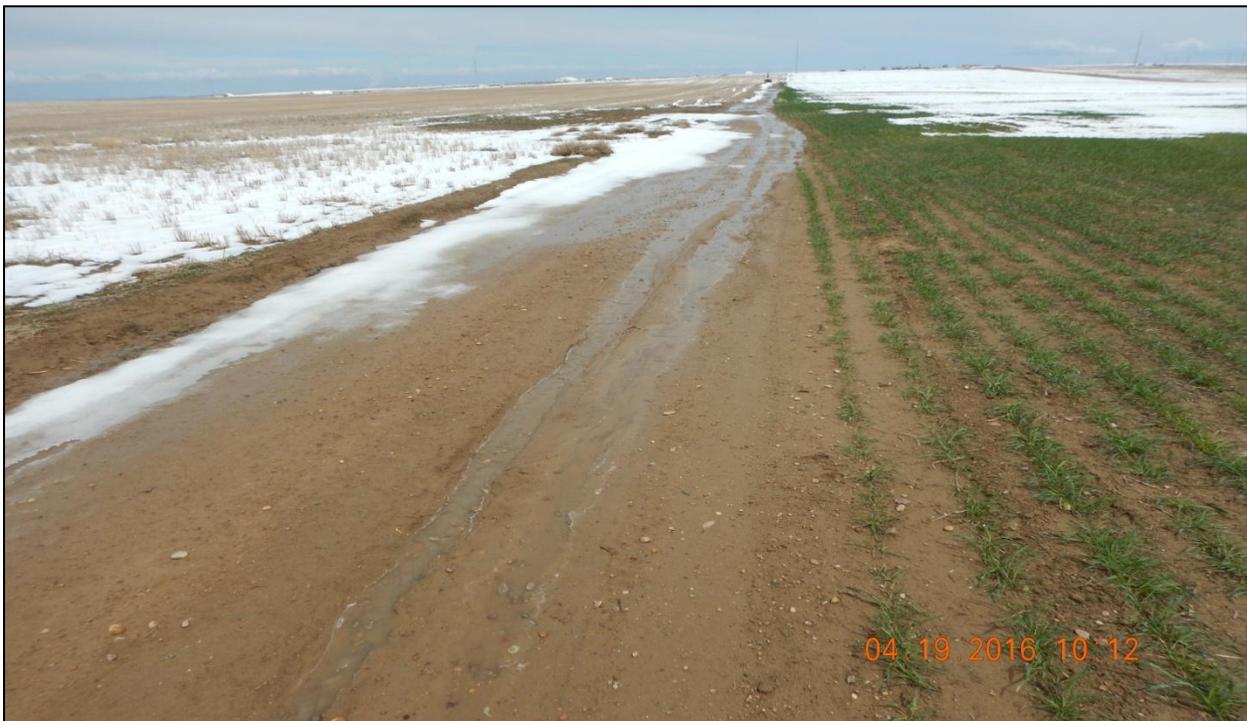
Photo 3: Photo taken 4/19/16 south of well, facing North. This photo illustrates stormwater traveling along the path of the lease road.

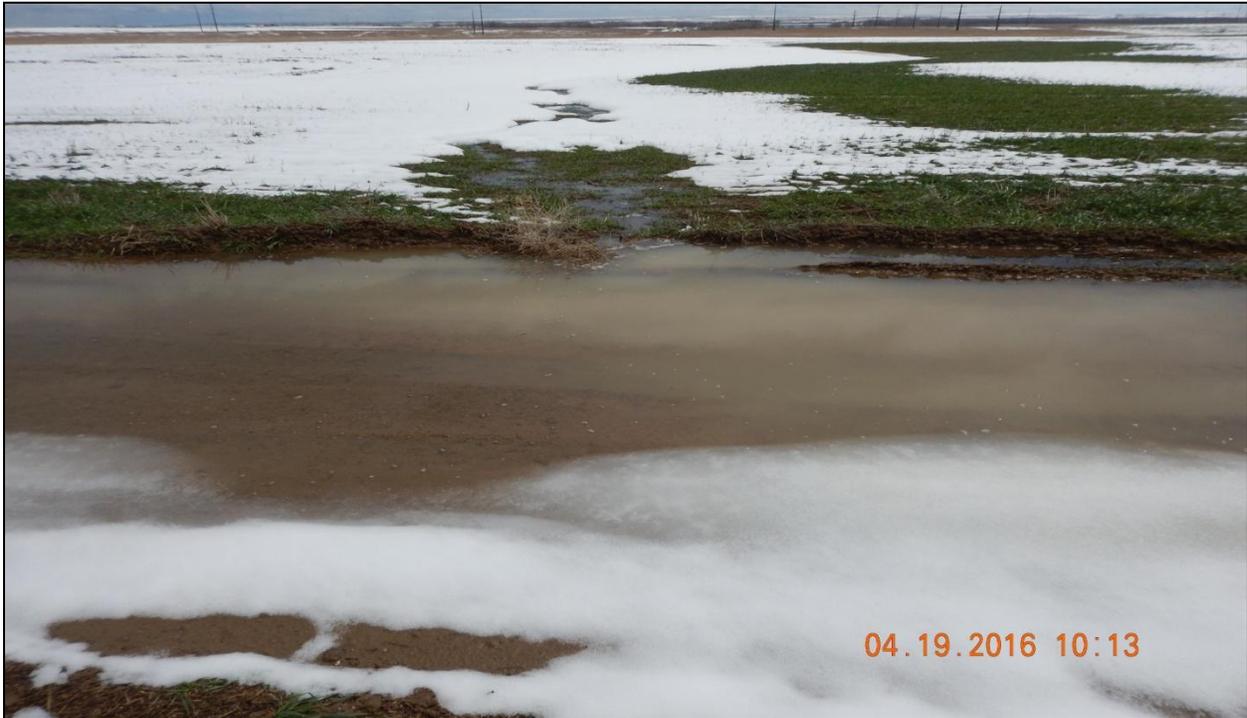
Photo 4: Photo taken 4/19/16 from location where run-off leaves lease road, facing East and onto the adjacent cropland.

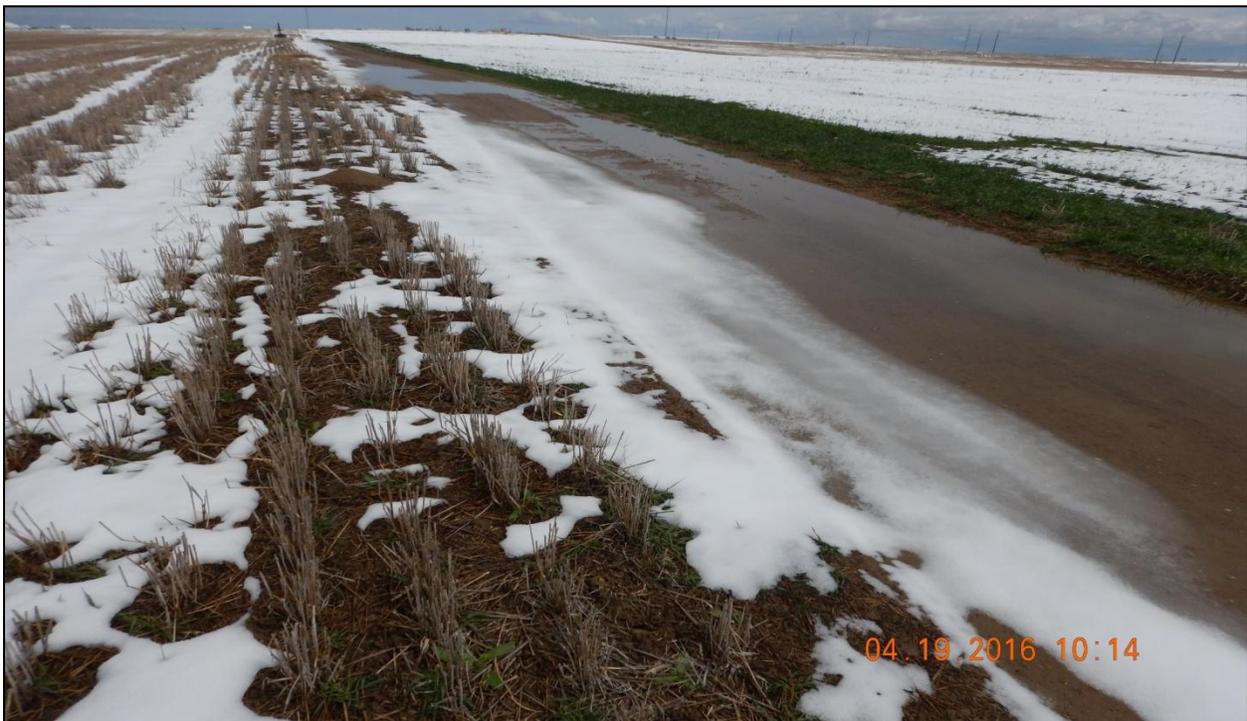
Photo 5: Photo taken 4/19/16 from previous location, facing North along the lease road. This photo illustrates stormwater traveling along the path of the lease road to this low point along the lease road.

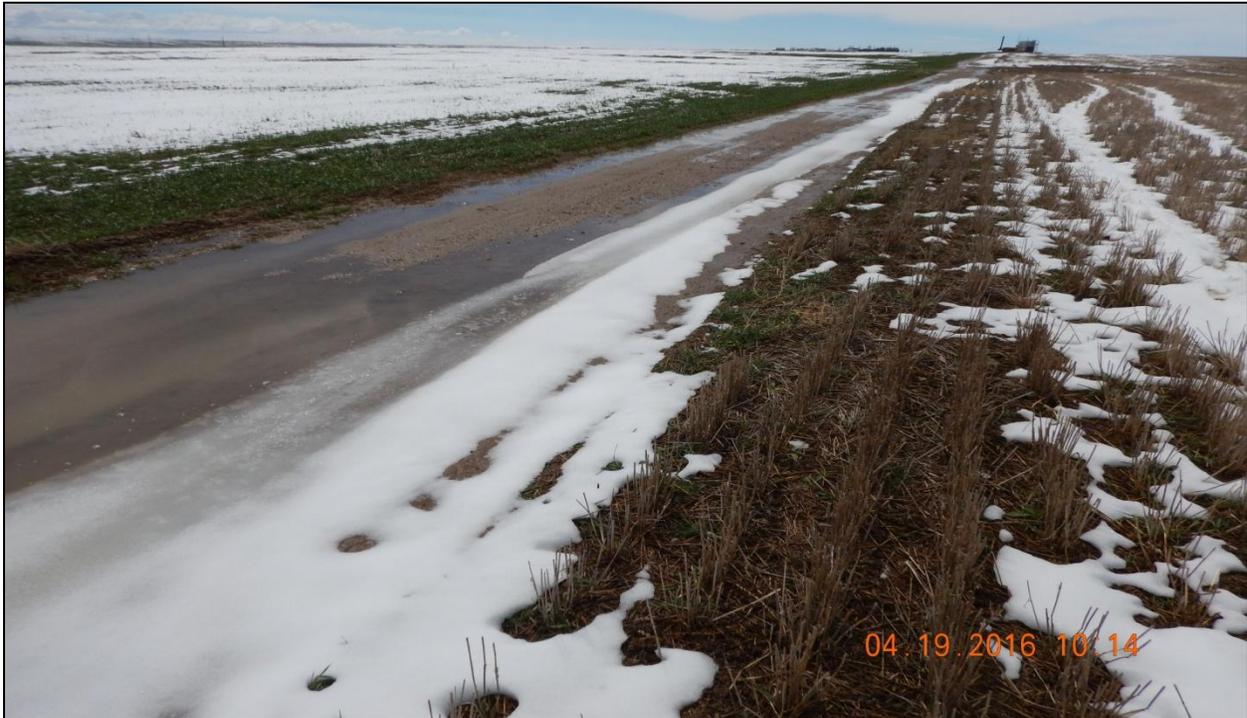
Photo 6: Photo taken 4/19/16 from previous location, facing South along the lease road. This photo illustrates stormwater traveling along the path of the lease road to this low point along the lease road.
