## Final Reclamation Inspection- Plugged and Abandoned

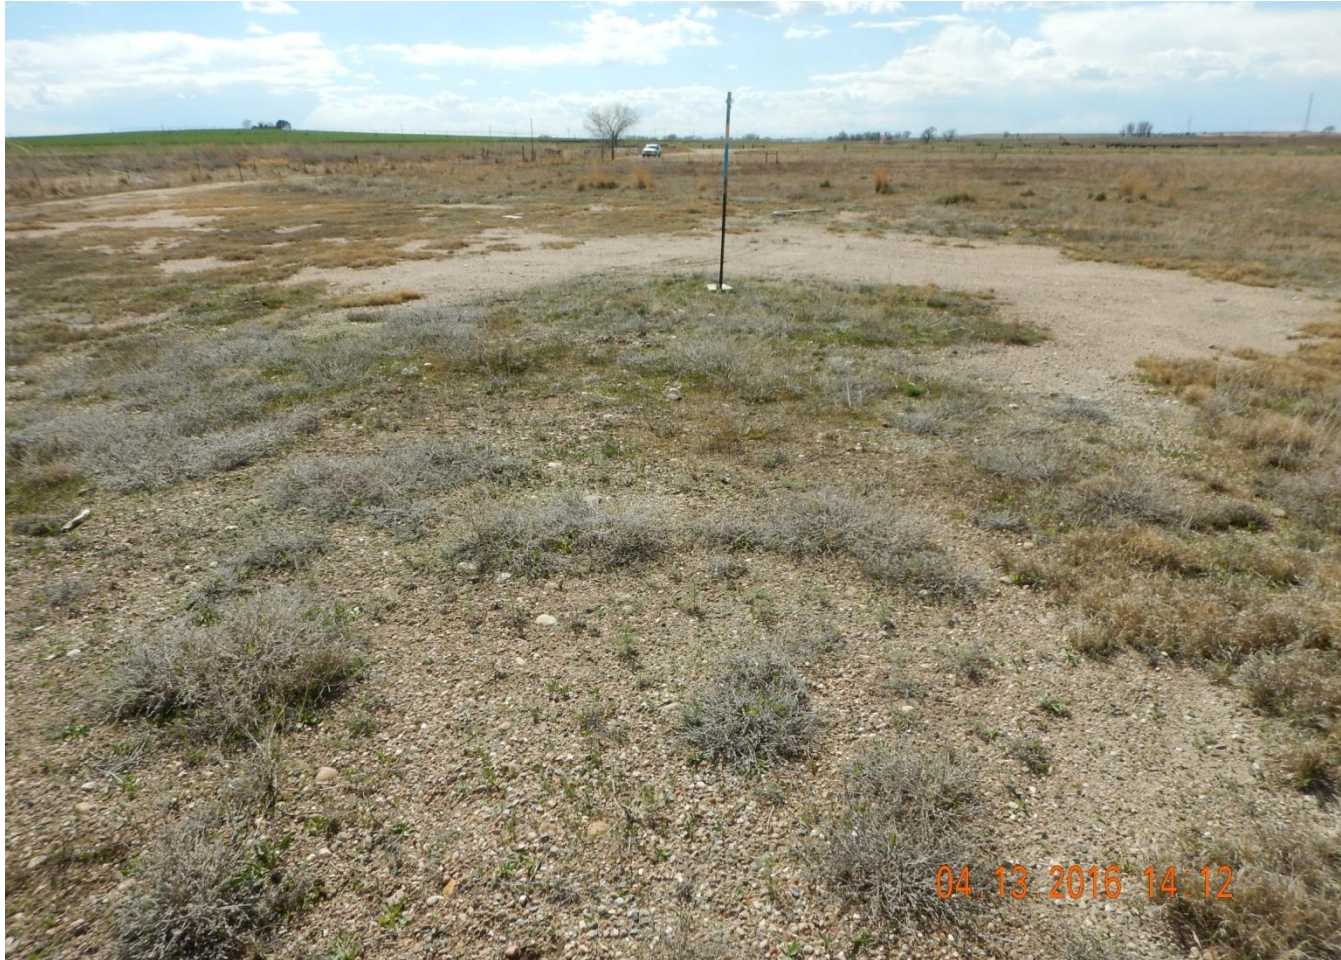
**Photo 1.** Photo taken from east of location, facing West. Well location and access road have not been reclaimed per Rule 1004. Undesirable plant species, Kochia (*Kochia scoparia*), exists throughout location with little to no native, perennial vegetative growth establishment.

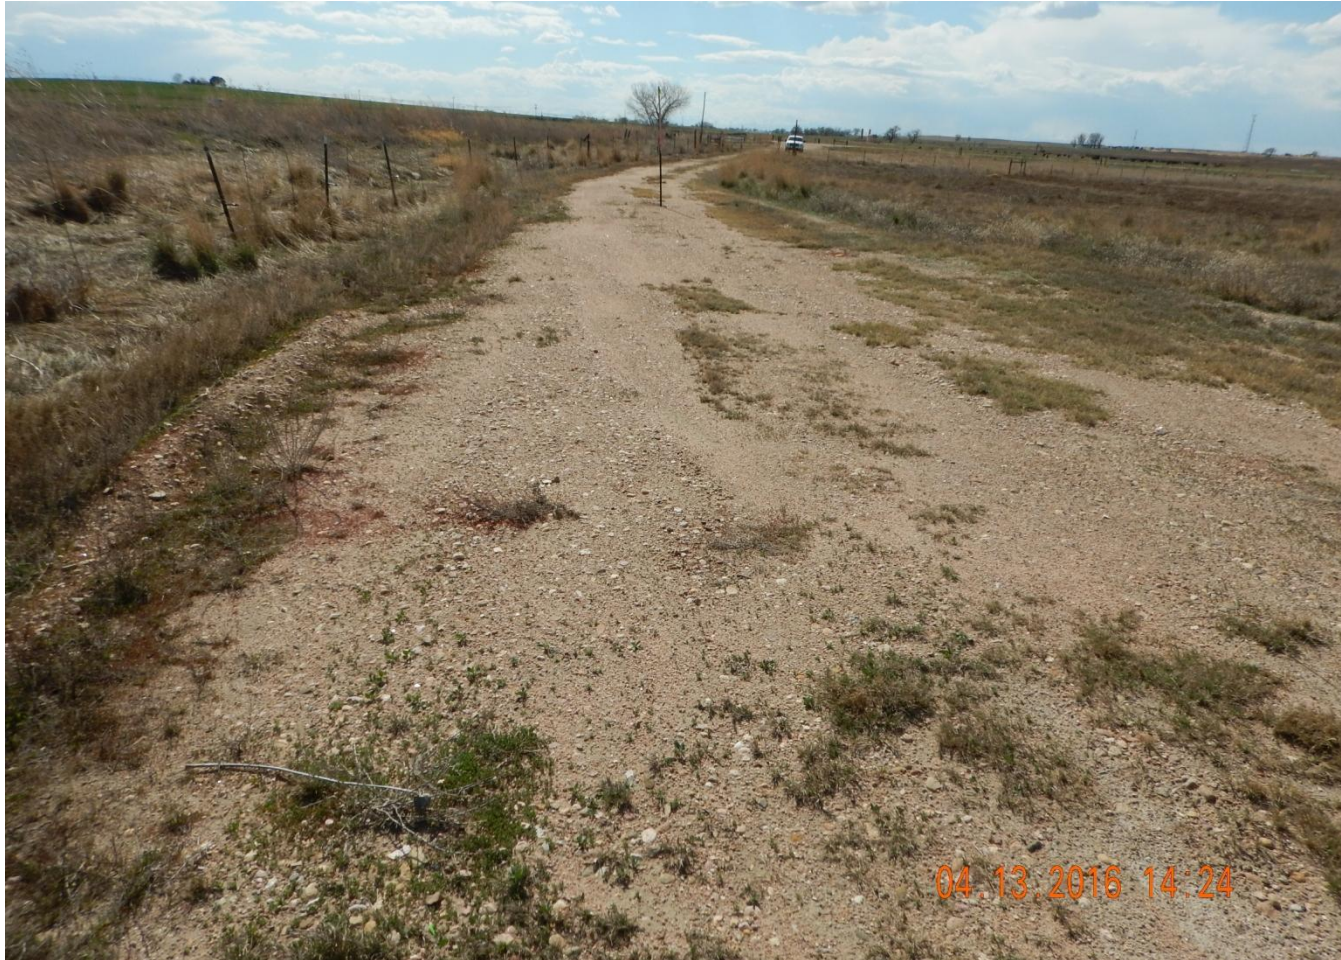
**Photo 2.** Photo taken from eastern access road, facing West. Access has not been reclaimed.

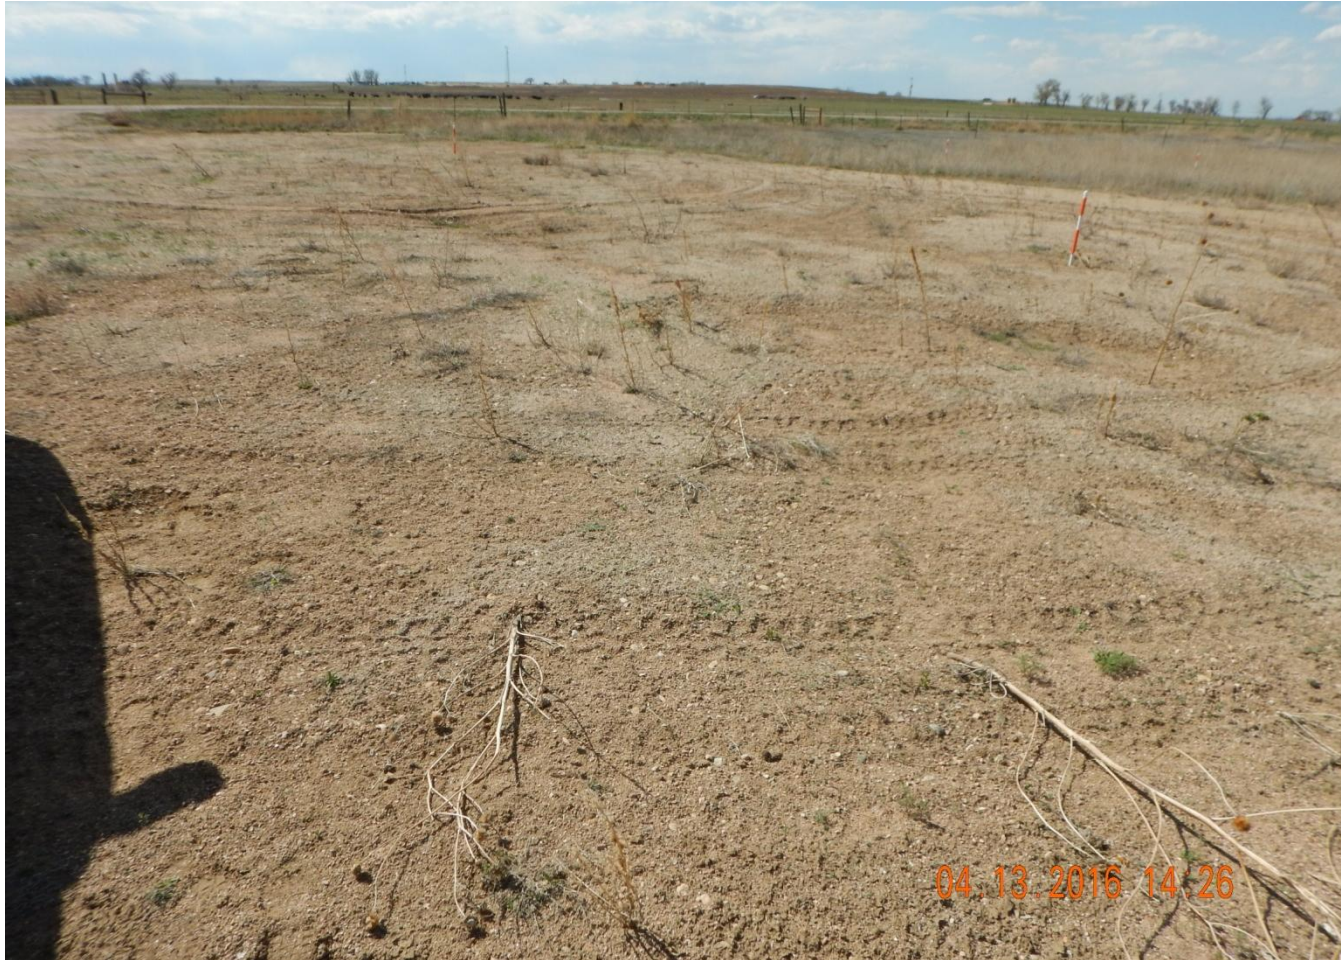
**Photo 3.** Photo taken from associated (i.e. tank battery) location, facing West. Location has not been reclaimed per Rule 1004.

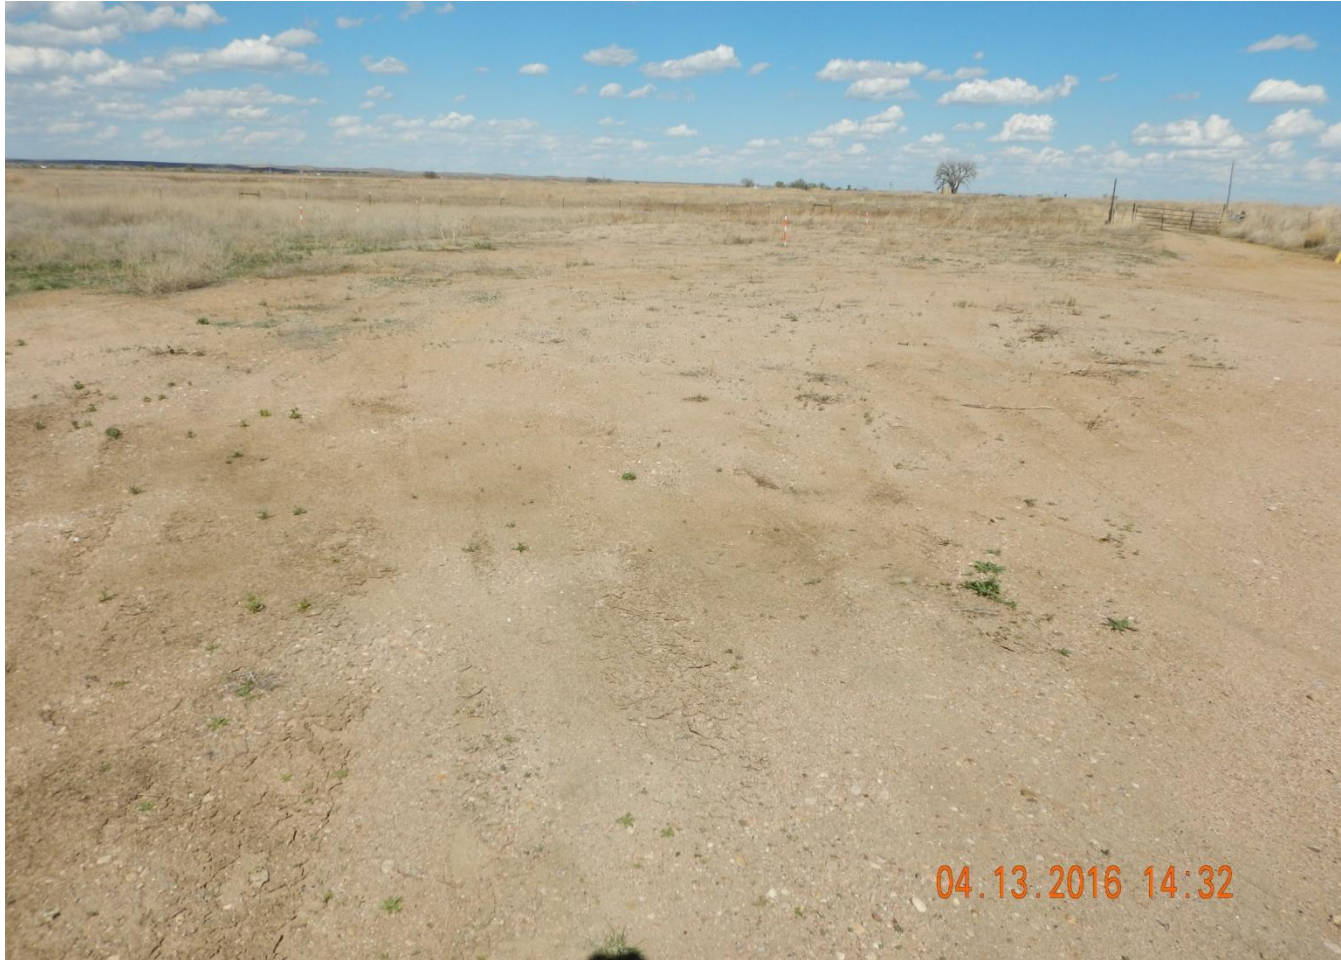
**Photo 4.** Photo taken from associated (i.e. tank battery) location, facing East. Location has not been reclaimed per Rule 1004.

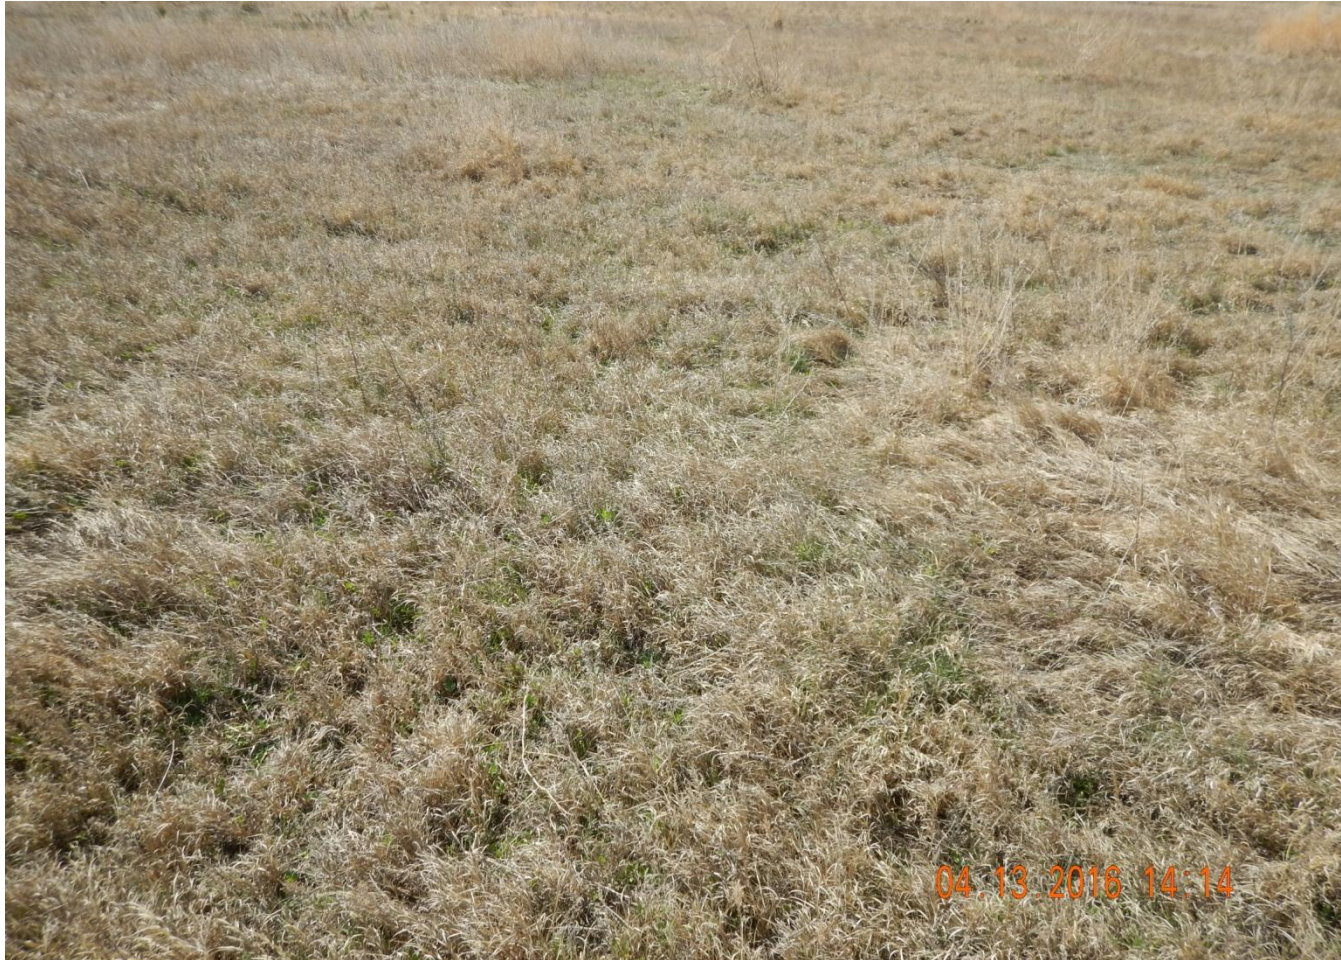
**Photo 5.** Photo taken north of location documenting reference native, perennial vegetative plant community (e.g. Salt Meadow) that is not reflective throughout well location and associated production facilities.

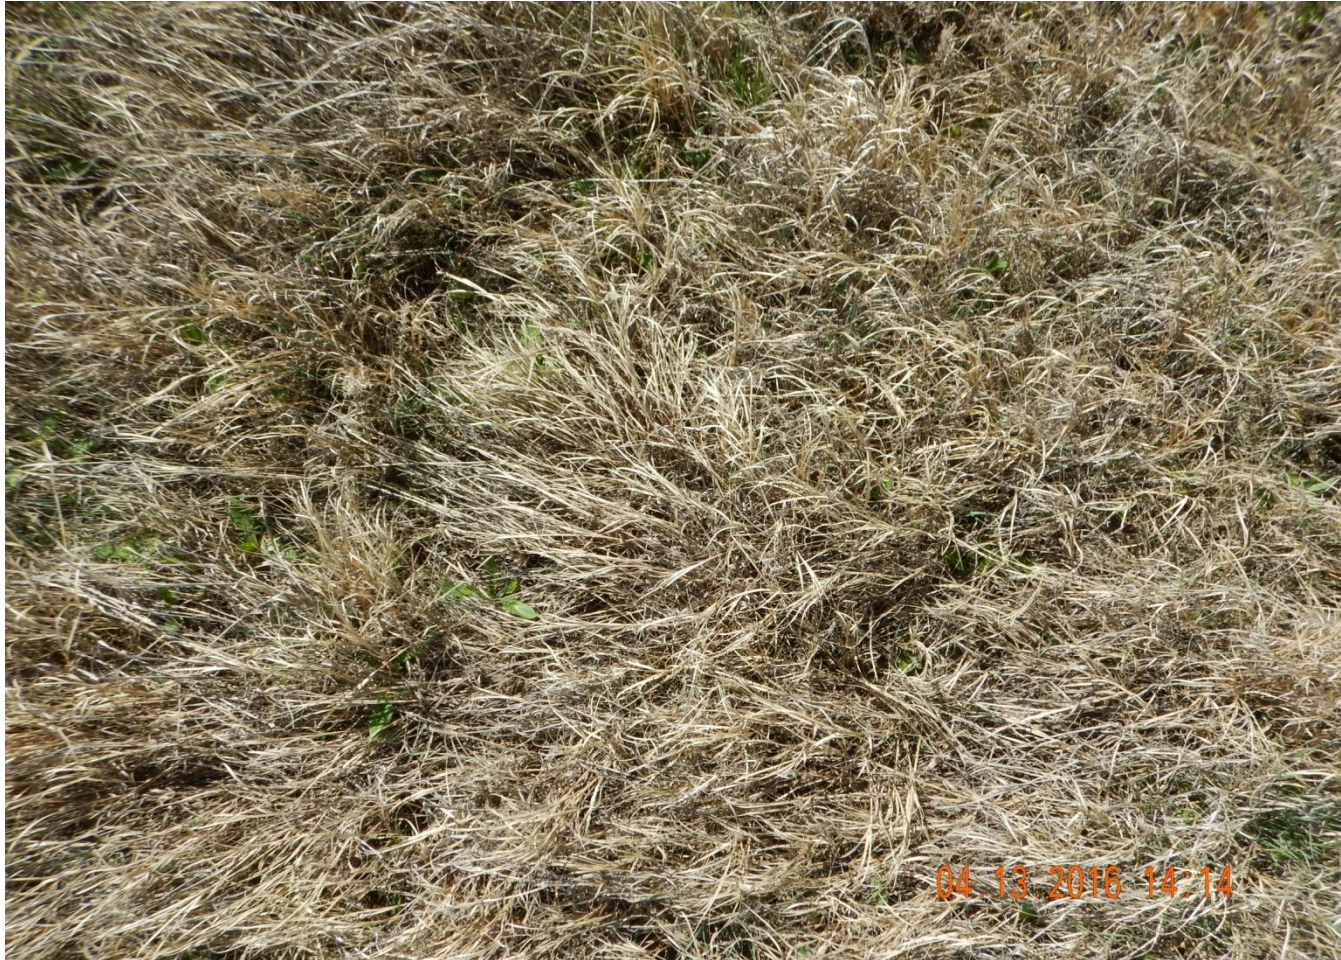
**Photo 6.** Close up photo of reference salt meadow plant community.

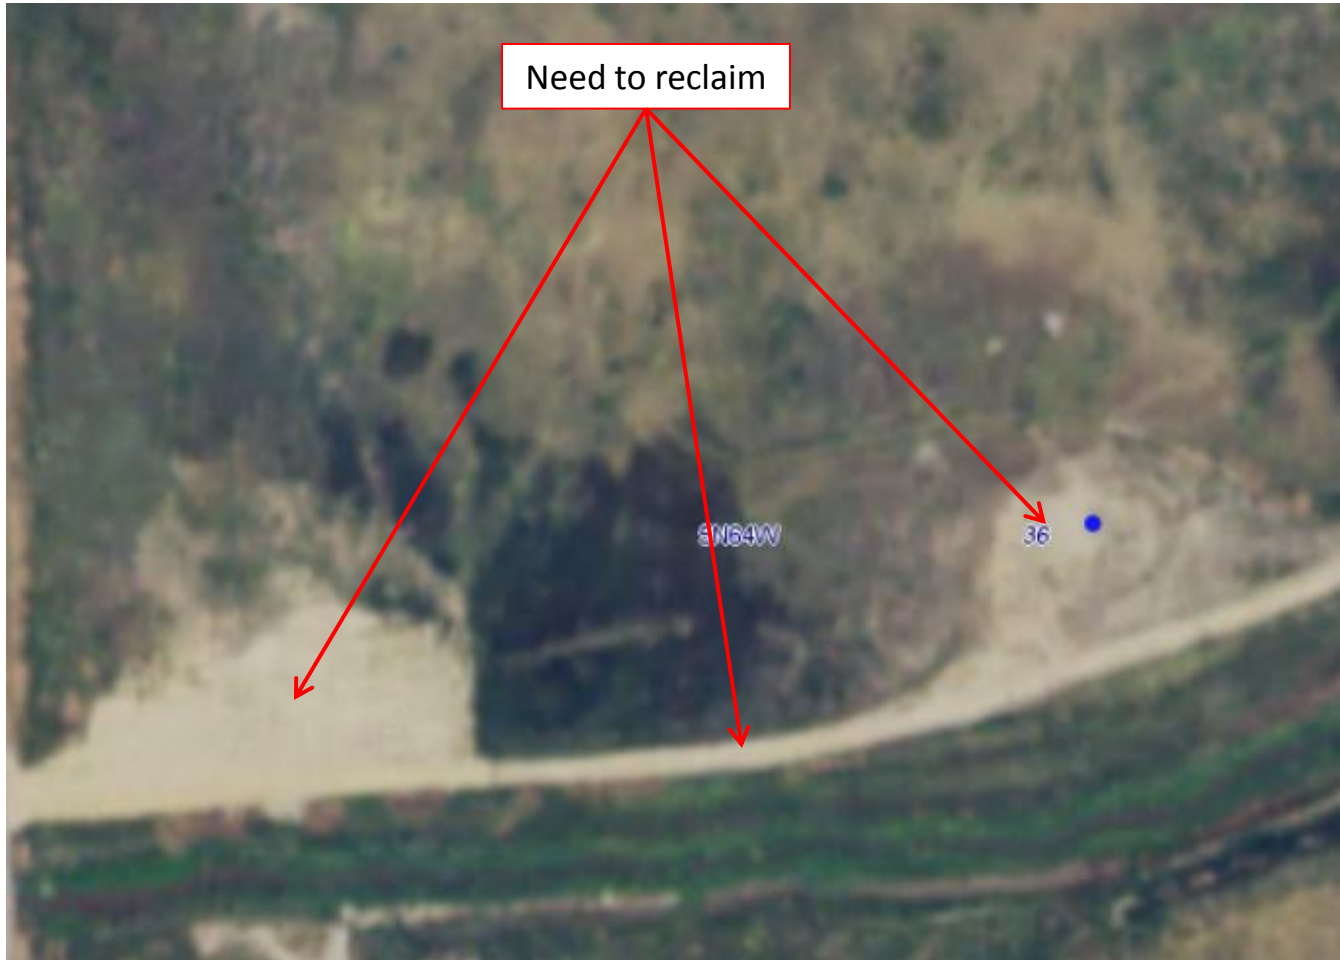
**Photo 7.** Aerial imagery of location using COGCC GISOnline. Need to reclaim well location, associated production facilities, and access road.
