# Construction Inspection

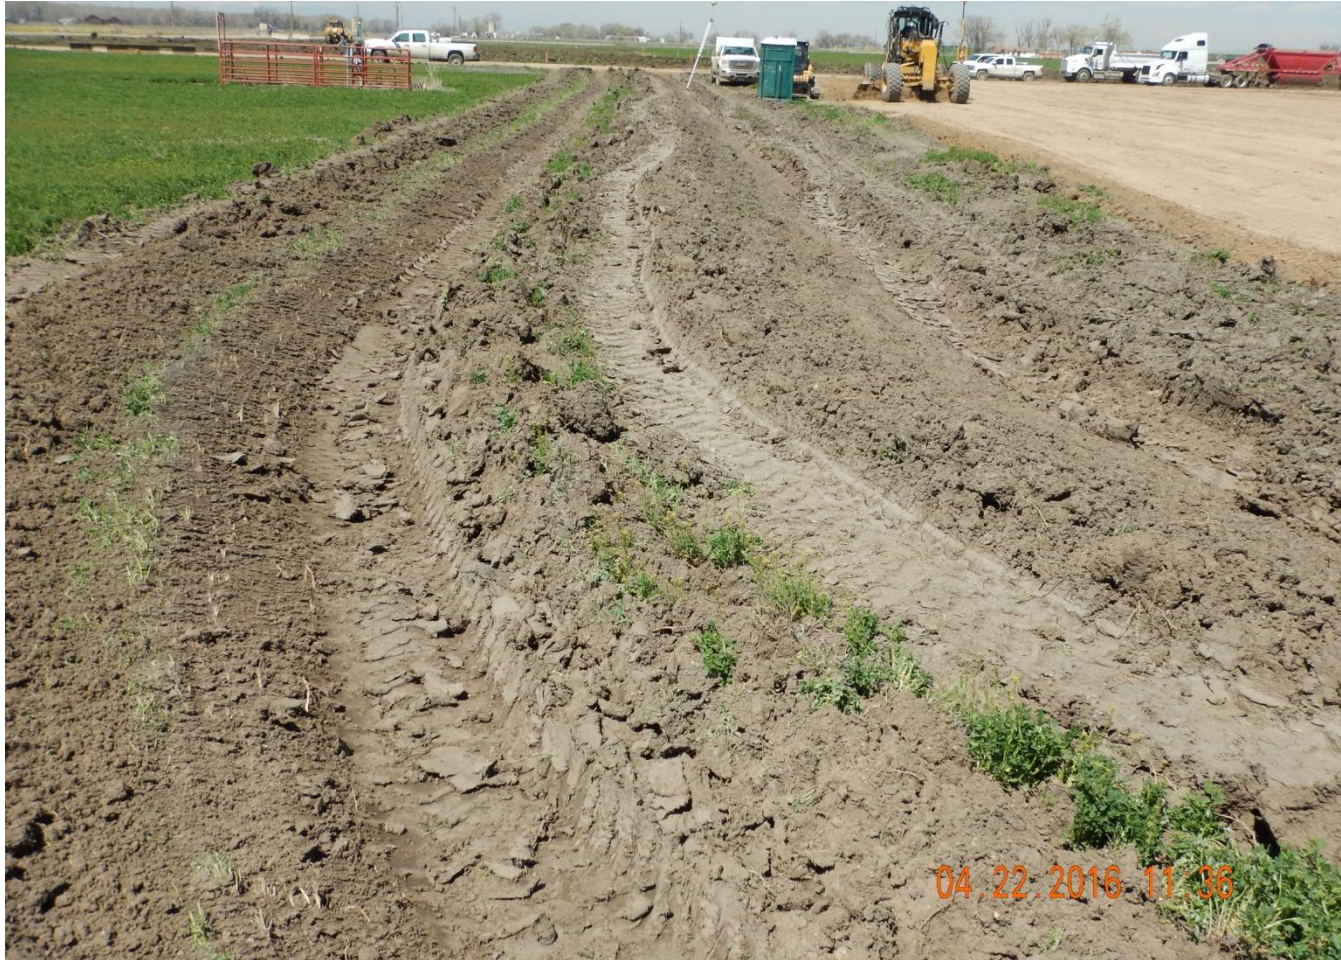
**Photo 1.** Photo taken from southeast location, facing West. Stormwater control BMP installed in center of photo.

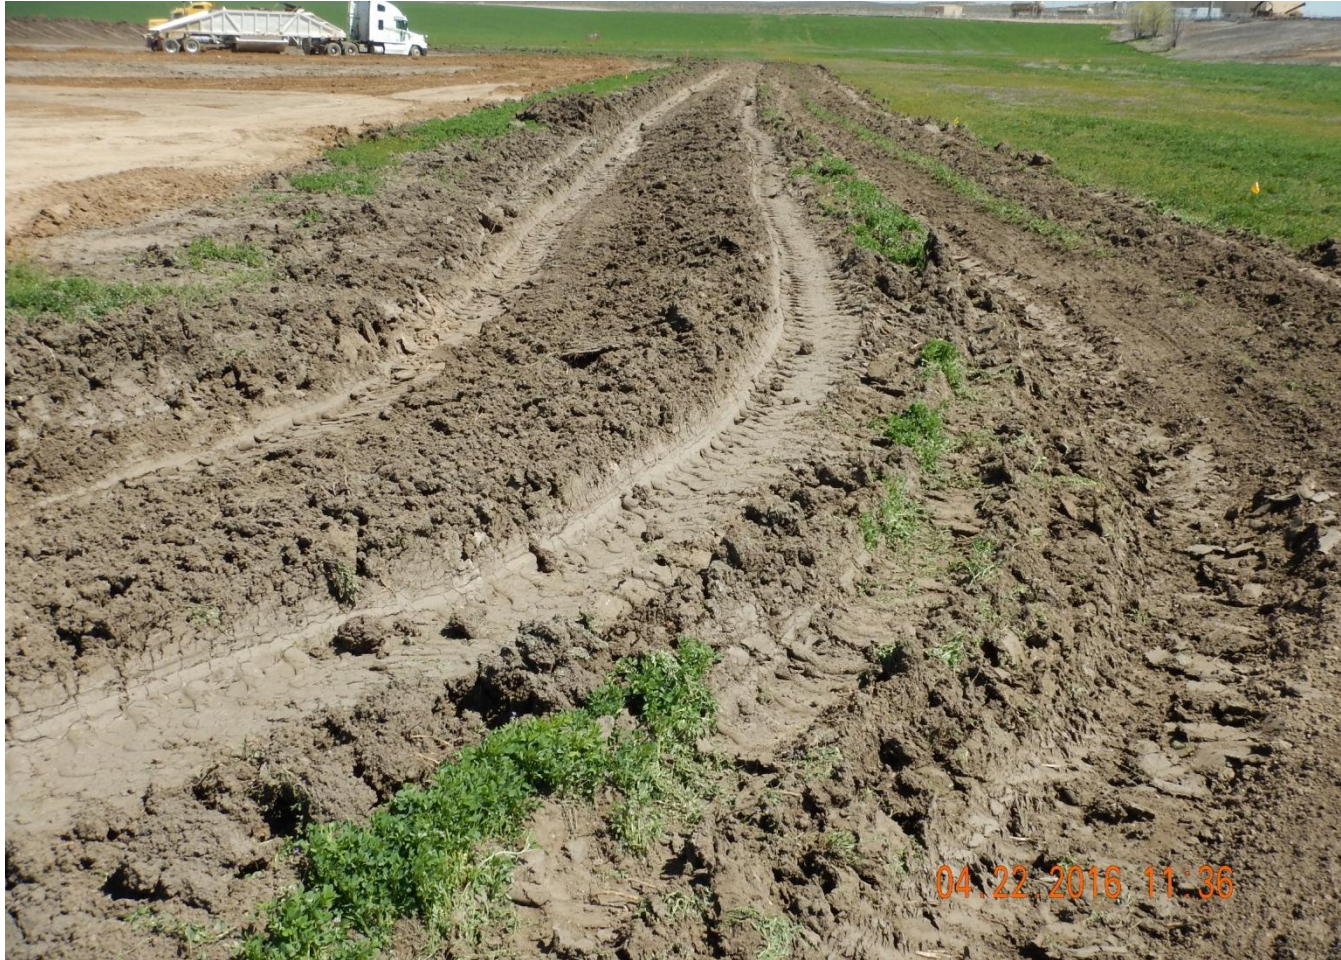
**Photo 2.** Photo taken from southeast location, facing North. Stormwater control BMP installed in center of photo.

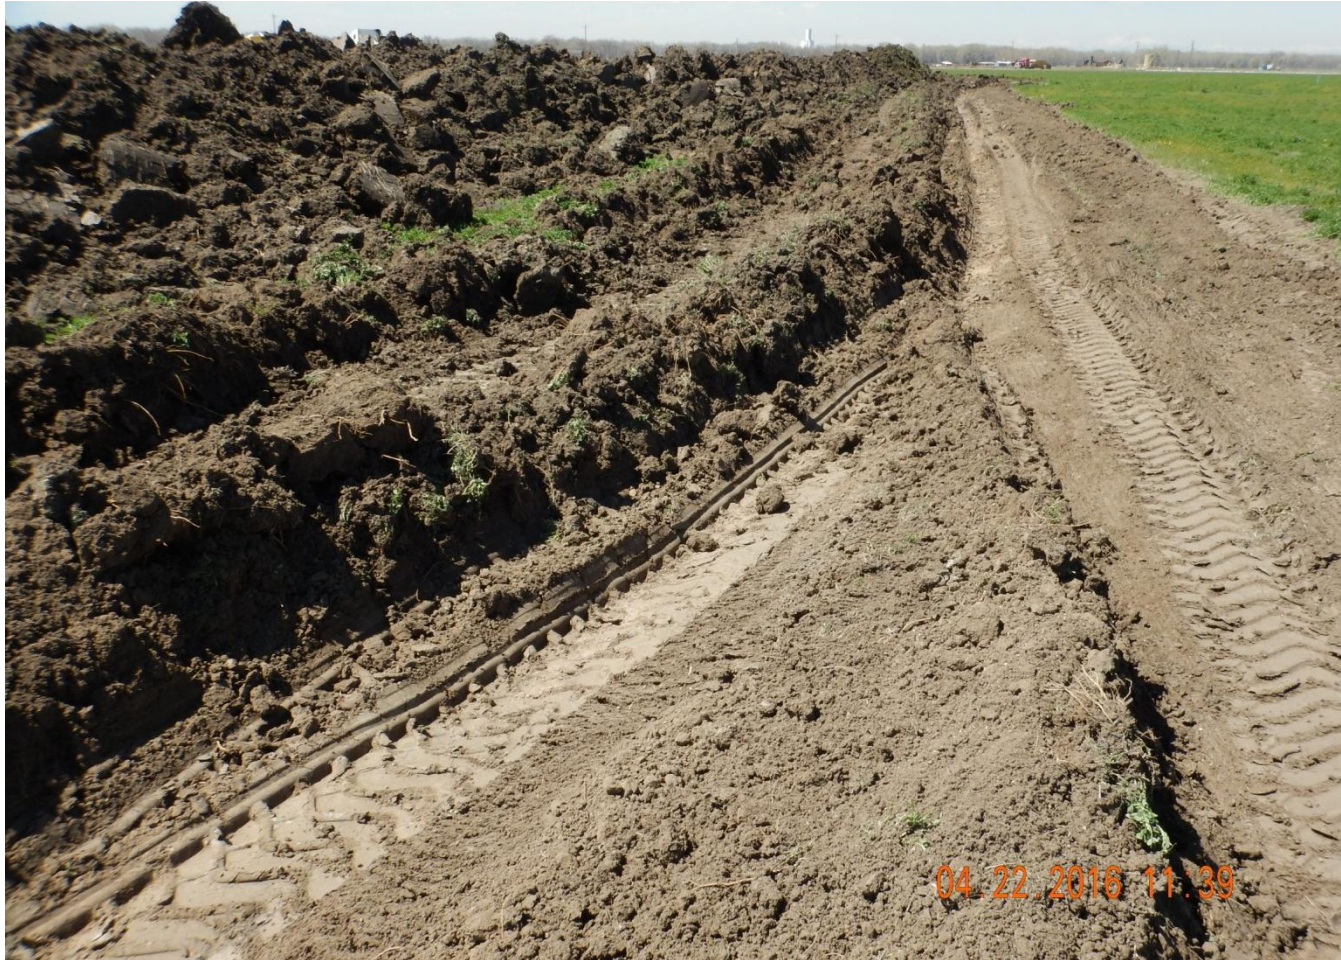
**Photo 3.** Photo taken from northeast location, facing West. Stormwater control BMP installed in center of photo.

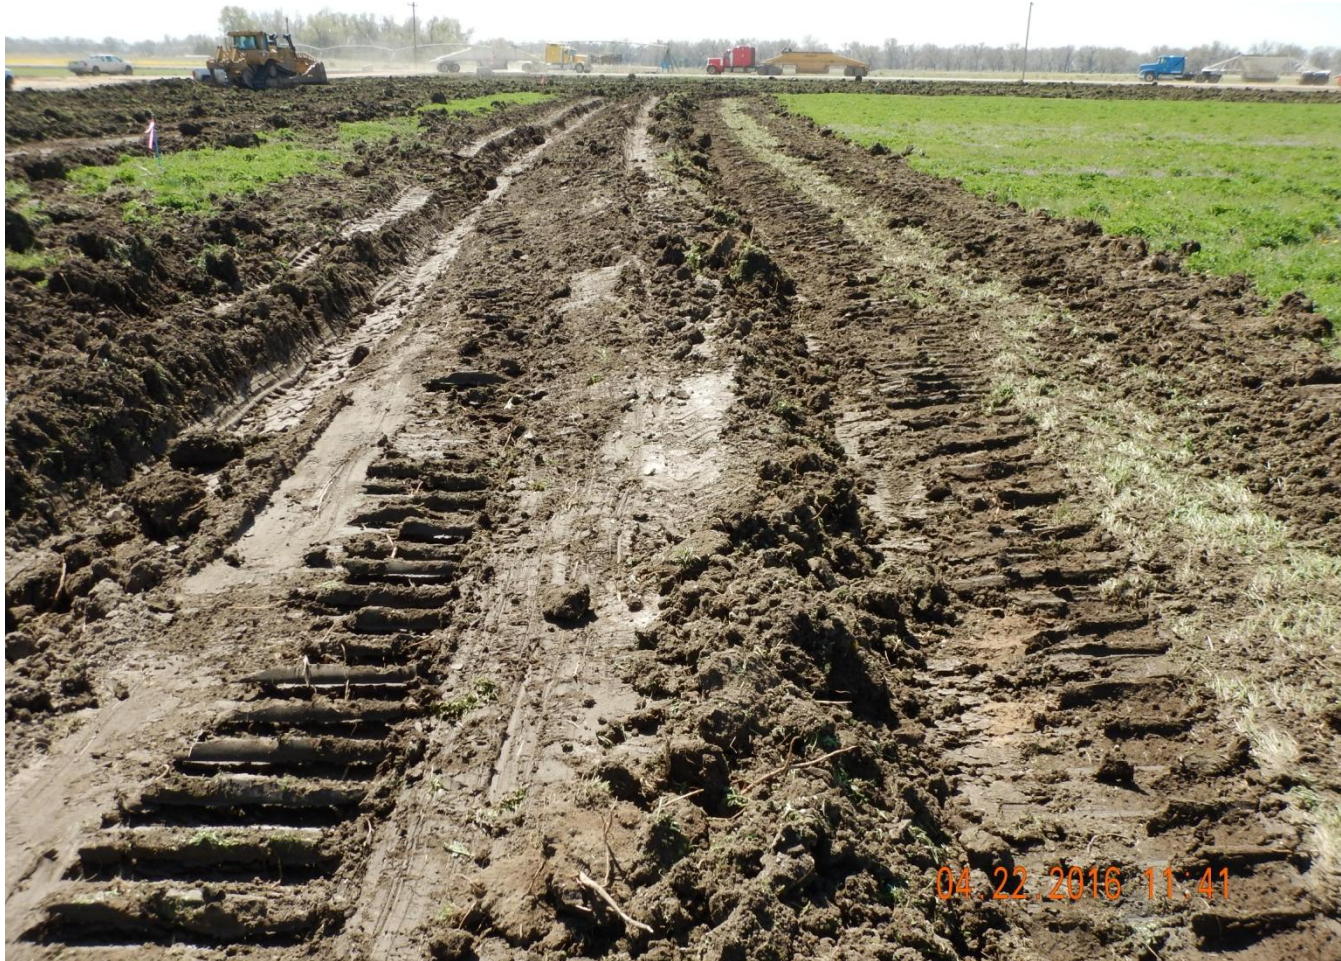
**Photo 4.** Photo taken from northwest location, facing South. Stormwater control BMP installed in center of photo.

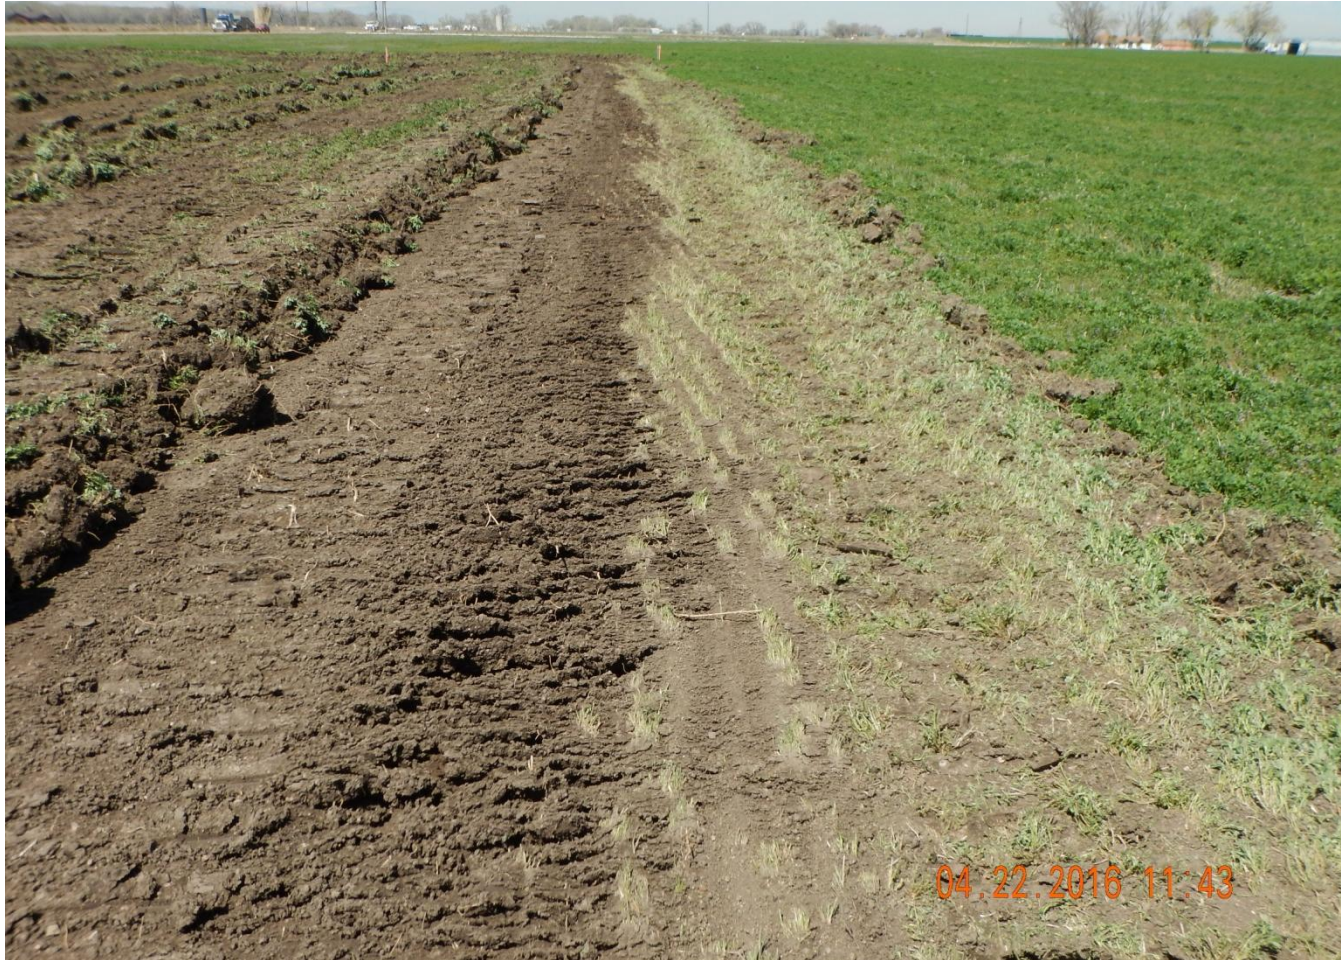
**Photo 5.** Photo taken from western location, facing West. Stormwater control BMP installed in center of photo.

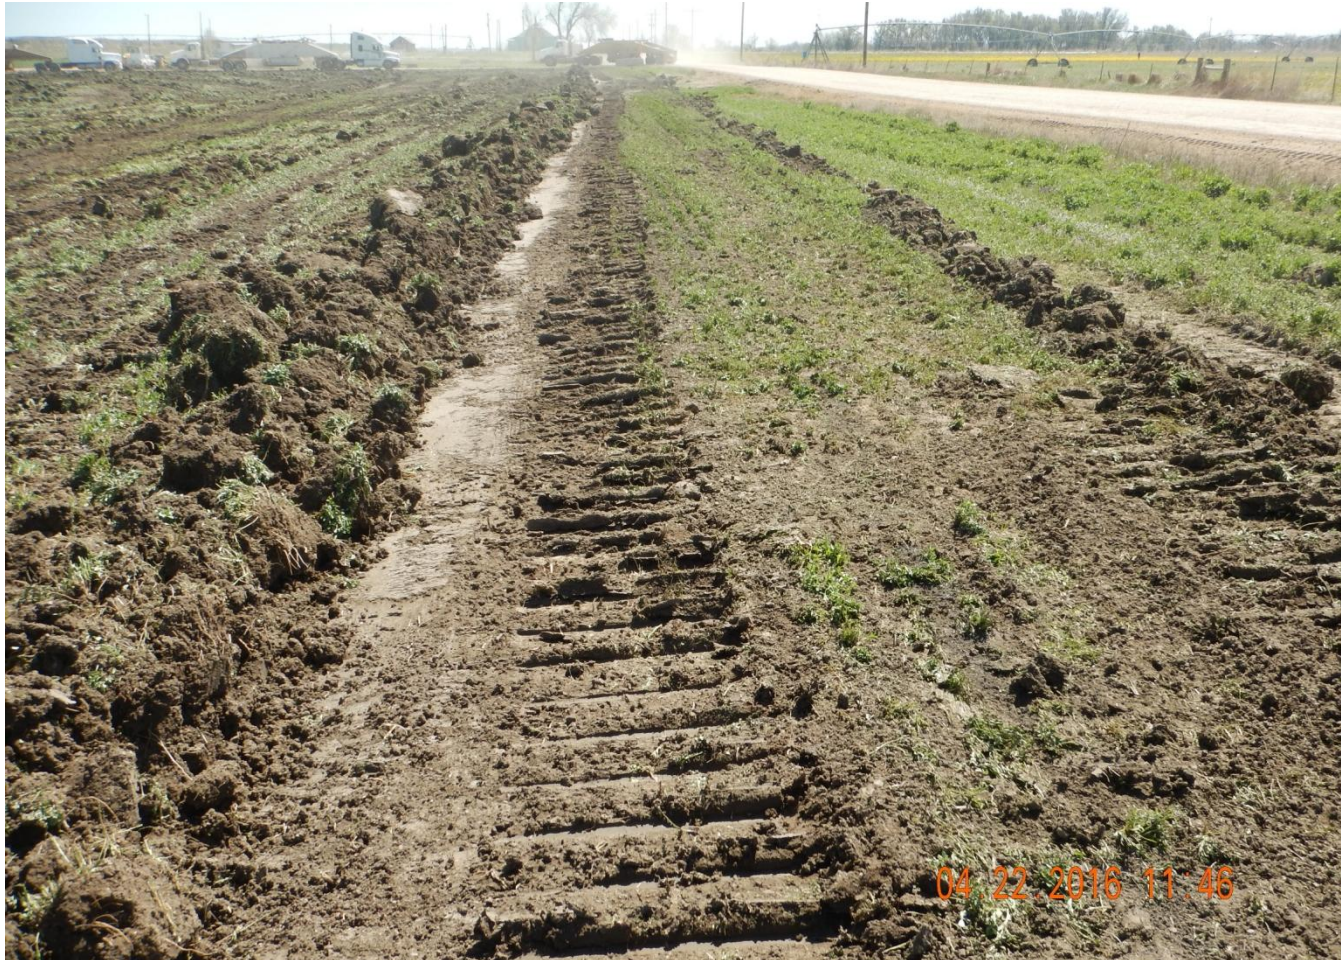
**Photo 6.** Photo taken from southwest location, facing East. Stormwater control BMP installed in center of photo.

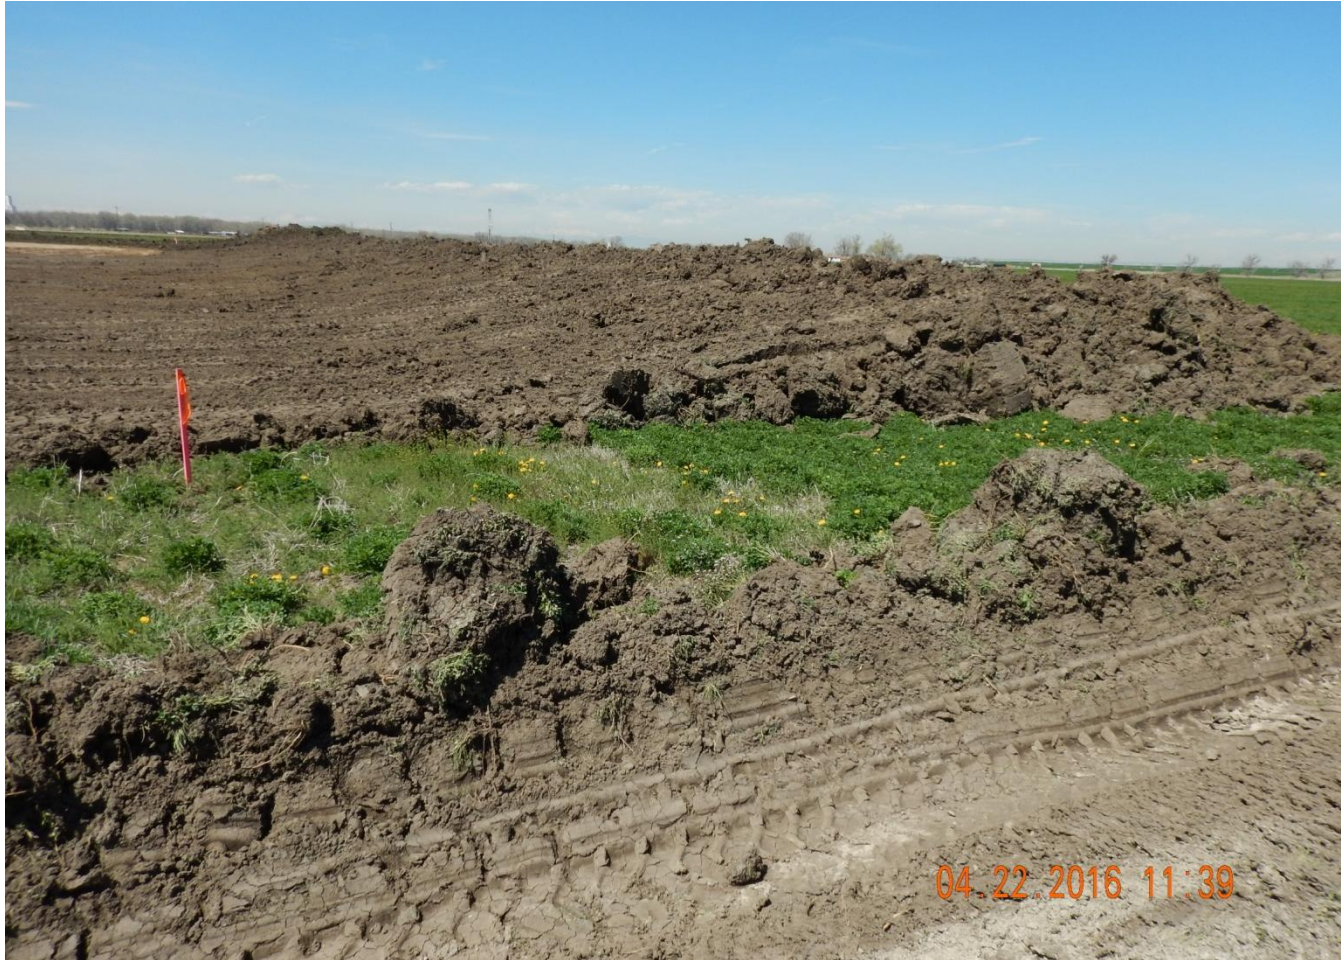
**Photo 7.** Photo taken from eastern location, facing West towards topsoil stockpile. Topsoil stockpile needs to be stabilized upon completion of salvage process.

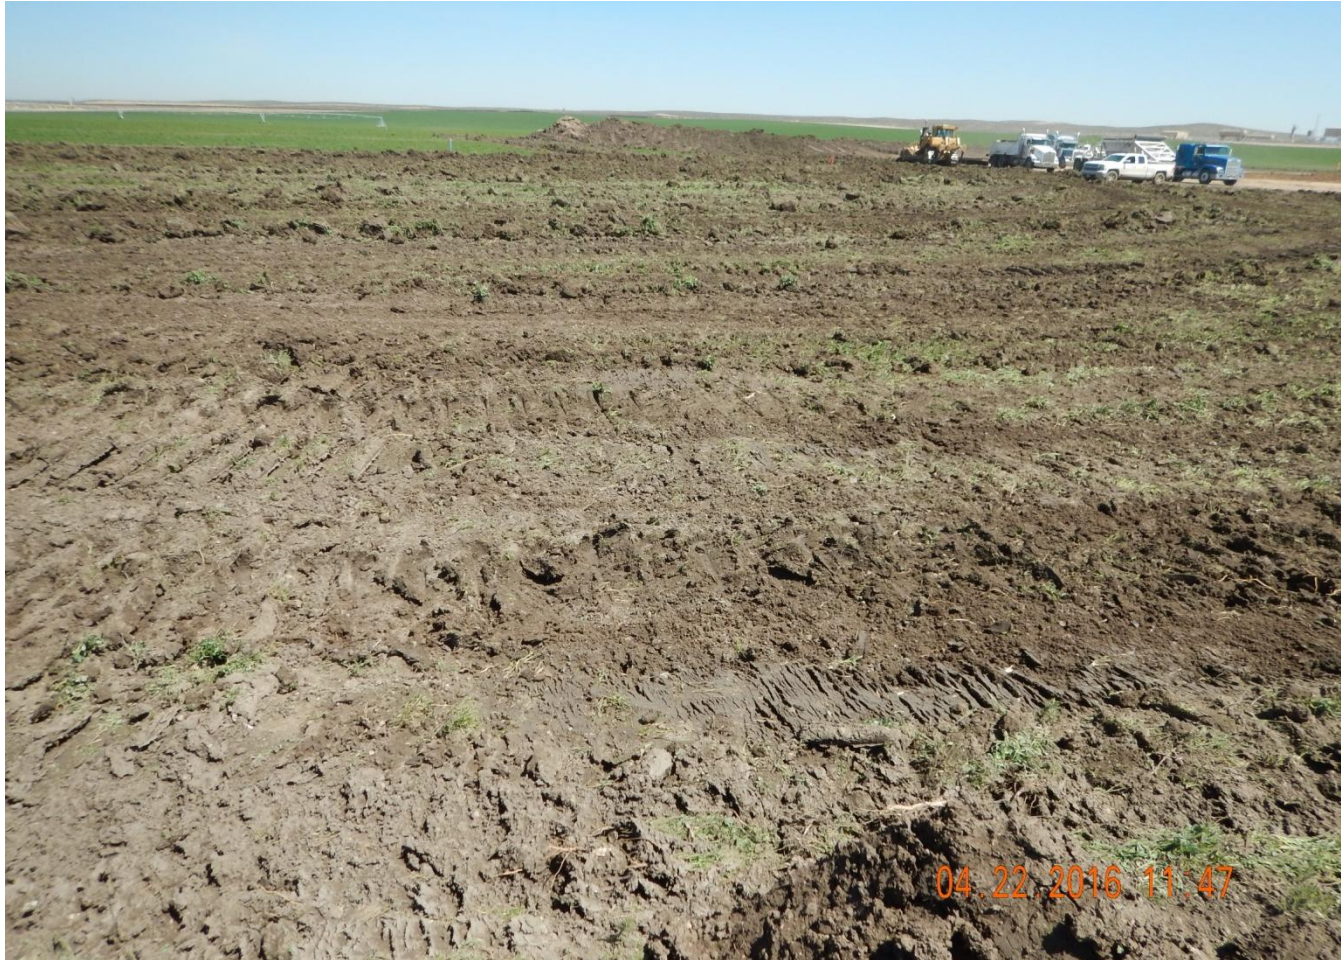
**Photo 8.** Photo taken from southern location, facing North. Topsoil salvage in process.

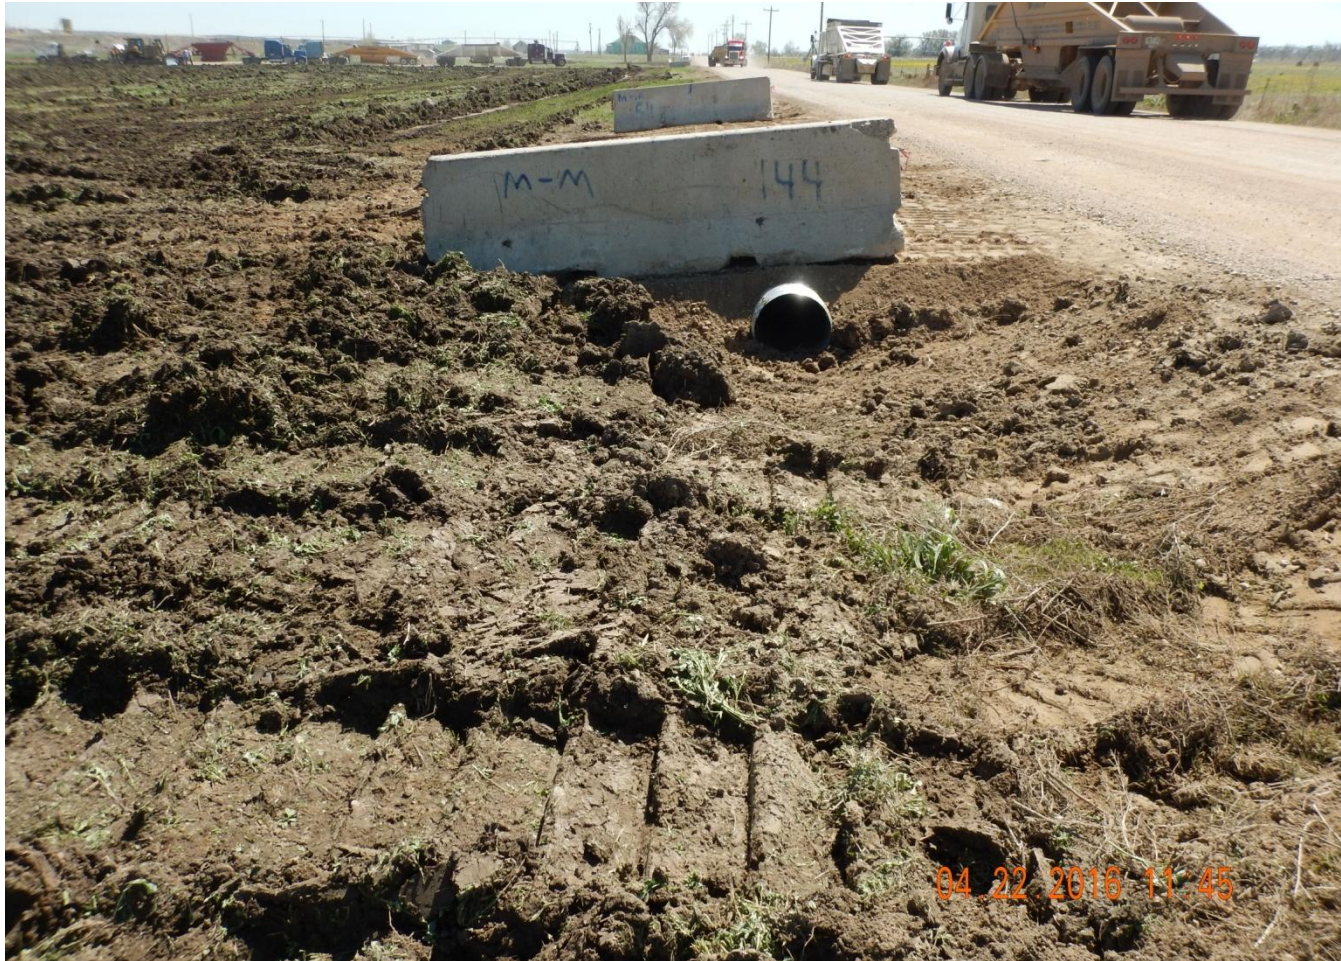
**Photo 9.** Photo taken from southwest entrance of location- culvert installed.

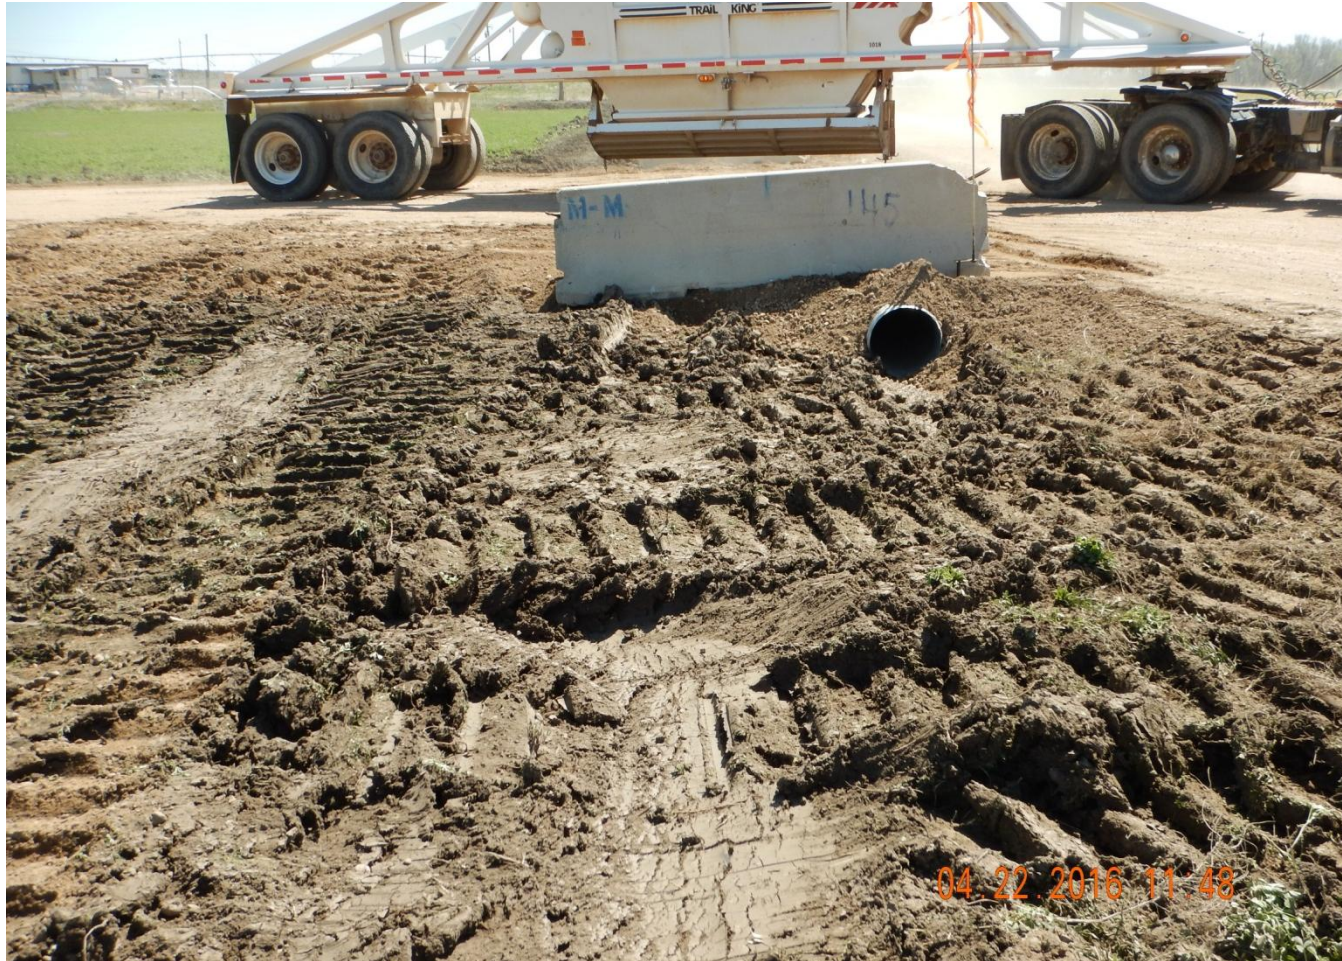
**Photo 10.** Photo taken from southeast entrance of location- culvert installed.
