## Construction Inspection

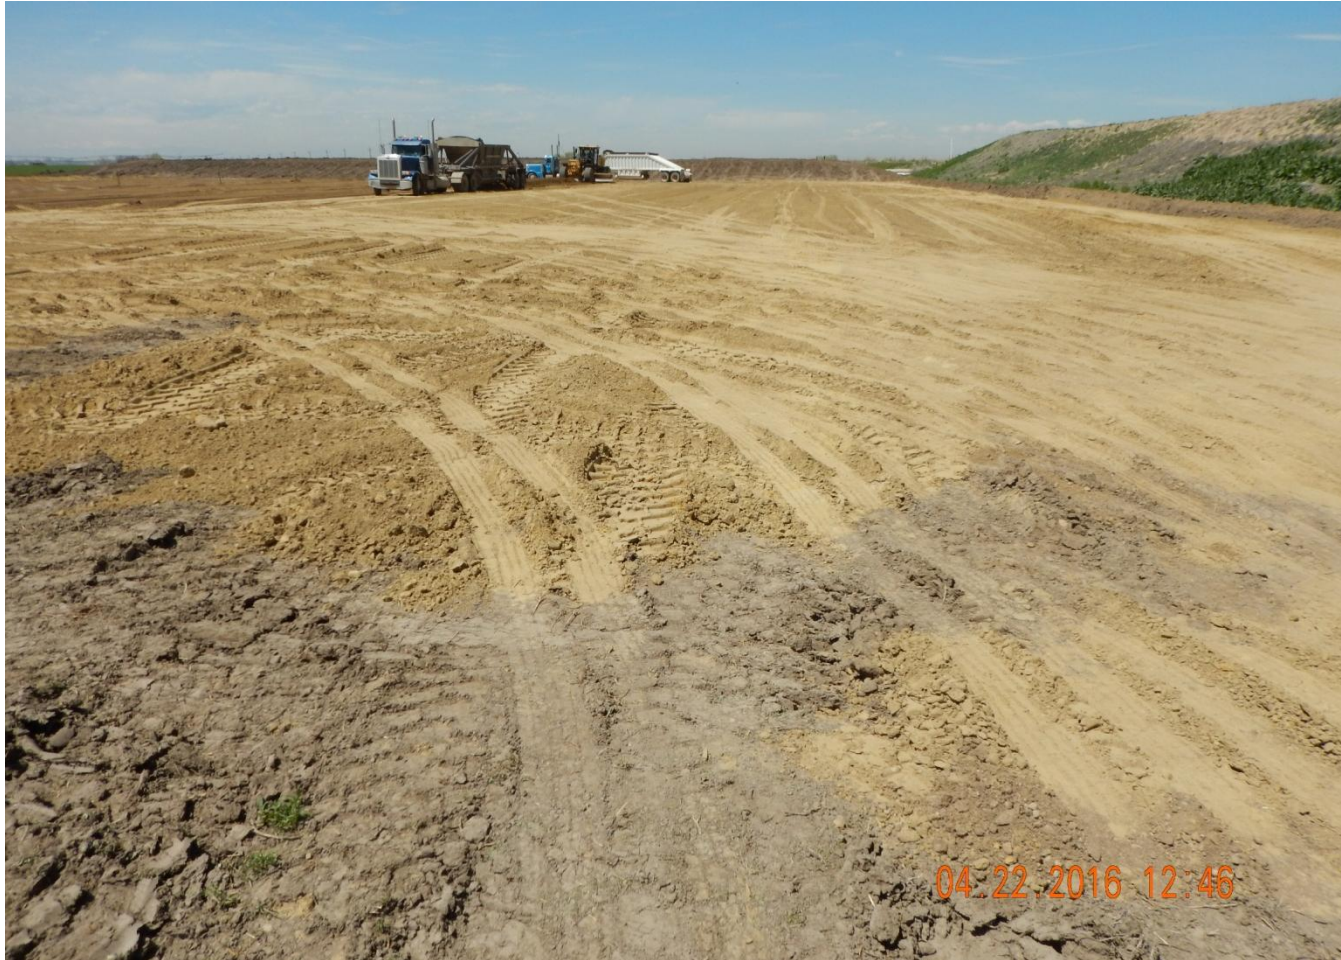
**Photo 1.** Photo taken from entrance of location, facing North.

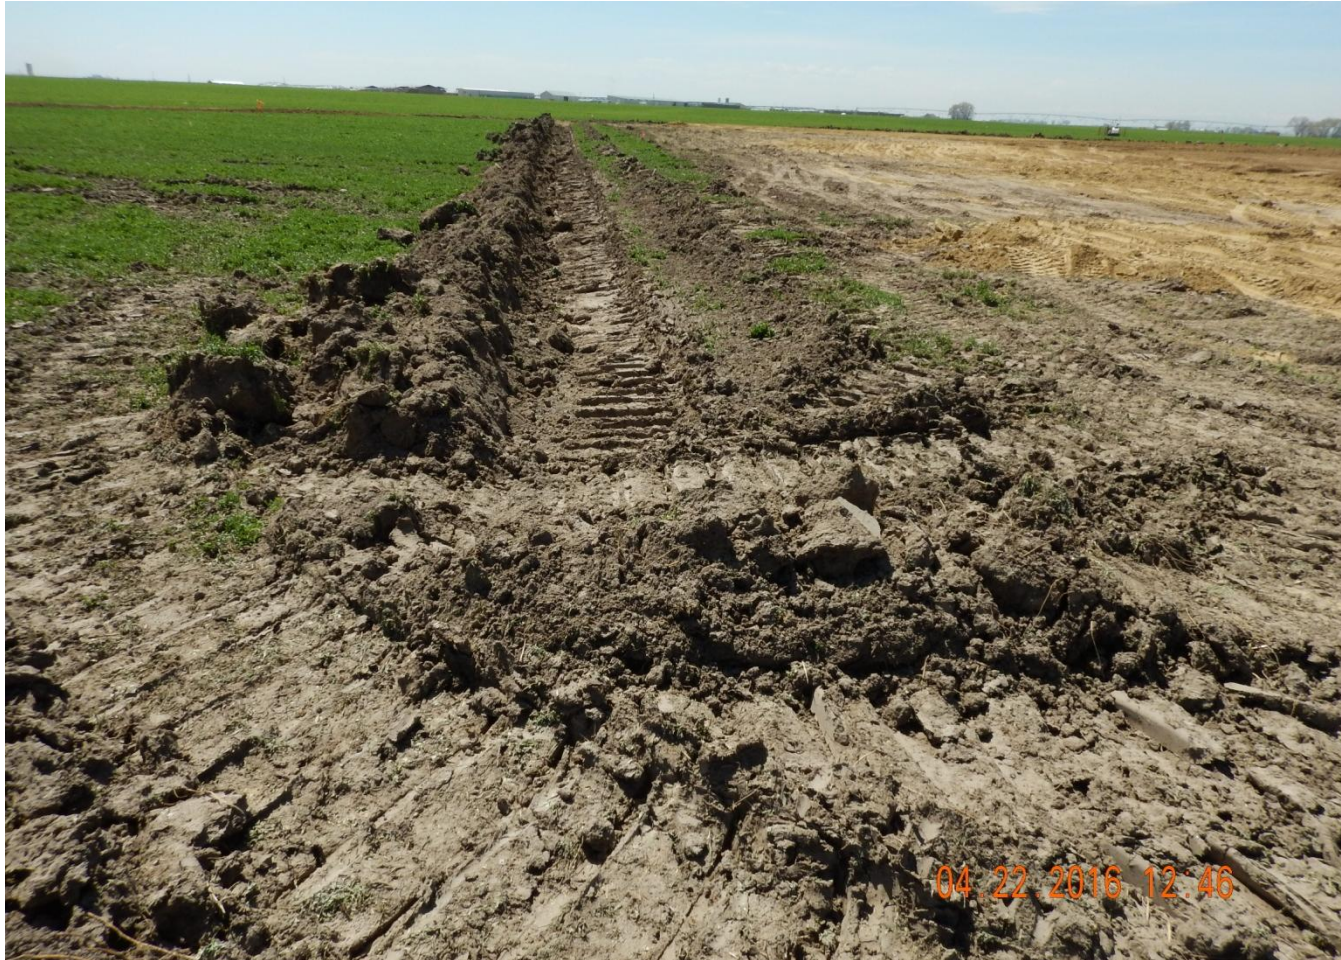
**Photo 2.** Photo taken from entrance location, facing East. Stormwater control BMP installed in center of photo.

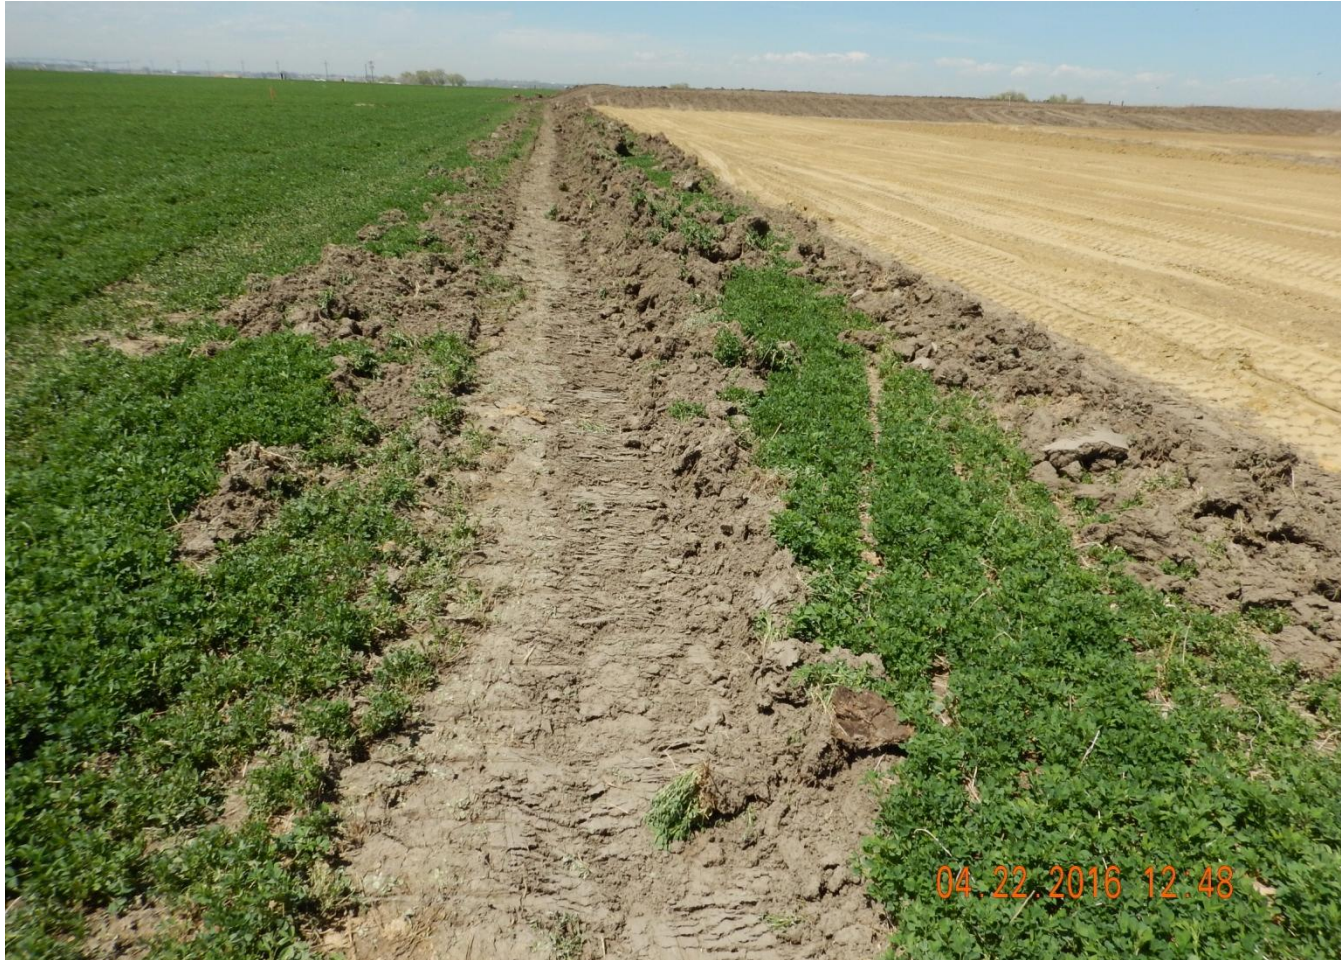
**Photo 3.** Photo taken from southwest corner, facing North. Stormwater control BMP installed in center of photo.

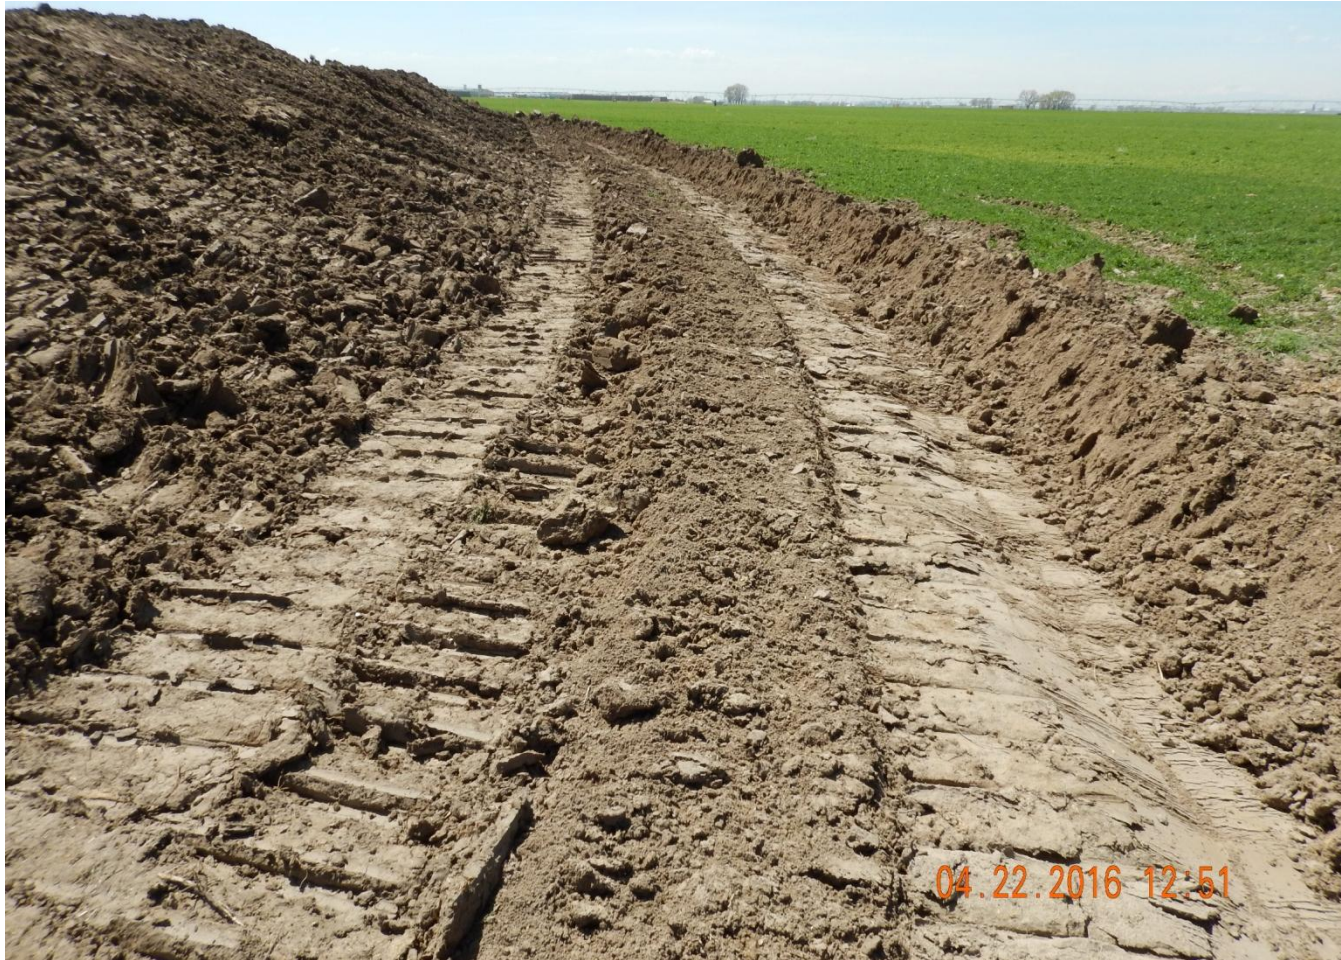
**Photo 4.** Photo taken from northeast corner, facing West. Stormwater control BMP installed in center of photo.

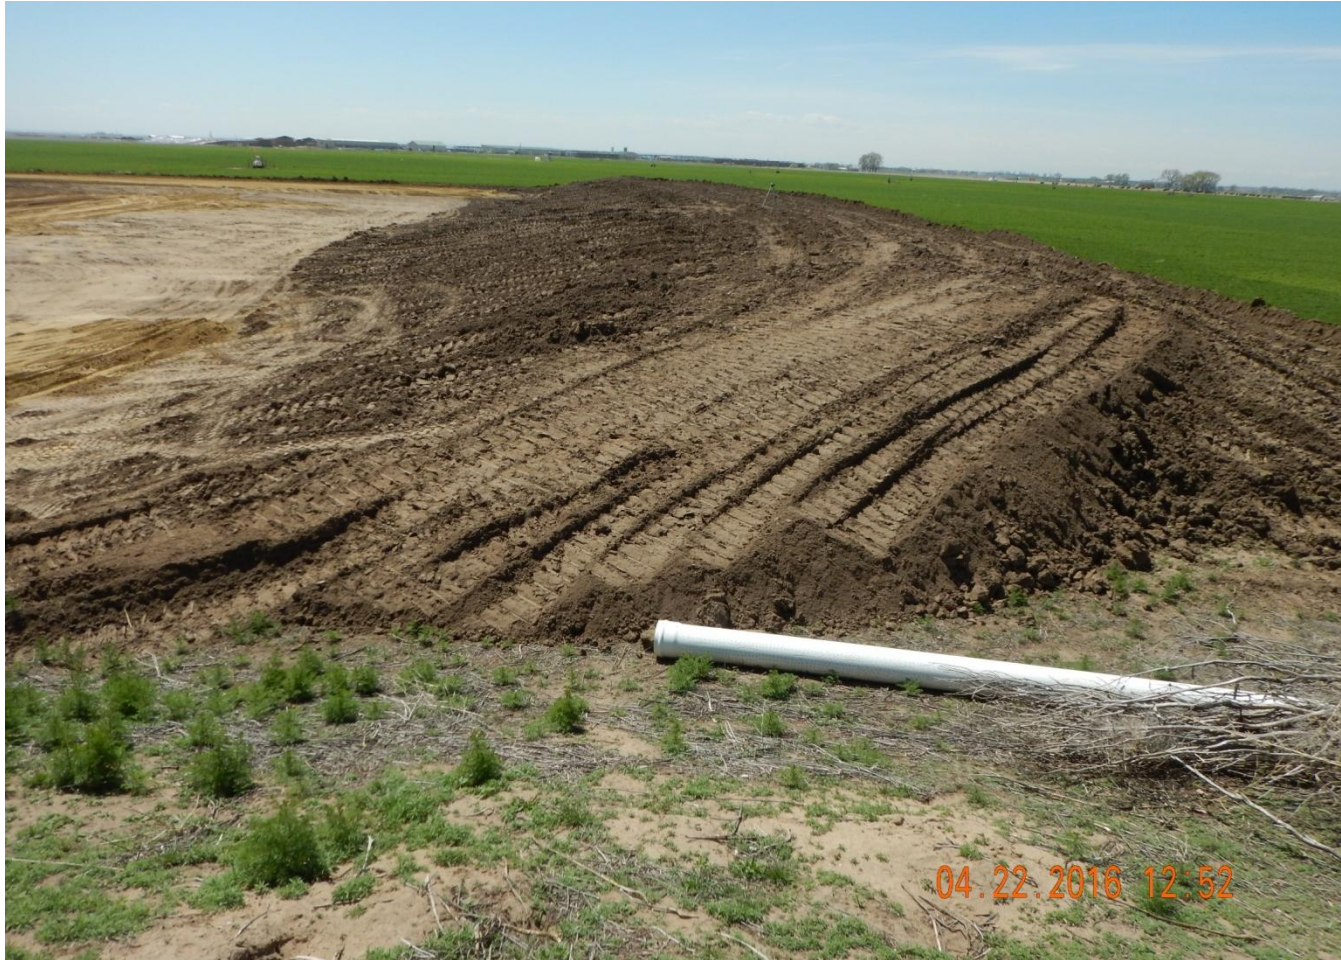
**Photo 5.** Photo taken from eastern location, facing West. Topsoil stockpile located on northern location.
