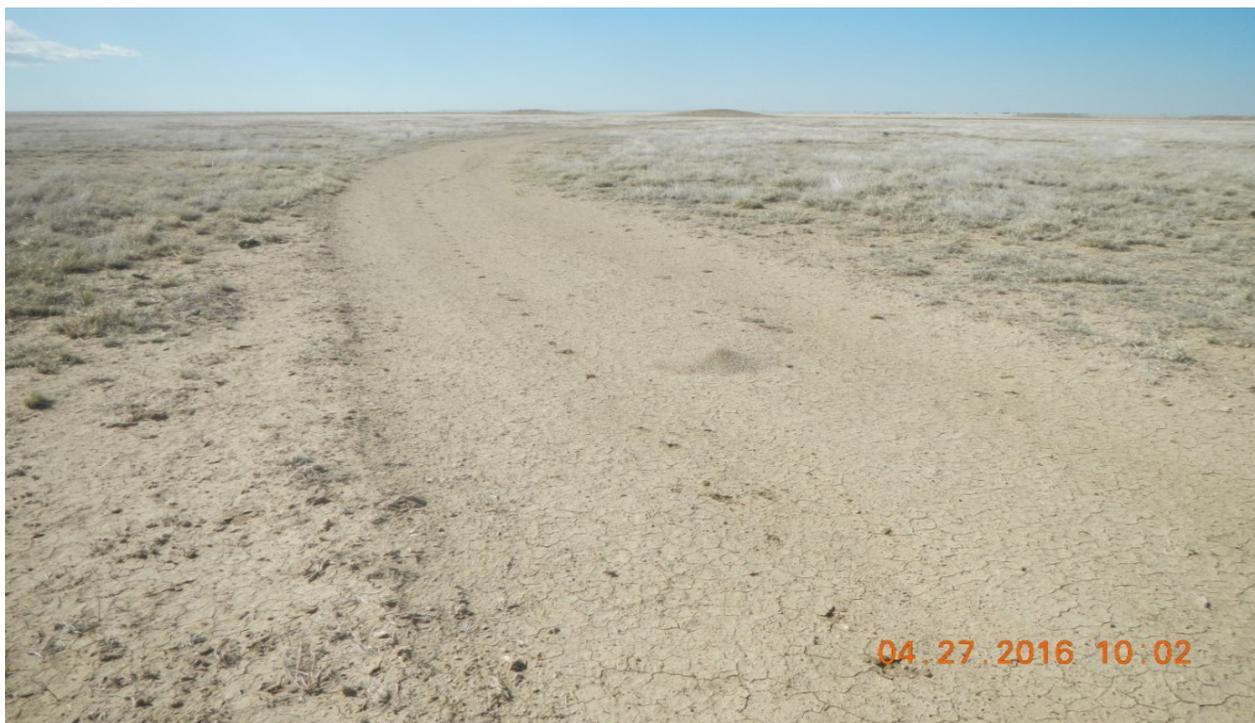
photo 1: Facing south along the access road.

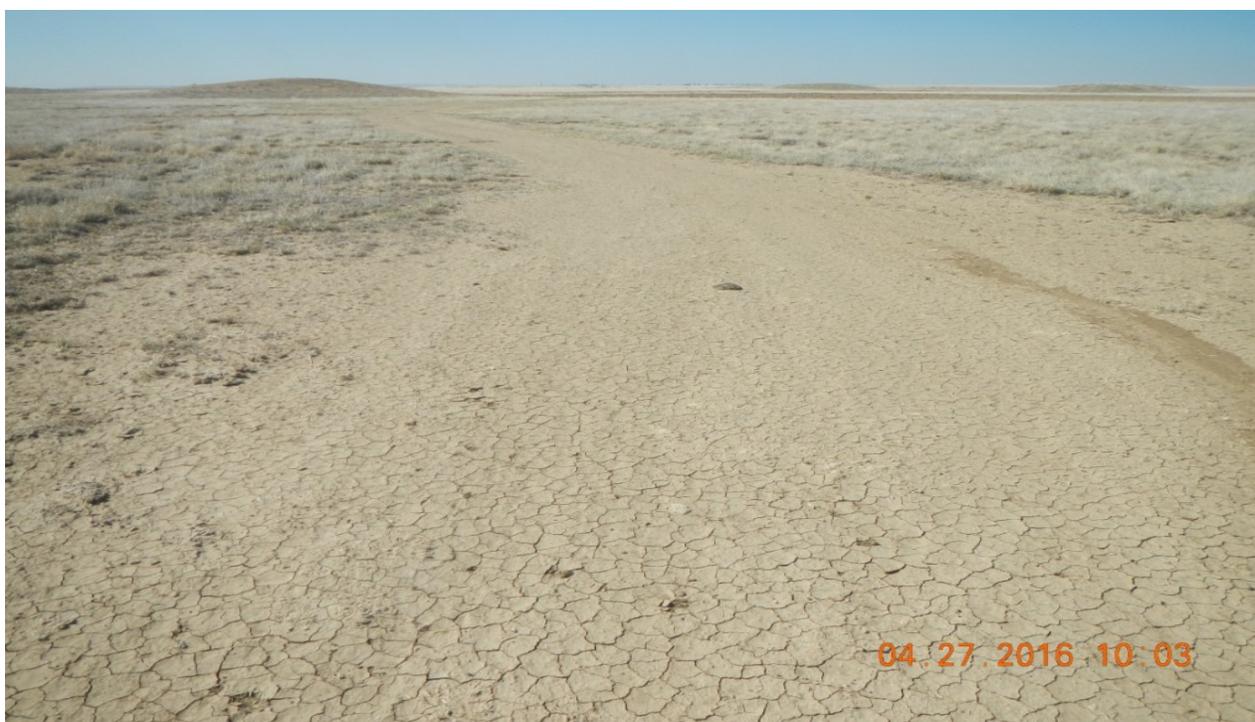
photo 2: Facing southwest along the access road.

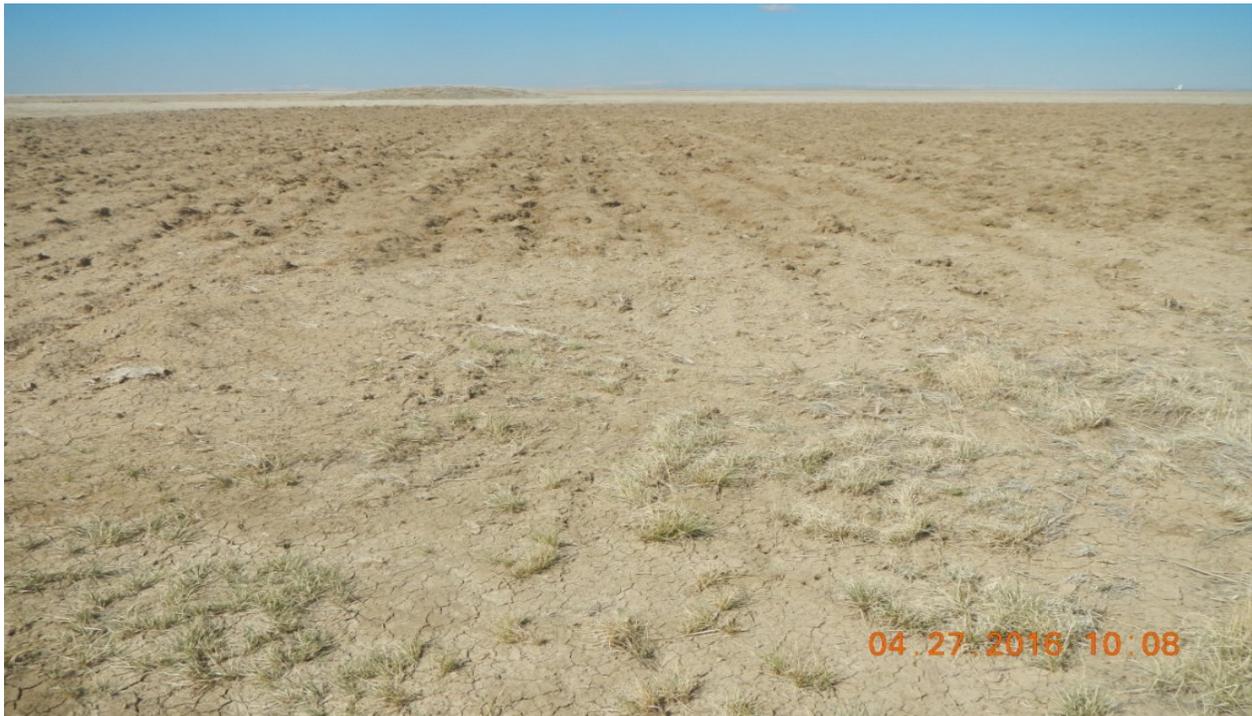
photo 3: Facing southwest toward the location.

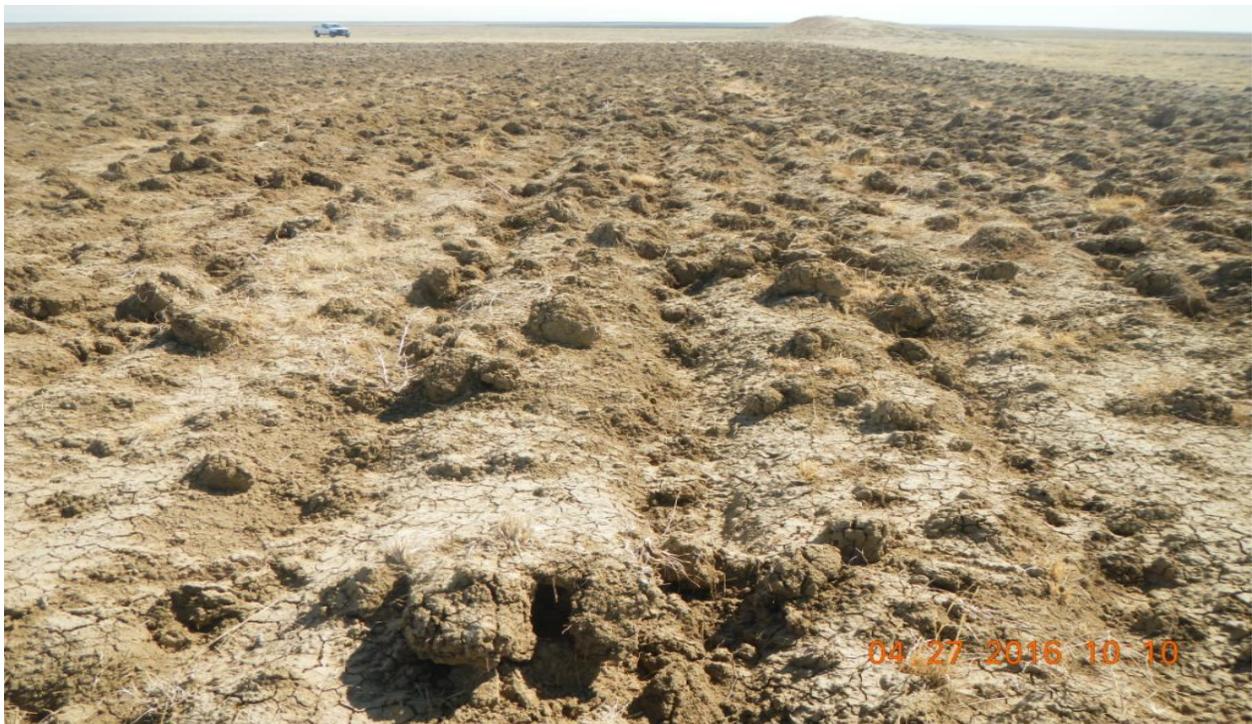
photo 4: Southwest side facing northeast. Soils appear to have been one direction. Dirt clods remain along the surface.

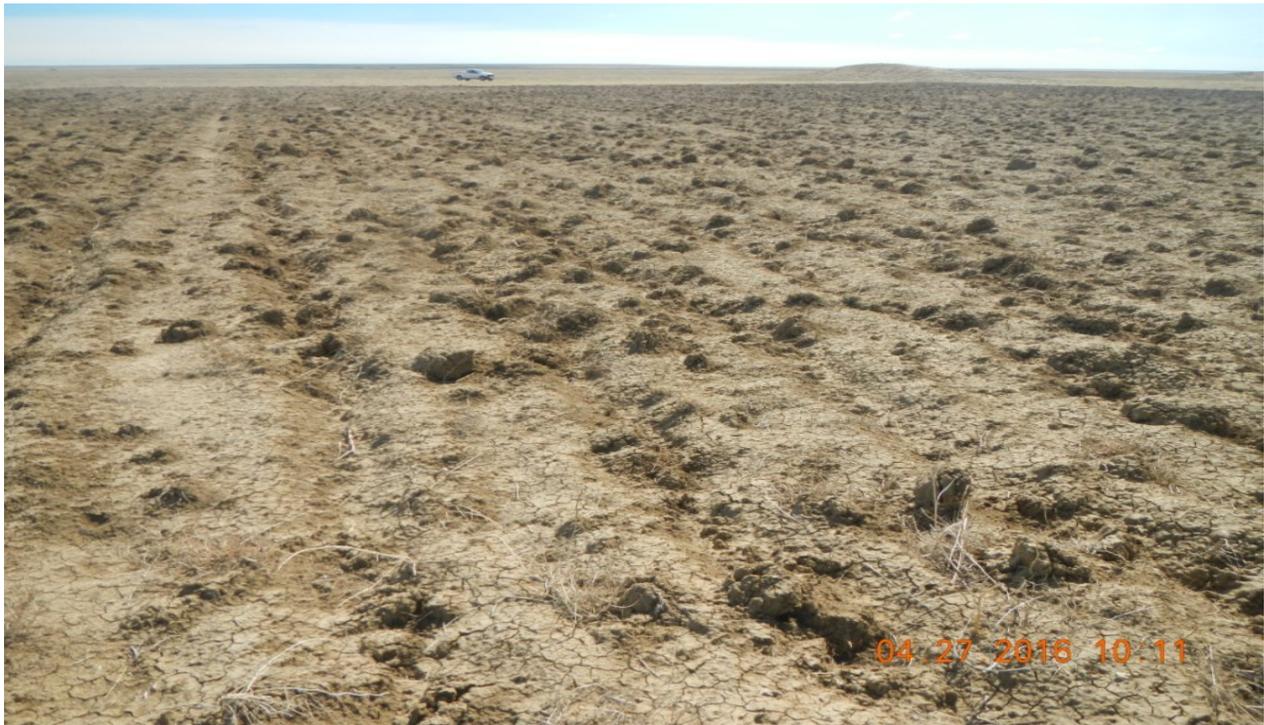
photo 5: West side of the location facing east.

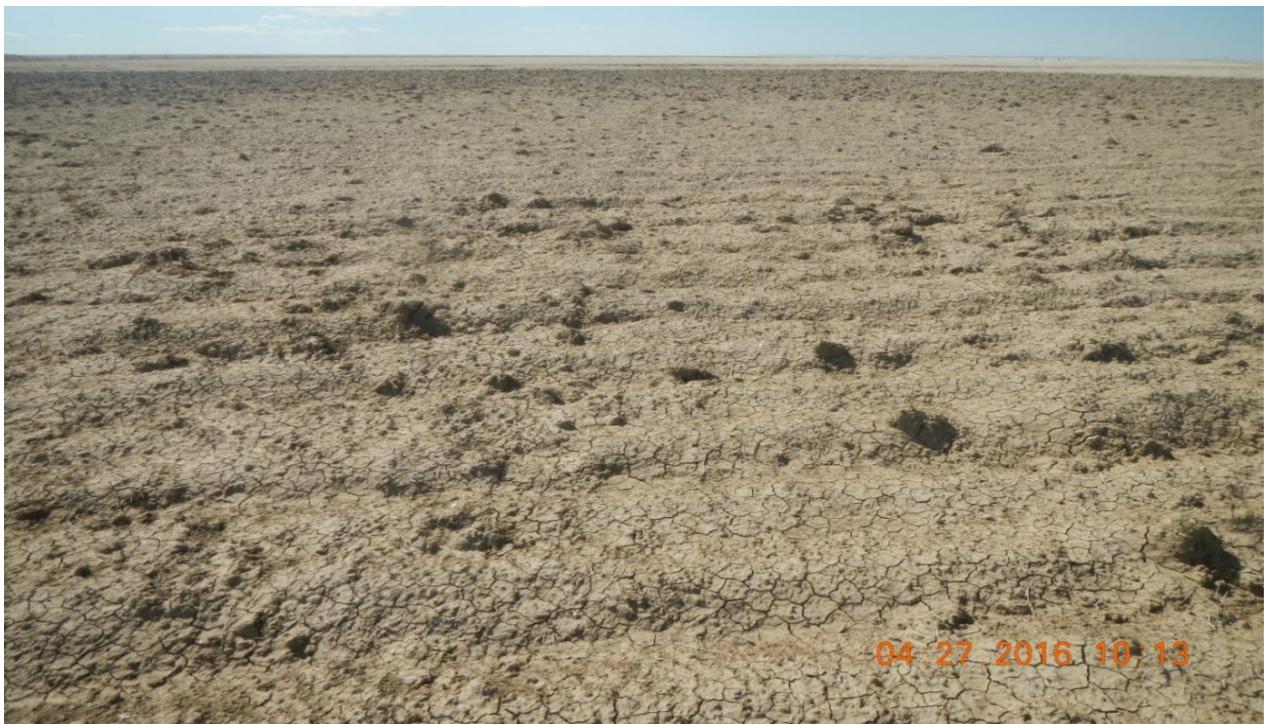
photo 6: North side of the location facing south.

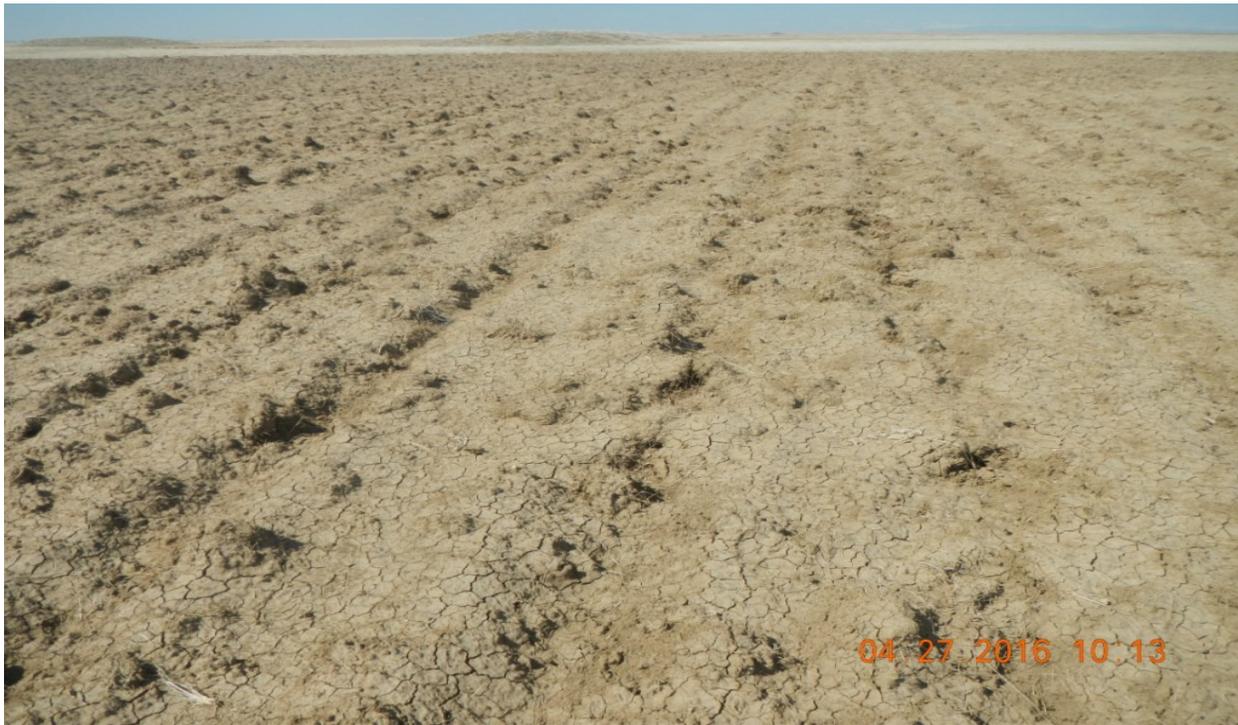
photo 7: Northeast side facing southwest.

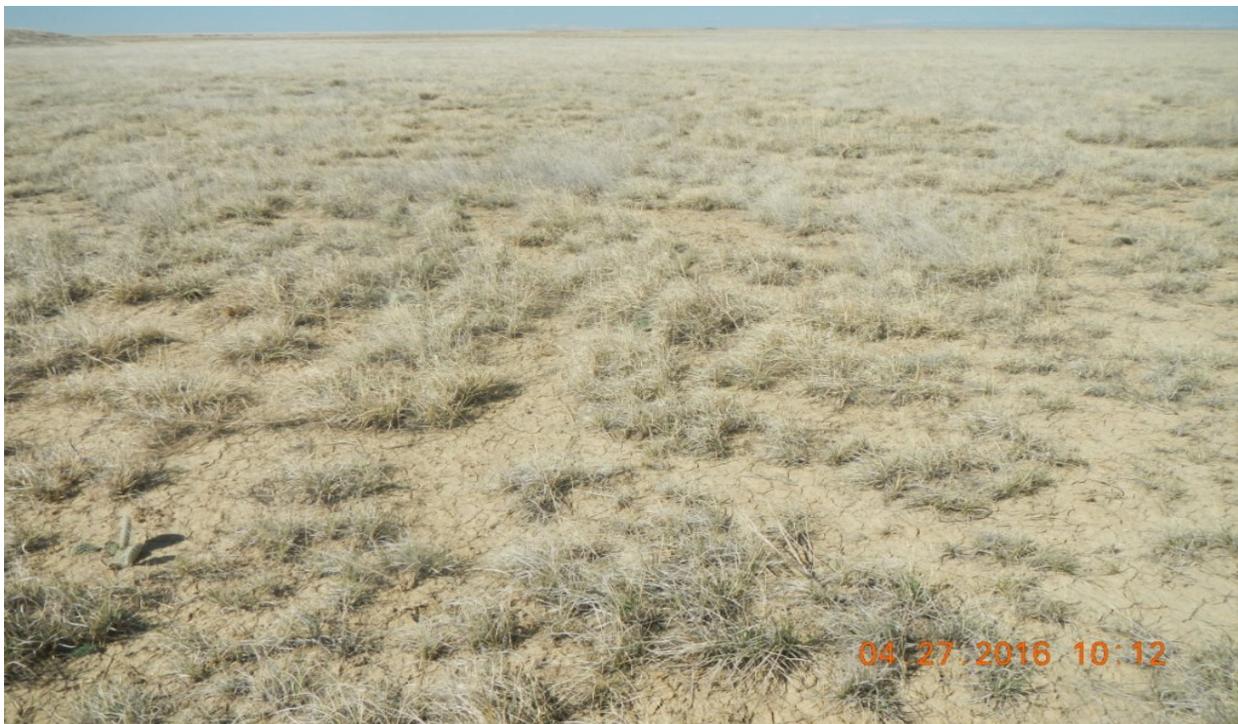
photo 8: Facing west at the surrounding undisturbed vegetation.
