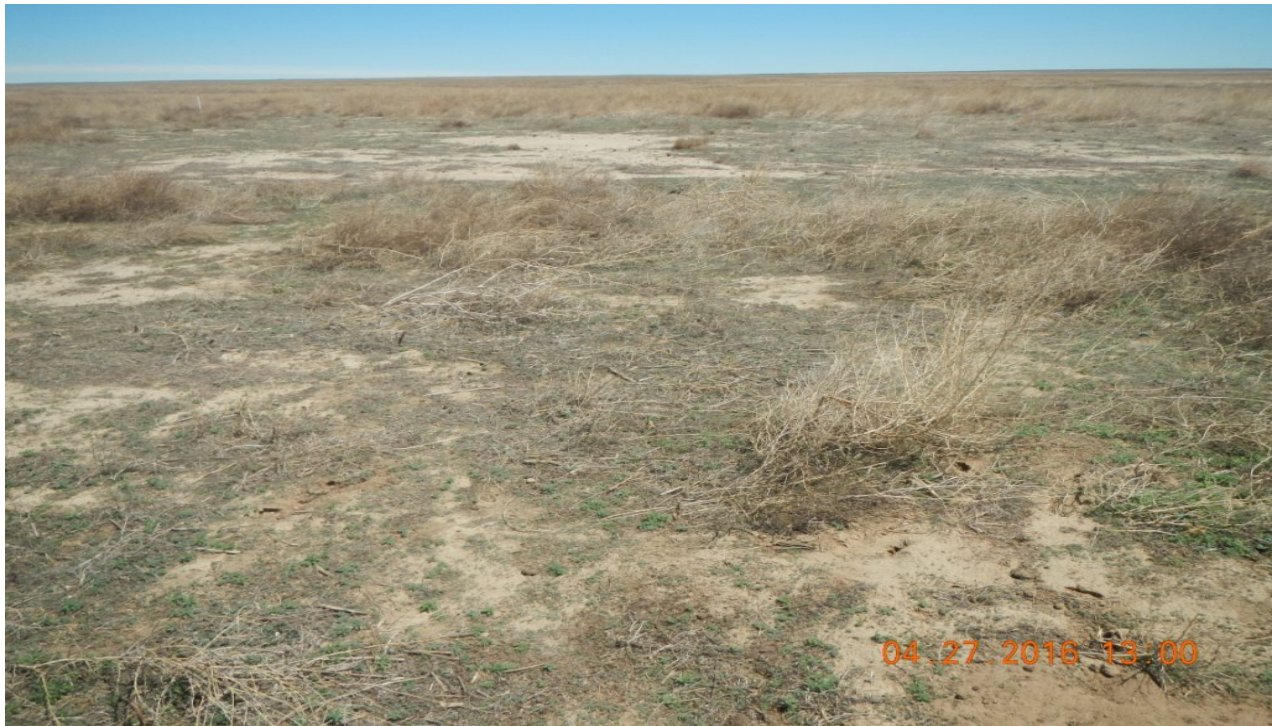
photo 1: West side of the location facing east.

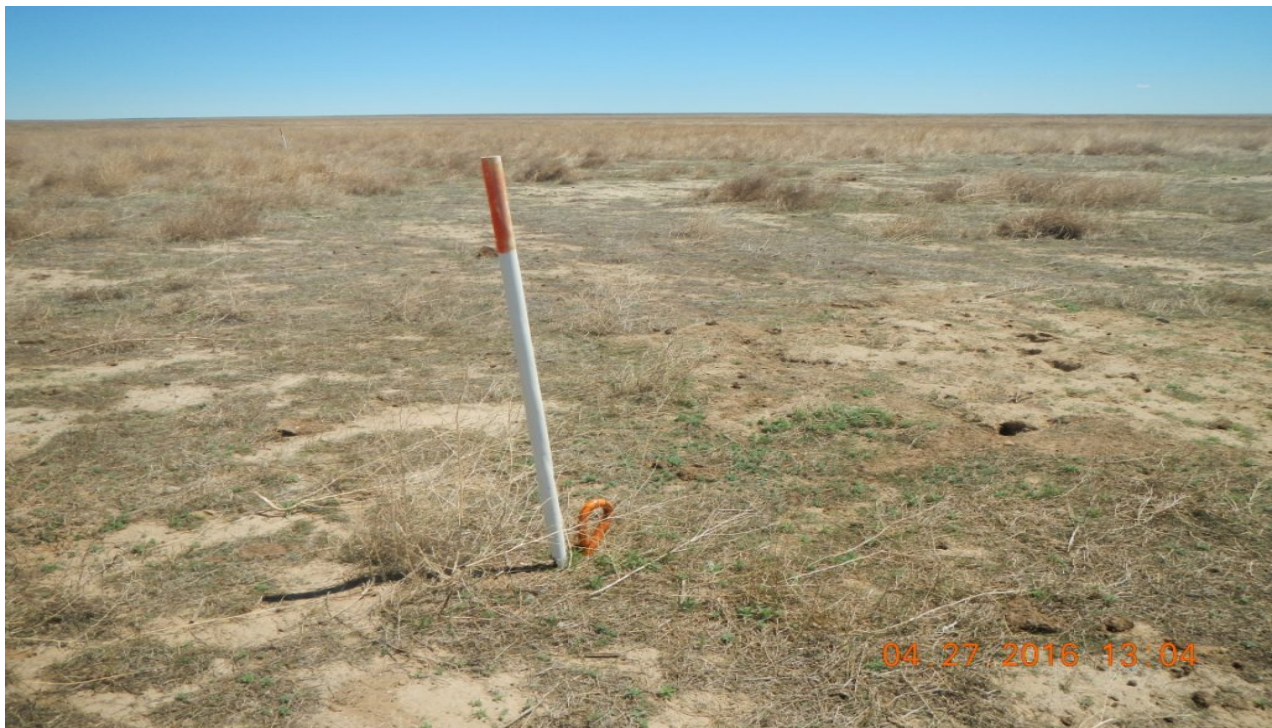
photo 2: Northwest corner facing east. All four guy line anchors are present.

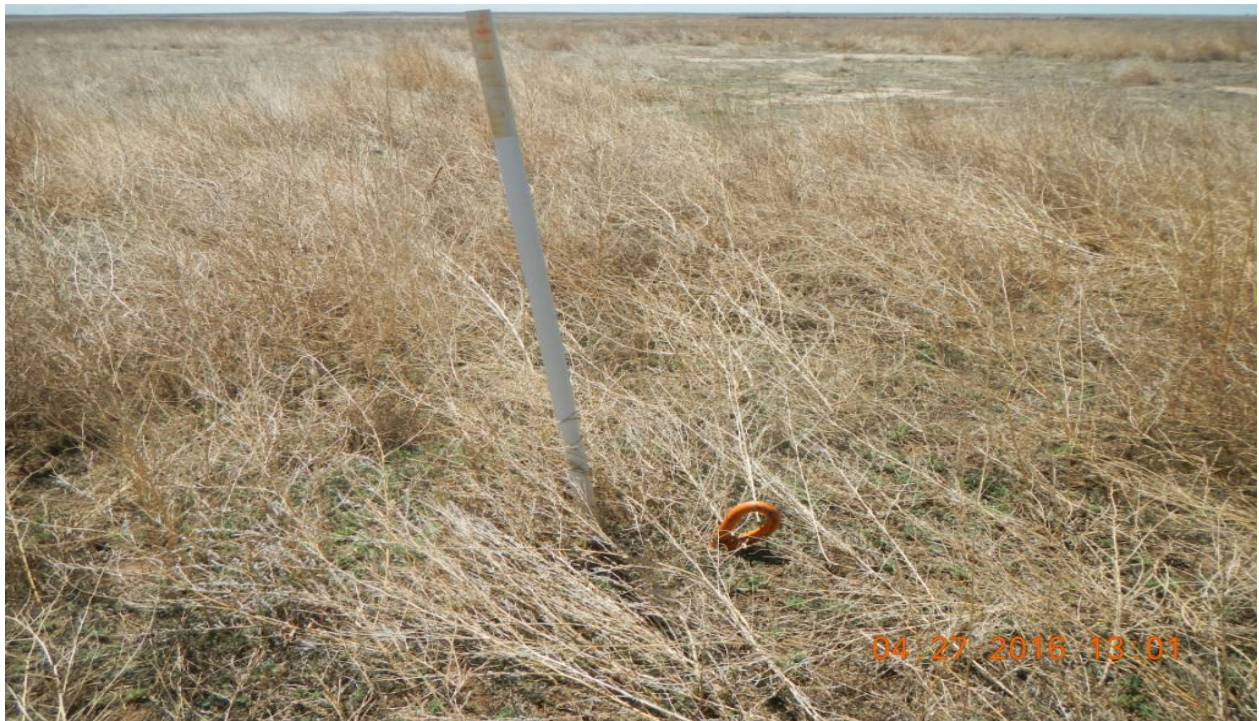
photo 3: Southeast guy line anchor.

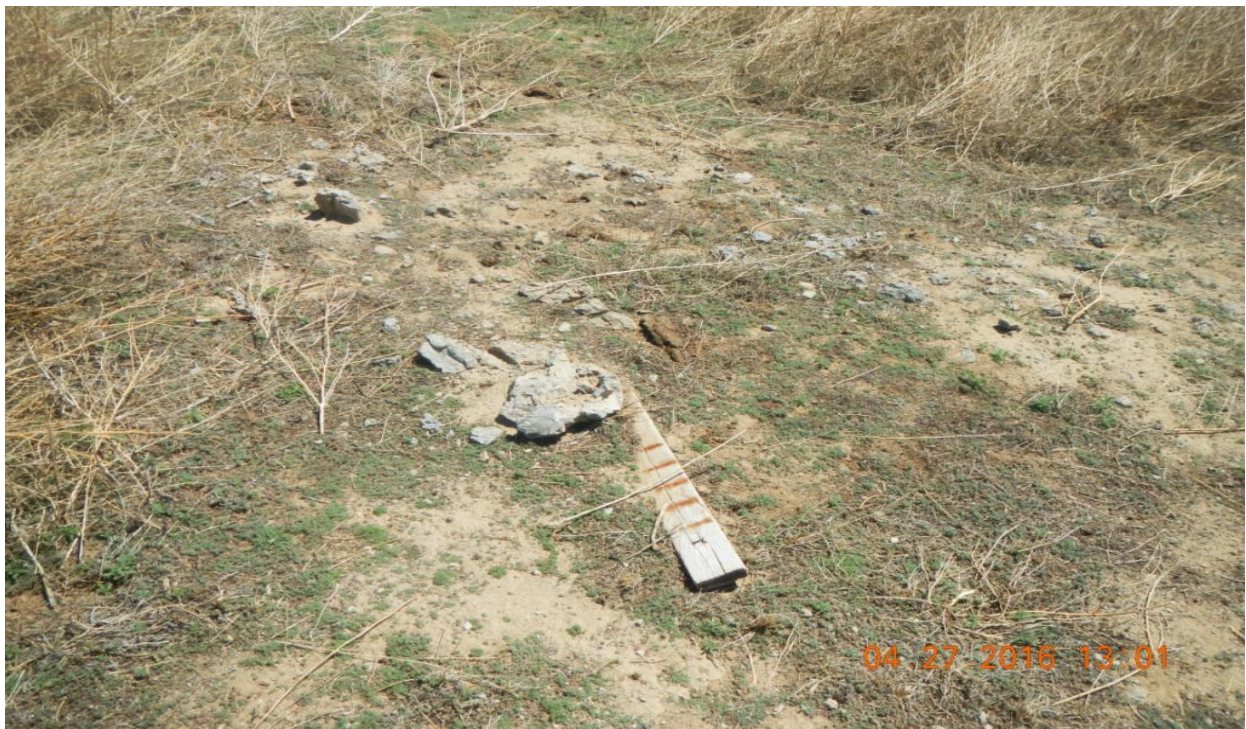
photo 4: Cement and a wood 2x4 debris noticed at the east side of the location.

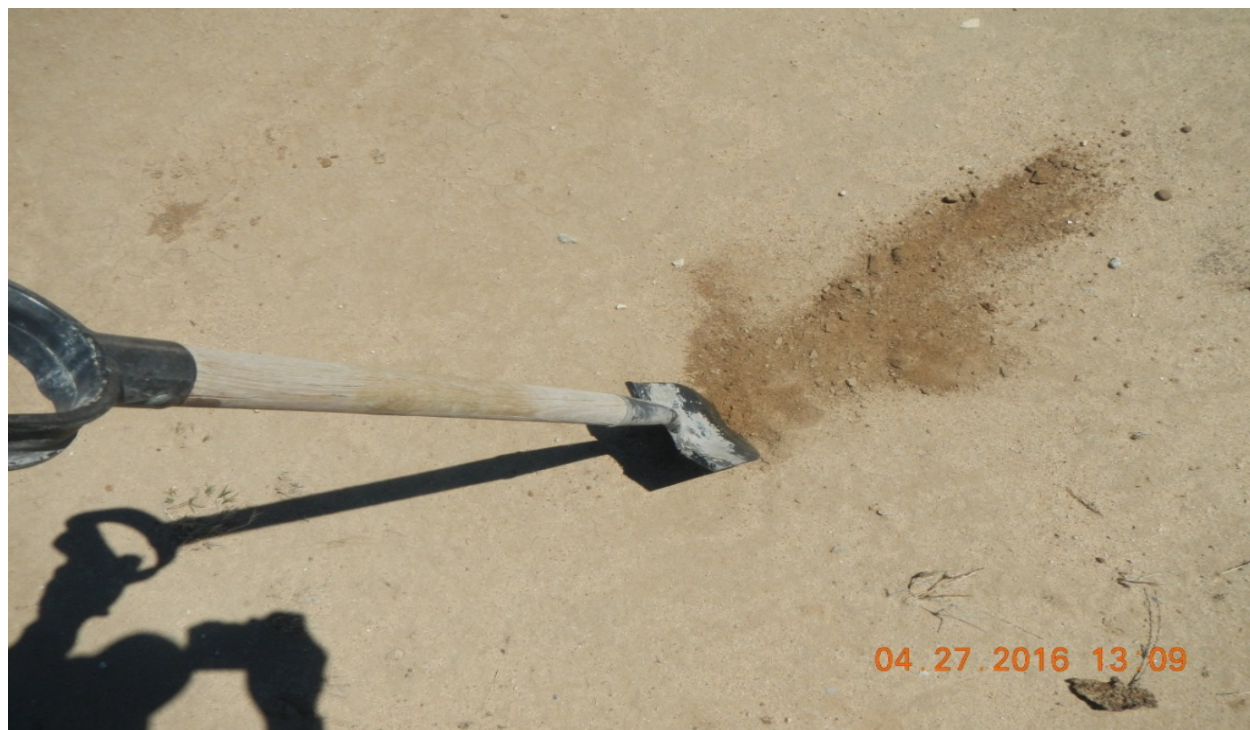
photo 5: Soils at the location seem to be compacted. The shovel could not penetrate the surface.

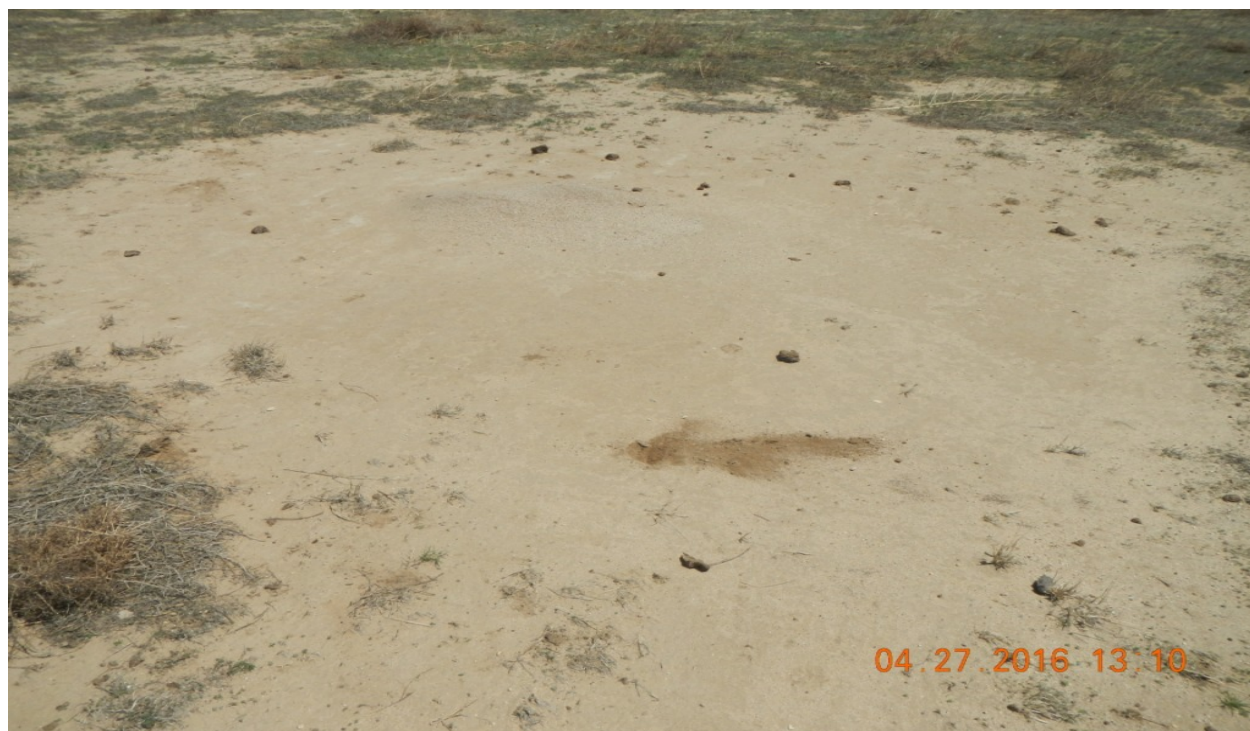
photo 6: View of area that seemed to have compacted soil. No vegetation growth noticed possibly due to compaction.
